INVITATION TO BID #2019-06
Engineering Services for 232nd Drive at MP 0.3 ("RFP")
RESPONSE TO CLARIFYING QUESTIONS
March 21, 2019

April 25, 2017

Geotechnical Site Visit
SE 232nd Drive Slide
Damascus, Oregon

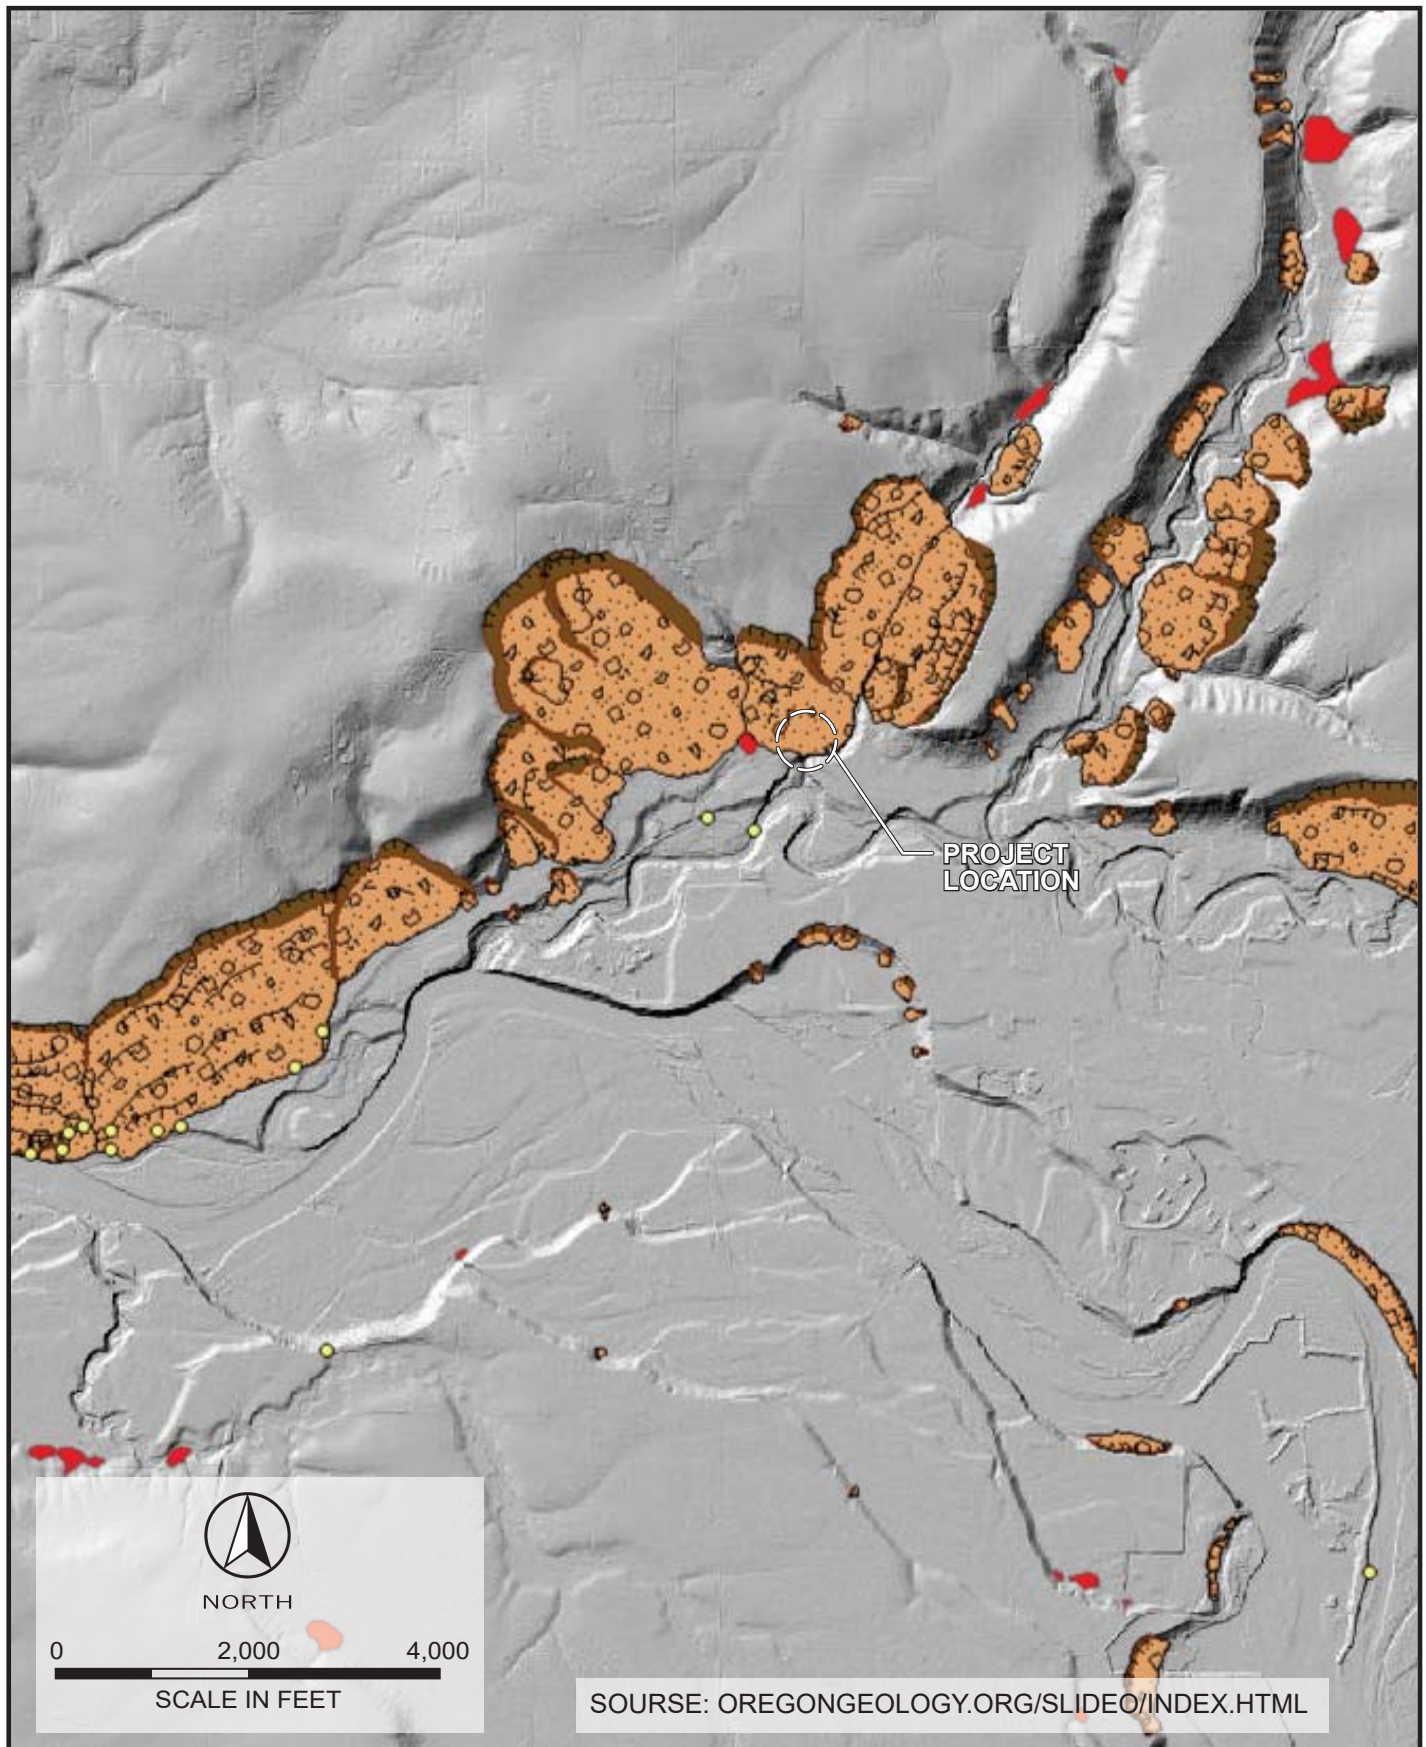
FIG. 2

portion of SE 232nd Drive crosses onto and traverses a previously mapped, large landslide complex (see Figure 2).

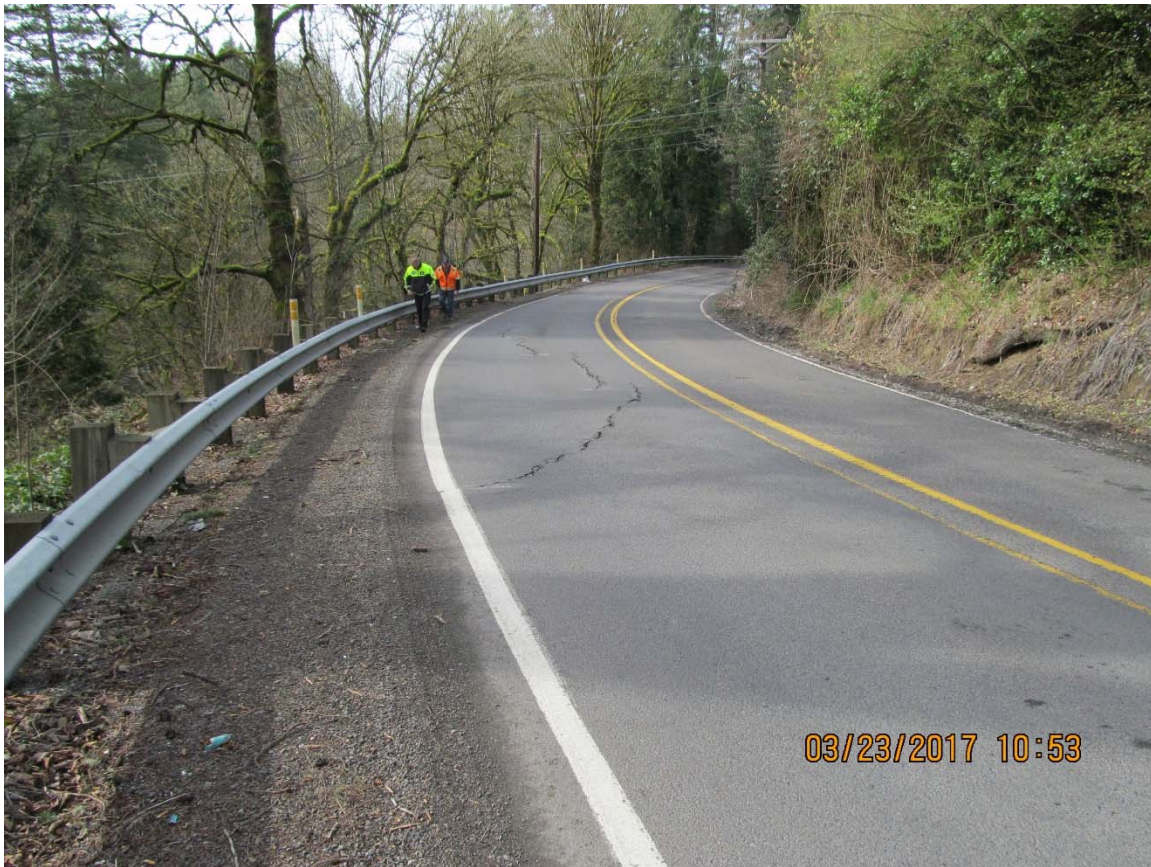
On March 23, 2017 pavement distress and signs of embankment slumping on the outboard side (northbound lane) of the roadway were observed and documented (see Photo Exhibit 1). Three sets of arcuate cracks in the pavement and slumping of the outboard edge of the roadway were observed over approximately 60 feet of northbound lane. Vertical displacement up to 1½-inches was observed in the pavement cracks (see Photo Exhibit 2). The maximum horizontal displacement observed in the pavement cracks was approximately 1-inch. The cracks extend up to nine feet into the northbound travel-lane from the fogline (roughly two feet from the centerline) as shown on Photo Exhibit 3. During our site visit, the cracks extended to the outboard fogline on the north end of the slump feature and stopped approximately two feet from the fogline on the south end. No cracks were observed extending into the shoulder or through the embankment. Evidence of a previous pavement overlay, approximately 85 feet in length, was observed on the northbound lane where the recent pavement cracks are located.

A. View looking south at recent pavement distress and roadway embankment slumping on the northbound lane of SE 232nd Drive.

We recommend that Clackamas County pursue Option 2. This concept to reinforce the upper road embankment and help control surface runoff and shallow groundwater is a concept that requires further evaluation and engineering to implement. Option 2 would need subsurface explorations that could likely be investigated using test pits to assist with final design. In the interim, if the County feels that pavement distress and roadway shoulder has deteriorated to a point that they present a relative hazard to the traveling public, the northbound travel-lane could temporarily be replaced with gravel and monitored on a regular basis to allow continued use.

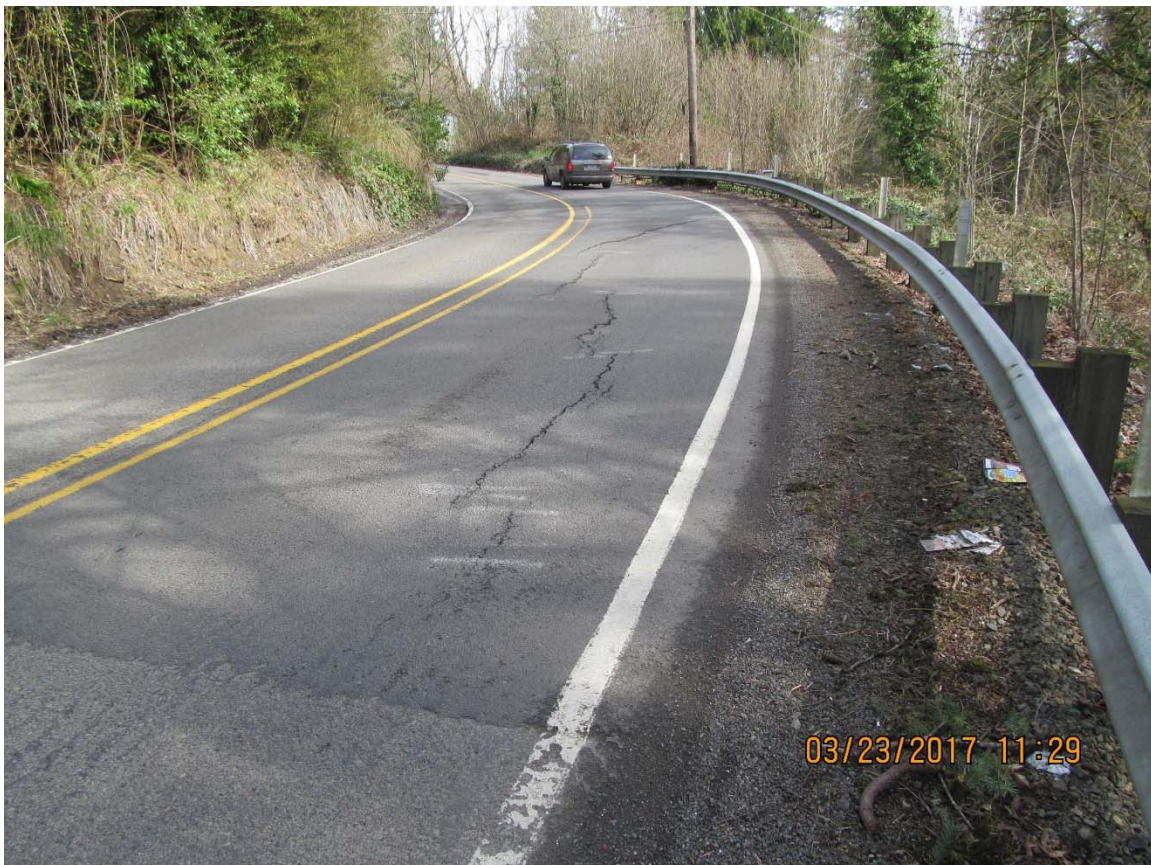
B. View looking north at recent pavement distress and roadway embankment slumping on the northbound lane of SE 232nd Drive.

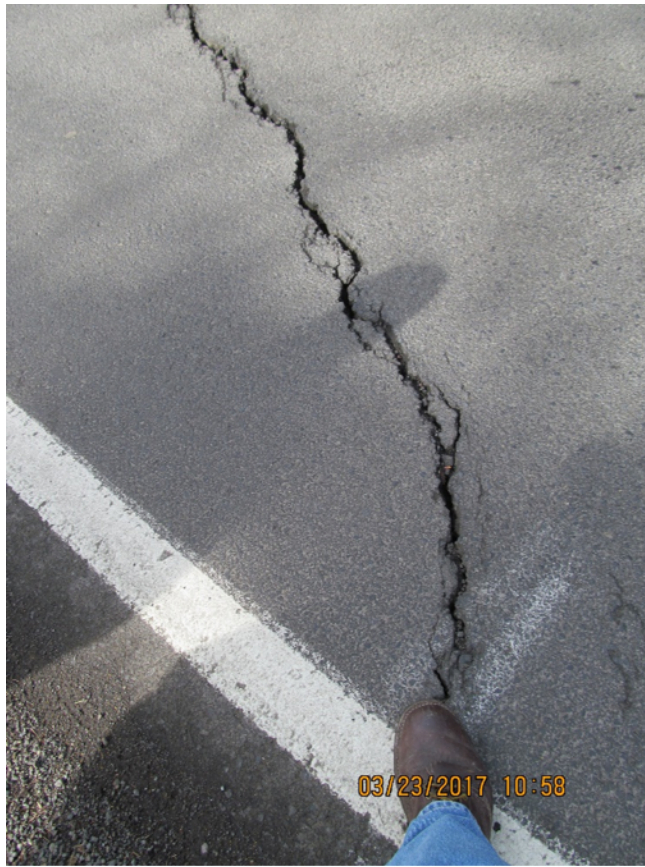
A. View of recent cracks in pavement at the fogline on the north end of the northbound lane.

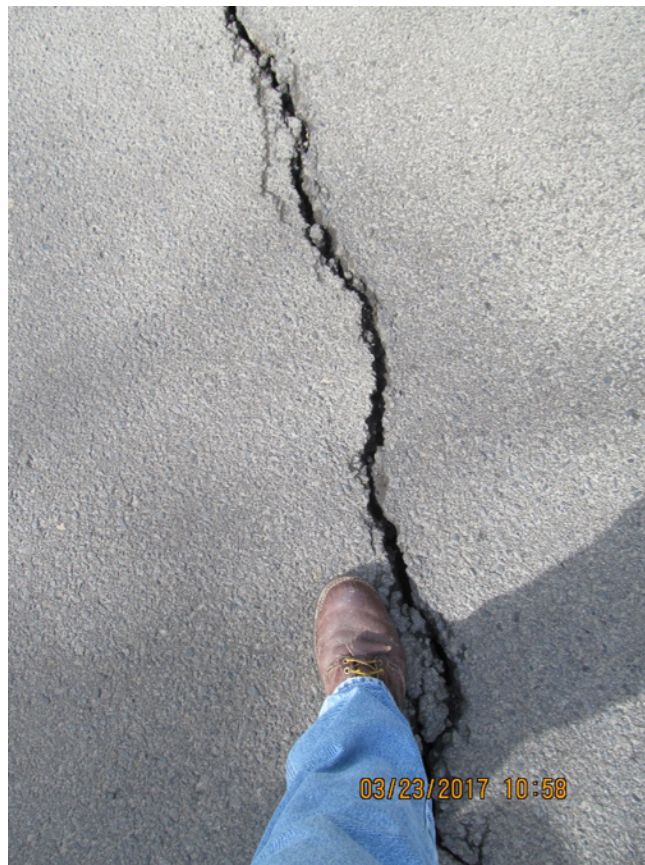
B. View of recent cracks in pavement on the northbound lane.

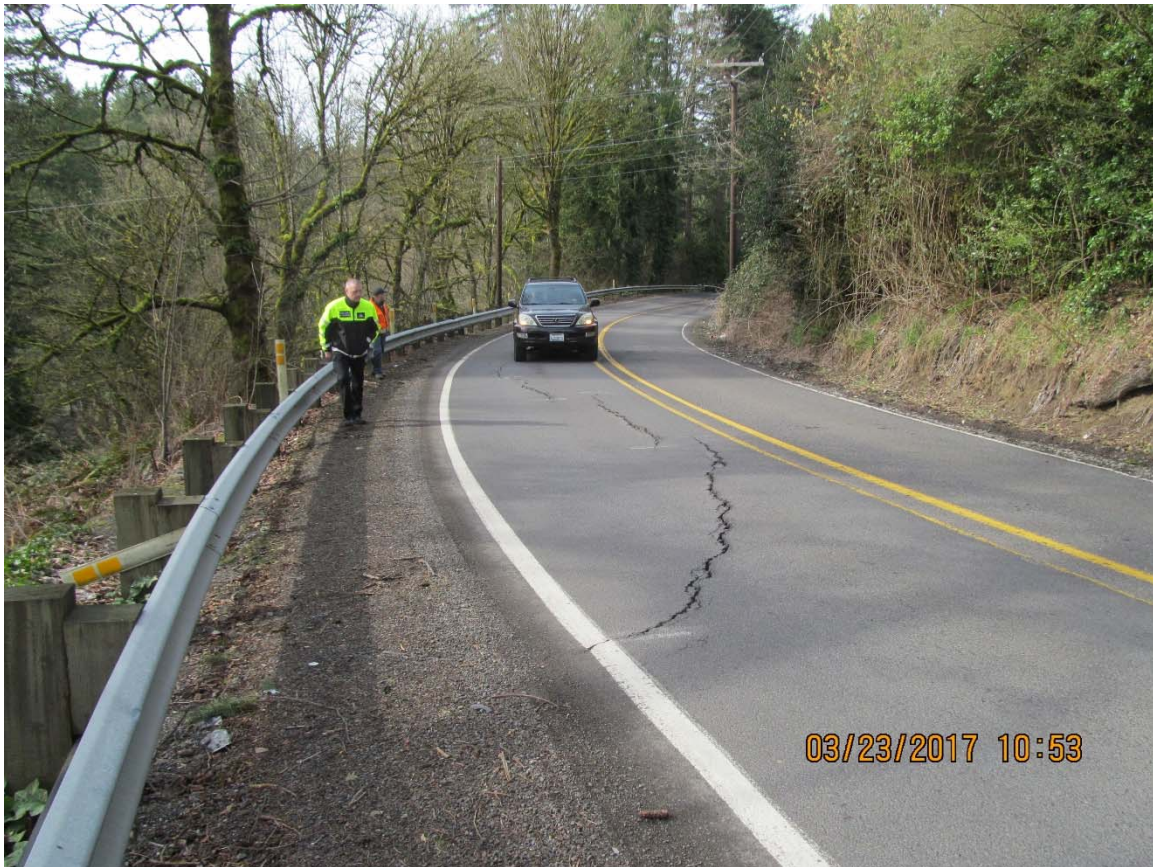
A. Up close view looking south at recent pavement distress and roadway embankment slumping on the northbound lane of SE 232nd Drive. Note distance to centerline

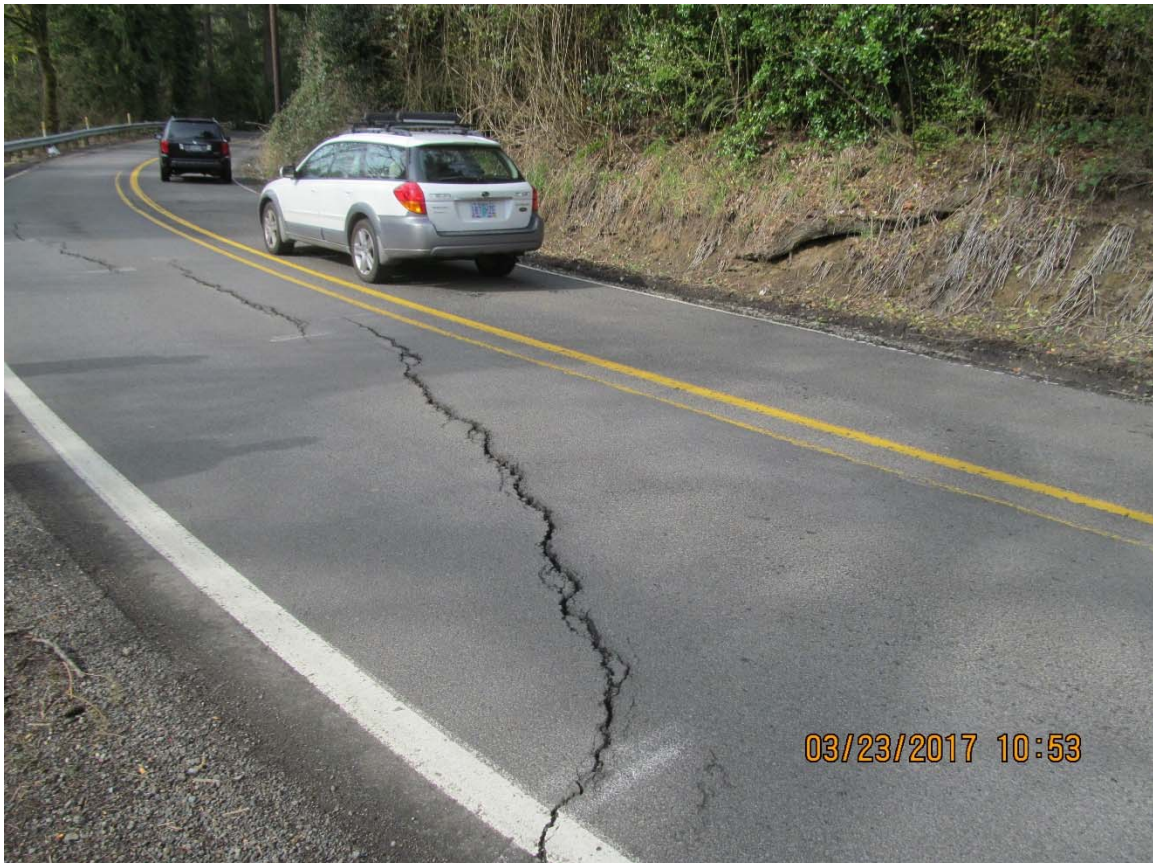
B. Up close view looking southwest at pavement cracks associated with roadway embankment slumping on the northbound lane of SE 232nd Drive.

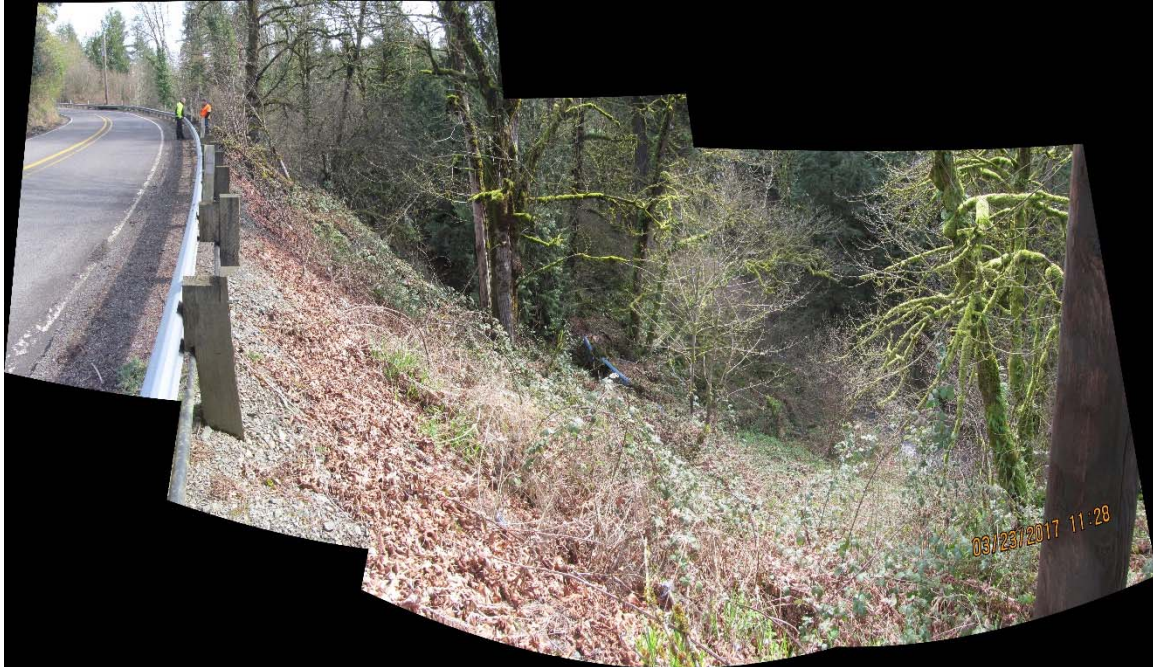
The outboard slope of the road embankment and the natural slope below the road embankment are moderately steep to steep (24° to 40° inclination from horizontal), as shown on Photo Exhibit 4A. Noyer Creek runs along the toe of the natural slope below the road embankment (see Photo Exhibit 4B). The creek is approximately 130 feet (horizontal distance) and 87 feet (vertical distance) from the edge of the road shoulder. A major seep was observed flowing from the slope, approximately 40 feet (horizontal distance and vertical distance) from the slope below the road (see Photo Exhibit 4B). This seep may be associated with the contact between embankment fill and native Troutdale material.

A. View looking north at outboard shoulder of the roadway embankment and the natural slope. Note the creek at the toe of the slope on the right-hand side of the photo.

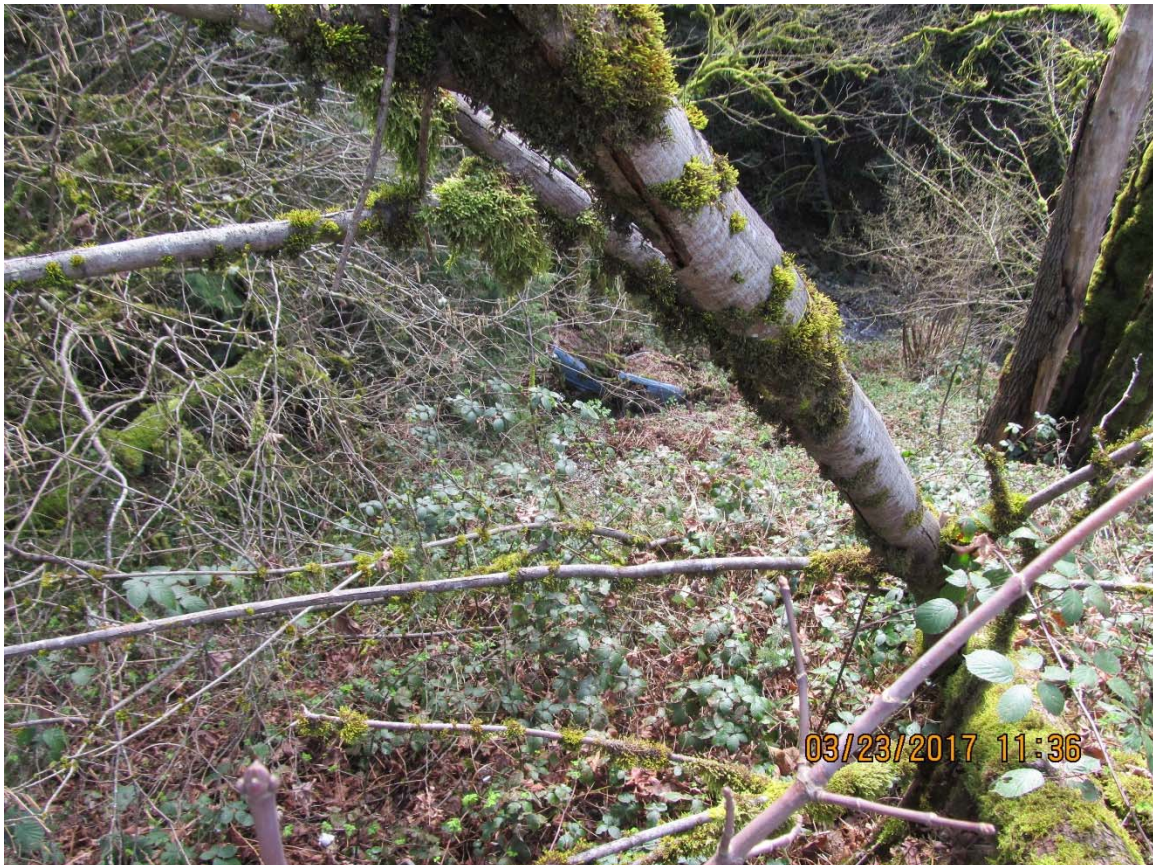
B. View looking down the road embankment (east). Note seep flowing from the slope just below the car body in the photo.

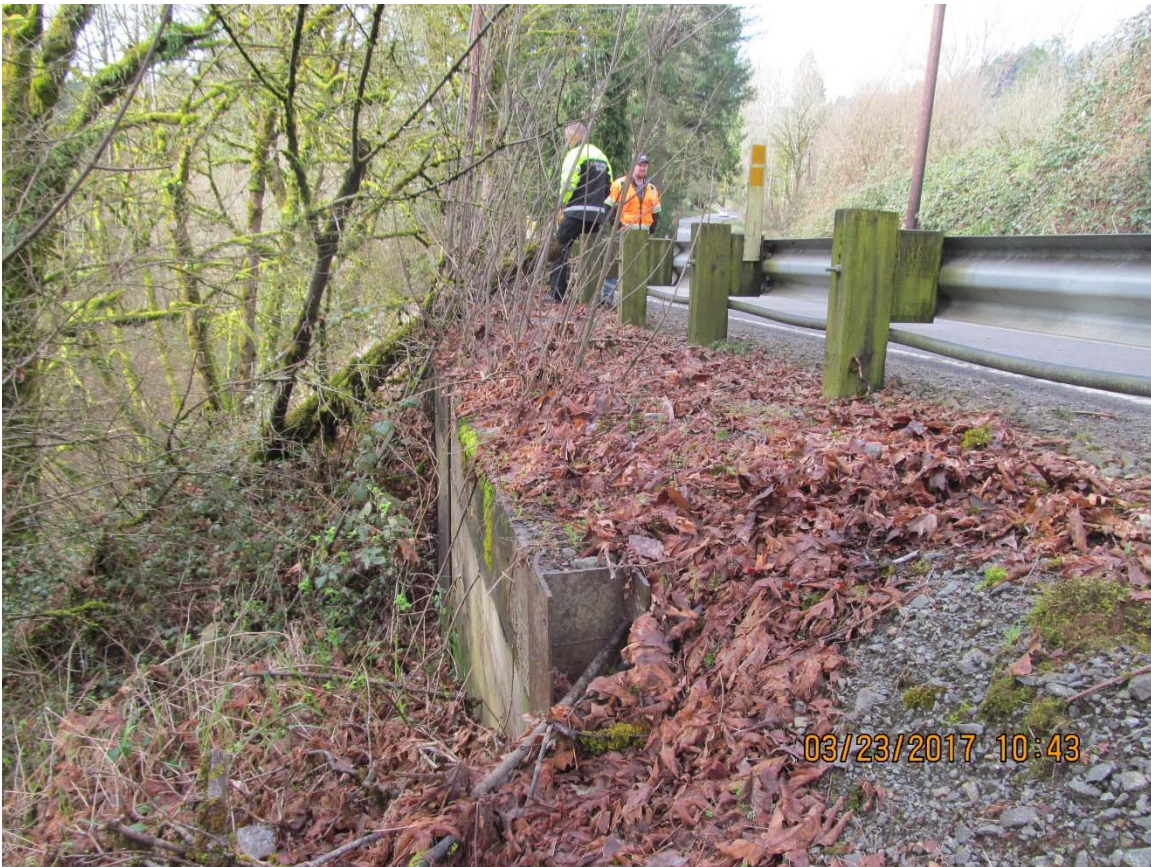
An existing cantilever soldier-pile wall with timber lagging was observed on the outboard edge of the roadway seven feet from the southern limits of the recent cracks in the pavement (see Photo Exhibit 5). The County was not sure when this approximately 32-foot long wall was constructed. The maximum exposed height of the wall is approximately 7½ feet. It is unclear how deep the soldier piles extend below the ground surface. The section of road that the soldier-pile road supports shows no signs of distress. A 2-inch steel pipe was observed attached to the underside of the wooden offset blocks on the guardrail that runs along the section of the road (see Photo Exhibit 6). A sign attached to the steel pipe indicated that it is a private waterline. It is unclear where this waterline originates or ends.

A. View looking south at the existing cantilever soldier-pile wall with timber lagging on the outboard edge of the roadway immediately south of the active slide area.

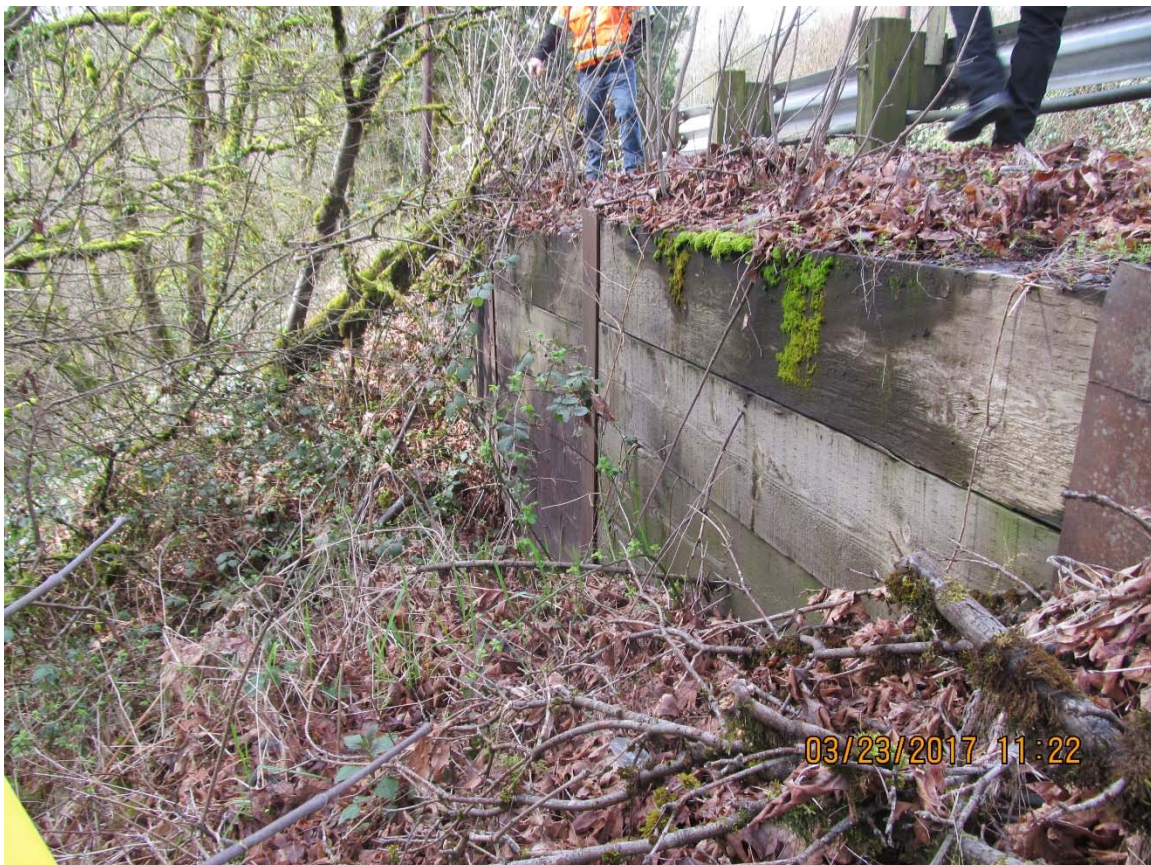
B. View looking south at the existing soldier-pile wall on the outboard edge of the roadway immediately south of the active slide area.

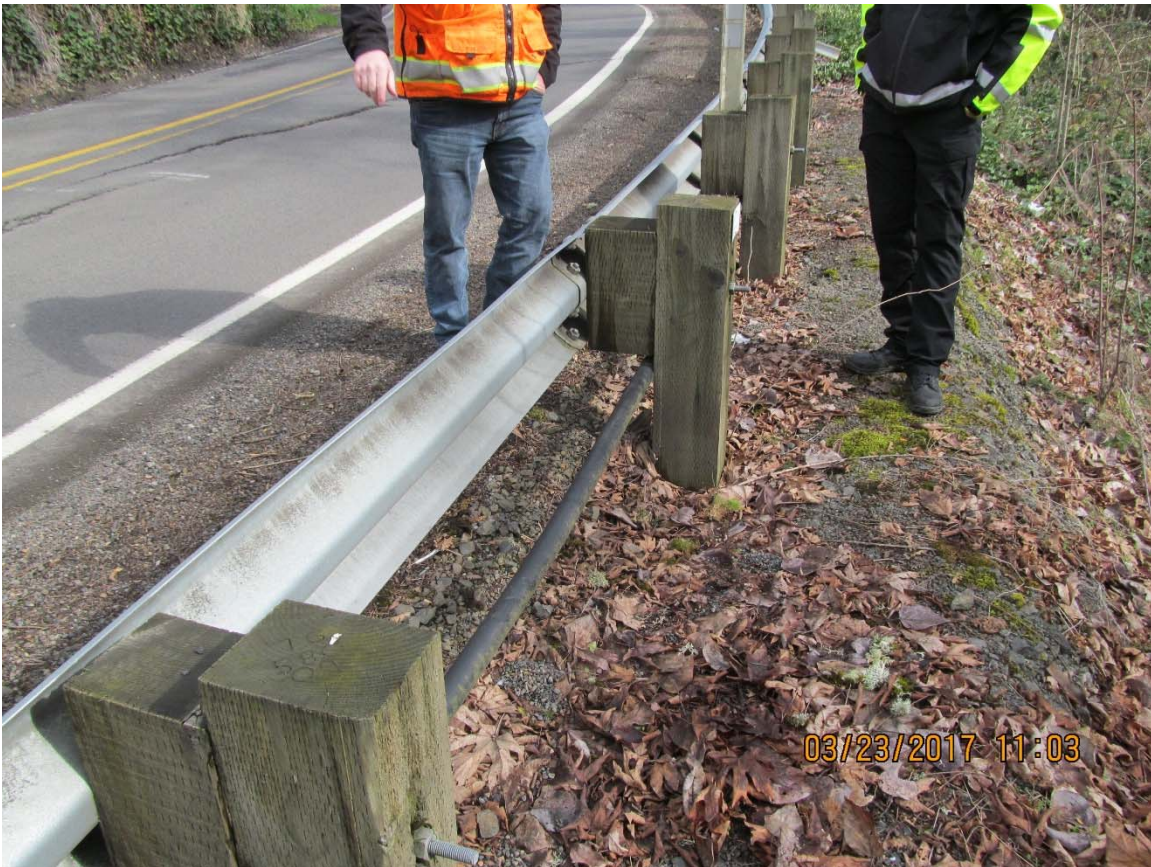
A. View looking northwest at the 2-inch waterline attached to the underside of the guardrail along the section of the road adjacent to the slide area and the soldier-pile wall.

Option 1 – Pavement Overlay, Monitor, and Remove the Existing Above Ground Waterline. This option consists of applying another pavement overlay and monitoring the slide activity on a regular basis via visual observations (i.e. pavement distress and shoulder slumping/sloughing) during the rainy season. This option will do nothing to improve stability of the roadway embankment or reinforce the pavement. This option would only improve the pavement surface so northbound vehicles would be less likely to swerve into the southbound (downhill) traveling lane to avoid the distress in the northbound lane. Based on past performance of overlays in this area, the useful life of the road surface would likely be less than five years, and may need mitigation within a year. In addition, there is a potential that the roadway embankment could fail to the point where it represents a hazard to the traveling public and/or necessitate the closure of the road. If this option is selected by the County, we recommend that the 2-inch water attached to the underside of the guardrail along the section of the road be removed. Deformation of the guardrail due to increased landslide

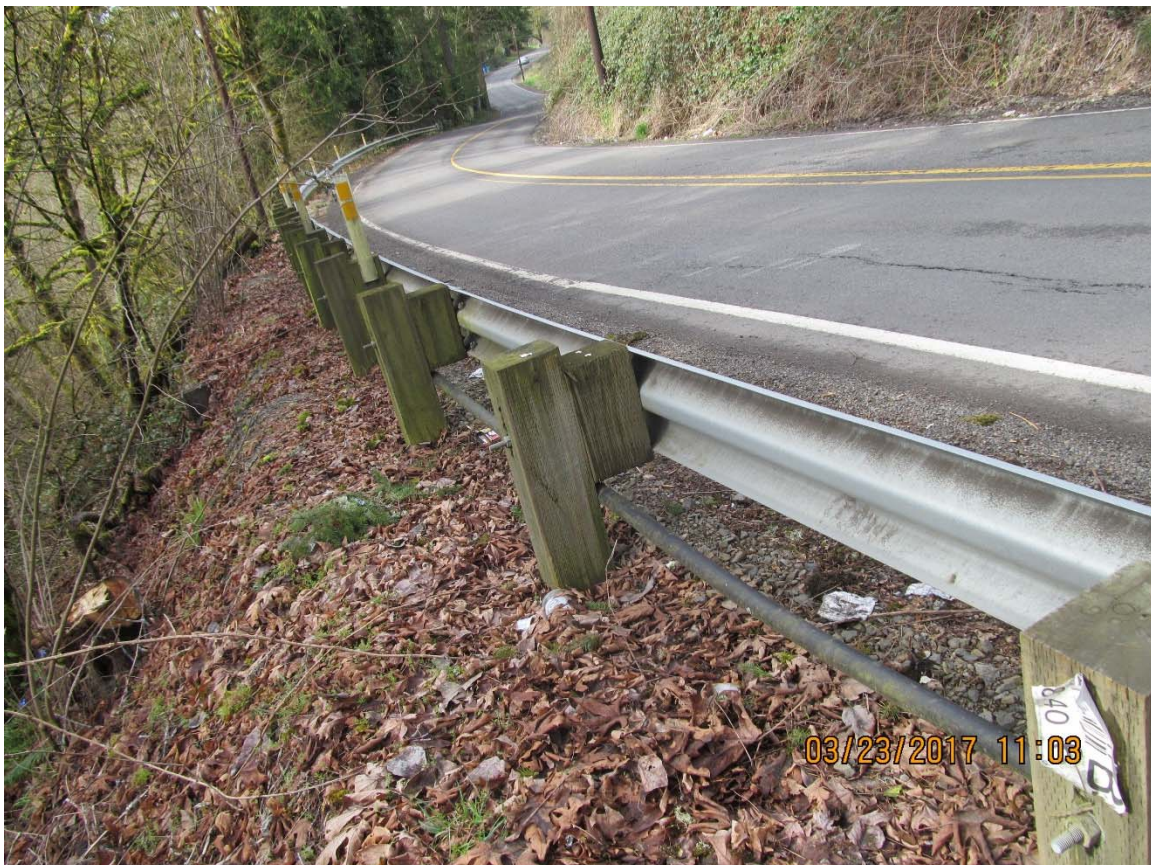
B. View looking southeast at the 2-inch waterline attached to the underside of the guardrail along the section of the road adjacent to the slide area and the soldier-pile wall.
