# Oak Lodge and Gladstone Community Project - Concord Property MEP Assessment

NCPRD Concord Property Community Center, Oak  
Lodge and Gladstone Libraries Planning (Opsis)  
2019-0467

**October 16, 2019**

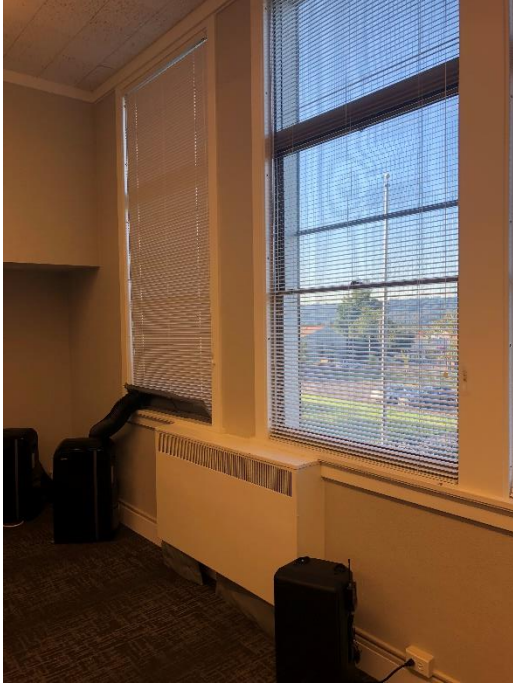
Photo M1: Classroom unit ventilation

Since the existing system is steam based without cooling or adequate ventilation, we propose a new HVAC system be provided and the existing system be demolished. The new system will need to be integrated without affecting structural systems. The proposed system will be a variable refrigerant flow (VRF) heat pump system with heat recovery ventilators (HRV) for dedicated outdoor air. The VRF heat pumps will likely be ground mounted while the fan coils are ducted above ceilings where possible or floor mounted if necessary. The HRV's can be roof mounted or inside the building. The estimated budget cost for demo and a new VRF system is \$39/SF.

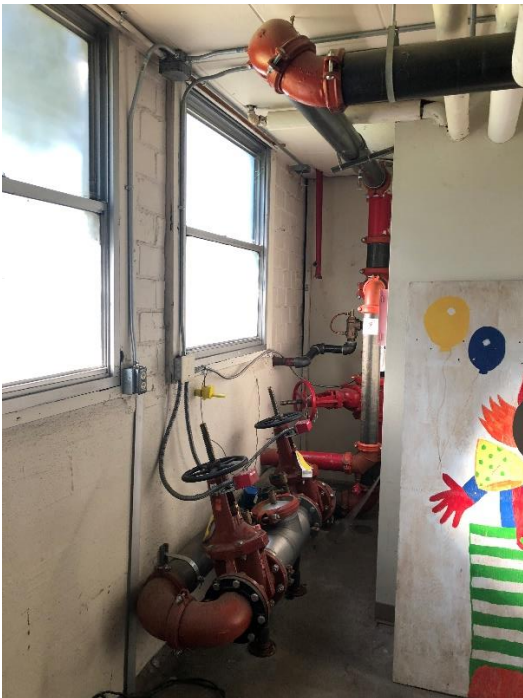
The building is served by a wet pipe sprinkler system which can be modified for the new program changes. The fire service is 6" and the fire main reduces to 5".

Photo M2: Fire sprinkler service

No changes are needed unless walls and ceilings are modified, then new/relocated heads will be required.

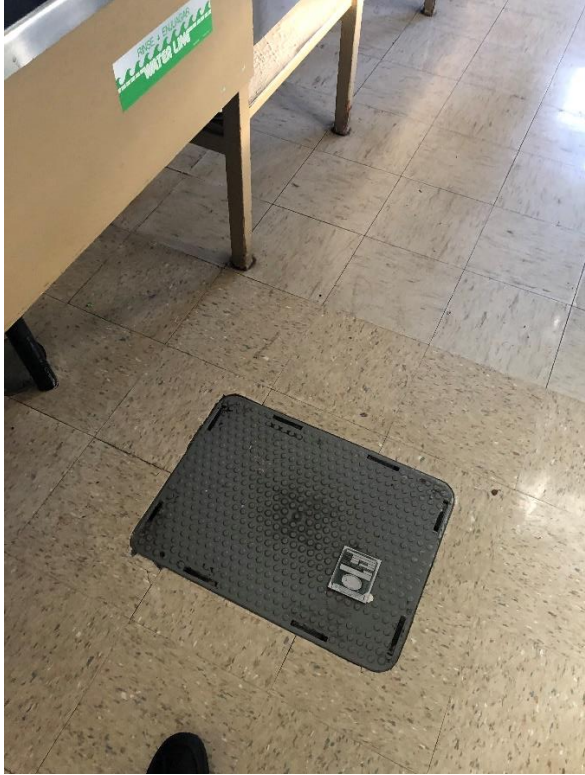
Photo M3: Kitchen grease interceptor

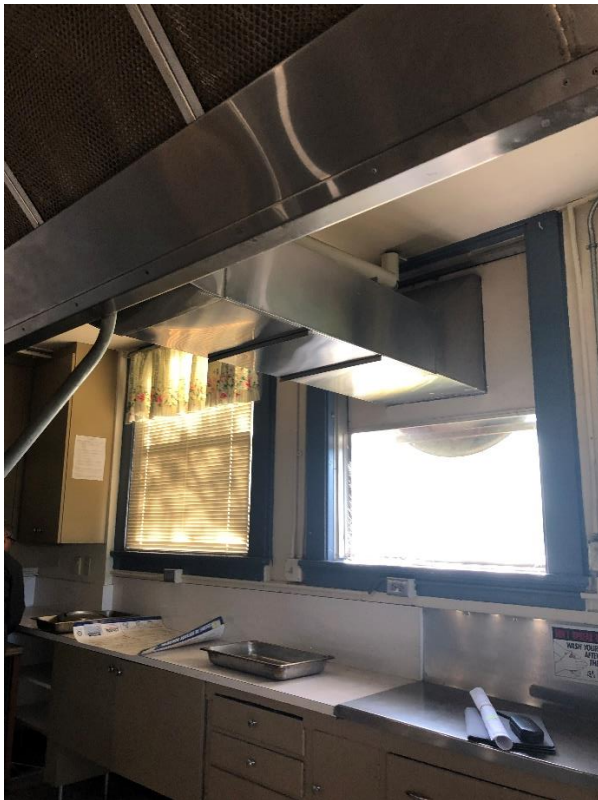
The controls are a combination of pneumatic and DDC. DDC controls are provided by Automated Logic. The kitchen area has a sidewall mounted grease exhaust fan but does not have dedicated makeup air for the exhaust.

Photo M4: Kitchen grease fan/duct

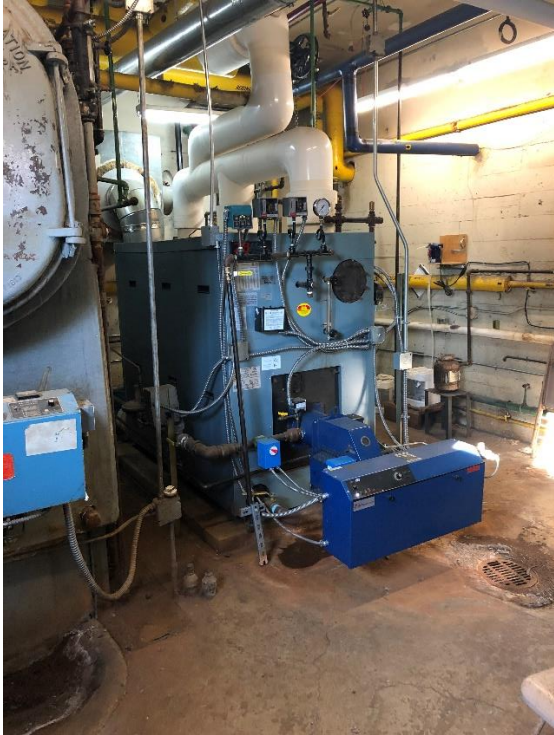
The Building is served by a 2718 mbh cast iron natural gas steam boiler. It is common for older steam boiler systems to have heating efficiencies between 50 and 70% compared to current standard practice systems with efficiencies close to 90%. The steam system supplies heat to radiators, air handlers (AHU's), fan coils and unit ventilators. The steam also supplies a domestic hot water converter.

Photo M5: Steam boiler

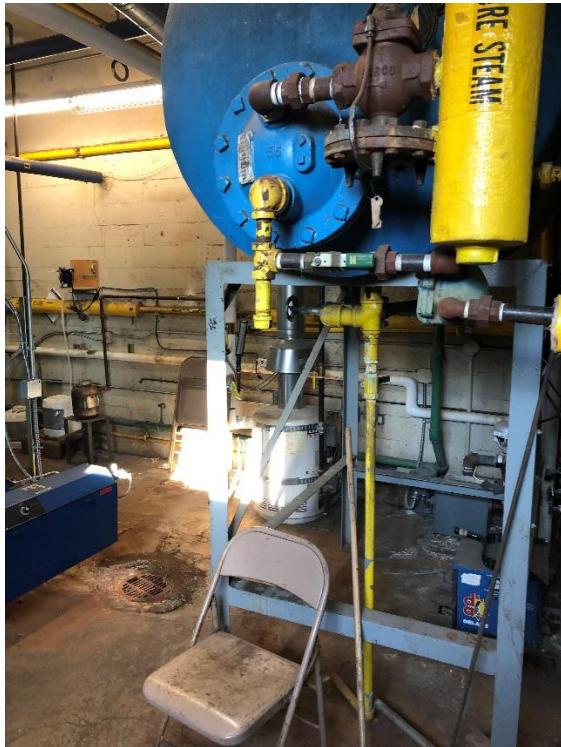
Photo P1: DHW Controller

The existing domestic cold-water system could remain with new plumbing fixtures provided. A new gas hot water heater and tank for the kitchen should be provided. The following budget number should be considered:

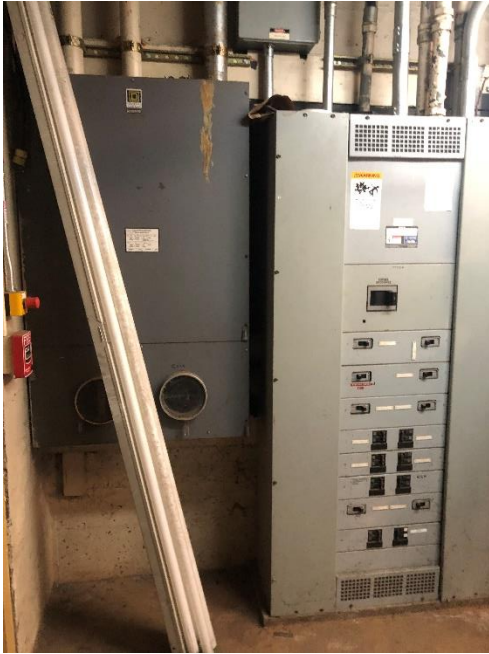
The main electrical service is located in the boiler room, and consists of a Siemens 800-amp, 240/120-volt, 1-phase, 3-wire switchboard (photo E1) installed in 1993 and consisting of molded case circuit breakers with adjustable settings on the main breaker. Power to this service is supplied by pole-mounted transformers on a nearby PGE utility pole to the east of the boiler room (photo E3). While the switchboard is in good condition, there is minimal capacity to add additional loads, and the service is not adequate to serve a code-compliant HVAC system for ventilation and cooling for a building of this size. There is also a separate 200-amp, 3-phase open-delta 240-volt service for the elevator (photo E2).

Photo E1: Existing main switchboard in boiler room.

For an electrical service upgrade sized to support a new VRF system and code-required added ventilation, the recommendation is for a 208Y/120-volt, 3-phase, 4-wire switchboard, 1600-amp with a main circuit breaker. This switchboard would likely be in an NEMA 3R enclosure on the exterior of the building by the boiler room, allowing it to easily backfeed existing loads by using the old switchboard enclosure as a splicing point after the breakers and busway are removed. The outdoor switchboard would be served by an underground service lateral from a new outdoor pad-mounted utility transformer to replace the current overhead service. A buck-and-boost transformer will be needed for connecting the elevator to the new service.

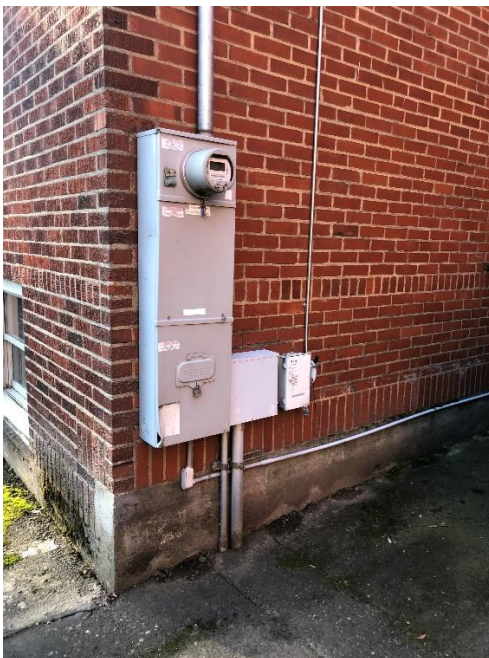
Photo E2: Separate three-phase, open delta service for elevator

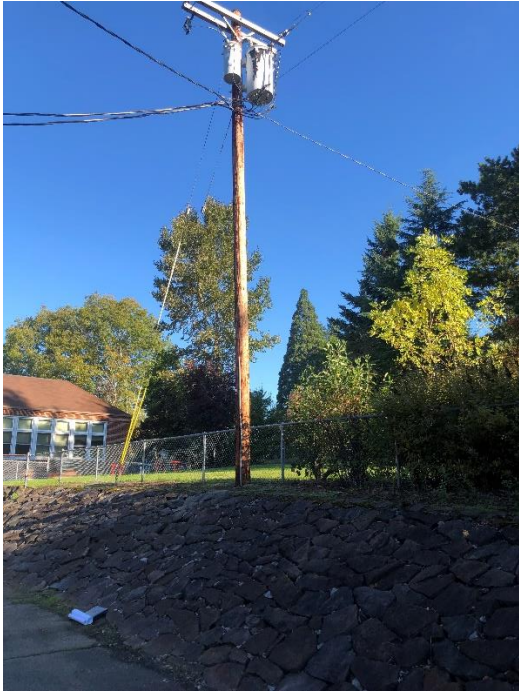
Photo E3: Outdoor pole-mounted transformer serving electrical services

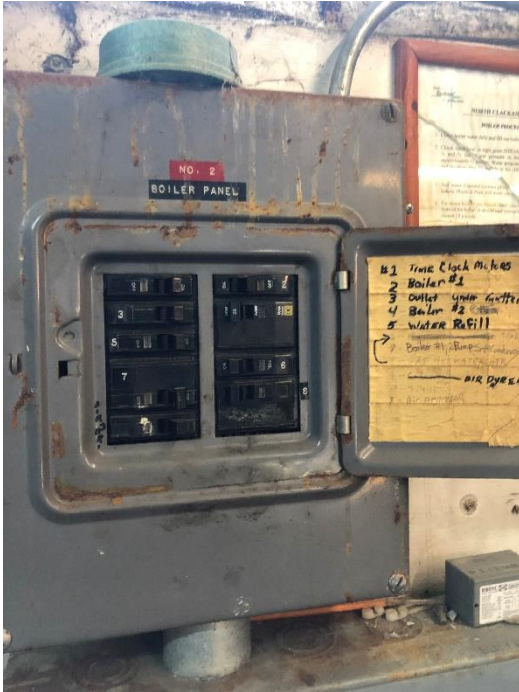
Panelboards in the building vary in age and condition, with the newest ones being Siemens panels installed in 1993 and 1999 for classroom lights and outlets, and older load centers in poor to fair condition in the kitchen and other miscellaneous spaces. Panels and load centers that predate the 1993 remodel are questionable for the ability of their breakers to safely clear a short circuit (photo E4).

Photo E4: Example of older load centers in kitchen area

If electrical improvements are limited to adding outlets for 240-volt and 120-volt power outlets and equipment for maker spaces and workshops and supporting exhaust fans, then the existing service is adequate to serve those needs, provided that the panels pre-dating the 1993 remodel are replaced. Estimated cost: \$25,000 for an allowance of up to five panelboards replaced one-for-one or added, including labor to reconnect existing circuits.

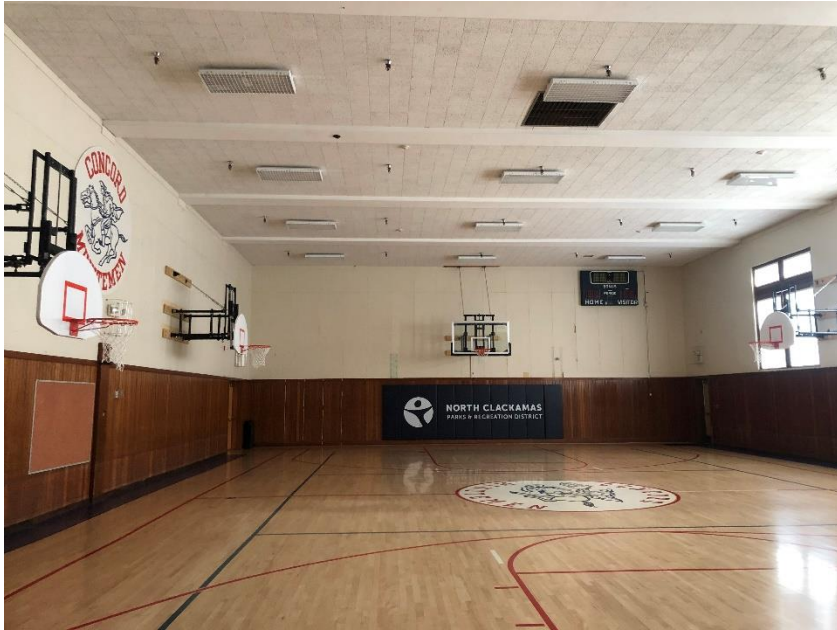
The existing lighting systems is in fair to good condition, and consists of T8-based fluorescent lighting, surface mount and suspended acrylic lensed luminaires in the corridors and classrooms, and surface mounted multi-lamp luminaires with wireguard in the gym (photo E5). Much of this lighting appears to date from the early 1990s. While relatively energy efficient, there are signs that some luminaires requiring ballast and lamp replacement. Most exit signs show signs that they need battery replacement.

Photo E5: Gym Lighting

We do not recommend reusing any of the existing lighting or lighting control systems in the renovated areas. Converting all interior lighting to LED is recommended because of the substantial Energy Trust incentives of between \$50 and \$75 per luminaire. Upgrading the lighting control systems are recommended because the current system does not allow for code compliant occupancy and daylight harvesting controls.

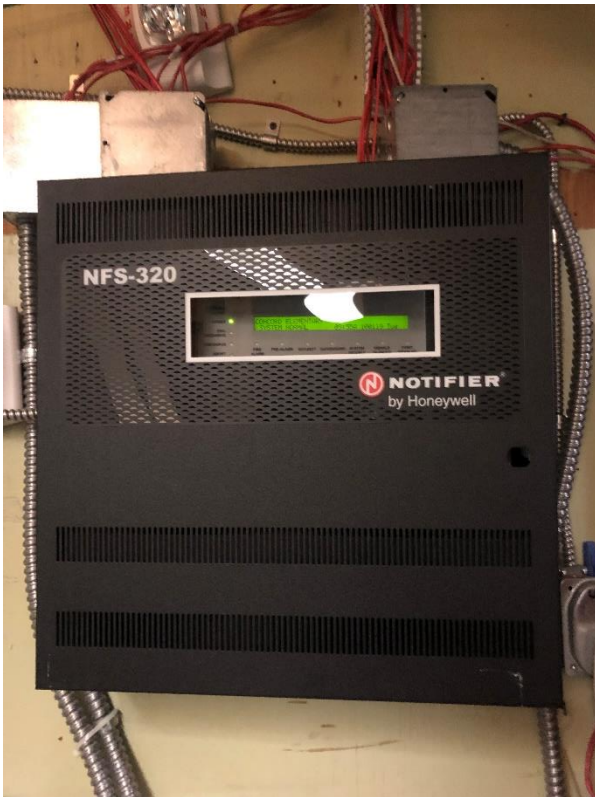
The existing fire alarm system (photo E6) is in good condition and is suitable for reuse. Additional booster panels for the horn/strobe notification devices will be required within the main building because only bare bones signaling devices have been installed within the vacant areas. To accommodate the new physical education building a new fire alarm sub panel will need to be installed and connected to the main fire alarm panel.

Photo E6: Existing Fire Alarm Panel

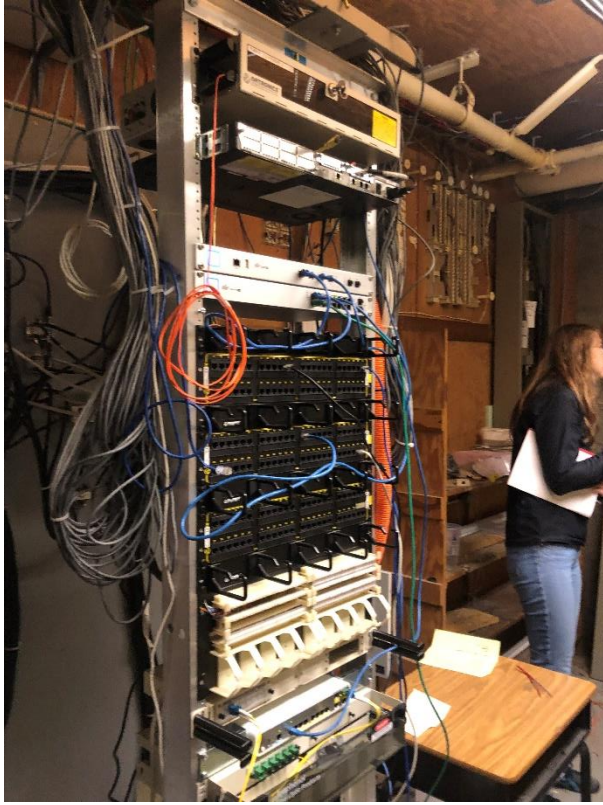
Photo E7: Existing main telecom rack

The existing telecommunications service (photos E7 and E8) to the building should be replaced with single-mode fiber optic, and for a building of this size, we anticipate needing a main telecom room and one satellite wall-mounted rack connected by single mode fiber optic backbone, minimum 6-strand.
