Presentation Title: 902 Abernethy Road Property (aka Big Blue) Engineer Report

**FEASIBILITY AND FLOOD MITIGATION REPORT
FOR
BUILDINGS LOCATED AT
902 ABERNETHY ROAD
BIG BLUE AND UTILITY BUILDING
OREGON CITY, OREGON**

January 22, 2014
Kleinfelder Project Number: 138488

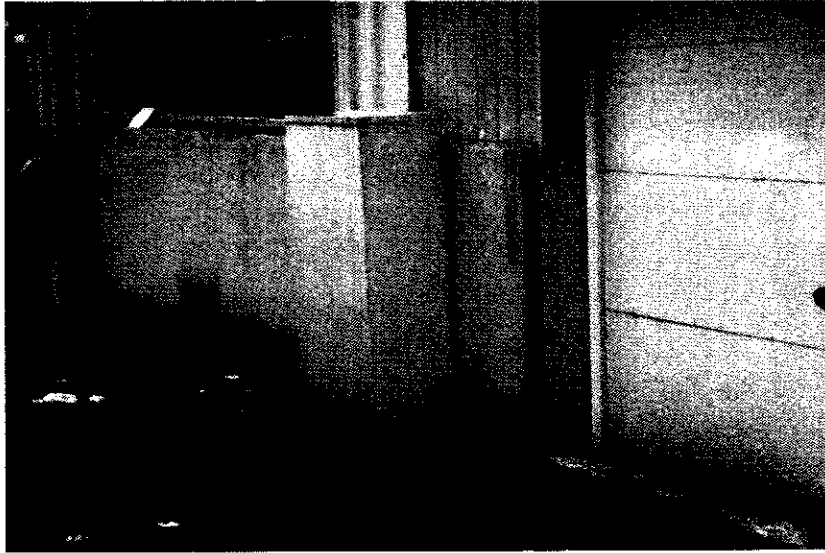
A 4'-0" high concrete wall was constructed in from Grid Line F-K in the maintenance area. This concrete wall is visible on the north and south elevations. The wall was constructed outside the steel frame system and is not part of the structural system. The wall was also noted inside at approximately column line F.

Big Blue Bldg. South Side, Concrete Wall – Photo 3

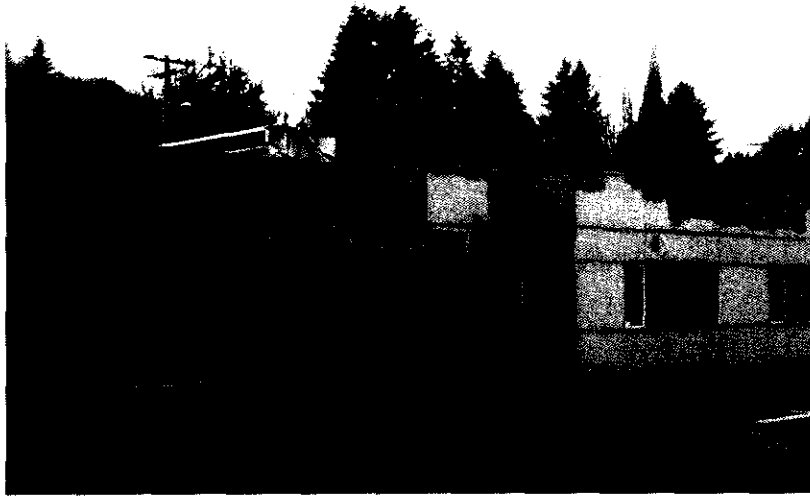
The exterior of the building is in fair to poor condition. Future use of the building should consider removal and reconstruction of the exterior walls.

Big Blue Main Front Entrance – Photo 9

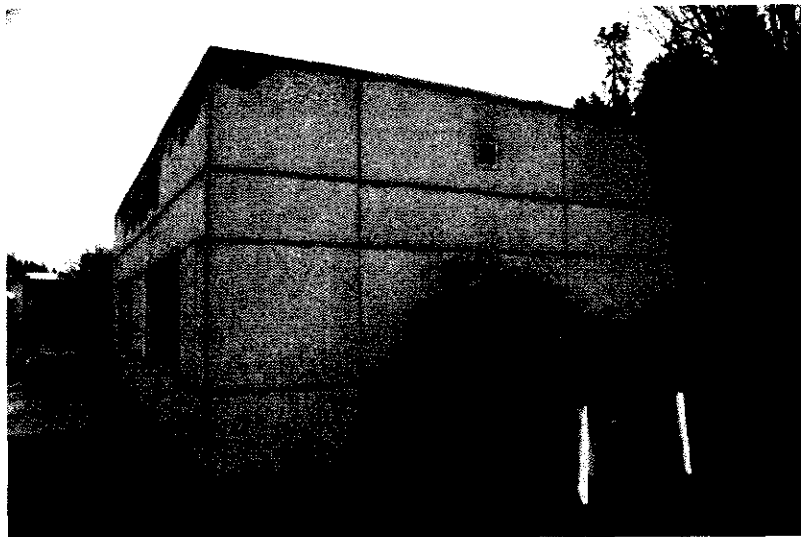
No structural damage was observed in the Utility Building. Similar to the Big Blue Building, all interior walls and surface need to be removed to eliminate mold. This would include the ceiling tiles and framing. The exterior siding of the building should be removed and replaced.

Utility Bldg. West Side 2 – Photo 12

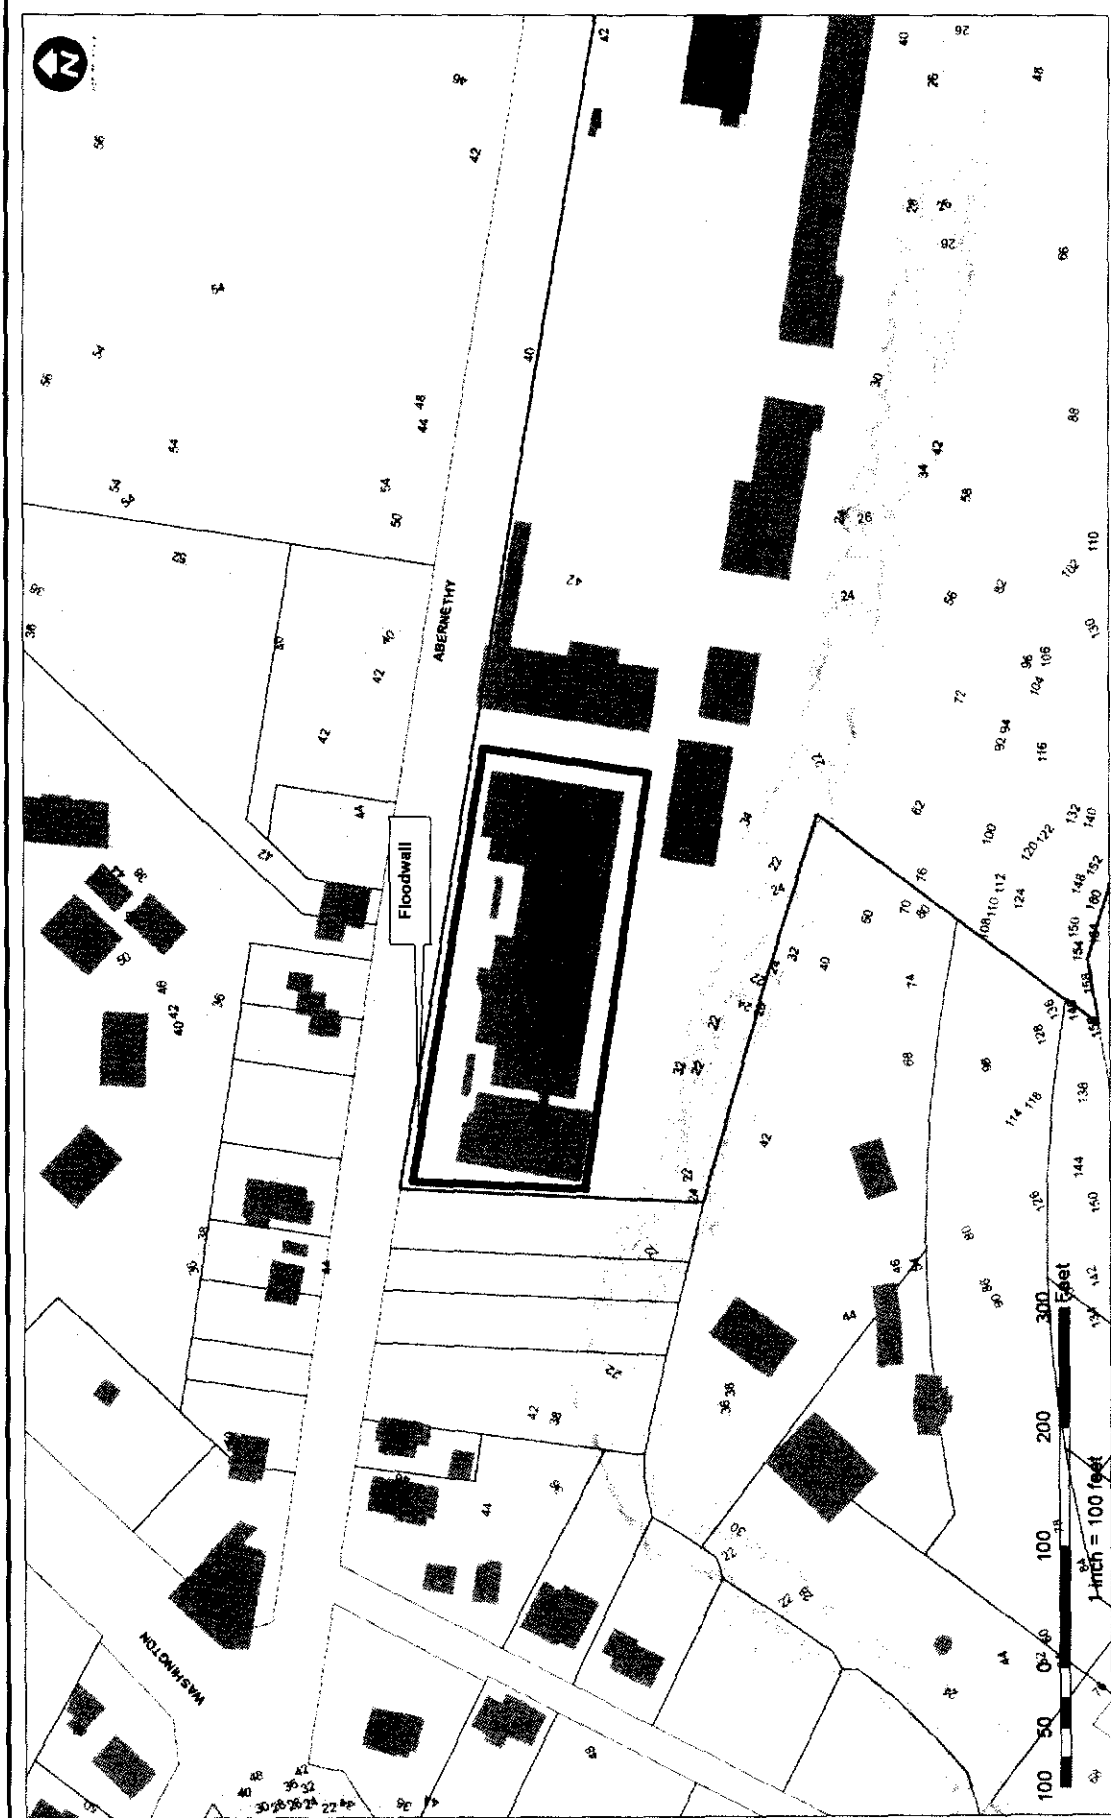
and trucks could drive onto the property. Figure 3 shows the approximate location of the floodwall. Because this would require construction in the 100-year floodplain and would affect the 100-year floodplain, a FEMA Conditional Letter of Map Revision (CLOMR) and Letter of Map Revision (LOMR) and a Clackamas County Floodplain Development Permit (FDP) would need to be acquired.

For Alternative 1 - Floodwall, a County FDP, a FEMA CLOMR, and a FEMA LOMR will be needed. A conceptual cost was generated (see Table 1), and the estimated cost of Alternative 1 would be about \$3,043,635. This alternative would be acceptable only if there is sufficient time and a warning system is in place to allow people in the buildings to leave before flood waters made travel from the property unsafe.
