# OAK LODGE AND GLADSTONE COMMUNITY PROJECT

## TECHNICAL ANALYSIS

# **BUILDING ASSESSMENT**

## **CONCORD PROPERTY**

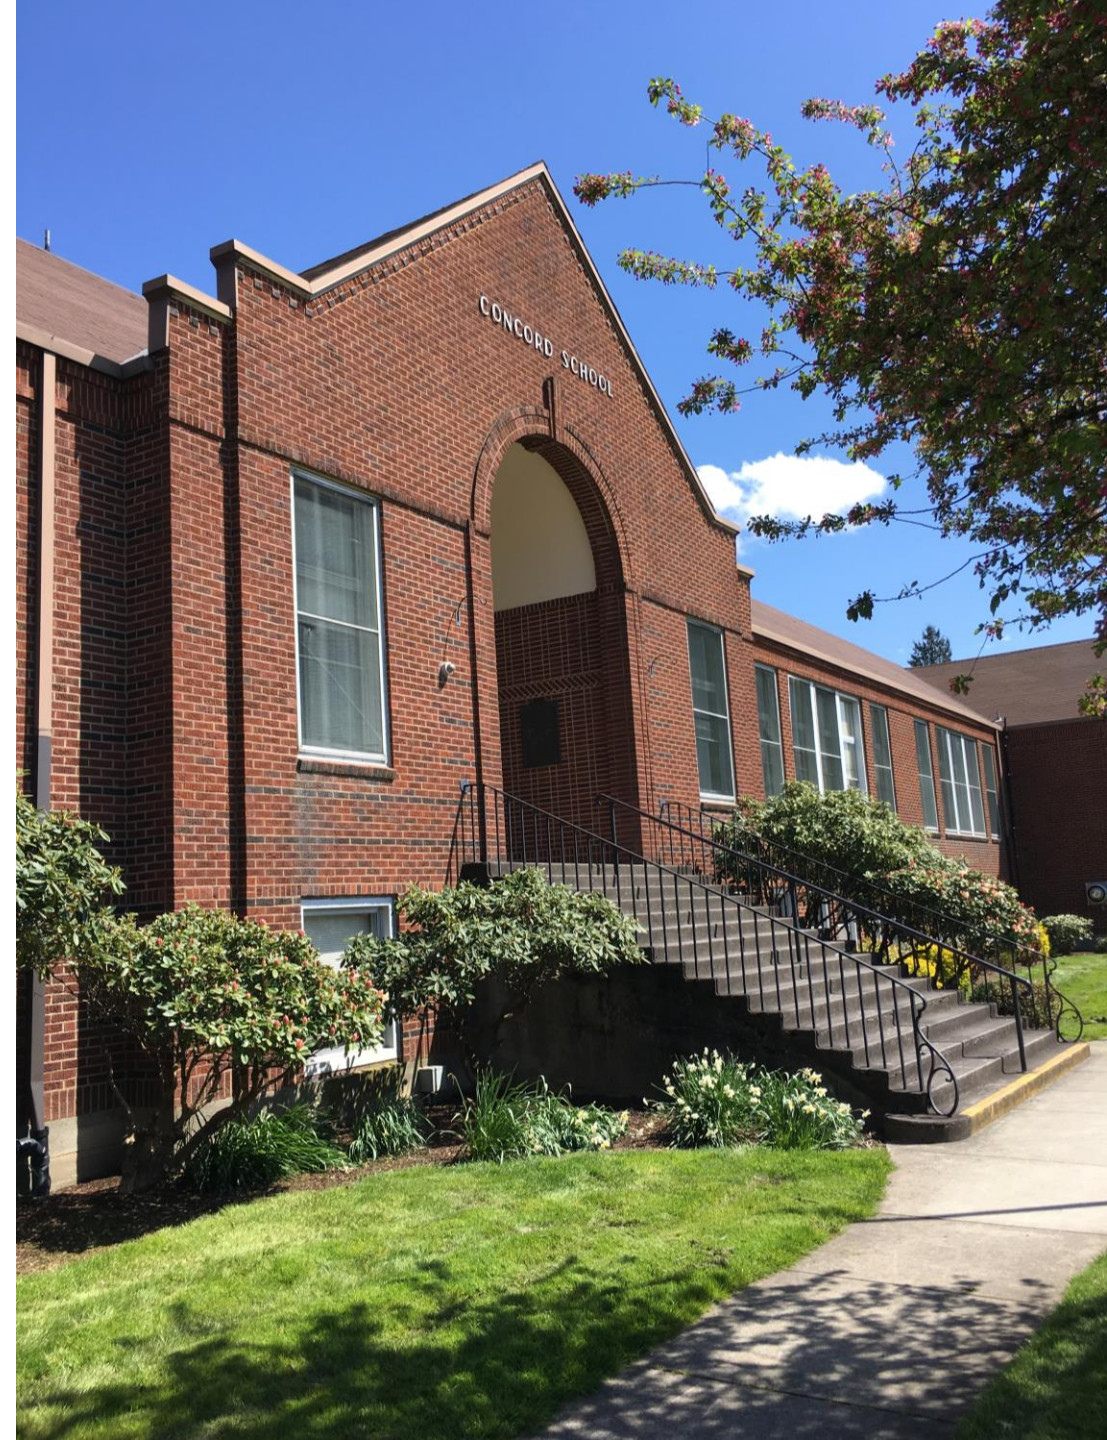
- 46,410 sf, two stories; 5.97 acres
- Originally built 1936; north wing 1948
- URM exterior bearing walls; interior wood bearing walls and steel columns
- Windows primarily aluminum
- Asphalt shingle / built-up roofing
- Interior gypsum, lath & plaster, wood paneling, built-in storage
- Flooring – carpet / vinyl composition tile (VCT), exposed concrete

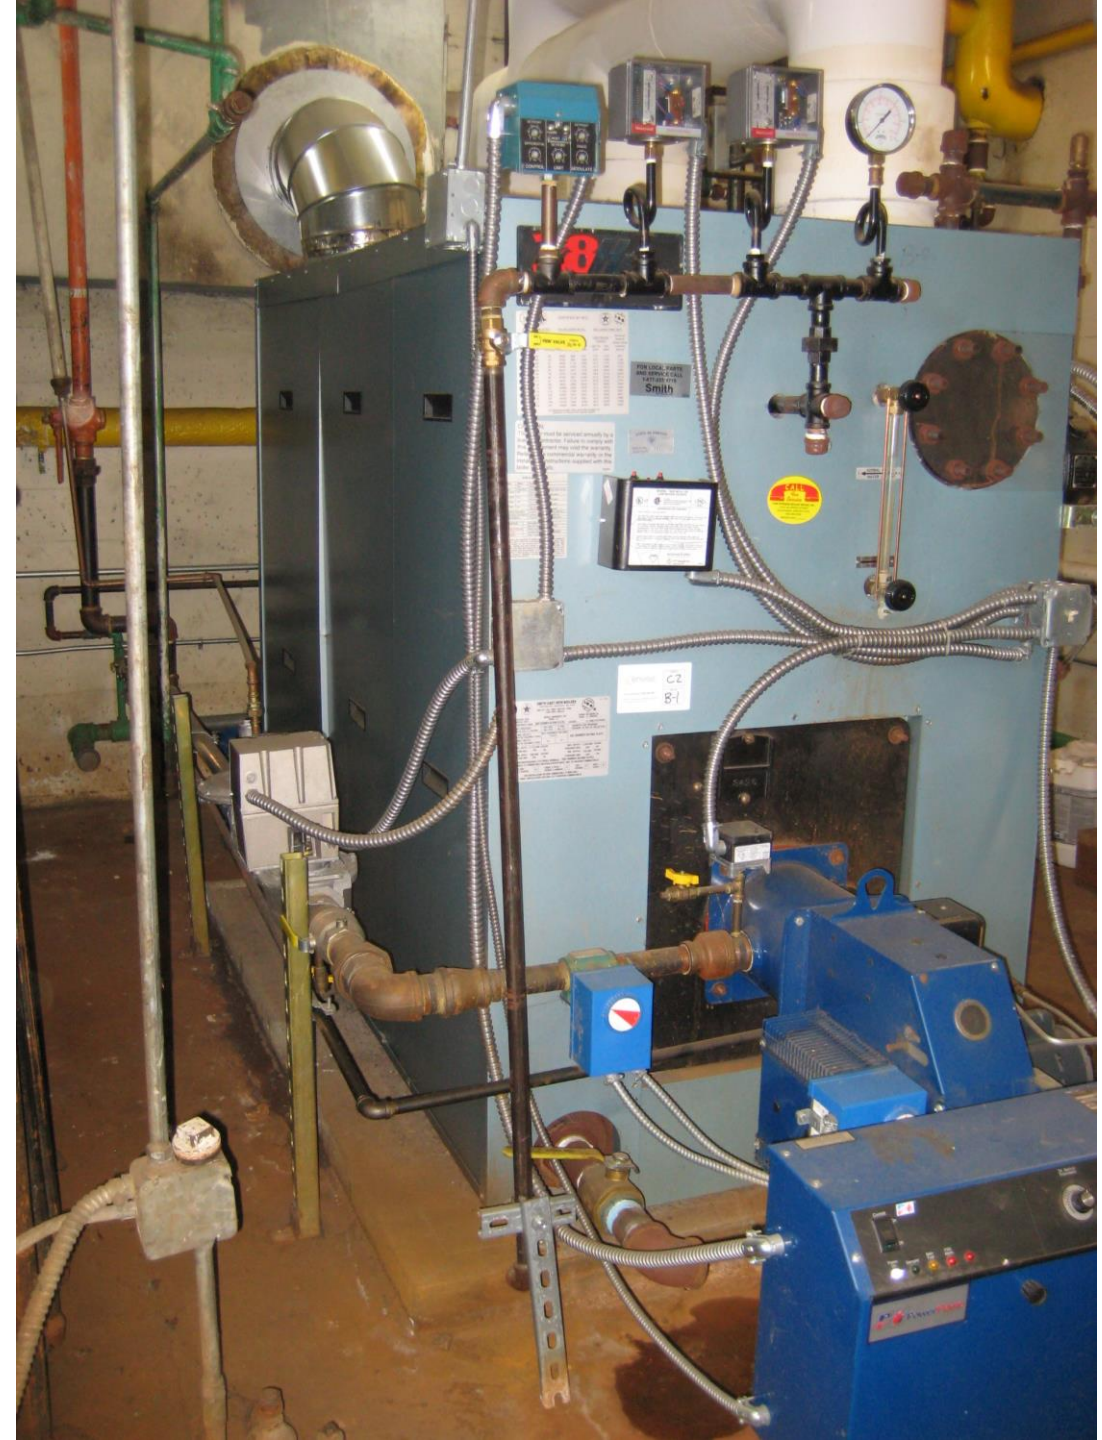
- **Mechanical** – cast iron natural gas steam boiler
  - No ventilation
  - No cooling
- **Electrical** – minimal capacity
  - Panelboards vary in age / condition
  - Limited emergency power
  - Lighting:
    - Interior – fair (not energy efficient)
    - Exterior - poor
- **Plumbing** – galvanized / cast iron
- **Fire Alarm** / suppression system
- **Data** / telecom – updated WiFi

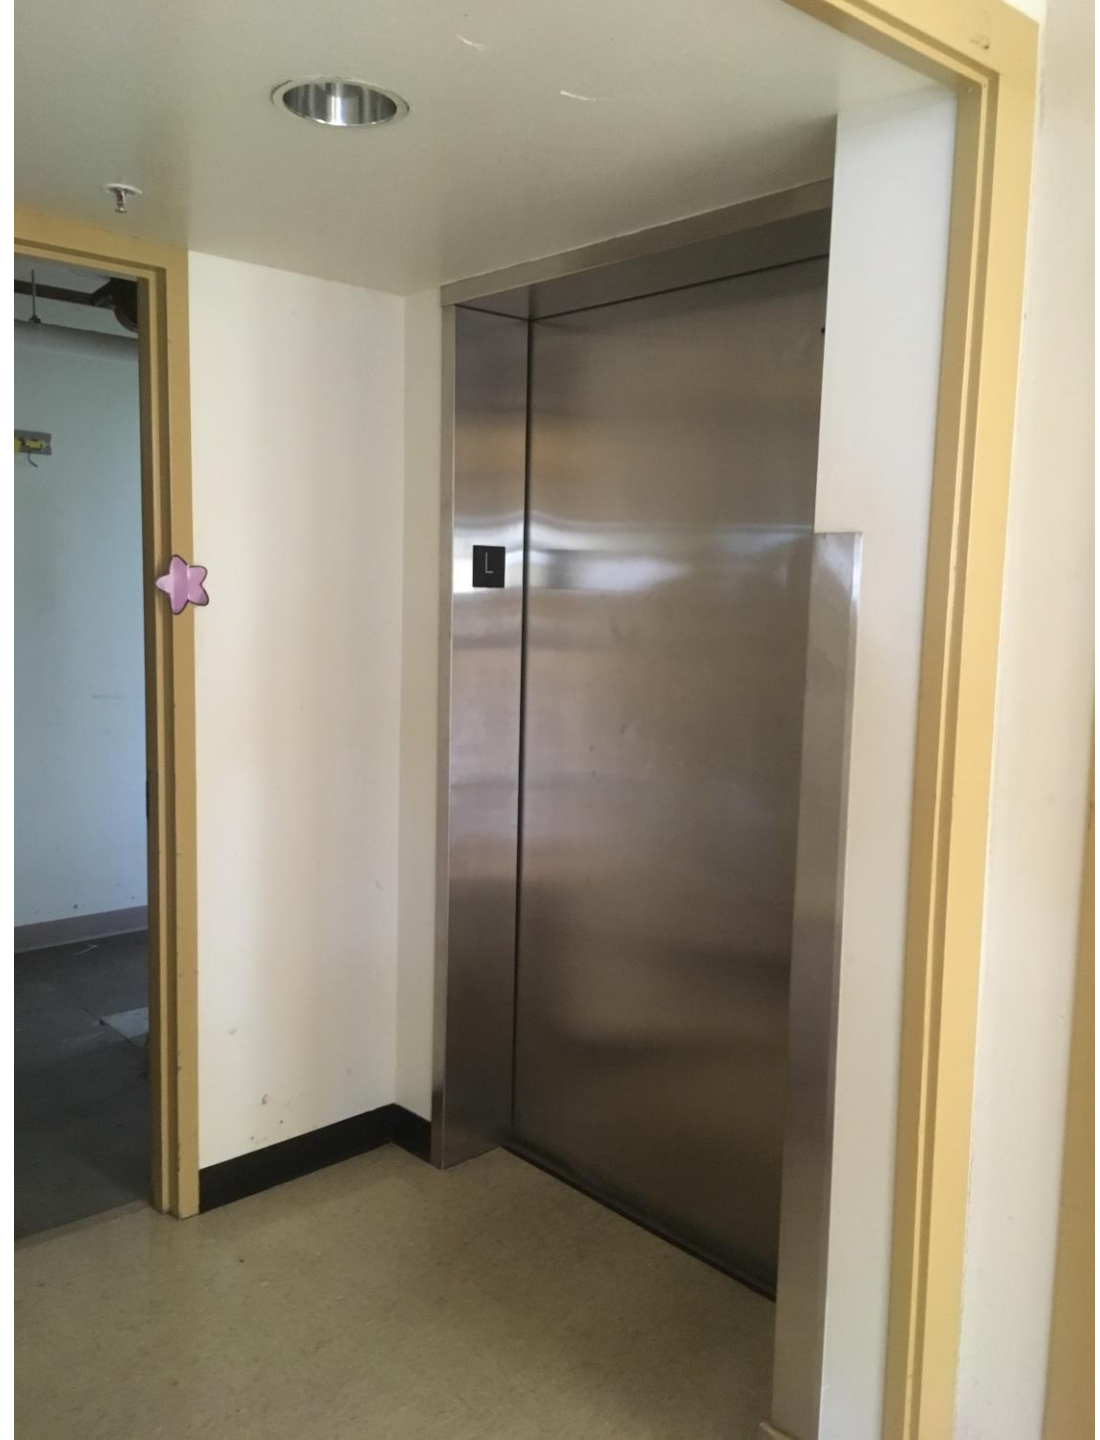
- Limited **seismic** work in 2010; determine level of future work
- Asbestos, lead and PCBs /mercury – **abatement** will be required
- **Accessibility**
  - Elevator at south entrance added in 2010
  - Challenges:
    - Main entry
    - Site / parking
    - Interior

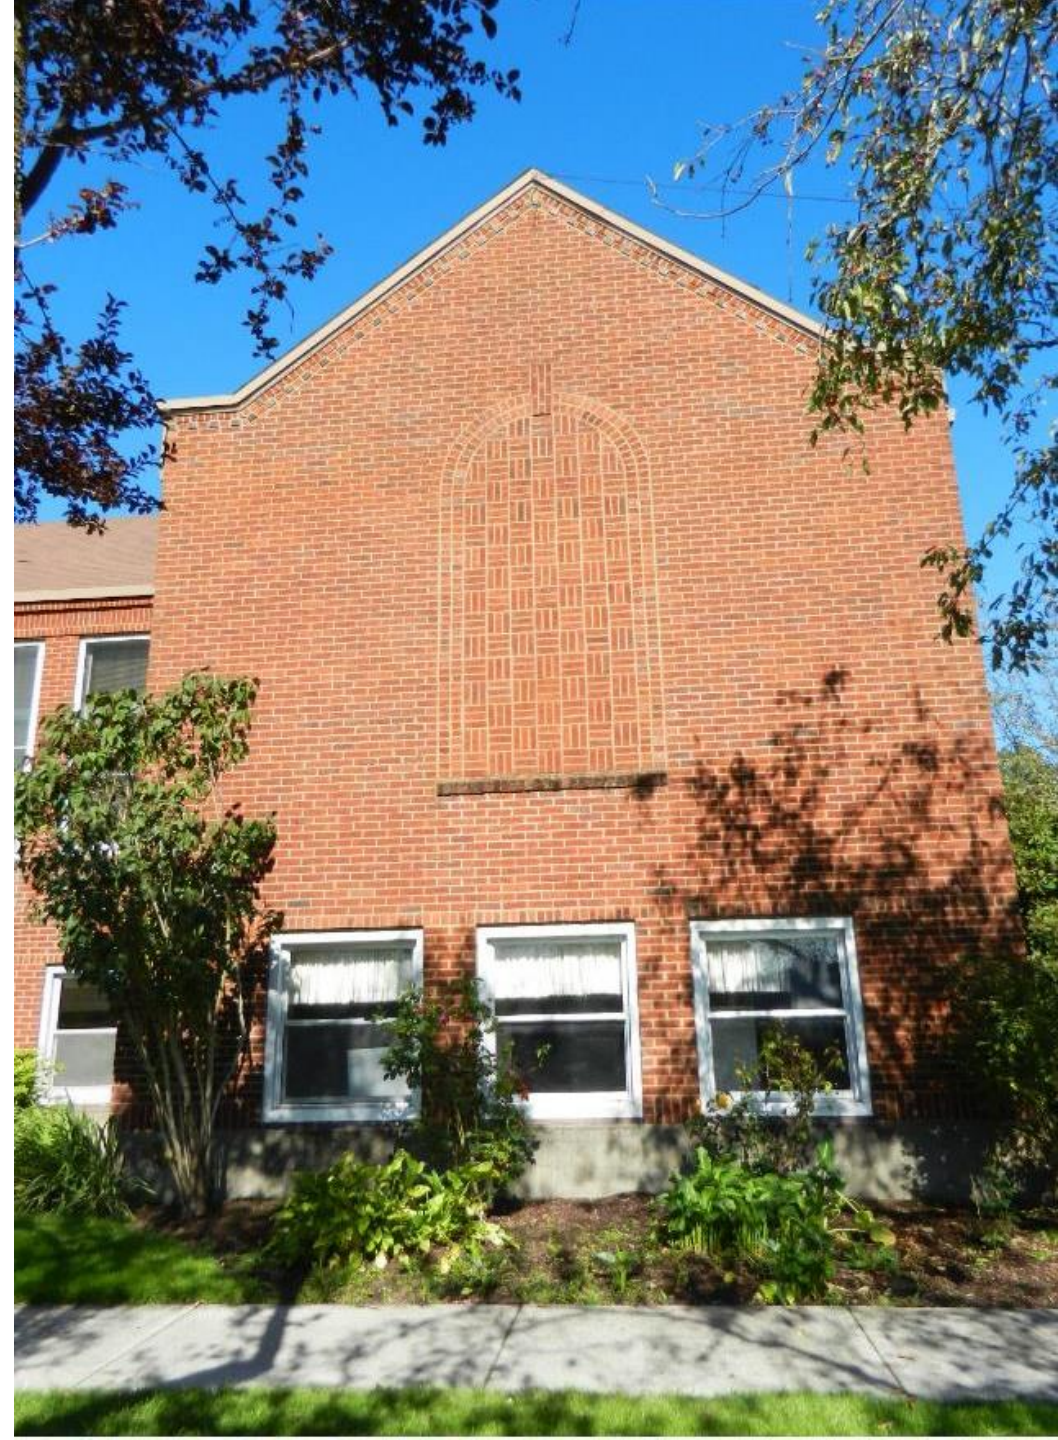
- Rug-faced red brick veneer
- Gabled end bays with basketweave brick veneer
- Window openings (most windows have been replaced)
- Original multi-light transom
- Wood wainscot, stage and proscenium in gymnasium/auditorium
