Presentation Title: Red Soils Courthouse Funding Request for 2017 Biennium

**Clackamas County New Courthouse
Oregon Judicial Department Application
February 2017**

Clackamas County Courthouse Evaluation: MEP Building Assessment

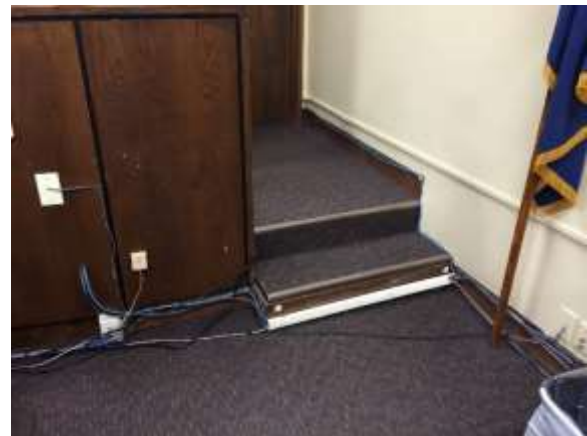
Image 2: Steps to witness stand in Courtroom 5

The courthouse falls short of complying with ADA accessibility standards in many respects, namely in that jury boxes, witness stands, and judicial benches are accessed by one or two steps throughout the courthouse.

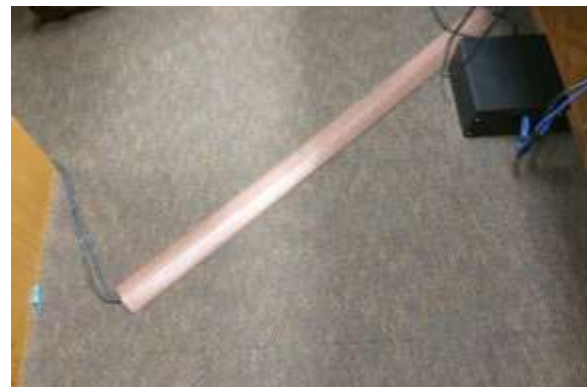
While much of the infrastructure has been updated over the years there is not enough space for adequate infrastructure or growth. Wires run across benches and litigation wells as there is no way to reach the areas from above or below. Although well maintained, they present a constant tripping hazard and the risk of disconnecting an important piece of equipment during a hearing. The fix to this would be costly and would require the floor and every judicial bench to be torn up in order to rewire each courtroom.

Image 3: Cables at litigation well in Courtroom

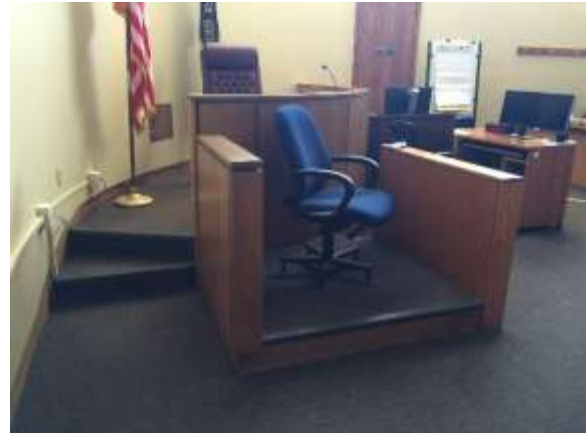
Image 6: Inaccessible witness stand

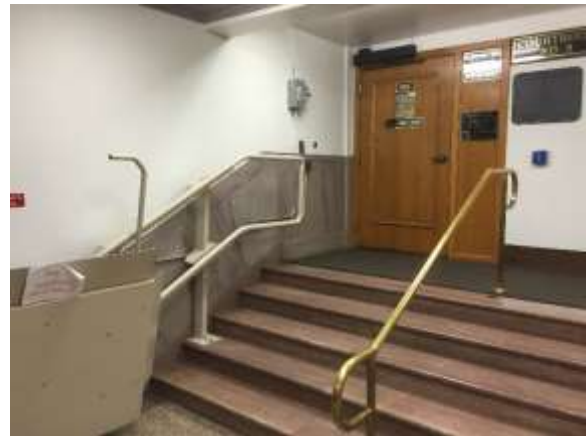
One courtroom and the jury room shared with another courtroom are entirely inaccessible to anyone with mobility disabilities due to the flight of steps that is required to reach them. A lift was installed some years ago, but it has since broken due to use beyond its weight capacity and now needs replacement. To remedy this, a

Image 7: Stairs up to Courtroom 8 and non-functioning lift due to inadequate existing wall bearing capacity

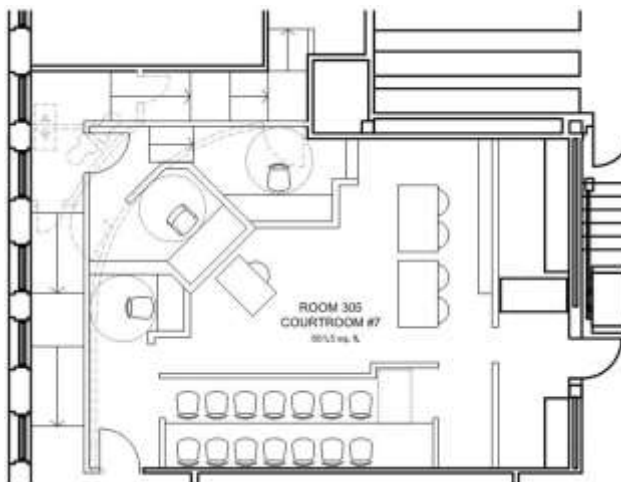
Image 5: Example of ADA Upgrade to Existing Courtroom-would mean loss of judicial chamber space

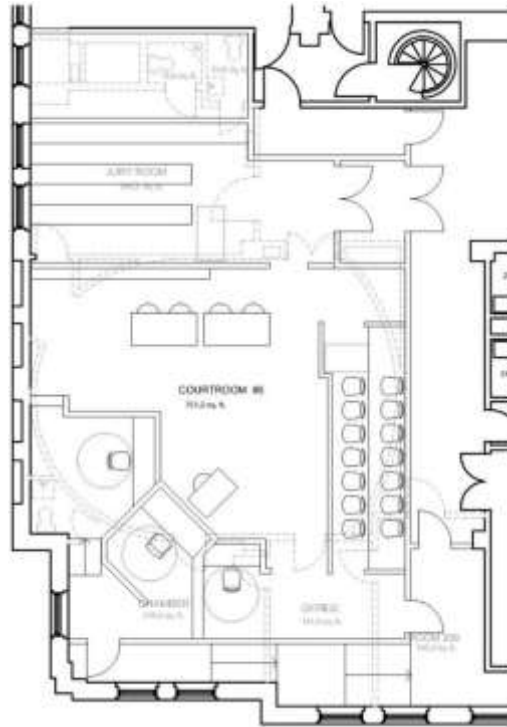
For example, to right size Courtroom 6 the neighboring jury room, judicial chamber and office, and part of the hallway would have to be removed to fit a 1,600 square foot courtroom that is in line with current courthouse requirements. Unfortunately, this would not be a singular event. Most courtrooms would have to expand into the surrounding support space to bring them up to size recommendations. This

*Image 8: Courtroom #6-work required to upgrade room
Dashed Lines reflect rooms that would need to be removed*

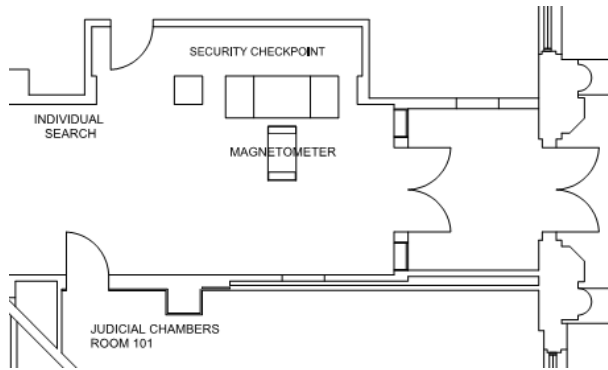
Image 11: Ground floor plan, detail at Main Entry

court spaces. On the ground level, within six-feet after passing through the magnetometer, across from the area designated for individual search, is the entrance to a Judge's Chamber. The judicial, civil and courts staff use the same circulation routes as in-custody prisoners and public to reach their chambers and two of the courtrooms. Although the sallyport and holding area were recently constructed, in-custody prisoners must still be transferred to courtrooms through public circulation routes and frequently use public restrooms during court appearances.

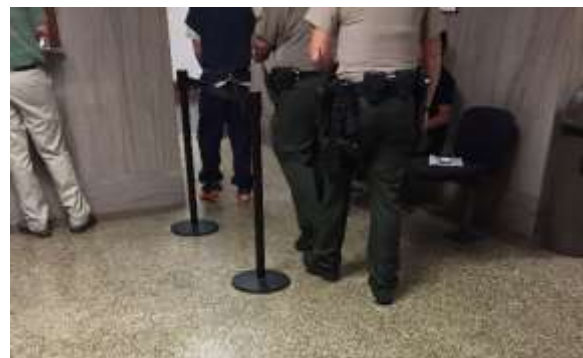
Image 12: In-custody prisoner accessing public restrooms on level 1 by public queuing

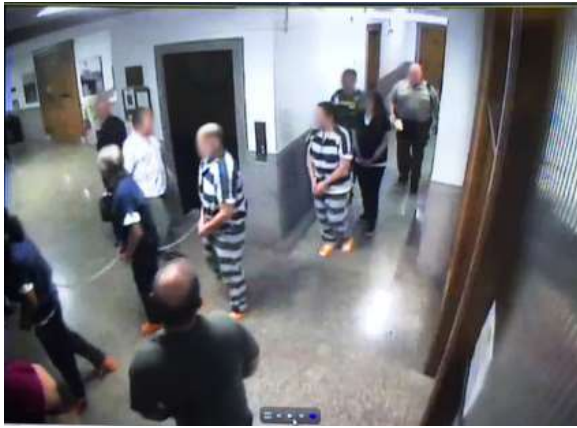
Image 13 In-custody prisoners being moved through public hallway

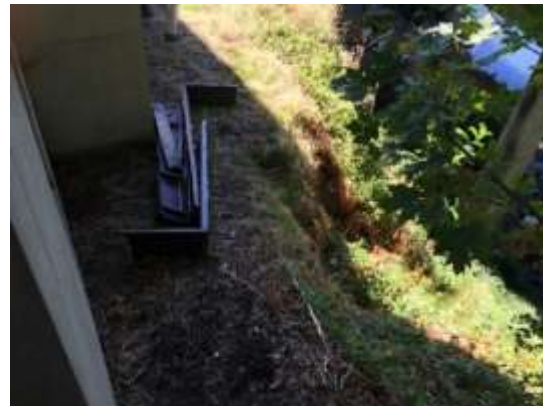
Image 15: Cliff at Willamette River (looking south)

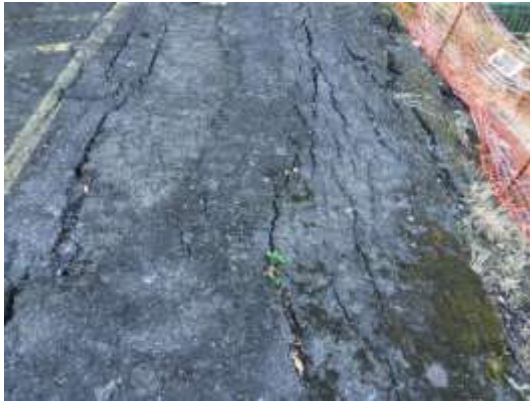
To the west the Courthouse is flanked by McLoughlin Boulevard at the point where the road bridges over a cliff to the Willamette River. Between the building and cliff there was a parking space, but the asphalt is eroding and the area has been deemed unsafe for parking, and the area shrinks to four-feet from cliff to building corner.

Image 16: Eroding asphalt at Willamette River elevation

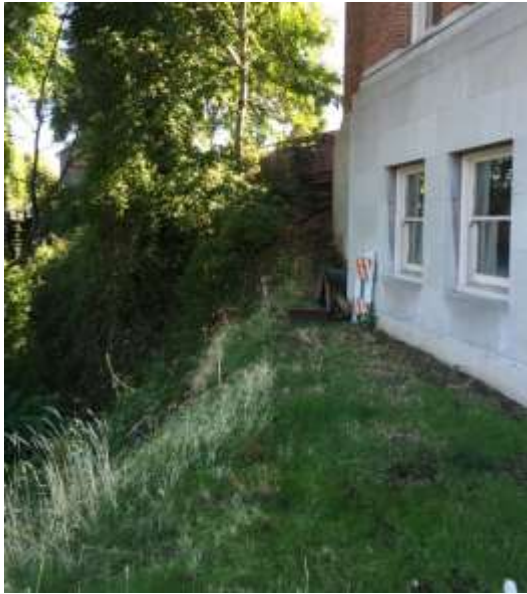
Image 17: Cliff at Willamette River (looking north)

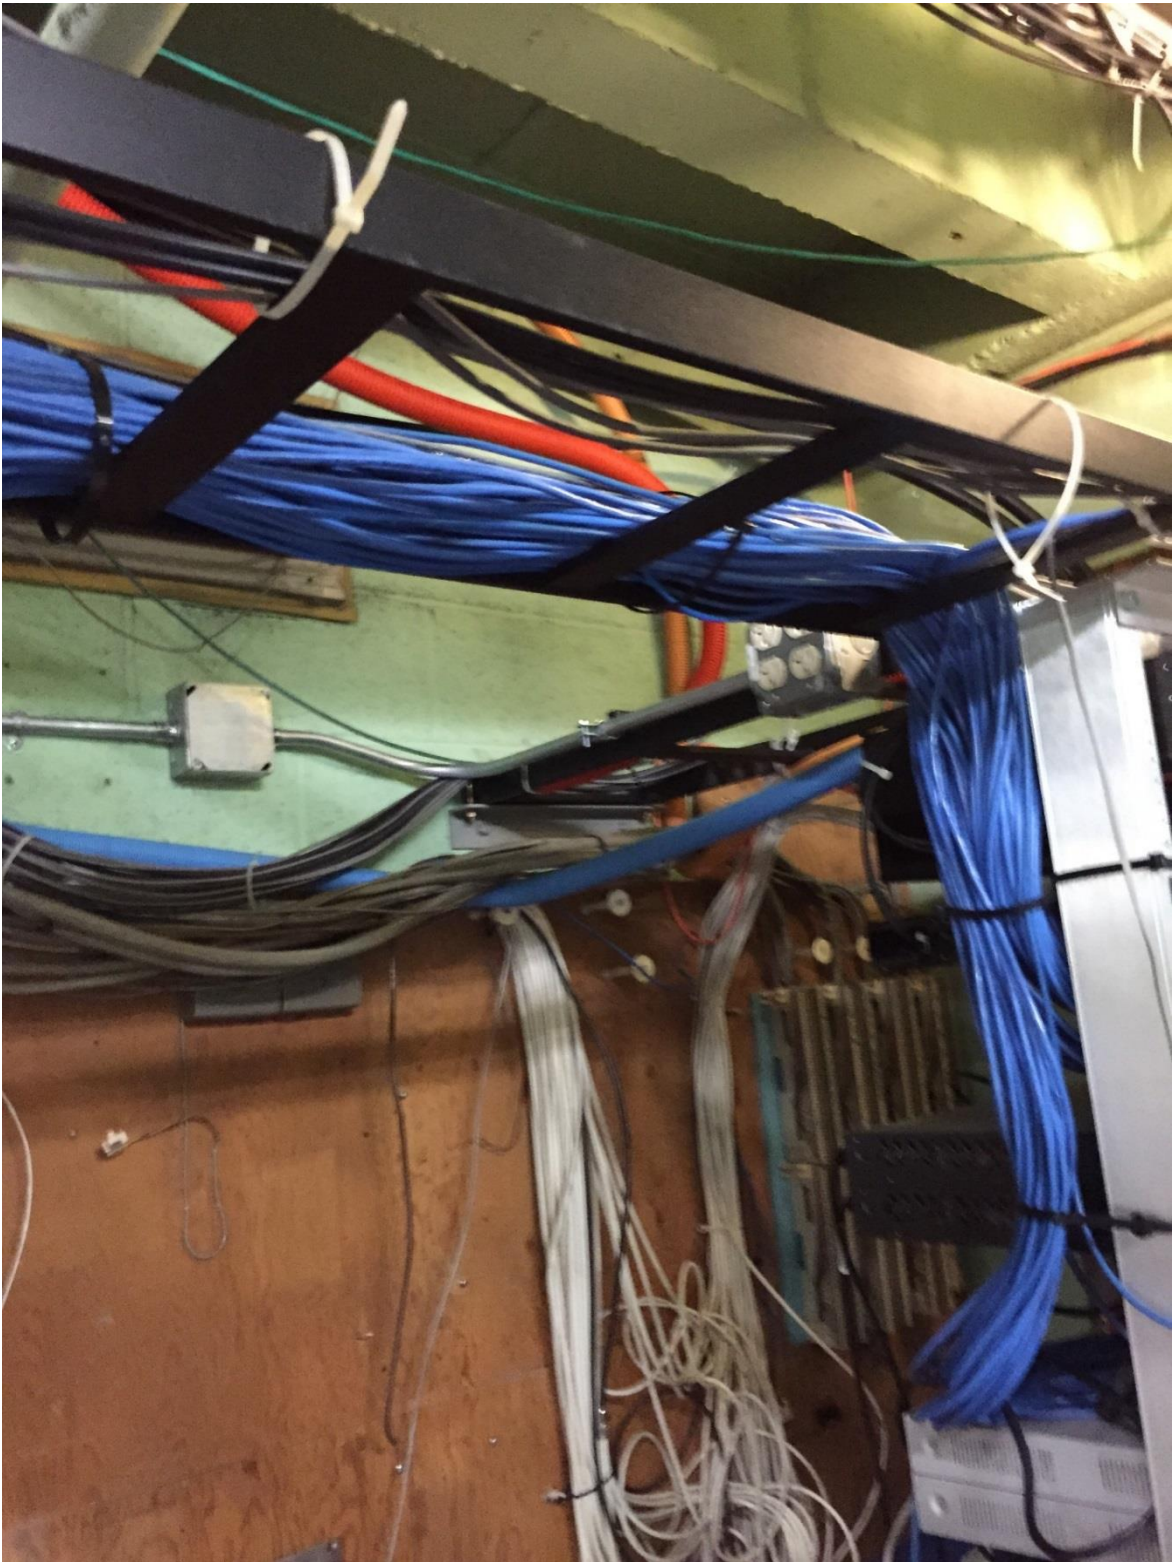
4.1 Photo #E1: Cable distribution in basement tele/data room.

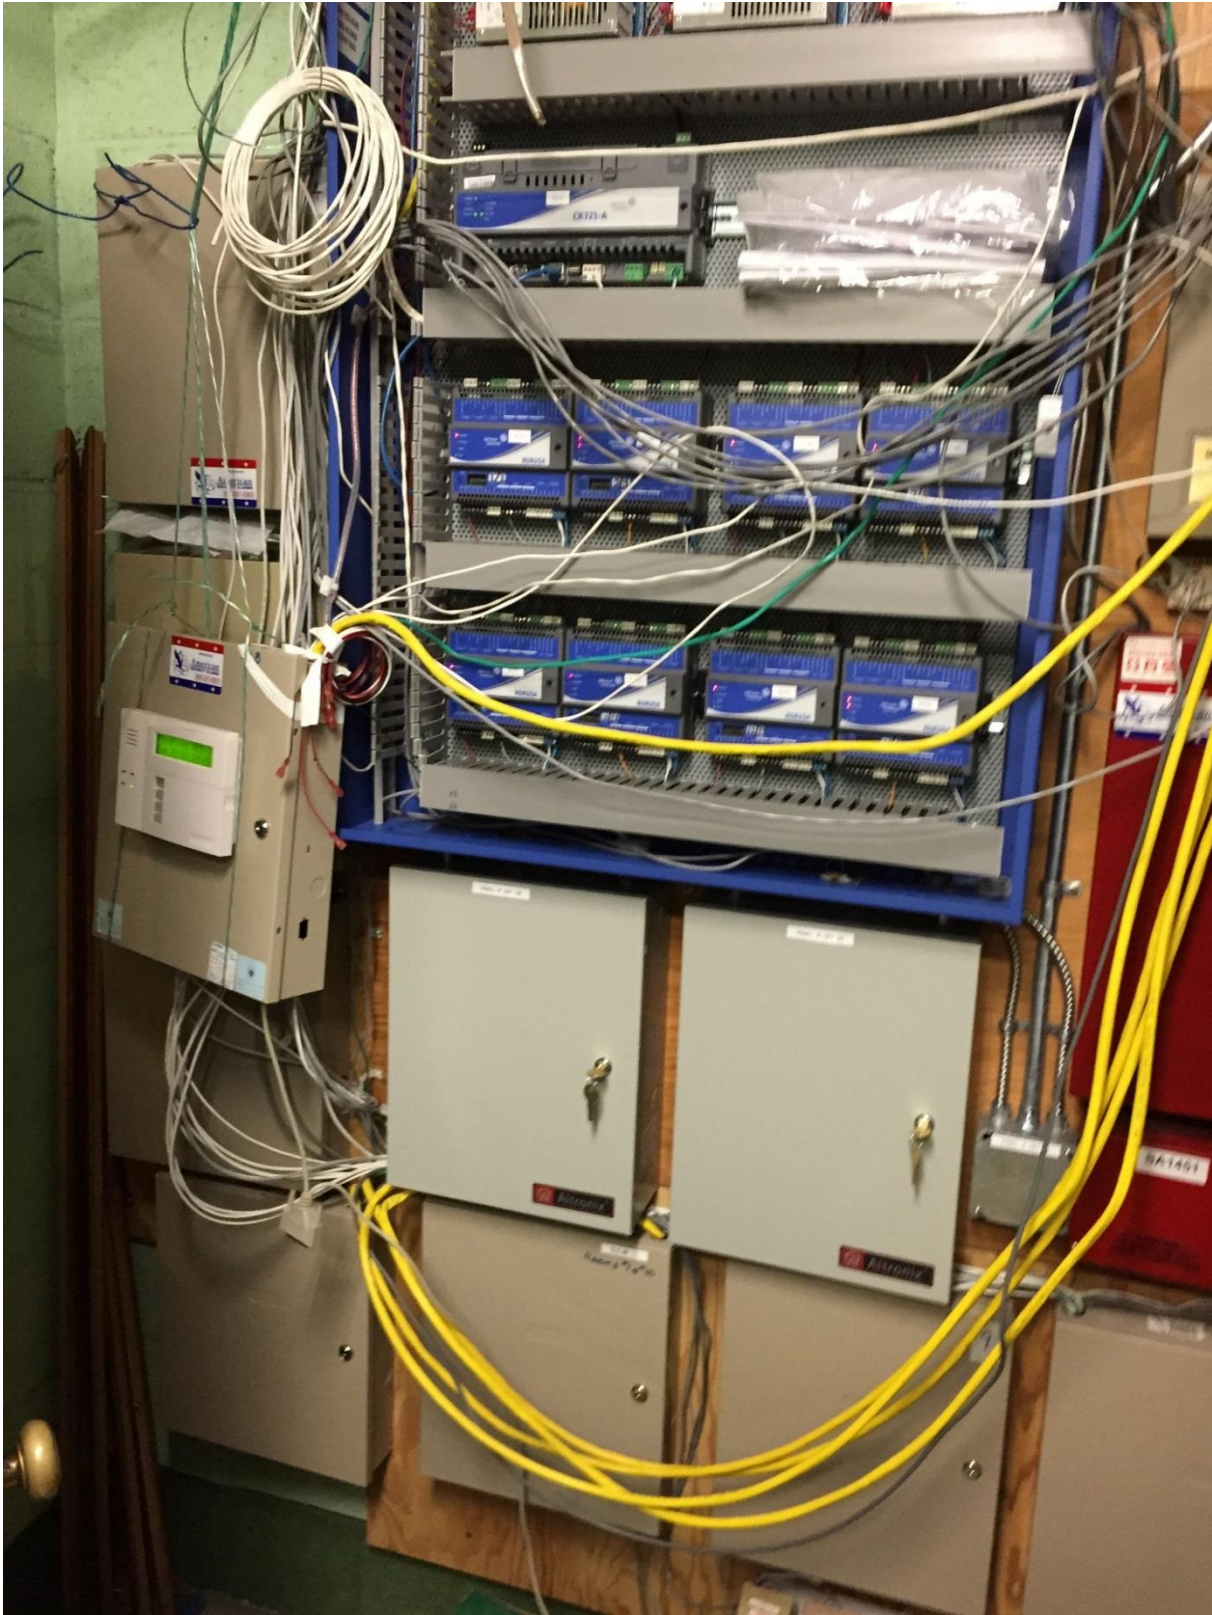
4.2 Photo #E2: New Johnson Controls door security system transition.
