**RENTAL ASSISTANCE DEMONSTRATION
PHYSICAL CONDITION ASSESSMENT (RPCA)
HILLSIDE MANOR
2889 SE HILLSIDE STREET
MILWAUKIE, OREGON 97222**

**D3G PROJECT NUMBER:
2018-0031**

**FINAL REPORT ISSUE DATE:
APRIL 13, 2018**

**INSPECTION DATE:
JANUARY 23, 2018**

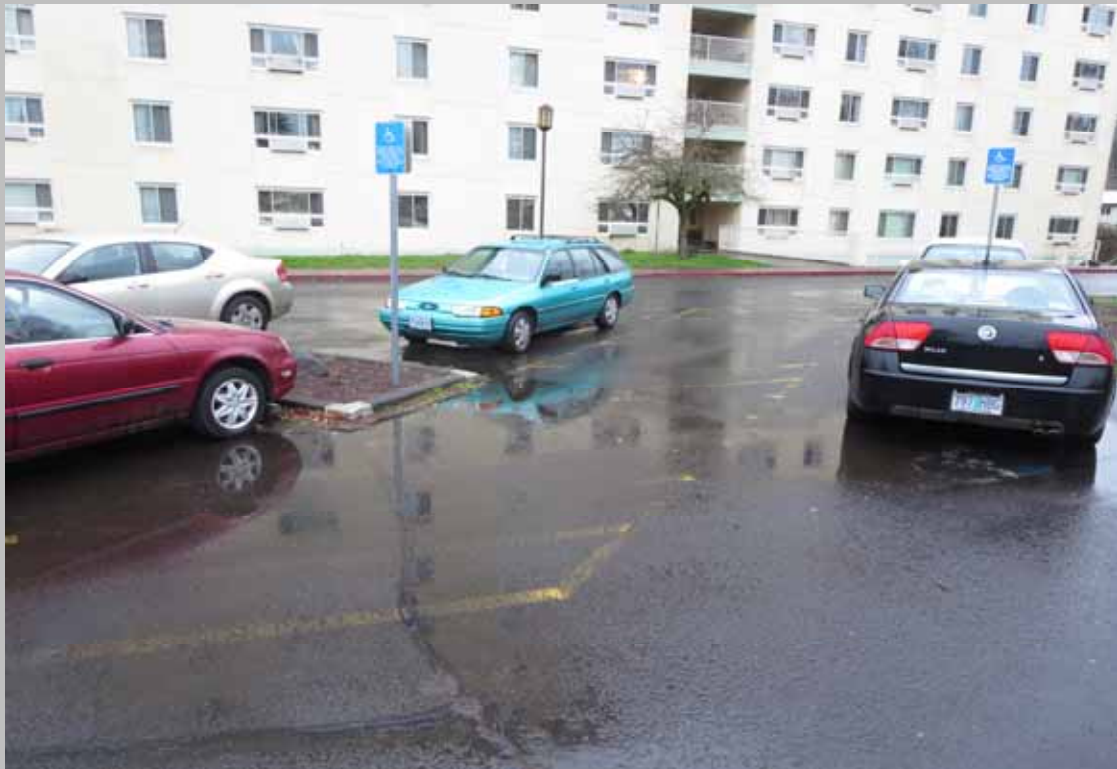
PHOTO #49

ASTM SECT	CRITICAL REPAIR (IMMEDIATE NEEDS)	TOTAL
Hillside Manor		
Accessibility		
3.2.4	<p>1. The property currently features nine (9) designated handicapped parking spaces and does not feature a designated van accessible parking space. The designated handicapped parking spaces were observed with faded pavement markings at all locations, the two (2) handicapped parking spaces at the west of the rear parking lot were observed missing an access aisle. The handicapped parking symbol must be marked horizontally on the parking spaces and the car parking spaces shall be 96 inches wide with a 60-inch access aisle. A van space can also have a minimum width of 96-inches with a 96-inch access aisle or the van space be 132-inches wide with a 60-inch access aisle. According to the Americans with Disabilities Act Accessibility Guidelines (ADAAG), the property is required to feature three (3) designated handicapped parking spaces inclusive of one (1) van accessible handicapped parking space. Reconfiguring the pavement markings, vertical signage, and access aisles is required at three (3) handicapped spaces inclusive of one (1) van accessible handicapped space in order to comply with ADAAG. "Van accessible" vertical signage is required at the van space. The remaining non-compliant handicapped parking spaces should be labeled "reserved." It should be noted that the timeframe to complete this accessibility repair has been extended and the cost reduced to zero as it is included in the concept package scope of work. (3 Each @ \$.00, Repair)</p>	No Cost

Restripe and configure handicapped parking spaces (Critical Repair)

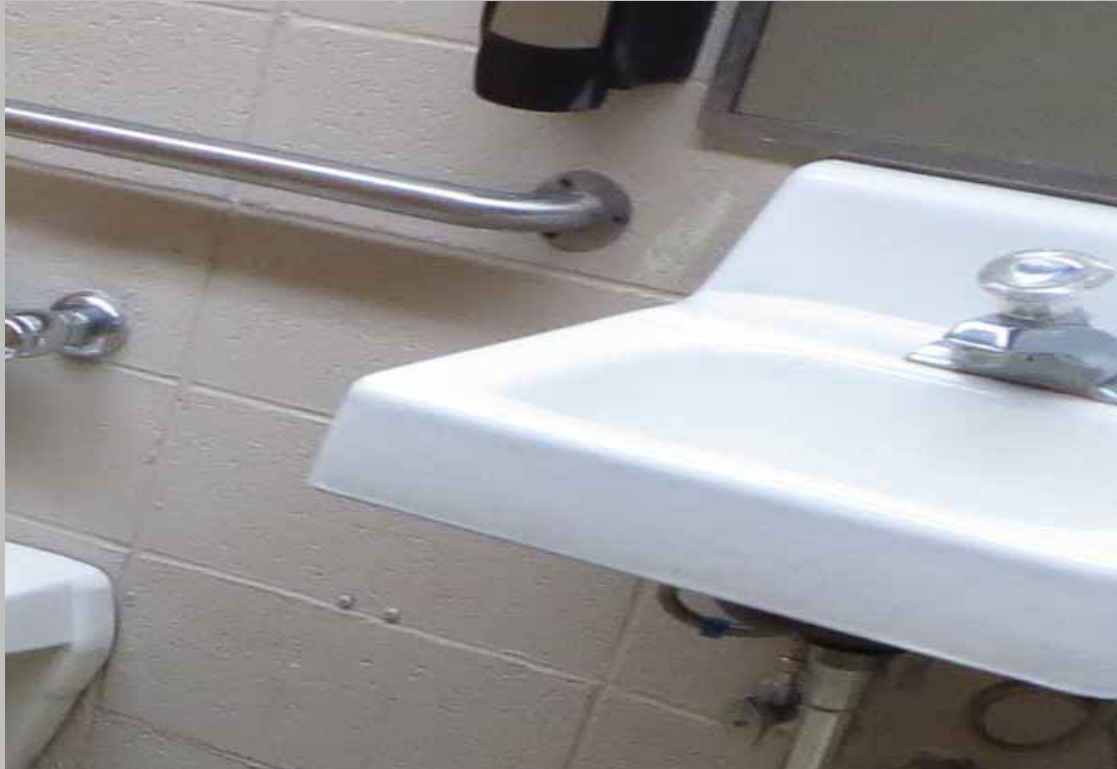
PHOTO #50

3.4.1	2. The sink in the first level women's restroom was observed with knobbed hardware. The installation of levered hardware is required in order to comply with the Uniform Federal Accessibility Standards (UFAS). The timeframe to complete this accessibility repair has been extended as it is included in the concept package scope of work. The cost is covered by the estimated cost in the scope of work. (1 Each @ \$.00, Repair)	No Cost

Install levered hardware at women's common restroom (Critical Repair)

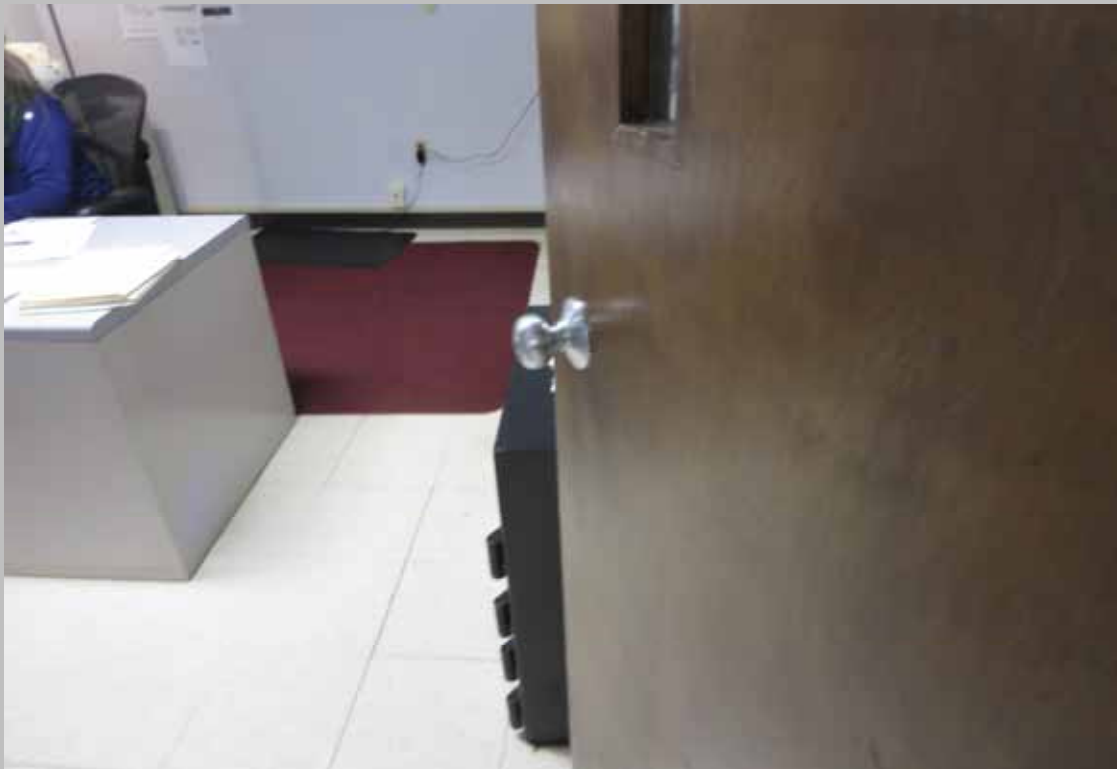
PHOTO #51

3.7.1	3. The common area doors located on the accessible route are not equipped with levered hardware at the staff kitchen, staff restroom, leasing office, leasing lobby, or resident services office. Replacement of the existing door hardware with "usable" hardware, which primarily consists of levered hardware is required to comply with UFAS. It should be noted that the time to complete this repair has been extended as it is included in the scope of work. The cost of this repair is covered by the provided cost estimate for the scope of work. (5 Each @ \$.00, Repair)	No Cost

Install levered handle door hardware at noted locations (Critical Repair)

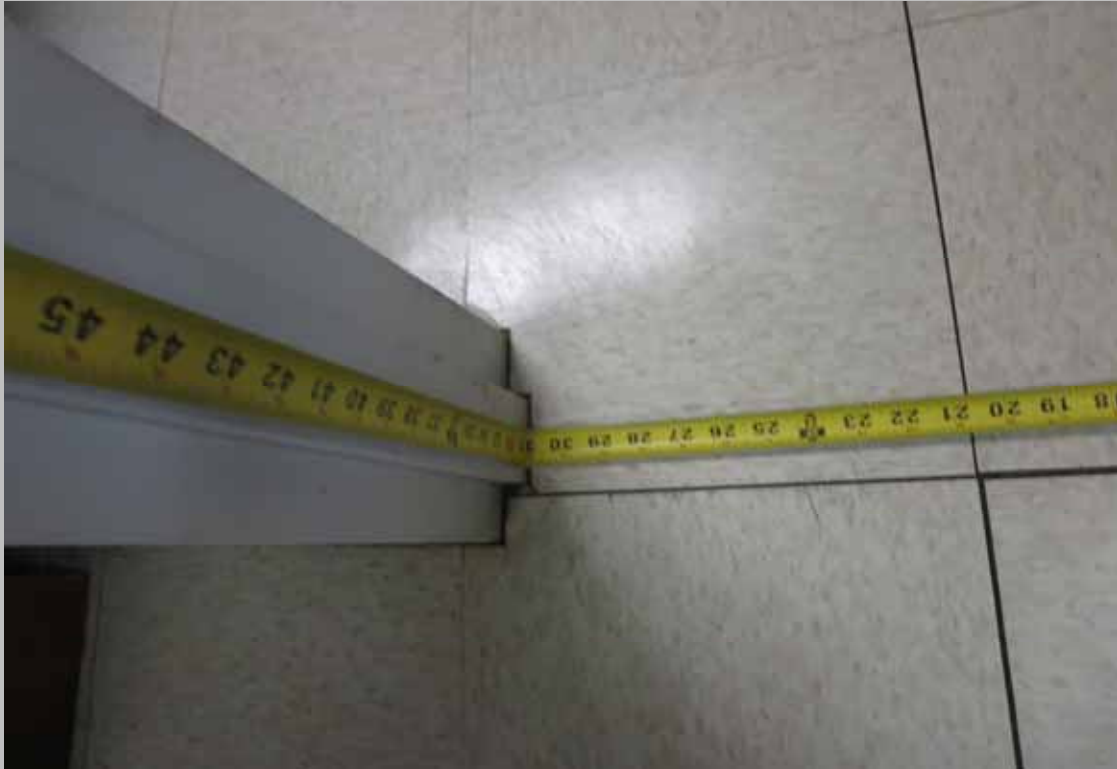
PHOTO #52

3.7.2	4. The entry doors at the leasing office lobby and leasing office were observed with clear door openings less than the minimum 32-inches (approximately 29-31-inches observed). Widening the doors in order to provide a minimum nominal 32-inch wide clear door opening is required in order to comply with UFAS. It should be noted that the time to complete this repair has been extended as it will be included in the larger reconfiguration of the leasing office in the provided scope of work. The cost for this repair is covered by the estimate cost for the provided scope of work. (2 Each @ \$.00, Level 1 Alterations)	No Cost

Widen door openings at noted locations (Critical Repair)

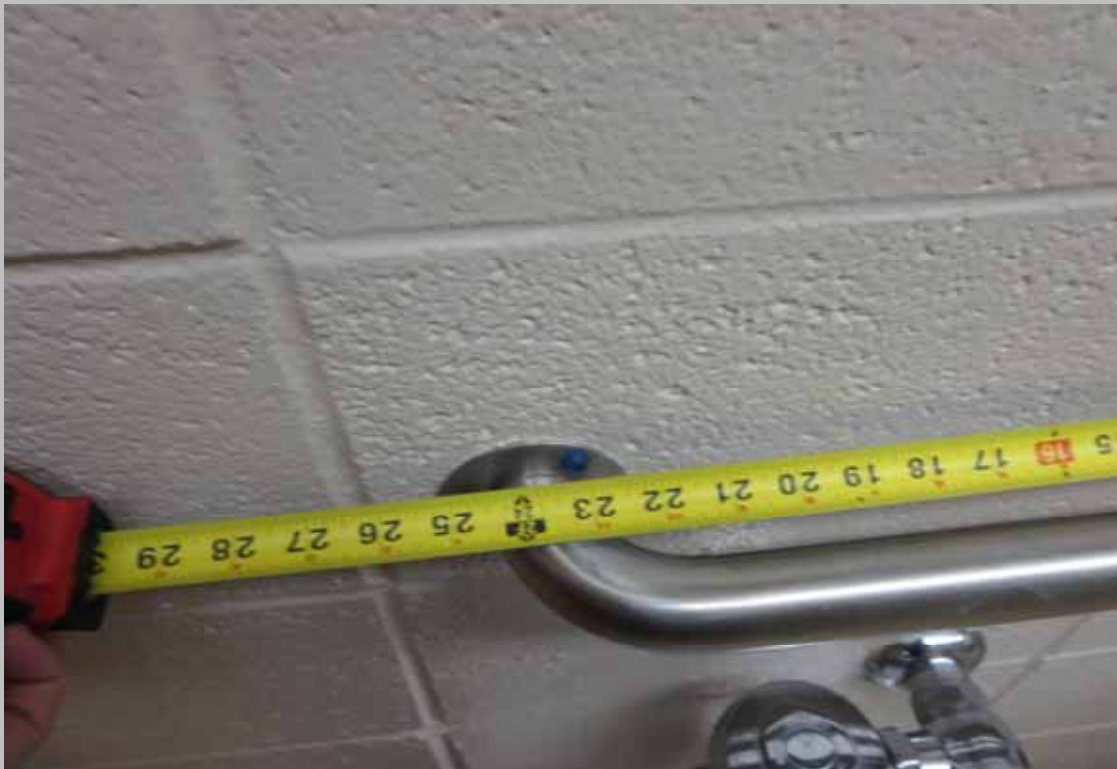
PHOTO #53

3.7.2	5. The handicapped toilet in the first level women's restroom was observed with a 24 inch rear grab bar. The installation of a properly sized 36 inch grab bar at rear wall of the toilet is required to comply with UFAS. It should be noted that the time to complete this repair has been extended as the common area restrooms will be completely reconfigured during the planned renovation. The cost of this repair is covered by the cost estimate in the provided concept package scope of work. (1 Each @ \$.00, Repair)	No Cost

Install 36 inch rear grab bar at women's common restroom toilet (Critical Repair)

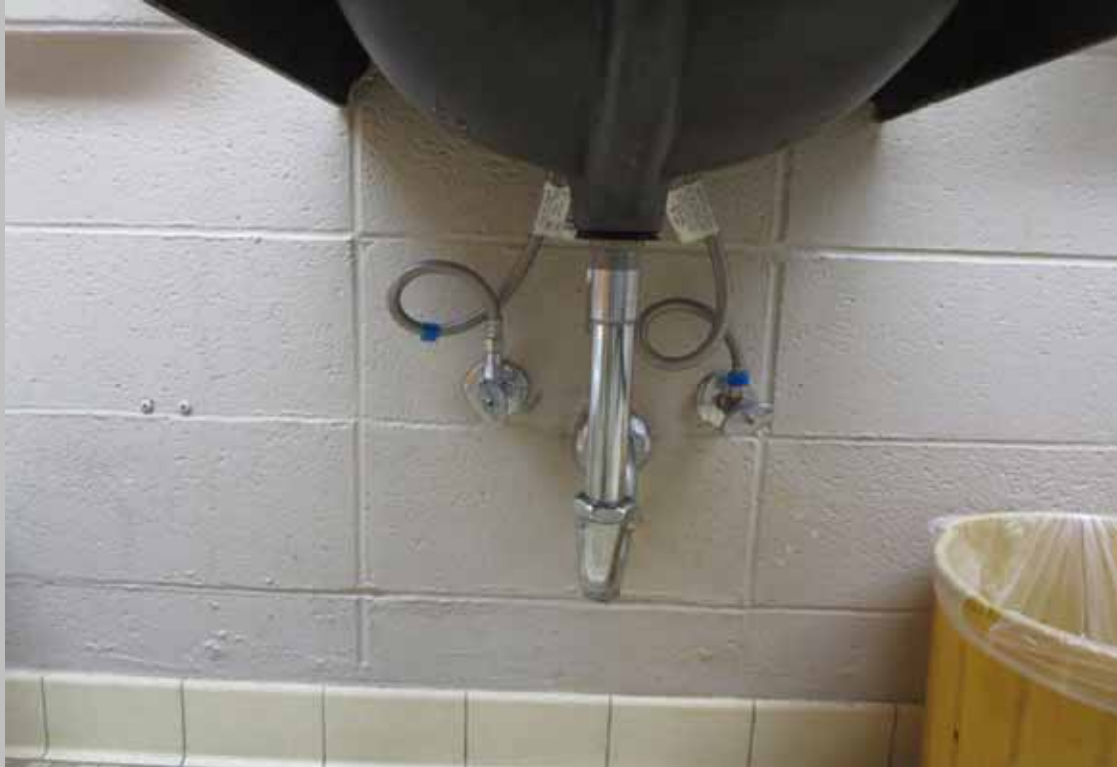
PHOTO #54

3.7.2	6. The sinks in the first level common restrooms, and handicapped dwelling unit sinks at unit 313 (kitchen), and unit 221 (bathroom) were observed without scald and abrasion sink pipe wrapping. The installation of scald and abrasion sink pipe wrapping is required in order to comply with UFAS. It should be noted that the time to complete this repair has been extended as the common area restrooms will be completely reconfigured during the planned renovation. The cost of this repair is covered by the cost estimate in the provided concept package scope of work. (5 Each @ \$.00, Repair)	No Cost
Life Safety

Install scald and abrasion protection at noted locations (Critical Repair)

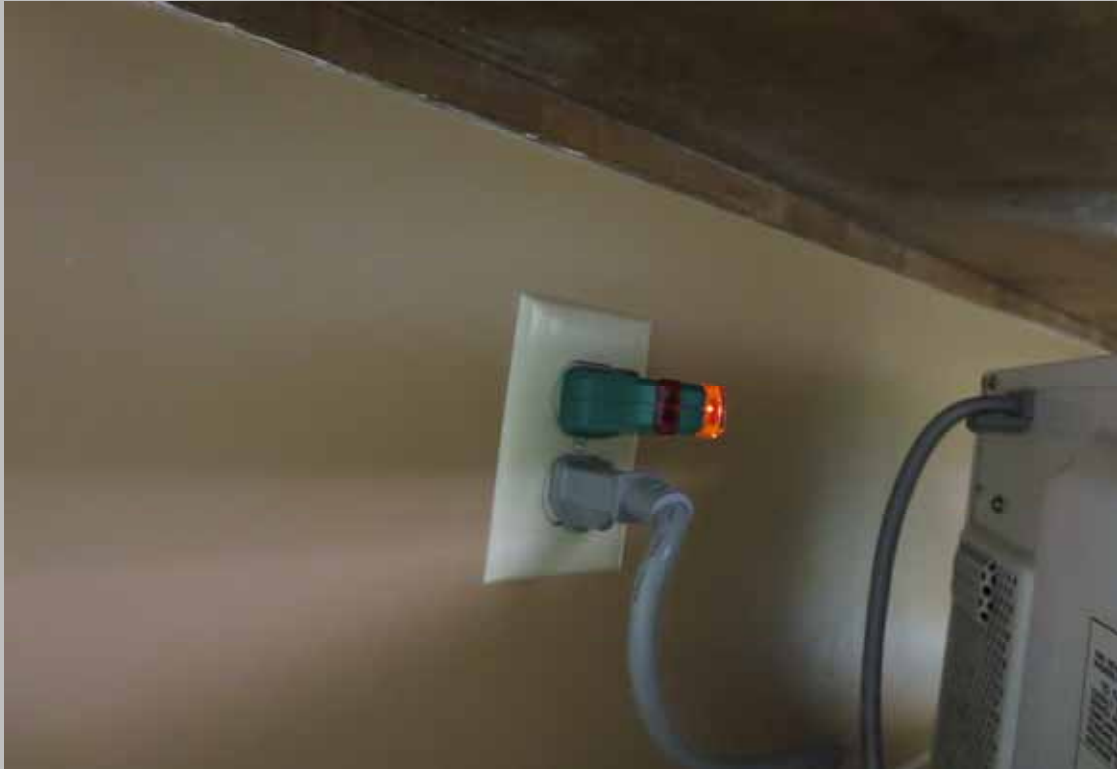
PHOTO #56

3.4.4	1. The staff kitchen and dwelling unit kitchens and bathrooms, with the exception of the handicapped dwelling units 402, 313, 312, 222, 221, and 220 were observed with countertop outlets that are not GFCI protected. Current NEC guidelines require any outlet that serves any kitchen counter be GFCI protected. It should be noted that the time to complete this repair has been extended as it is included in the scope of work, and the dwelling unit kitchens and bathrooms will be completely renovated. The cost is included in the estimated scope of work. (190 Each @ \$.00, Repair)	No Cost

Install GFCI protected outlets at noted locations (Critical Repair)

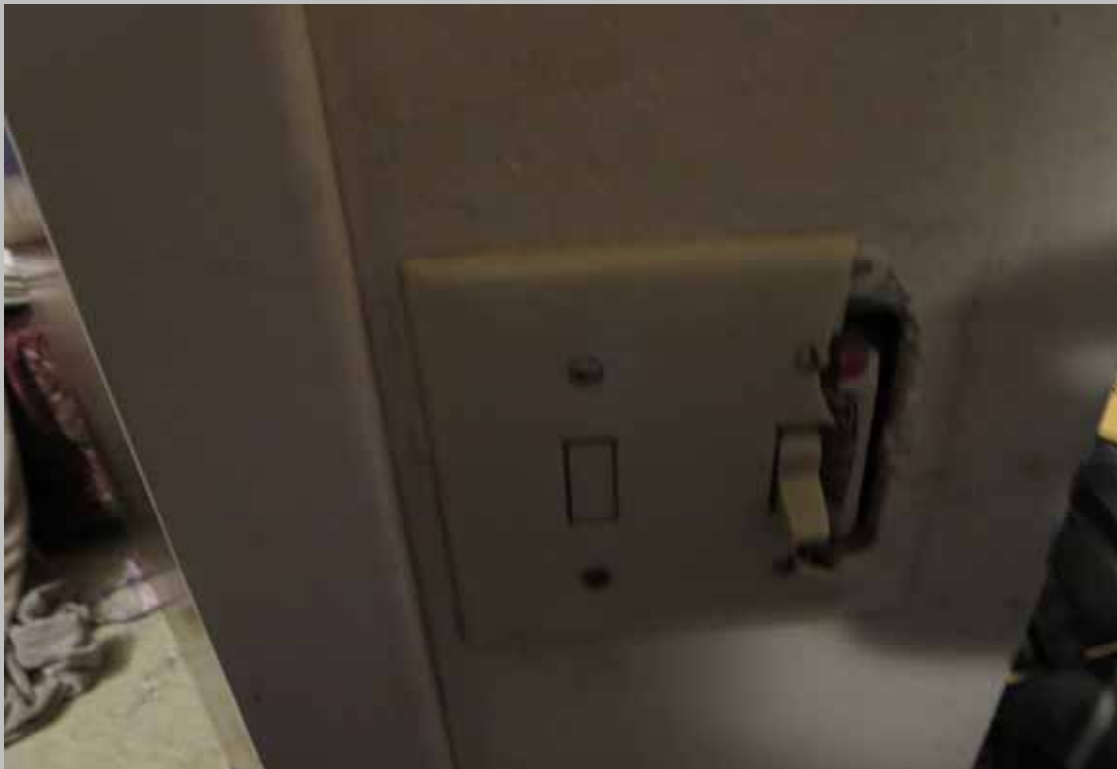
PHOTO #57

3.4.4	2. Dwelling unit 903 was observed with a broken electrical switch cover at the living room. Replacement of the switch cover is recommended. The cost of this repair is included in the routine maintenance budget. (1 Each @ \$.00, Repair)	No Cost

Repair switch cover at unit 903 (Critical Repair)

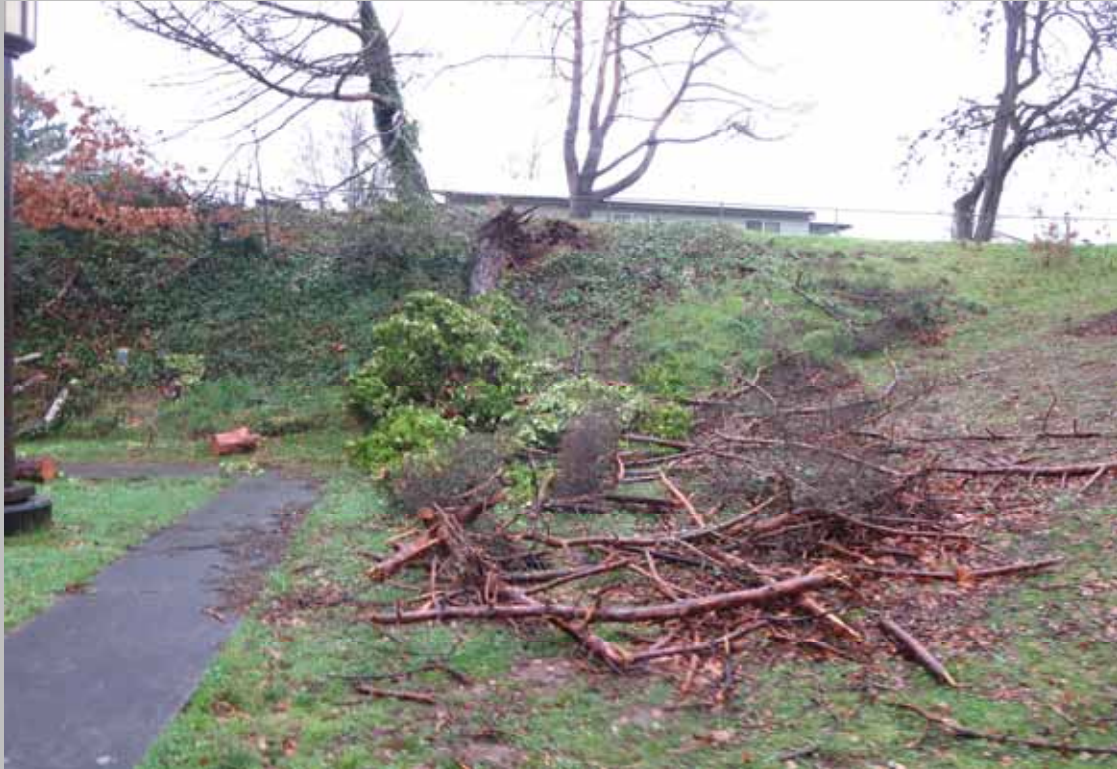
PHOTO #58

ASTM SECT	NON-CRITICAL REPAIR (12-MONTH PROPERTY CONDITION)	TOTAL
Hillside Manor		
3.2.2	1. The southeast lawn was observed with down trees and scattered wood debris. Removal of the trees and debris is recommended. According to the architect the cost of this repair is included in the Site work & Landscape Allowance in the concept package scope of work. There is no cost included due to be handled out of Operations and Maintenance budget. (1 Each @ \$.00, Repair)	No Cost

Clear trees and debris from common lawn (Non-Critical Repair)

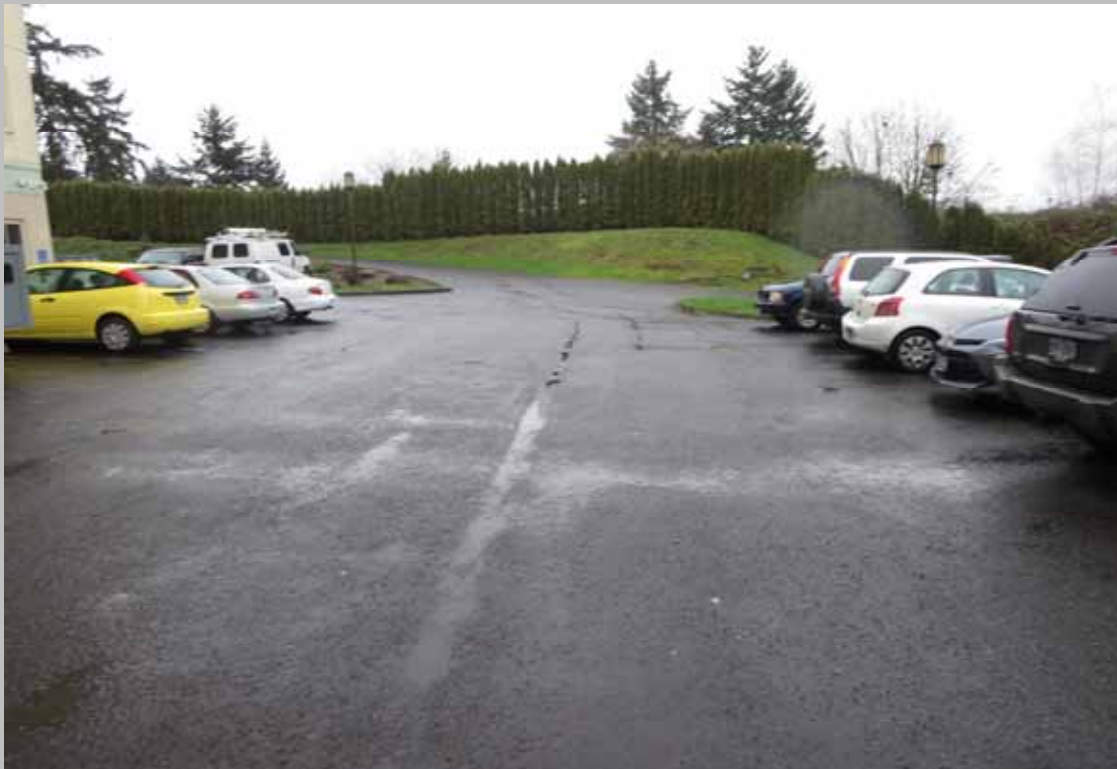
PHOTO #59

3.2.4	2. Seal coating of the asphalt parking areas has been included in the concept package scope of work. (37745 SF @ \$.12, Repair)	\$4,487.88
3.2.4	3. Restriping of the asphalt parking areas and the inclusion of handicapped parking identification markings is recommended, and has been included in the concept package scope of work. (59 Each @ \$8.87, Repair)	\$523.29

Seal coat parking areas (Non-Critical Repair)

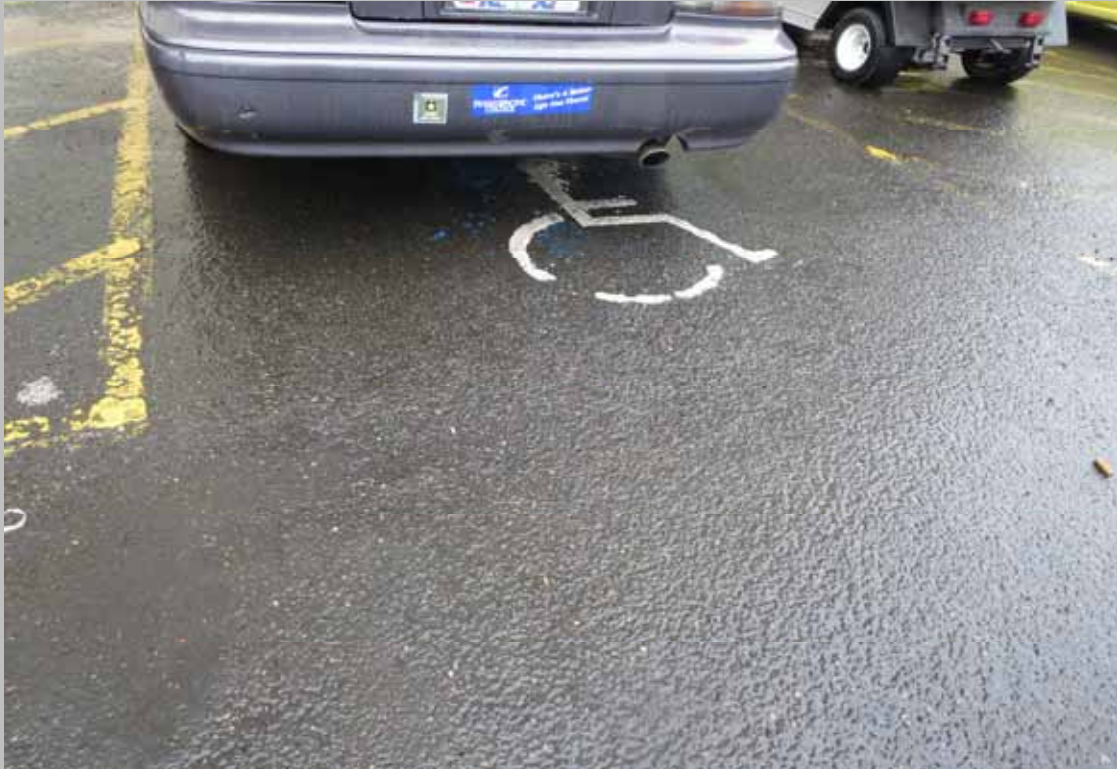
PHOTO #60

Restripe and mark parking areas (Non-Critical Repair)

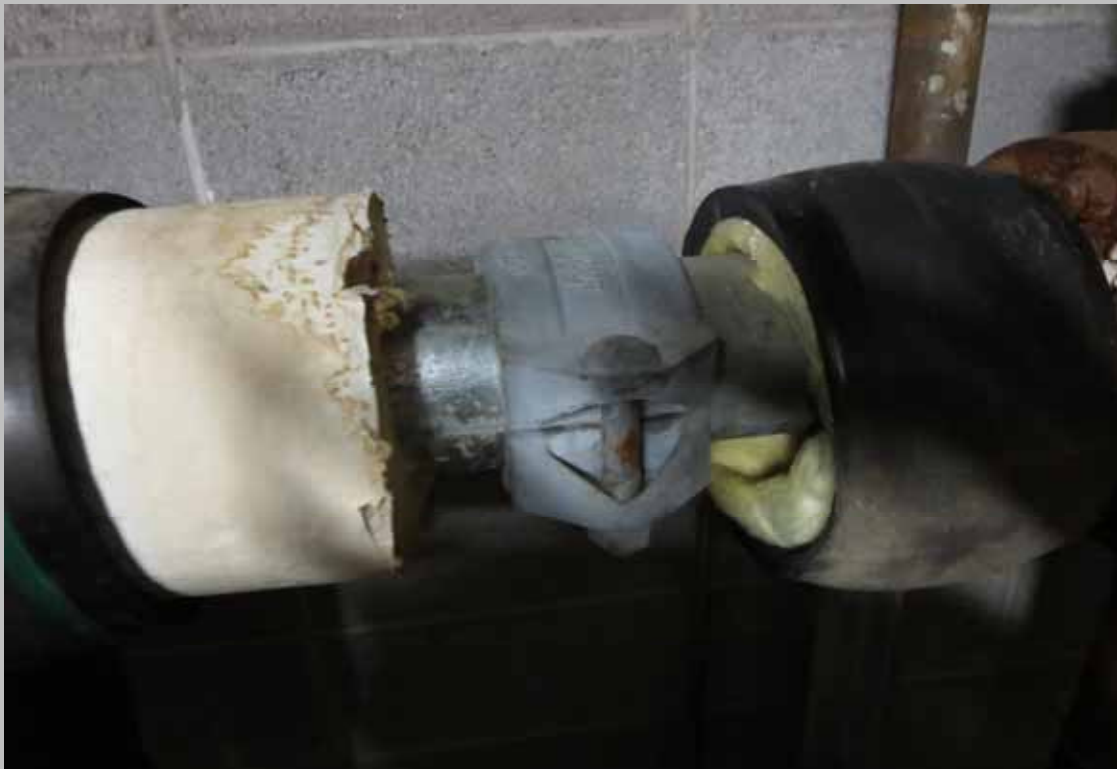
PHOTO #61

3.2.8	6. The interior main water line providing service to the building was observed with a leaking section. Repair of the water main is recommended. The cost of this repair is included in the Domestic Water Distribution cost estimate in the concept package scope of work. The property manager has not been able to identify the source of the leak. (1 Each @ \$.00, Repair)	No Cost

Repair water main leak (Non-Critical Repair)

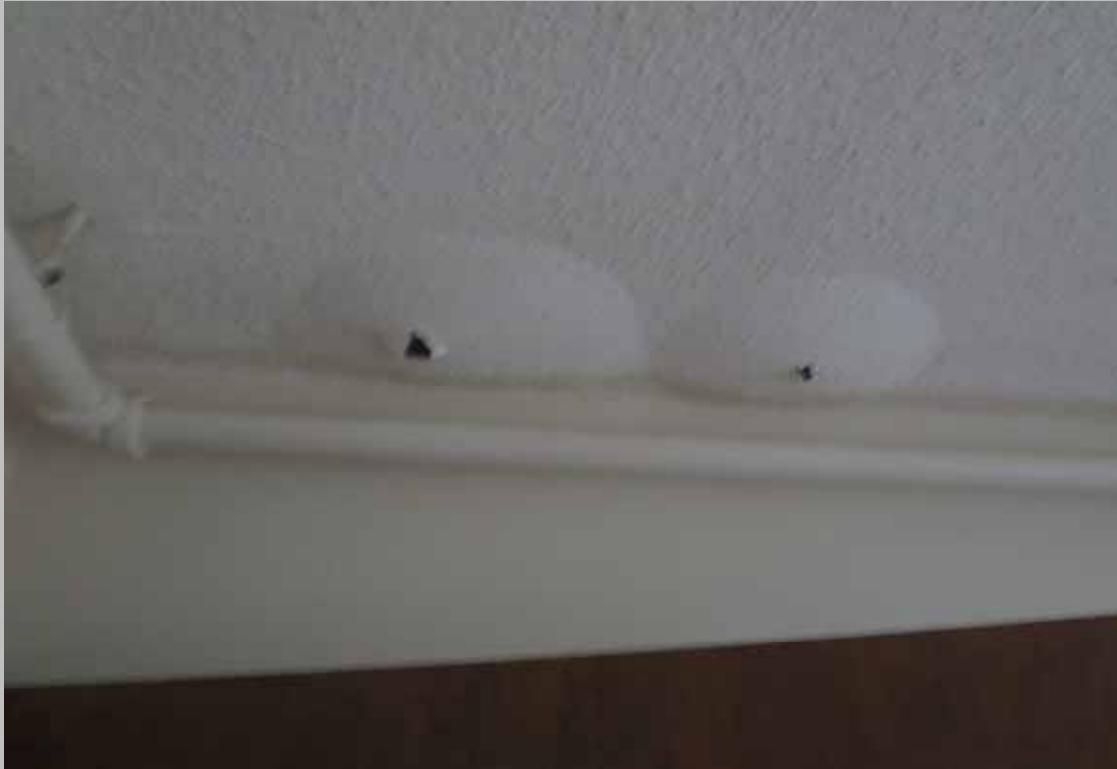
PHOTO #62

3.3.2	2. Dwelling units 711 at the living room, 304 at the bedroom closet, and 306 at the shower were observed with damaged ceilings due to localized flooding at adjacent upper dwelling units. Repair of the ceilings is recommended. The cost of this repair is covered by the cost to abate and refinish all of the asbestos ceilings, which is included in the provided concept package scope of work. According to the architect the property manager has already completed this repair. (3 Each @ \$.00, Repair)	No Cost
Proposed Rehabilitation Items

Repair ceiling at unit 711 (Non-Critical Repair)

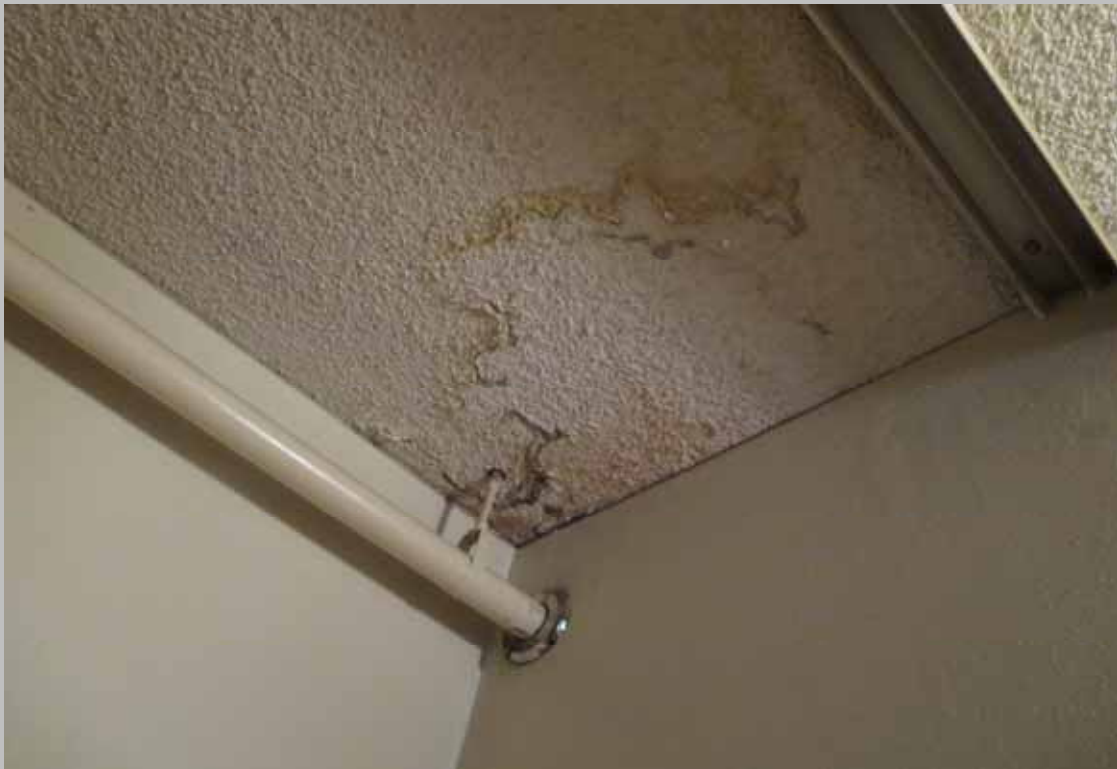
PHOTO #63

Repair ceiling at unit 304 (Non-Critical Repair)

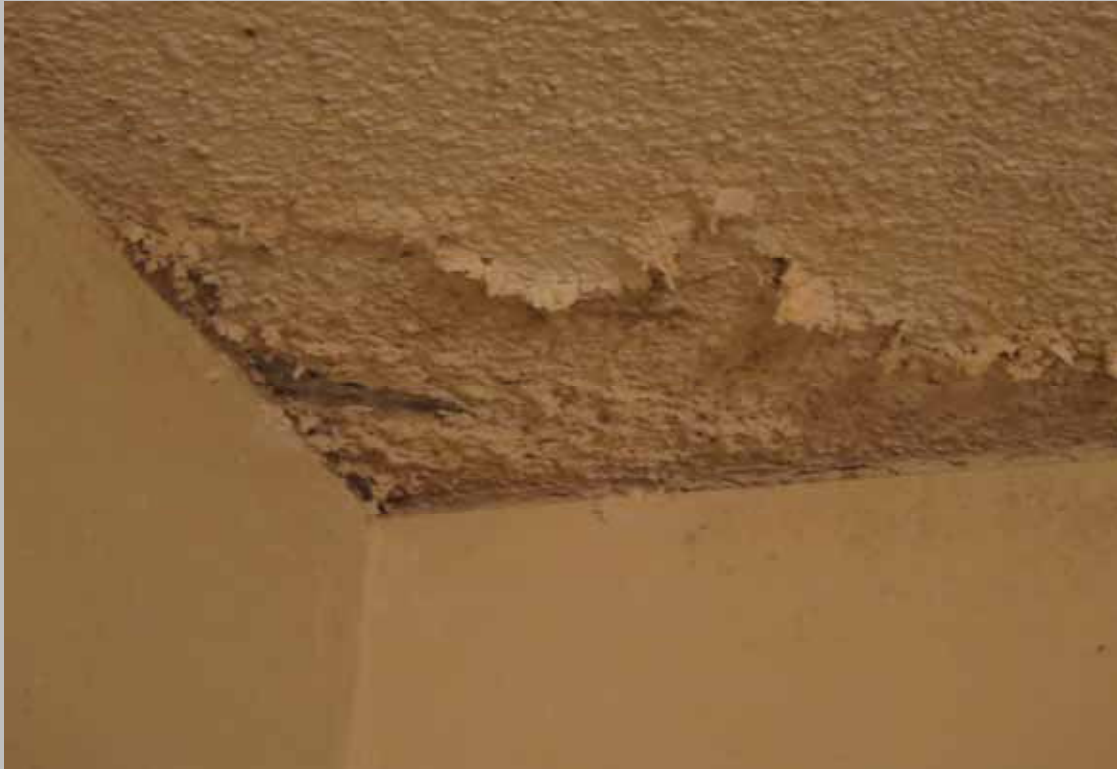
PHOTO #64

Repair ceiling at unit 306 (Non-Critical Repair)

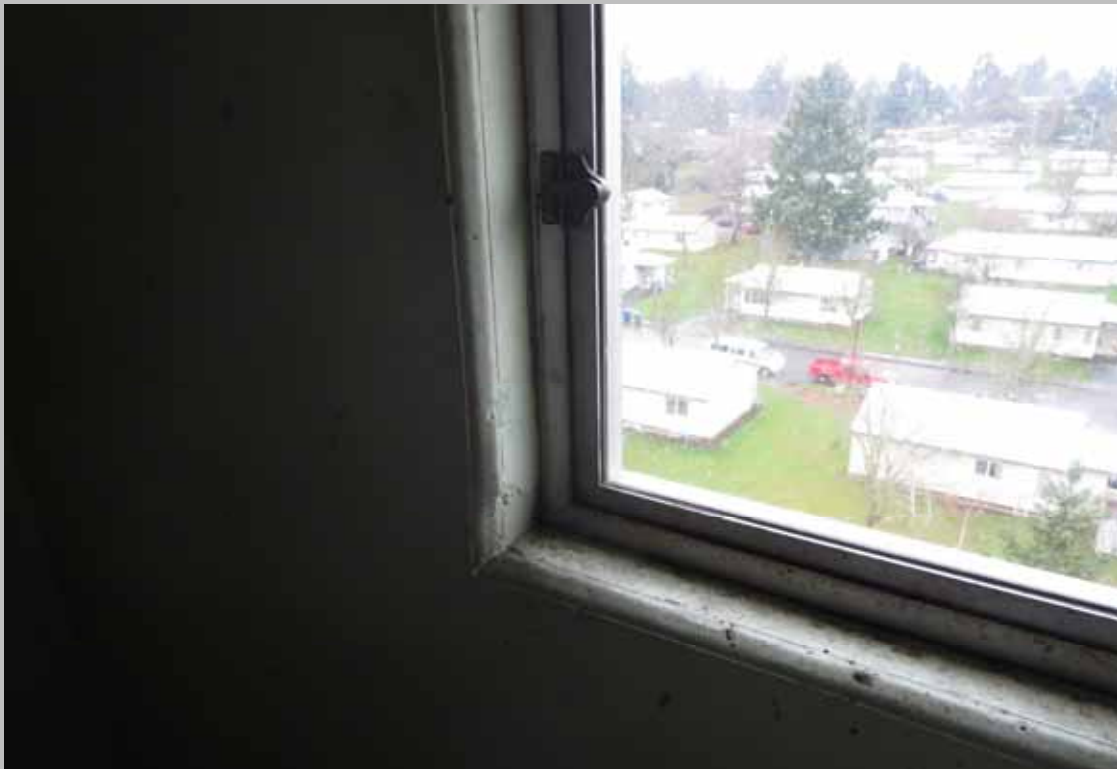
PHOTO #65

3.3.3	12. According to the concept package scope of work, the casement windows will be replaced. (8 Each @ \$545.00, Level 1 Alterations)	\$4,360.00
3.3.3	13. According to the concept package scope of work the fixed windows will be replaced. (4 Each @ \$1,200.00, Level 1 Alterations)	\$4,800.00

Replace original casement windows (Non-Critical Repair)

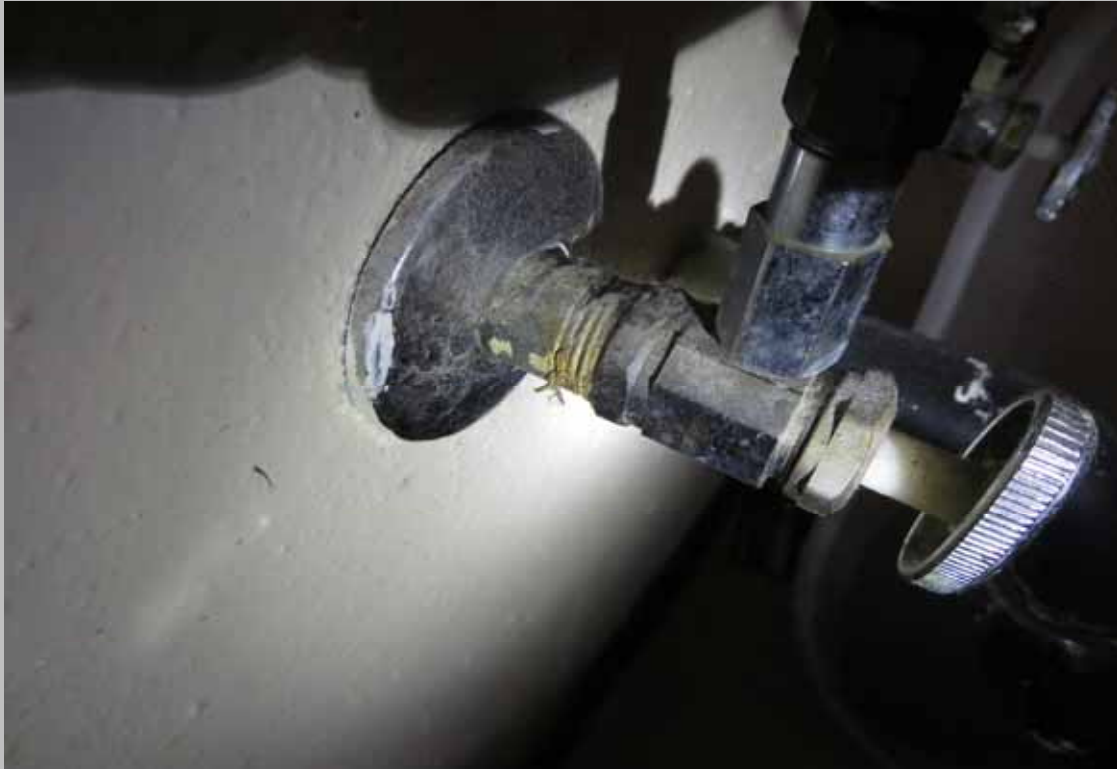
PHOTO #66

3.4.1	14. Replacement of the original galvanized supply plumbing is recommended. According to the provided concept package scope of work the domestic water distribution lines will be replaced. (1 Each @ \$283,008.00, Level 1 Alterations)	\$283,008.00

Replace original galvanized plumbing (Non-Critical Repair)

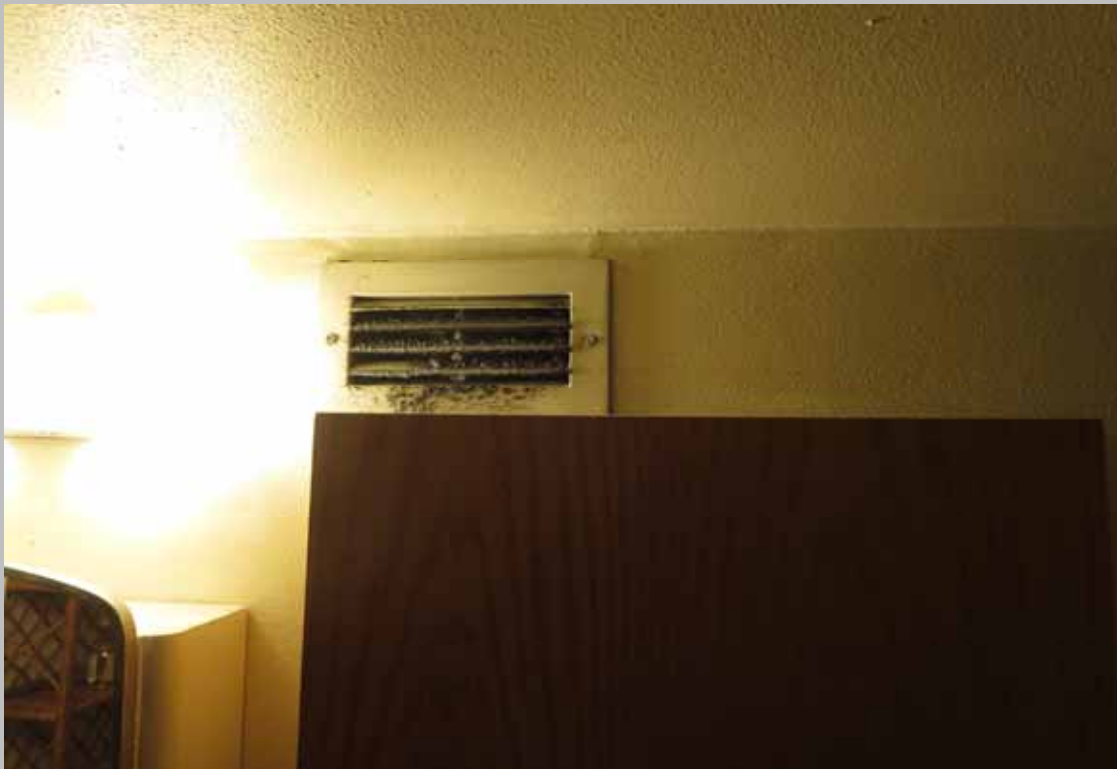
PHOTO #67

3.4.3	28. The dwelling unit ventilation registers were observed with discoloration and debris buildup. Investigation to determine the source of the ventilation contaminants and cleaning of the ductwork is recommended. According to the concept package scope of work the ductwork and registers will be cleaned. (1 Each @ \$35,561.00, Repair)	\$35,561.00

Clean dwelling unit ventilation ducts and registers (Non-Critical Repair)

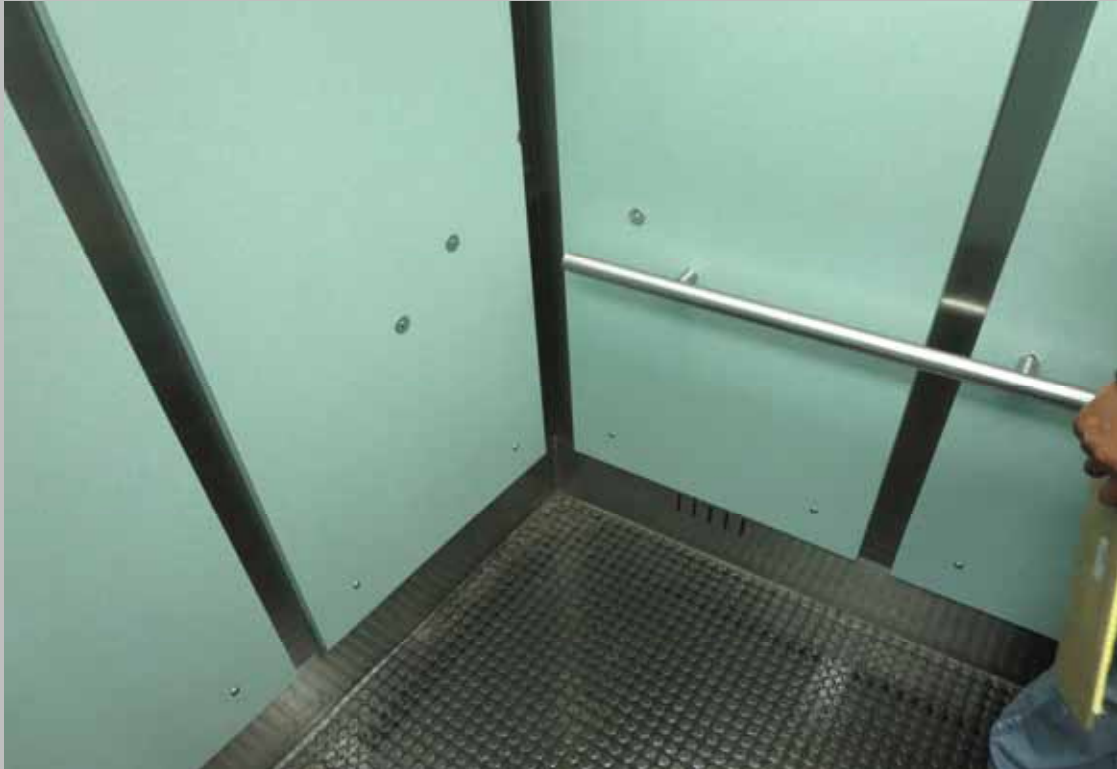
PHOTO #68

3.5.1	33. Refurbishment of the interior elevator cabs is recommended. According to the concept package, modernization of the elevators is included in the scope of work. (2 Each @ \$4,955.00, Level 1 Alterations)	\$9,910.00

Refurbish interior elevator cabs (Non-Critical Repair)

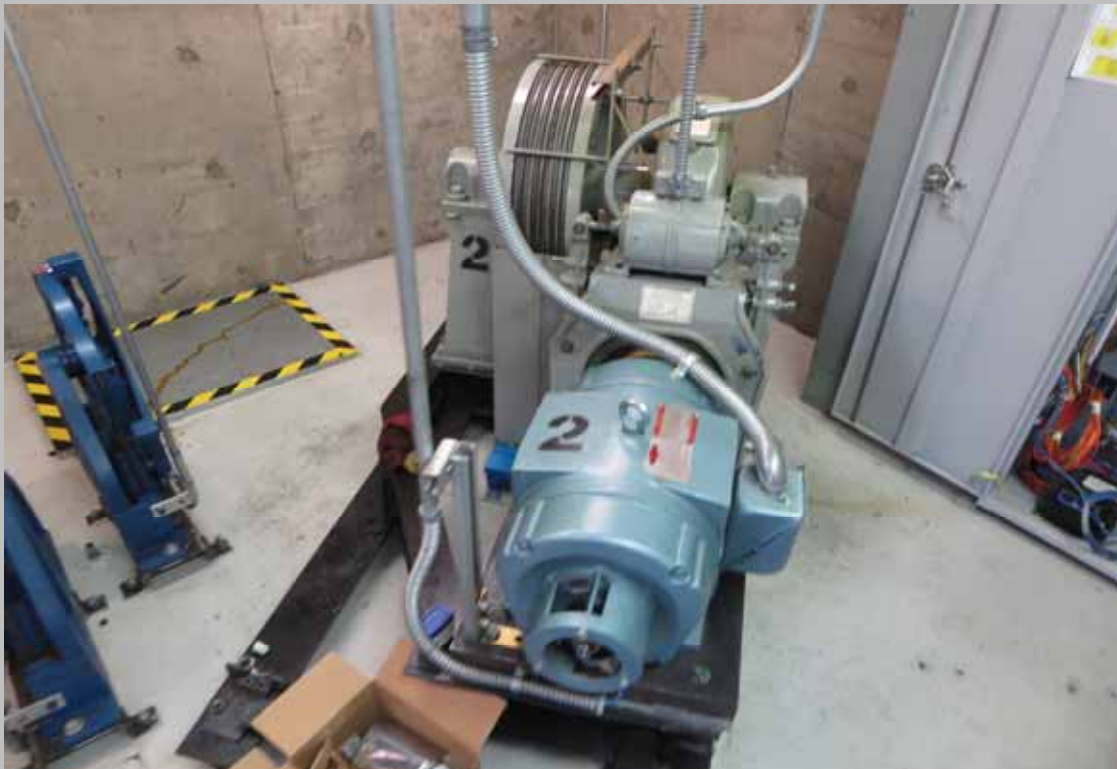
PHOTO #69

3.5.1	34. The elevators were reported with inconsistent operation and feature many original components which have exceeded their EUL. Replacement/modernization of the 2,000 lb elevator equipment is recommended. According to the concept package, modernization of the elevators is included in the scope of work. (1 Each @ \$185,416.10, Level 1 Alterations)	\$185,416.10

3.5.1	35. The elevators were reported with inconsistent operation and feature many original components which have exceeded their EUL. Replacement/modernization of the 3,500 lb elevator equipment is recommended. According to the concept package, modernization of the elevators is included in the scope of work. (1 Each @ \$242,547.25, Level 1 Alterations)	\$242,547.25

Replace elevator equipment (Non-Critical Repair)

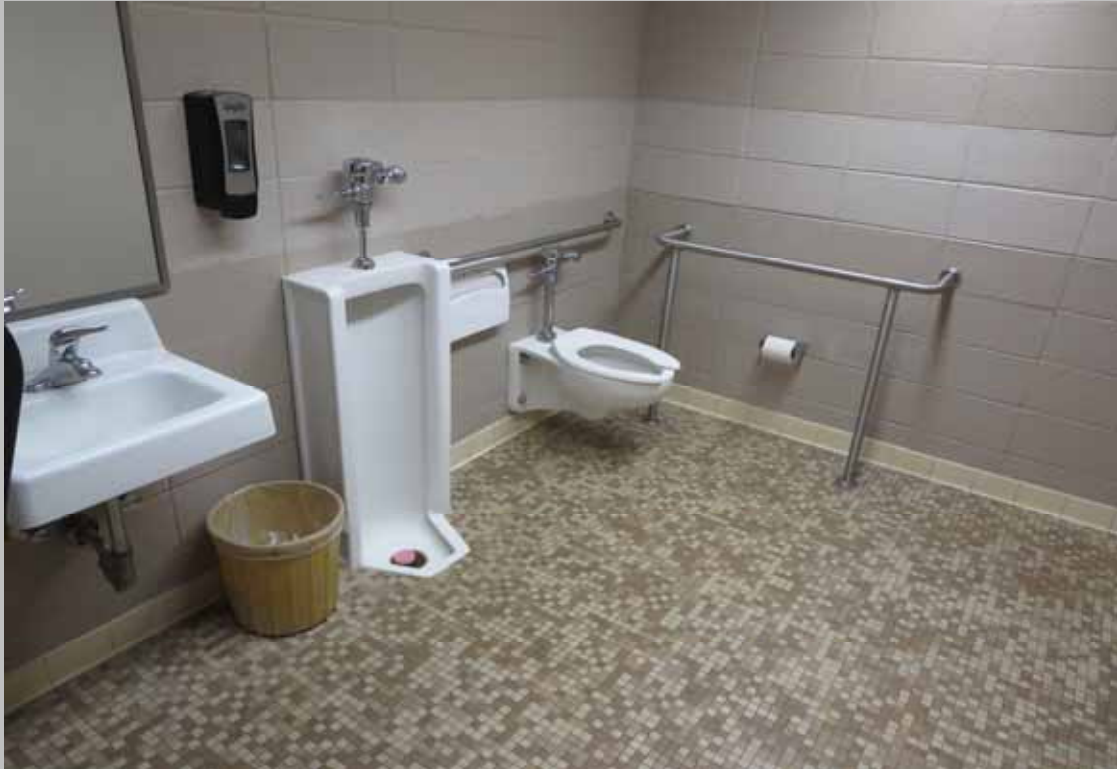
PHOTO #70

Replace common area restroom tile (Non-Critical Repair)

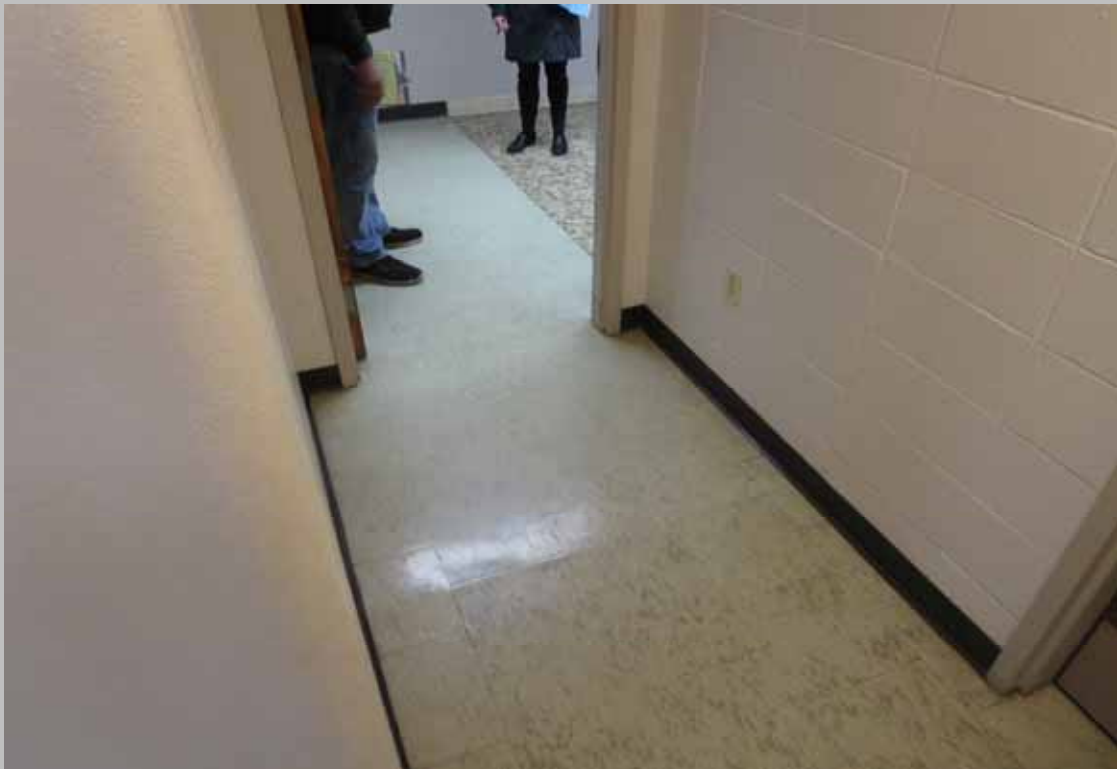
PHOTO #71

Replace common areas VCT flooring (Non-Critical Repair)

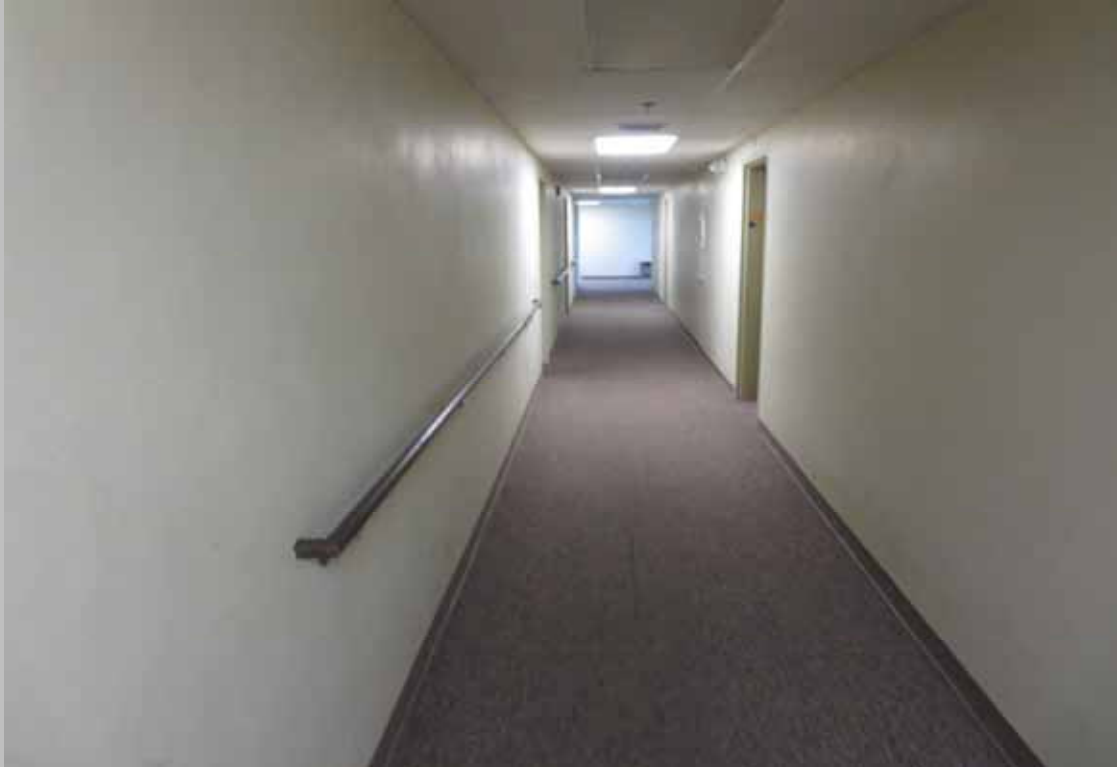
PHOTO #72

Replace common area carpeting (Non-Critical Repair)
