**RENTAL ASSISTANCE DEMONSTRATION
PHYSICAL CONDITION ASSESSMENT (RPCA)
HILLSIDE MANOR
2889 SE HILLSIDE STREET
MILWAUKIE, OREGON 97222**

**D3G PROJECT NUMBER:
2018-0031**

**FINAL REPORT ISSUE DATE:
APRIL 13, 2018**

**INSPECTION DATE:
JANUARY 23, 2018**

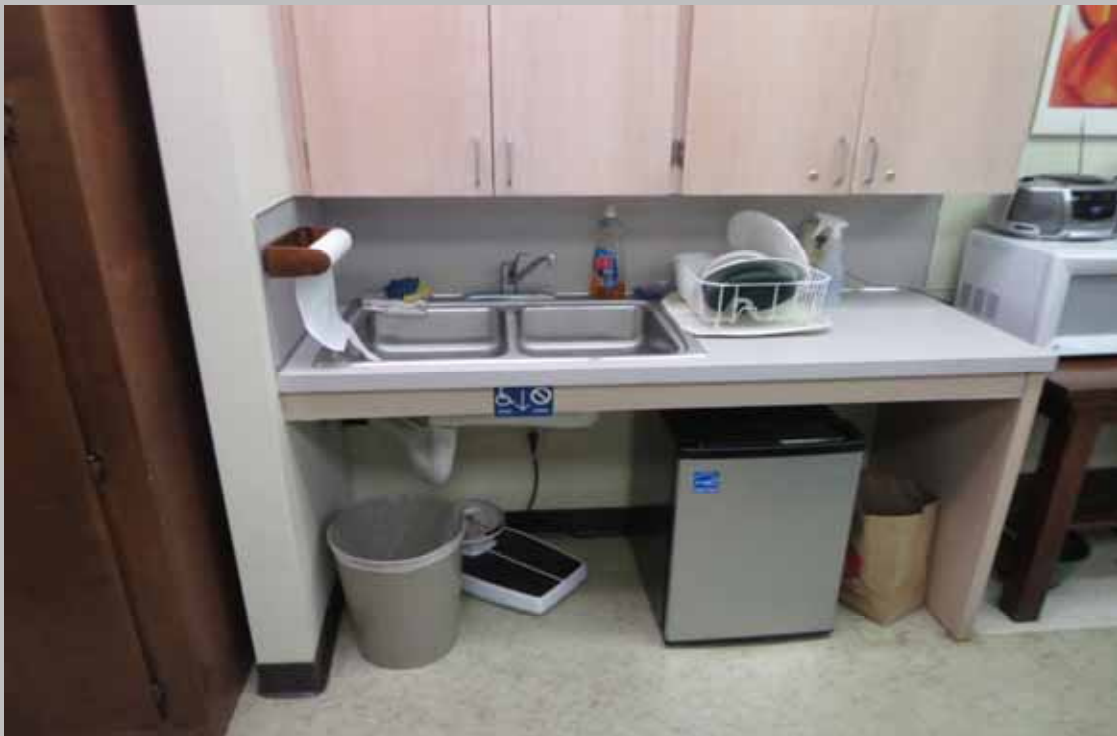
PHOTO #73

Replace common area cabinets and counters (Non-Critical Repair)

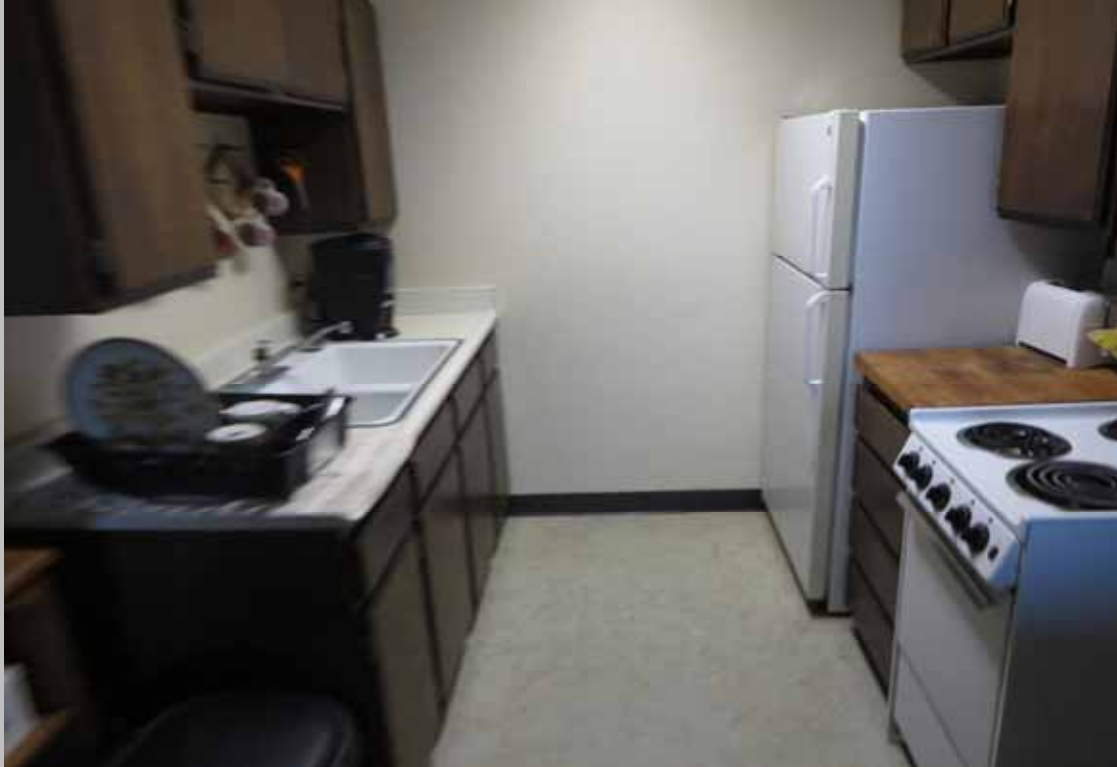
PHOTO #74

Replace refrigerators with Energy Star refrigerators (Non-Critical Repair)

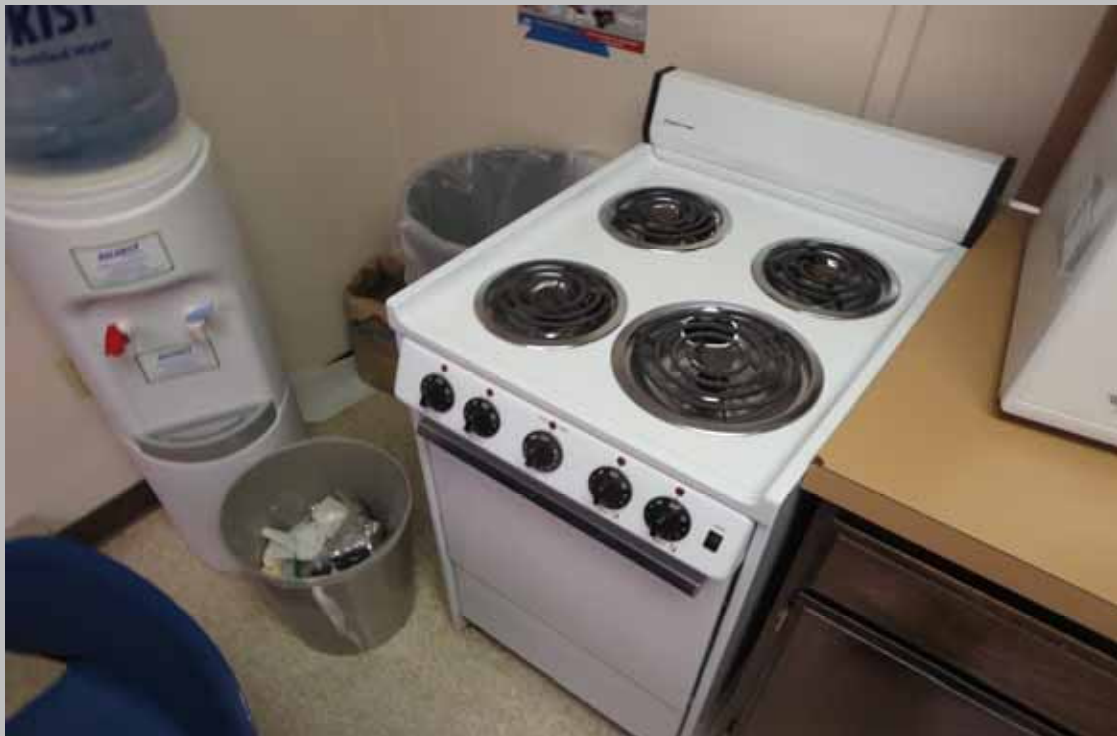
PHOTO #75

Replace ranges (Non-Critical Repair)

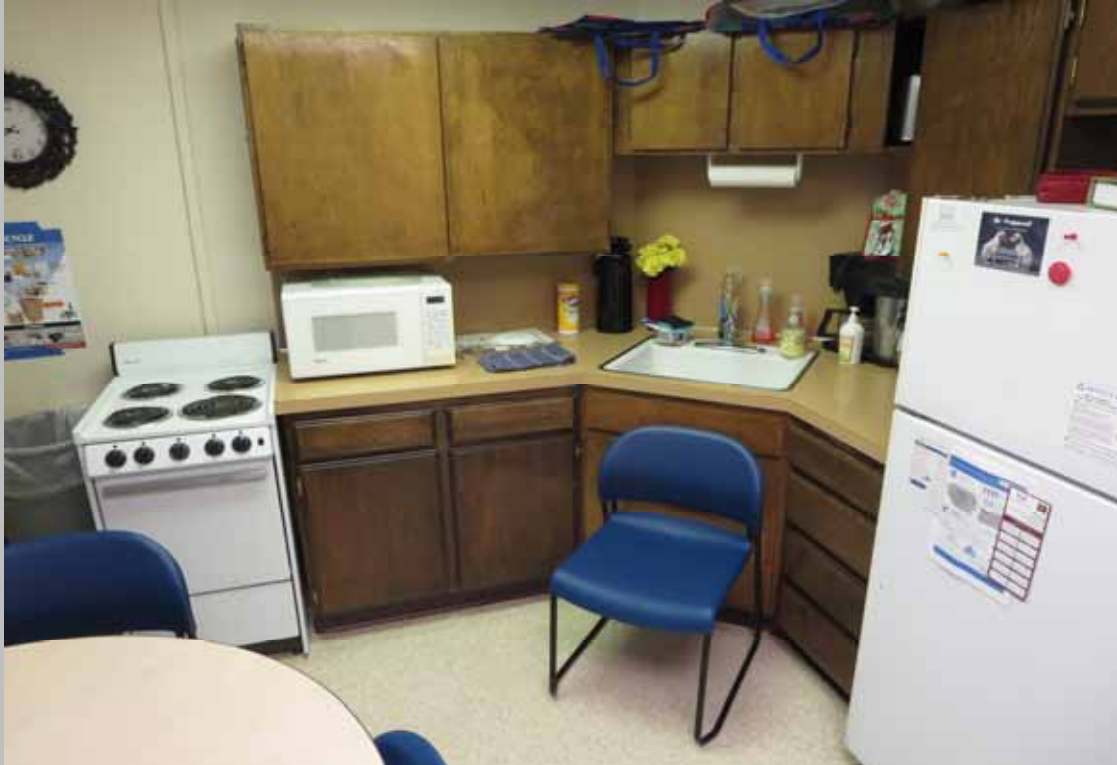
PHOTO #76

Replace common area appliances (Non-Critical Repair)

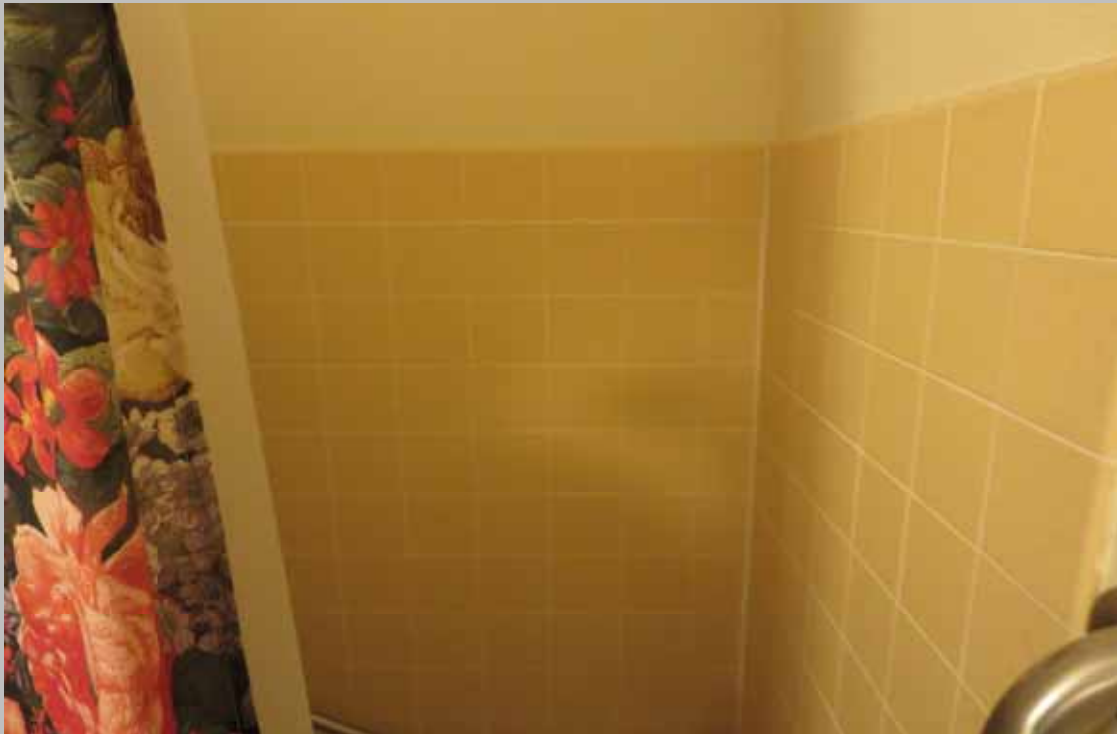
PHOTO #77

Replace tub/shower surrounds (Non-Critical Repair)

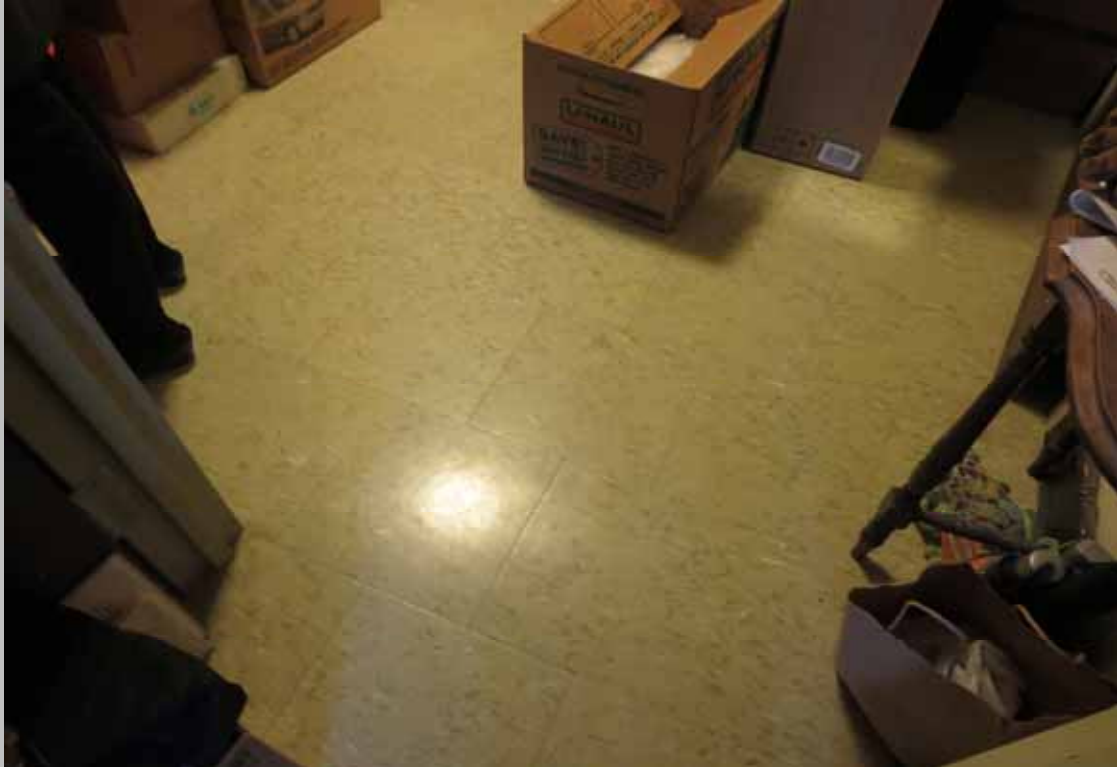
PHOTO #78

Replace dwelling unit VCT (Non-Critical Repair)

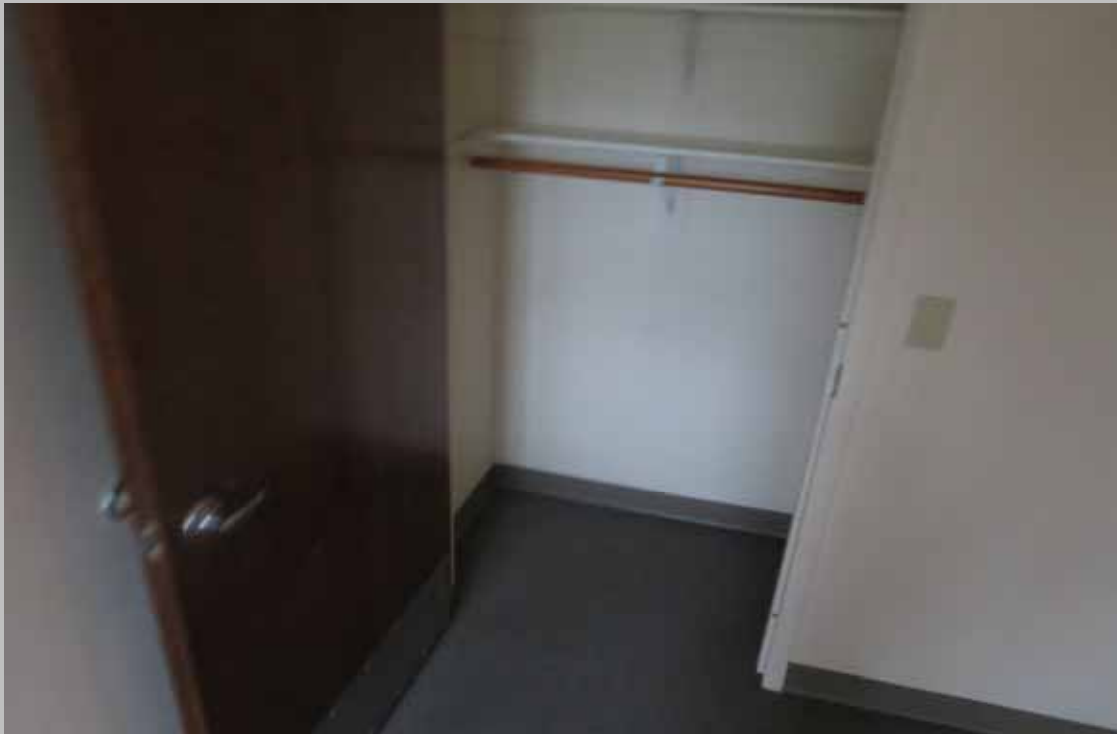
PHOTO #79

Replace dwelling unit carpeting (Non-Critical Repair)

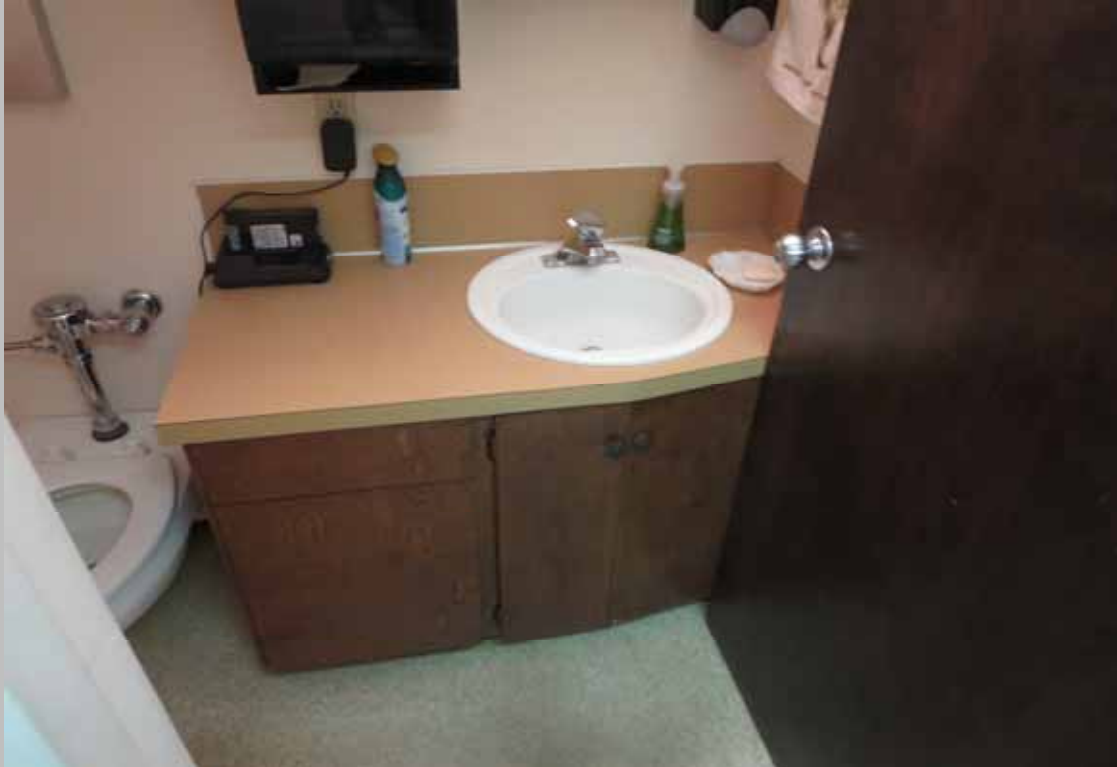
PHOTO #80

Replace common vanities (Non-Critical Repair)

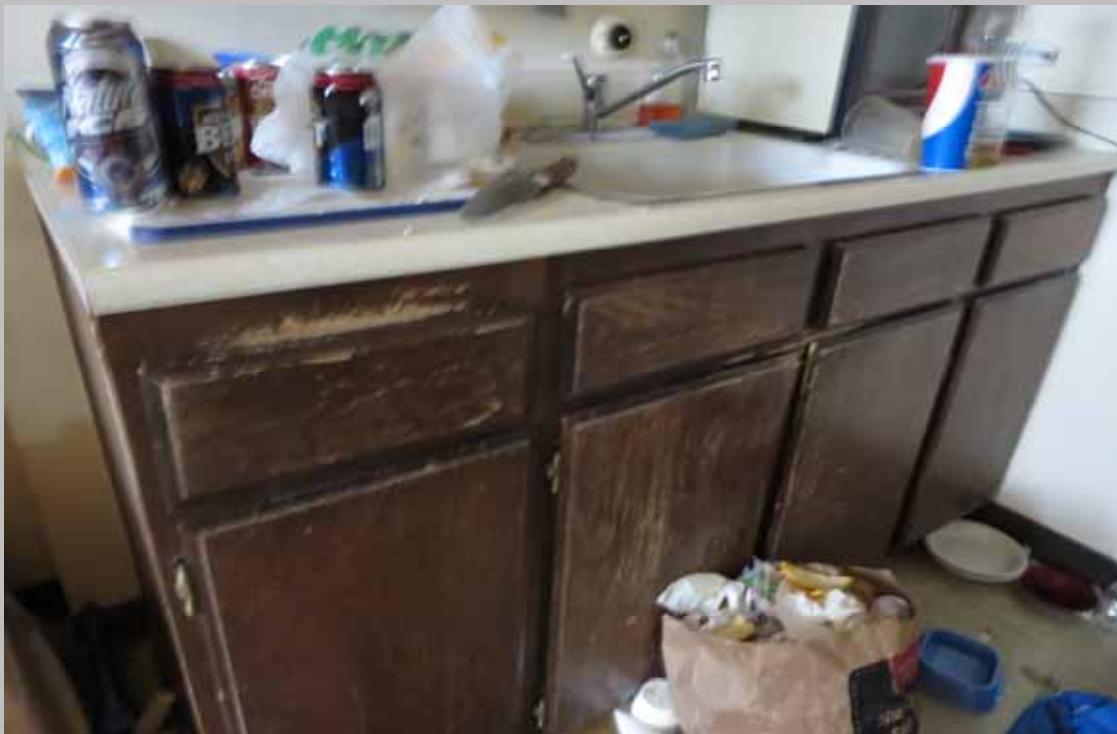
PHOTO #81

Replace dwelling unit kitchen cabinets and counters (Non-Critical Repair)

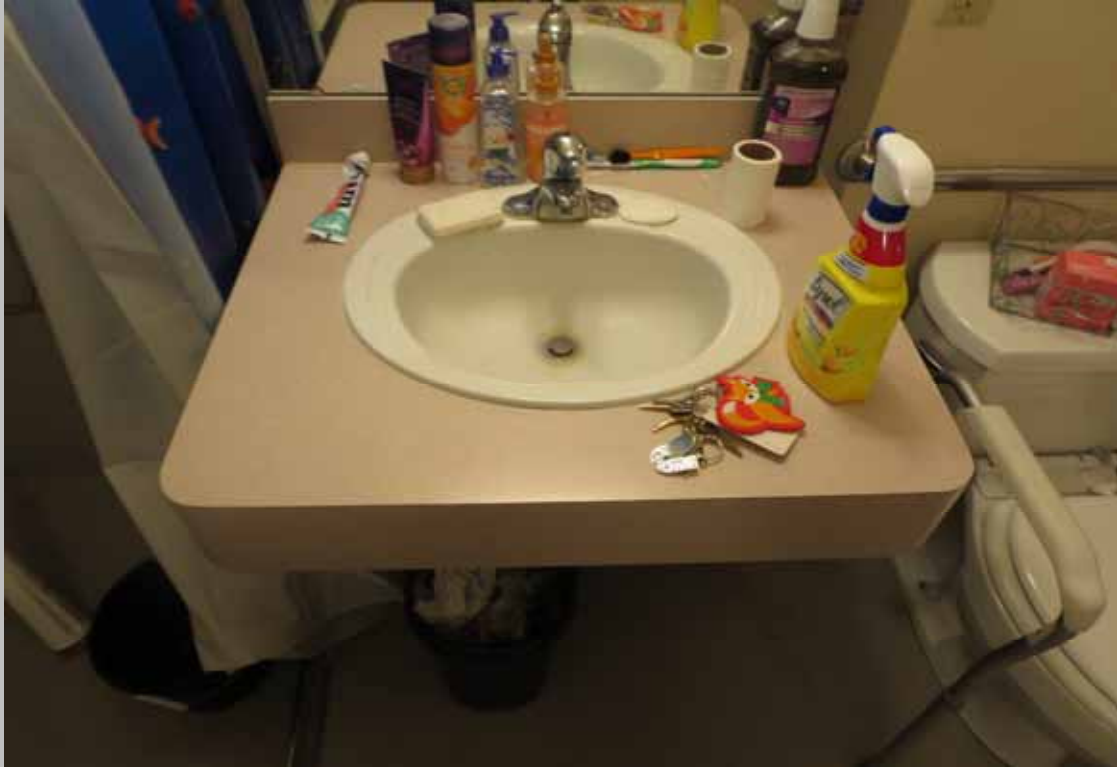
PHOTO #82

Replace dwelling unit bathroom counters (Non-Critical Repair)

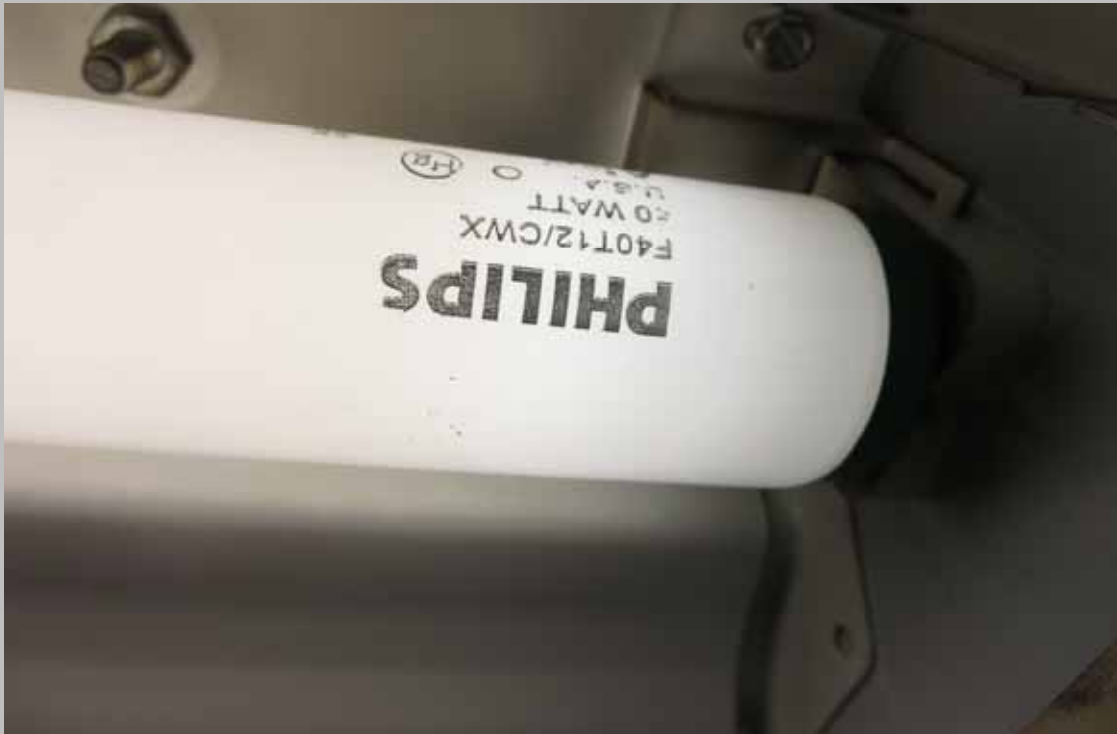
PHOTO #83

3.4.4	32. Replacement of the inefficient interior dwelling unit T-12 fluorescent lighting fixtures with high efficiency lighting fixtures is recommended as an EWCM repair. (1 Each @ \$18,900.00, Repair)	\$18,900.00

Replace inefficient fluorescent fixtures (Non-Critical Repair)

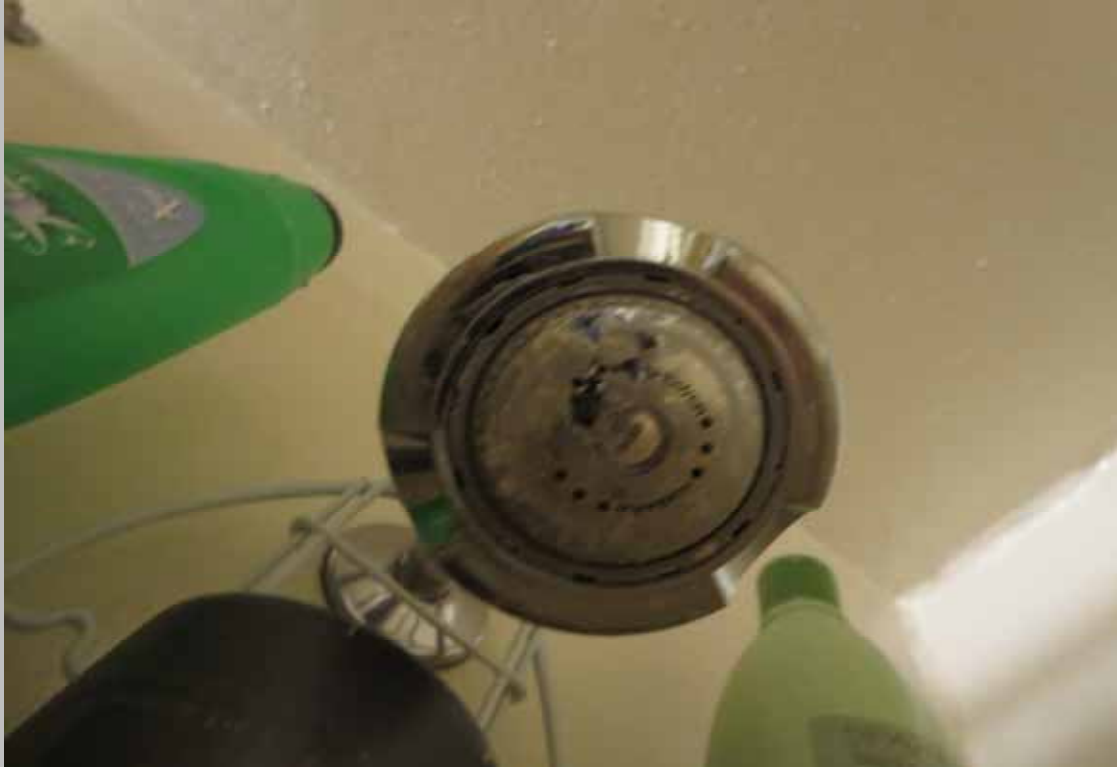
PHOTO #84

3.4.1	18. According to the concept package scope of work the shower plumbing and fixtures will be replaced. It is recommended to replace the remaining dwelling unit bathroom showerheads with Low-Flow showerheads (1.5 GPM). (100 Each @ \$43.00, Repair)	\$4,300.00

Replace showerheads with low-flow fixtures (Non-Critical Repair)

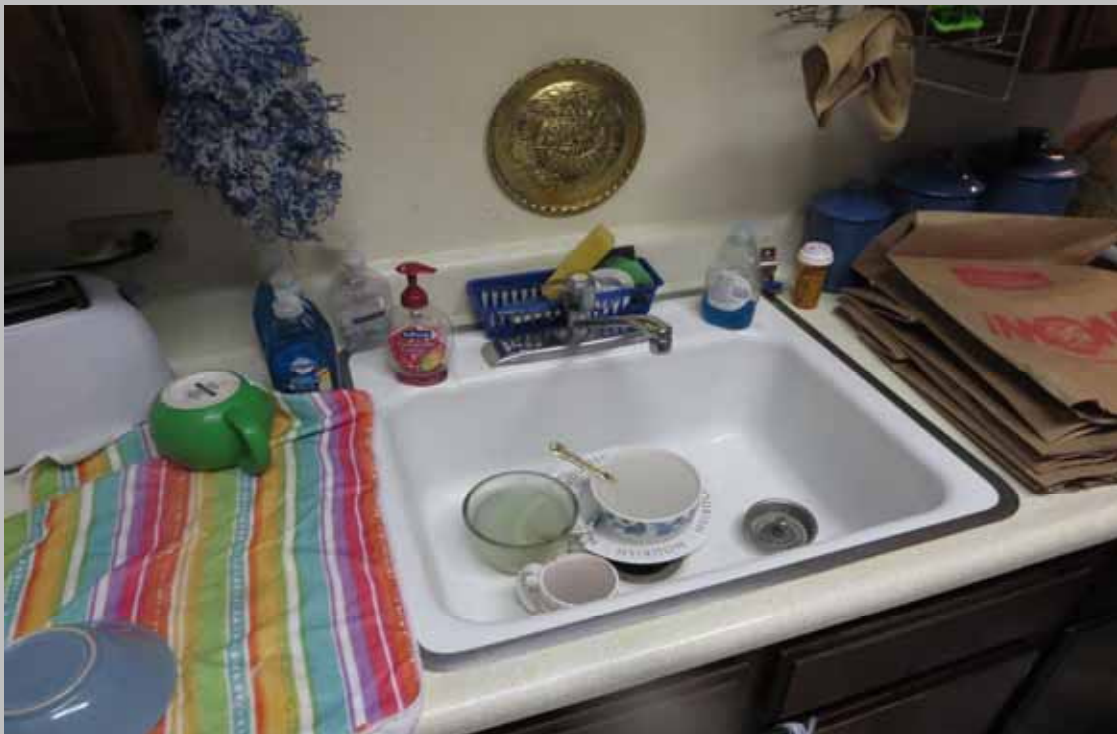
PHOTO #85

3.4.1	19. According to the concept package scope of work the dwelling unit sinks and lavatories will be replaced. It is recommended to replace the remaining dwelling unit and common area 2.2 GPM kitchen aerators with Low-Flow Aerators (≤ 1.8 GPM). (207 Each @ \$3.00, Repair)	\$621.00

Install low-flow aerators in kitchens (Non-Critical Repair)

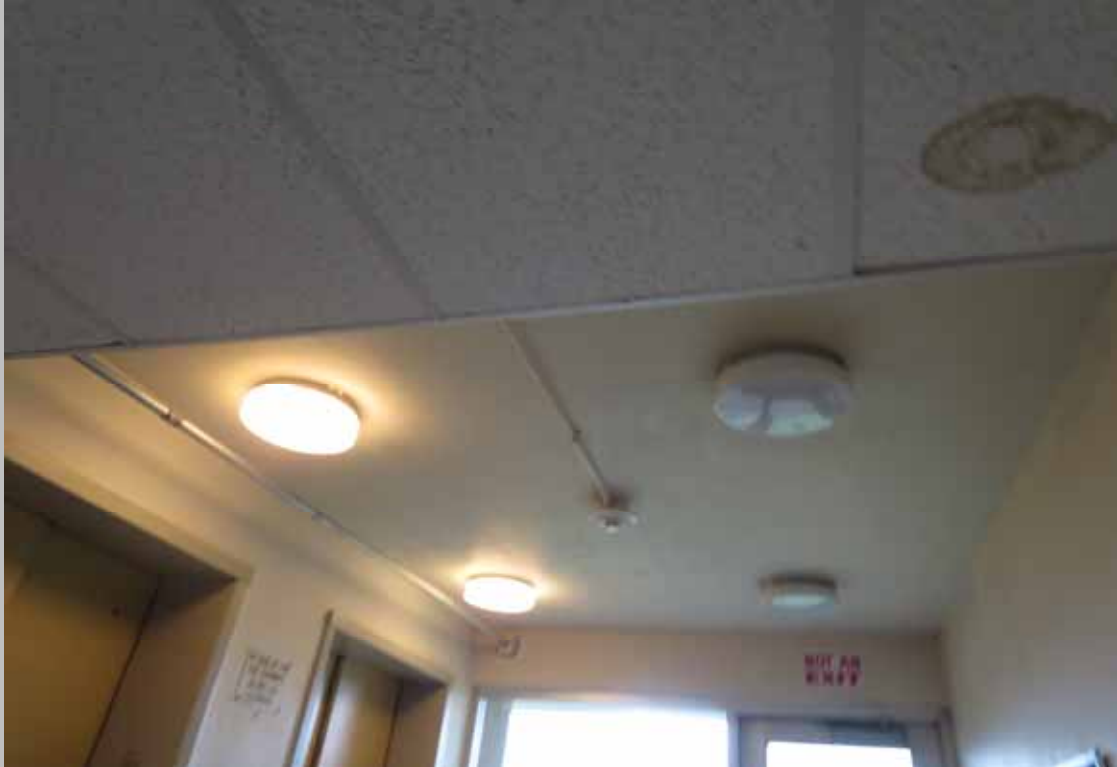
3.4.4	31. Replacement of the inefficient interior common area T-12 fluorescent and incandescent lighting fixtures with high efficiency lighting fixtures is recommended as an EWCM repair. (1 Each @ \$38,205.00, Repair)	\$38,205.00

Replace inefficient incandescent fixtures (Non-Critical Repair)
