Limited Hazardous Building Materials Survey Report

Concord Elementary School
3811 SE Concord Road
Milwaukie, OR 97267

North Clackamas Parks & Rec District

July 2017

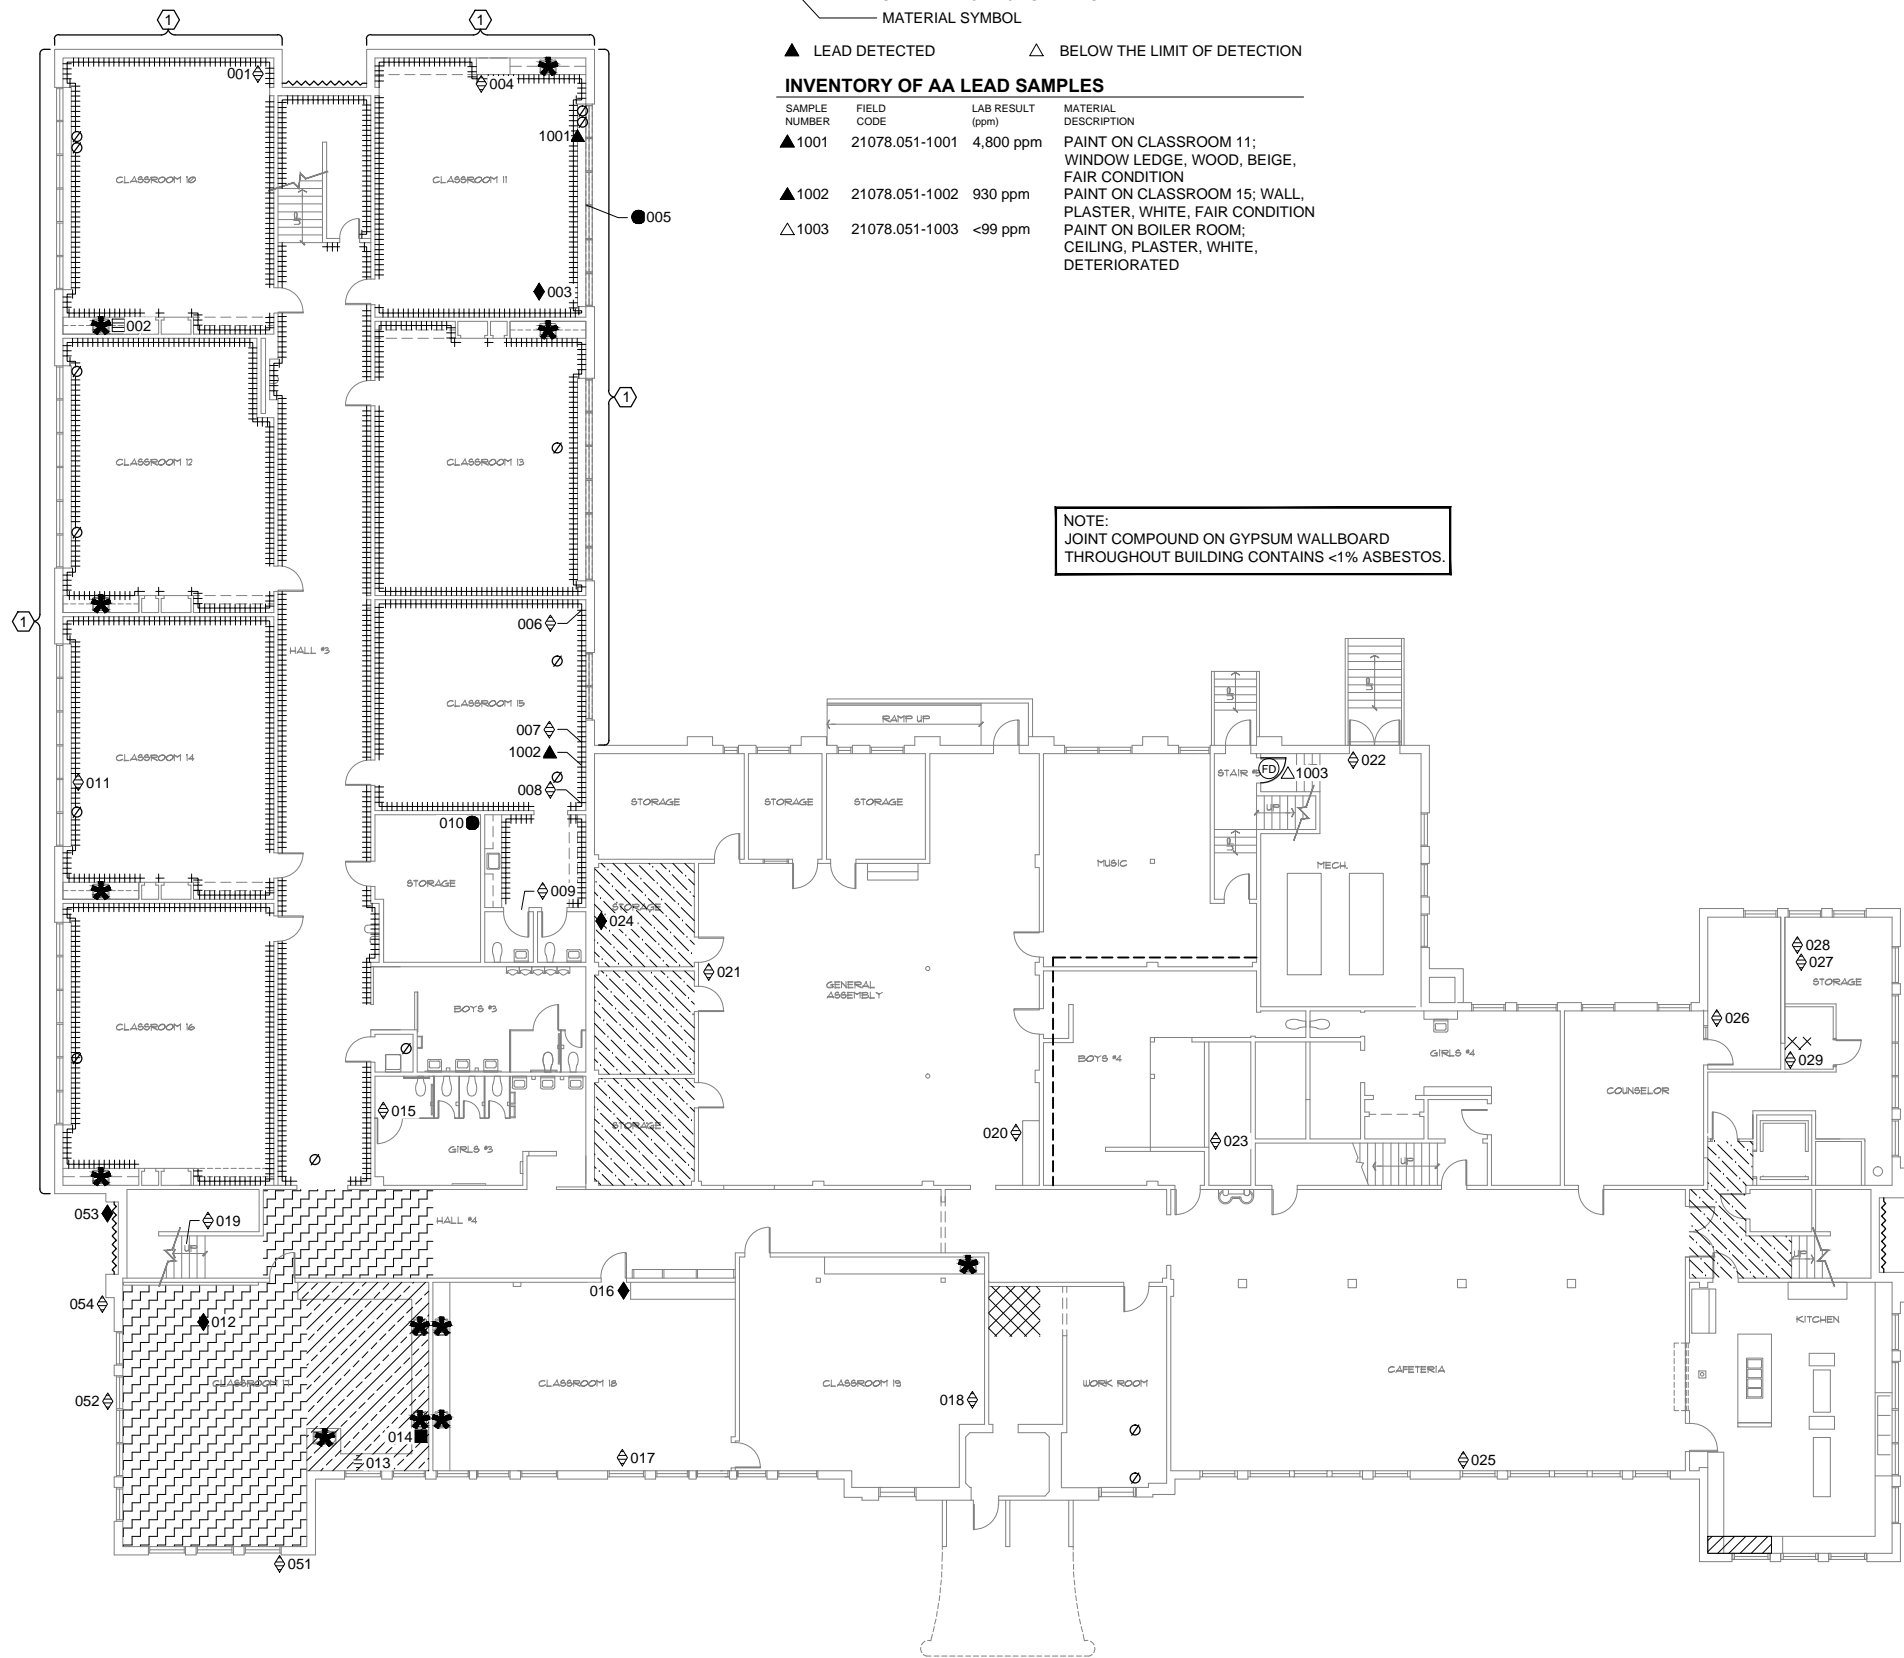
FIRST FLOOR PLAN

- ① ASBESTOS-CONTAINING AIR-CELL PIPE INSULATION AND HARD FITTINGS WERE IDENTIFIED IN INTERSTITIAL WALL CAVITIES ASSOCIATED WITH DOMESTIC WATER PLUMBING IN THE NORTHEAST ADDITION WING OF THE BUILDING.

NOTE: JOINT COMPOUND ON GYPSUM WALLBOARD THROUGHOUT BUILDING CONTAINS <1% ASBESTOS.
