EVENT CENTER LIVESTOCK BUILDING TIME LINE AND COMMENTS

June 17, 2014

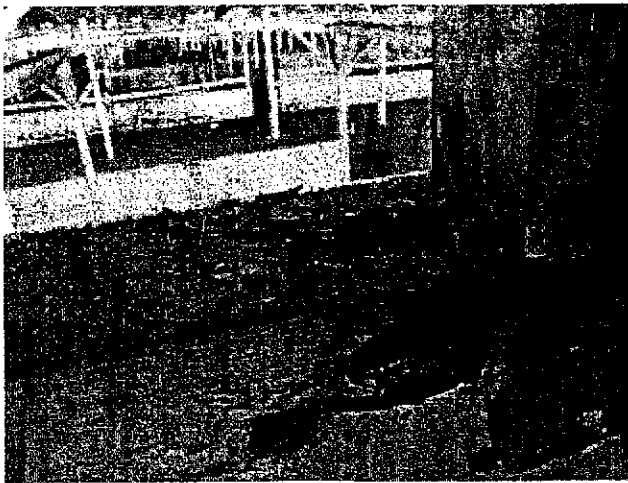
Photo 3: Beam water damage

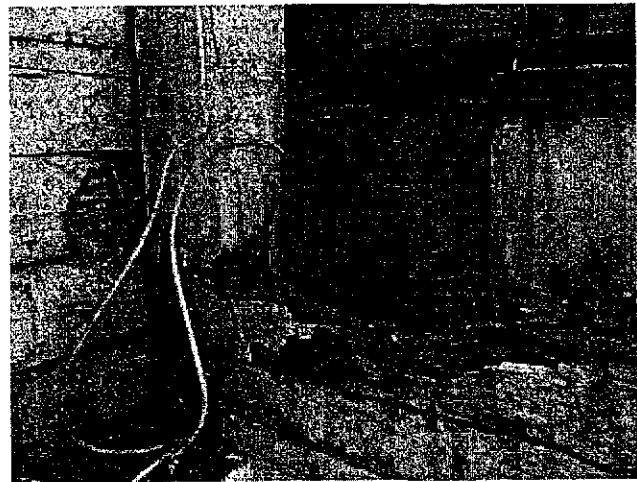
Photo 4: West wall beam end damage

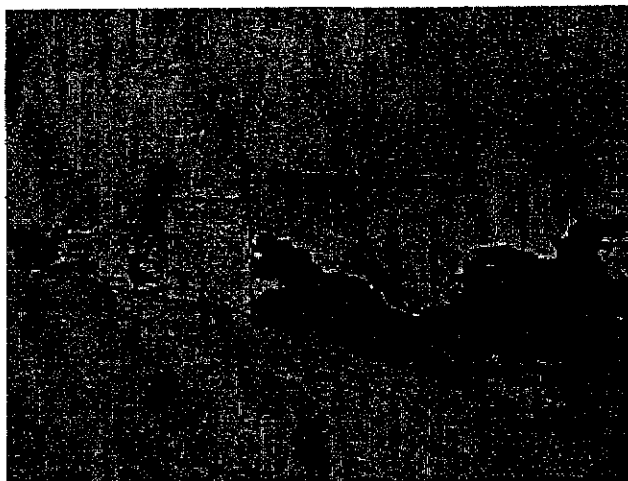
Photo 5: Dryrot at base of wall

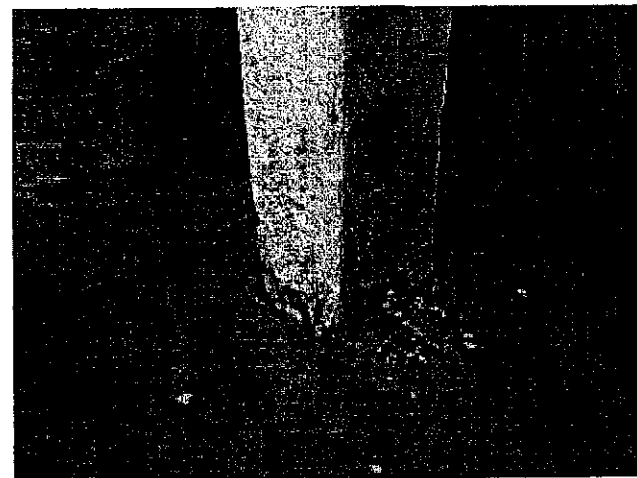
Photo 6: Typical column base damage
