# CLACKAMAS COUNTY BOARD OF COUNTY COMMISSIONERS

## Policy Session Worksheet

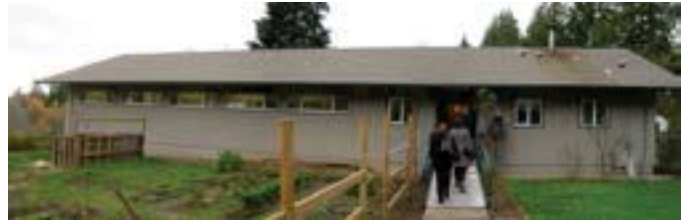
- Fixtures in the kitchen rest room are in need of replacement.
- Two water heaters appear to be in good working condition.
- No drinking fountain is present in the basement. Code requires a minimum of one in an E occupancy.

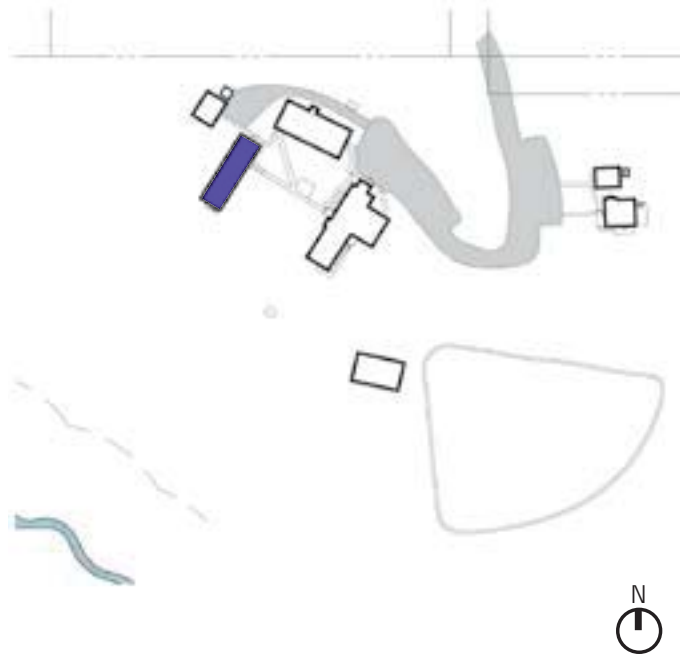
## Summary of the Issues

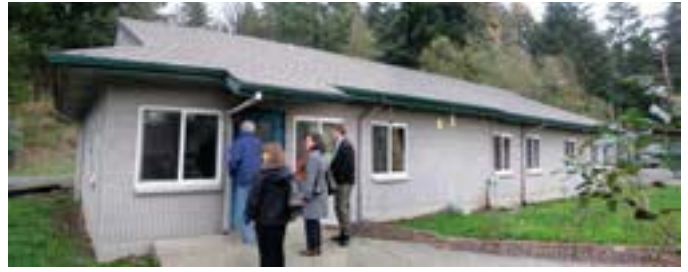
## Residential Care Dorm Building

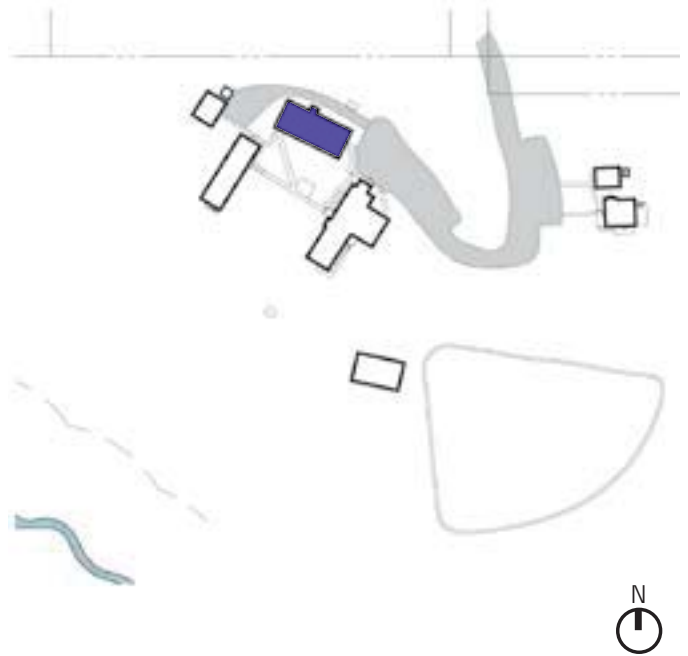
### Summary of the Issues

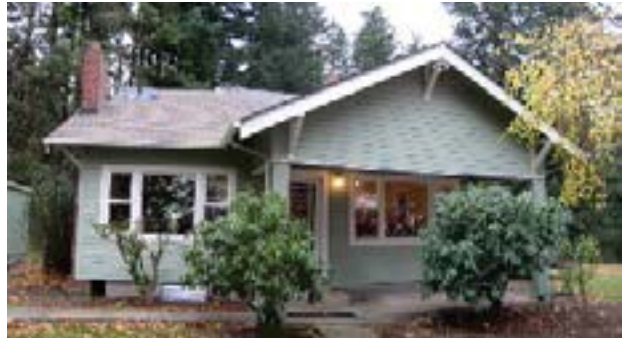
- Three instantaneous propane water heaters appear to be in working condition.
- Rest room and shower facilities have been remodeled within the past few years and appear to meet current code requirements.

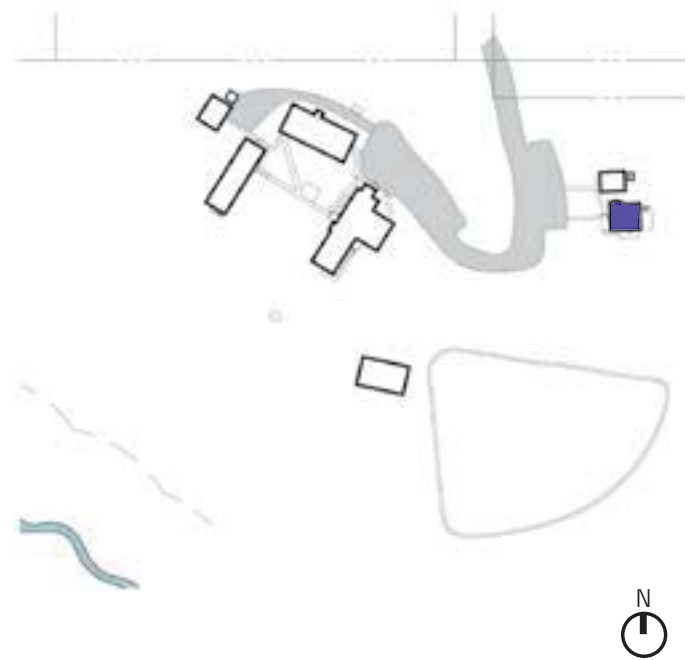
## Summary of the Issues

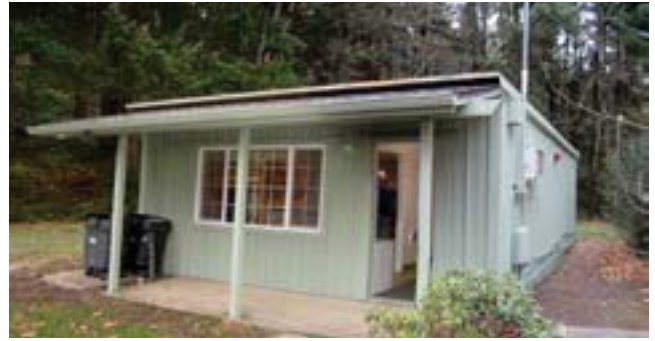
## Shelter Care Dorm Building

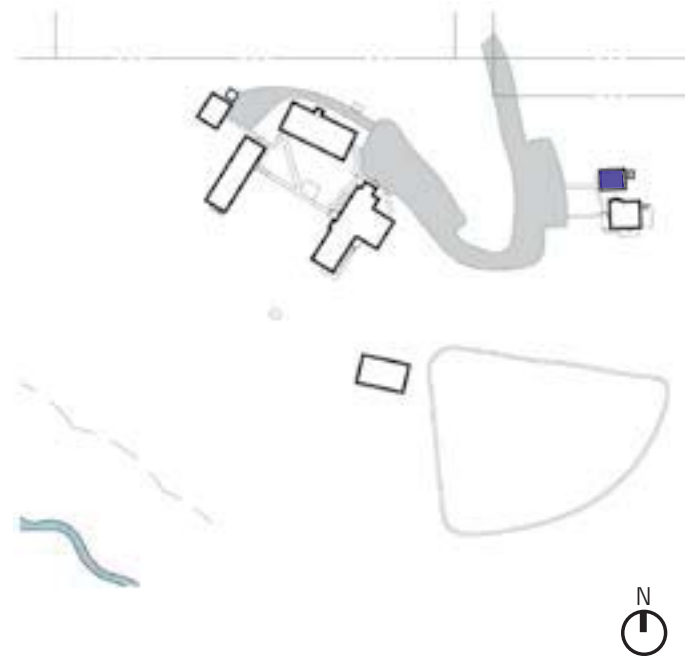
## Summary of the Issues

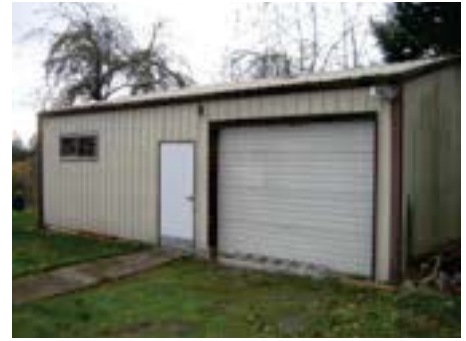
- Mechanical closet needs to be labeled "Fire Riser Room" to meet code requirements.
- Staff noted that the toilet has had leaking problems.
- Fire water supply is noted to enter the building as 1/2" and then up sizes to 3/4". The system is being supplied off of the domestic well water system. This does not meet any modern codes. This system was installed relatively, therefore we can only assume that some agreement was made with the County officials to install a system that does not meet code. At this point in time we recommend doing nothing to resolve this as resolutions will be very costly. If, at some point in time in the future, major renovations and/or additions are built, a system will be required to be installed. At that time this building can be tied into the new system, making it compliant with code. No cost information is included in this assessment.

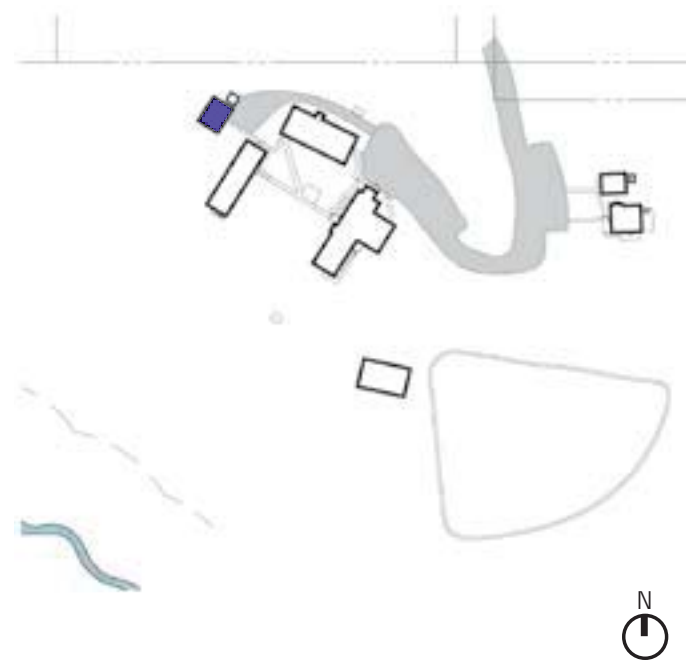
## Summary of the Issues

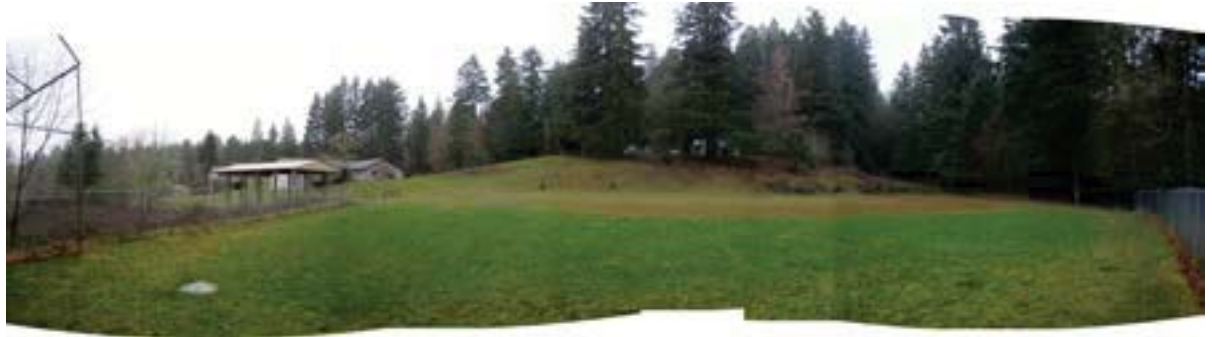
- No plumbing present.

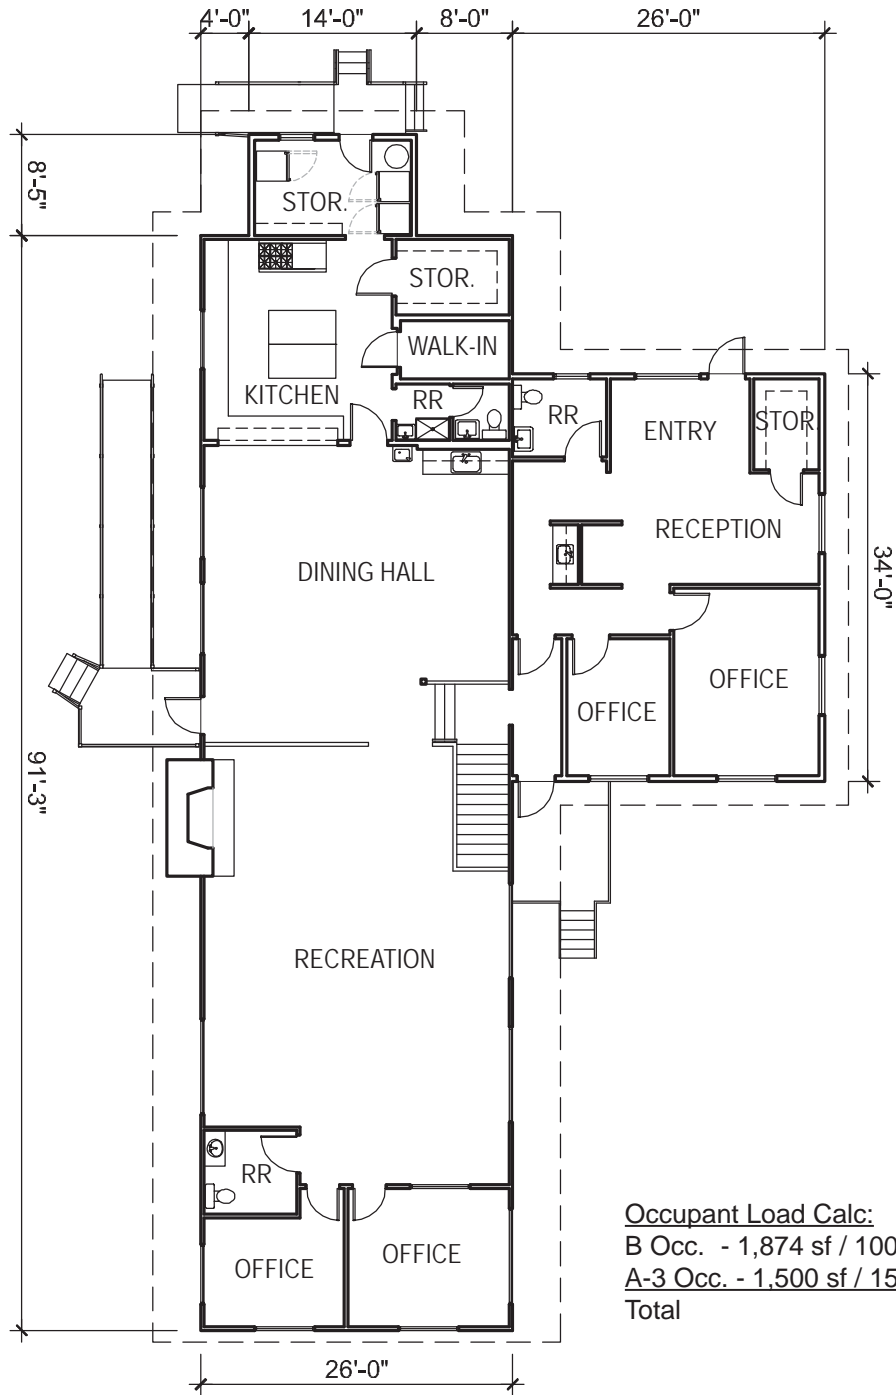
| <u>Contents:</u> | <u>Number of Pages:</u> |
|---|---|
| F-1. Civil Engineers - Existing Conditions Report<br>HHPR, dated January 7th, 2010 | 18 |

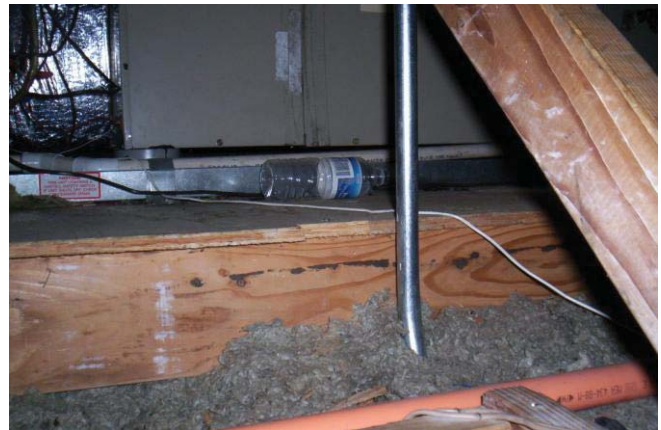
Attic mechanical platform

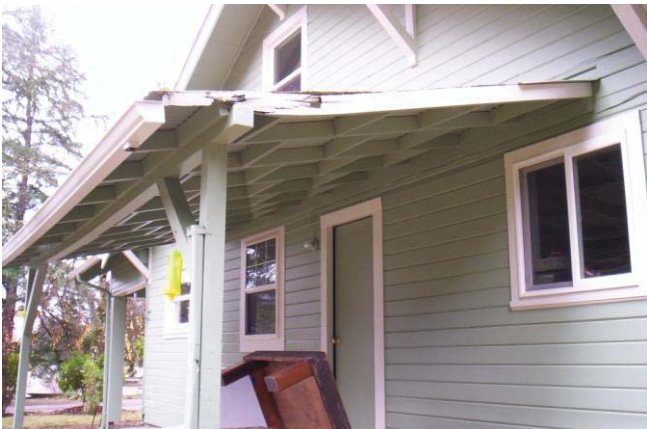
Patio beam and decayed fascia

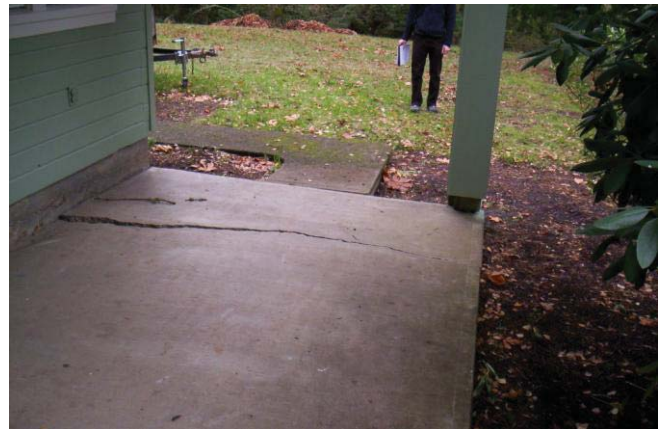
Settlement at entry porch and decayed post base

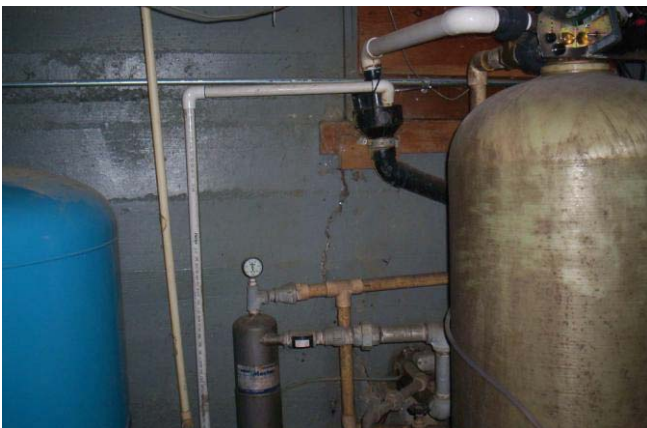
Basement north wall crack

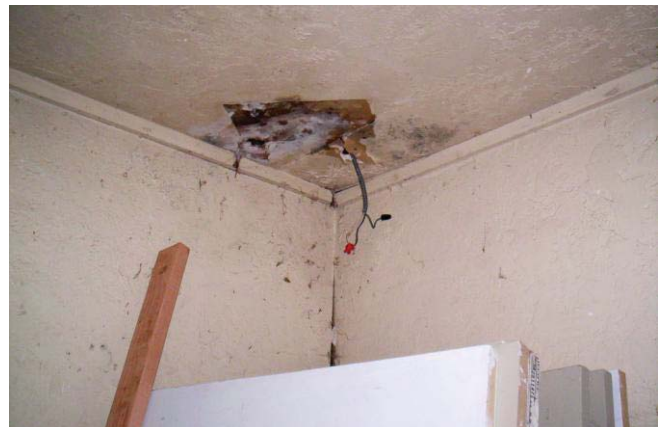
South Elevation grade at siding

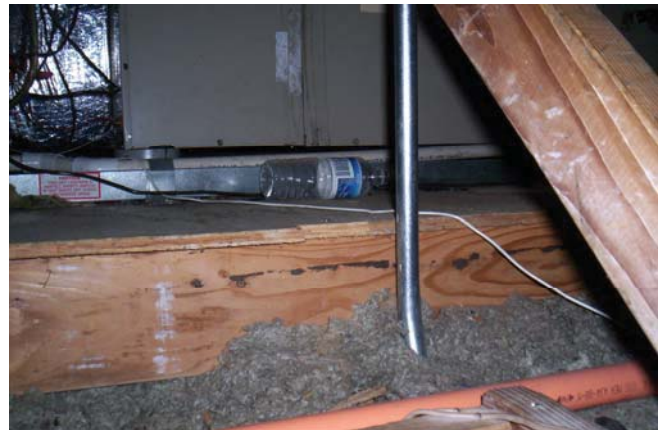
Attic mechanical platform

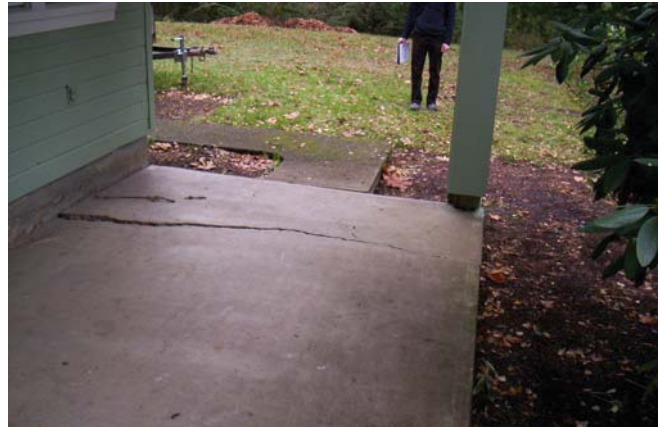
Settlement at entry porch and decayed post base

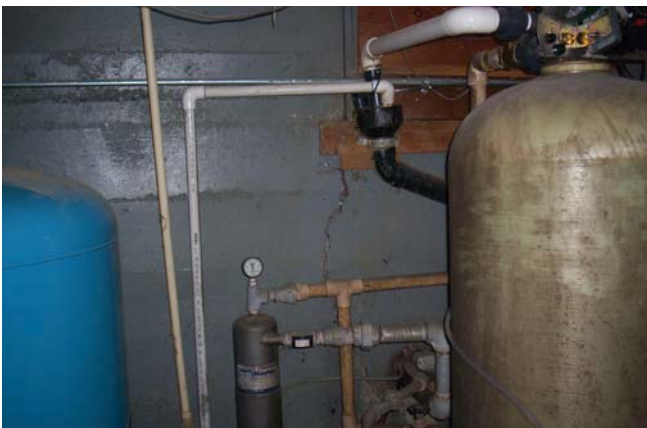
Basement north wall crack

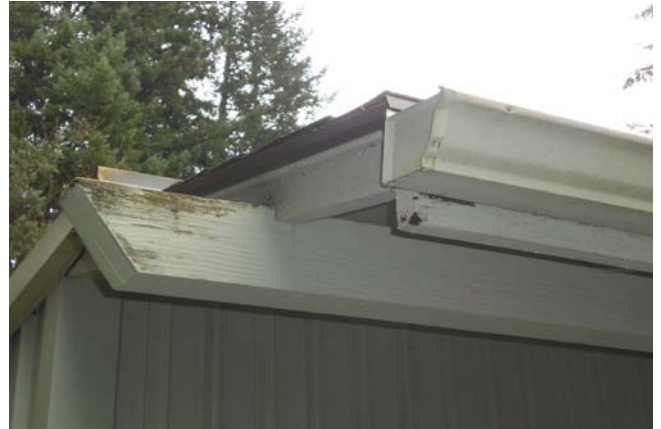
Entry Canopy Framing

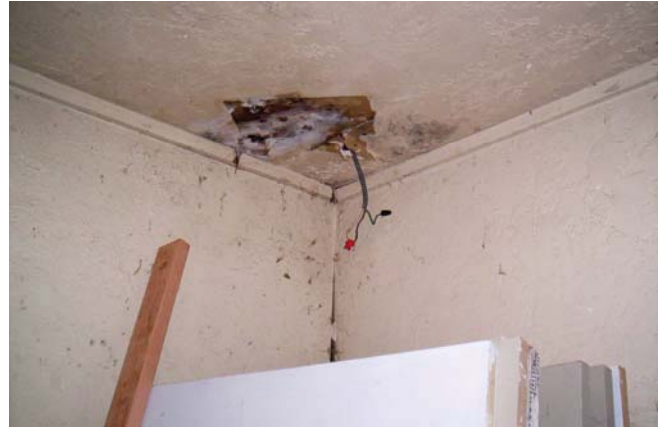
Roof leak damage (2009)

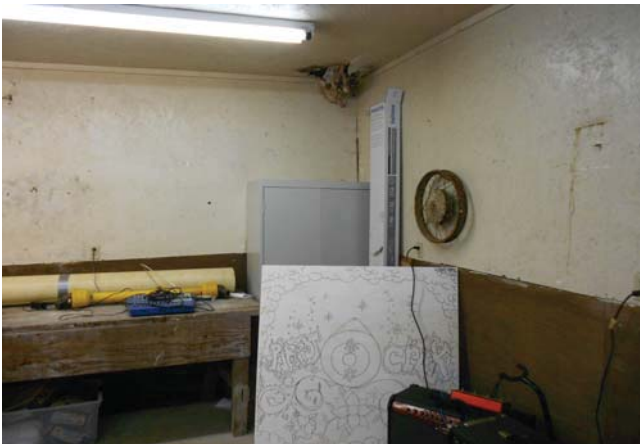
Roof leak damage (2014)

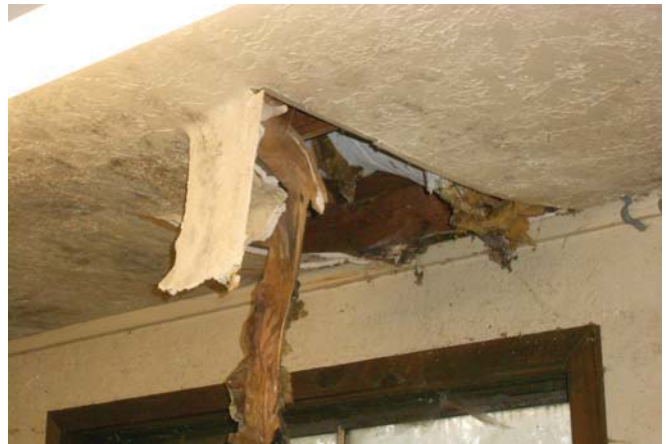
Roof leak damage (2014)

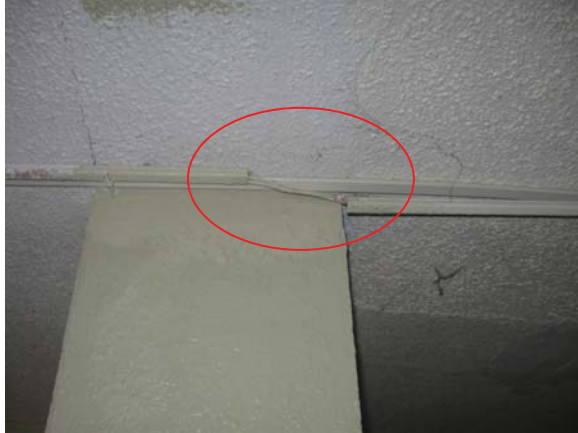
- A number of receptacles and cover plates are damaged or missing, have been coated with textured wallcovering, or are lacking GFCI protection as required per OESC.

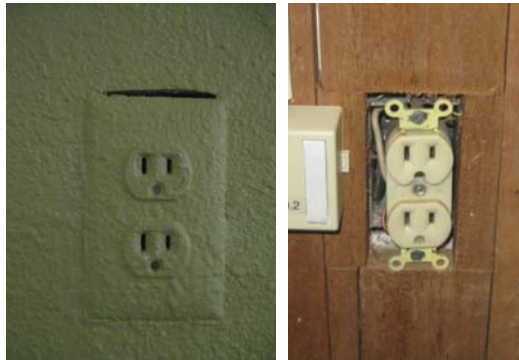
Existing receptacle outlets can be replaced with new tamper-resistant devices designed to protect individuals from accidental shock resulting from the insertion of foreign objects. Product information is included in the appendix.

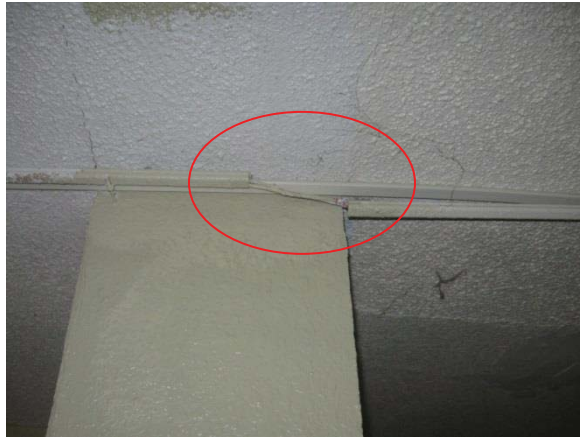
- A number of receptacles and cover plates are damaged or missing, have been coated with textured wallcovering, or are lacking GFCI protection as required per OESC.

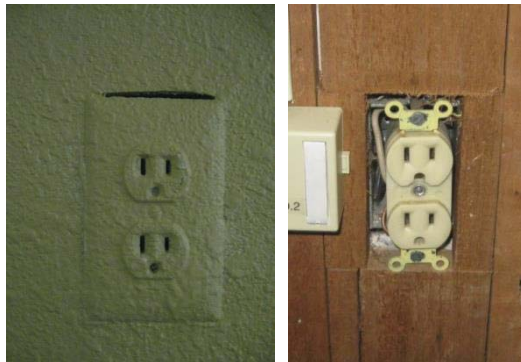
Existing receptacle outlets can be replaced with new tamper-resistant devices designed to protect individuals from accidental shock resulting from the insertion of foreign objects. Product information is included in the appendix.

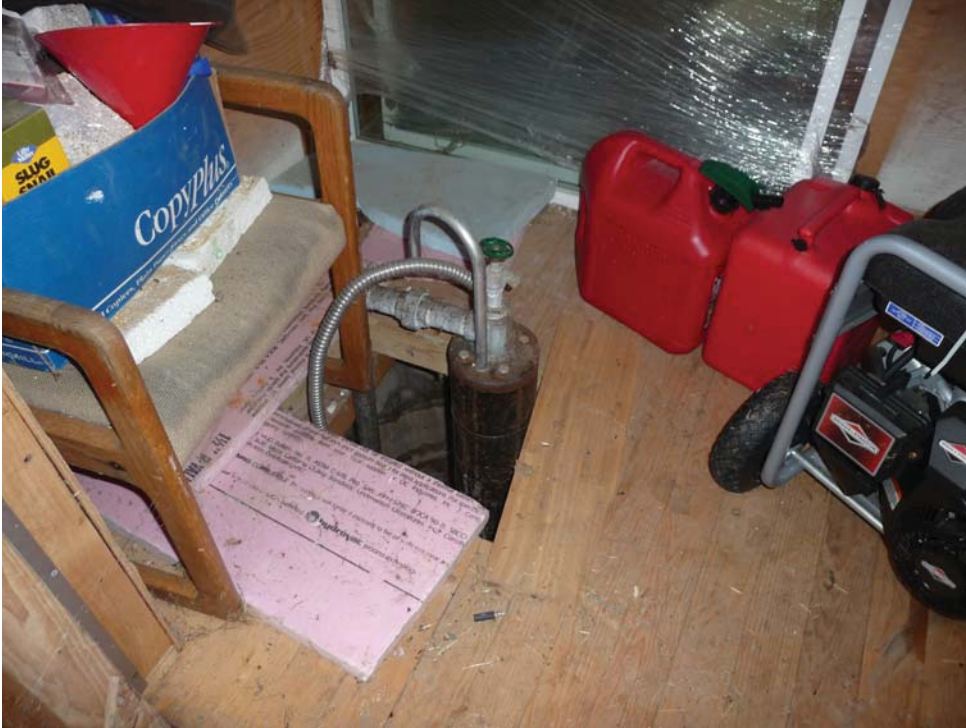
6" Wellhead within the pump house.

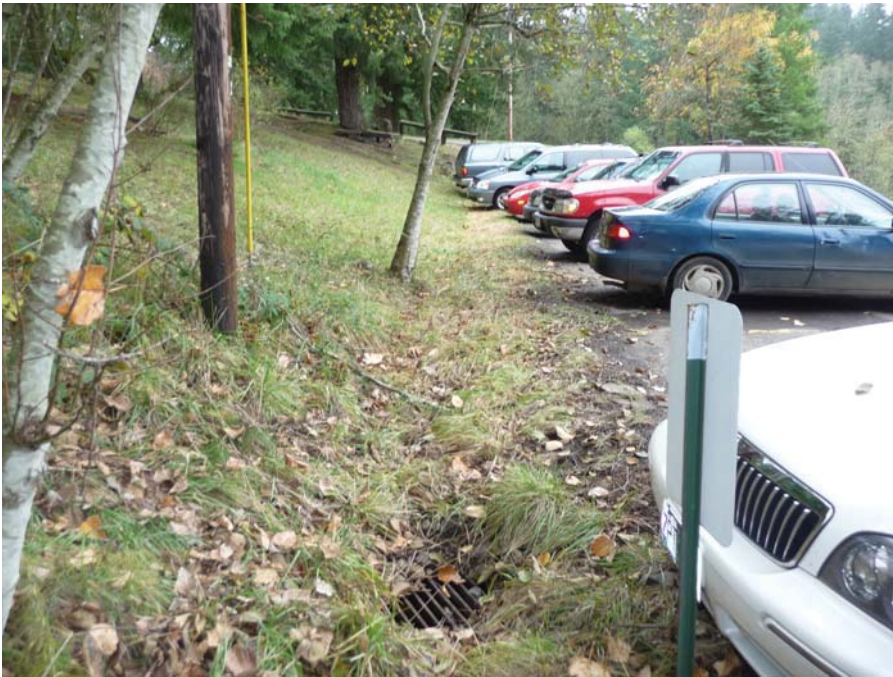
Inlet for parking area drainage

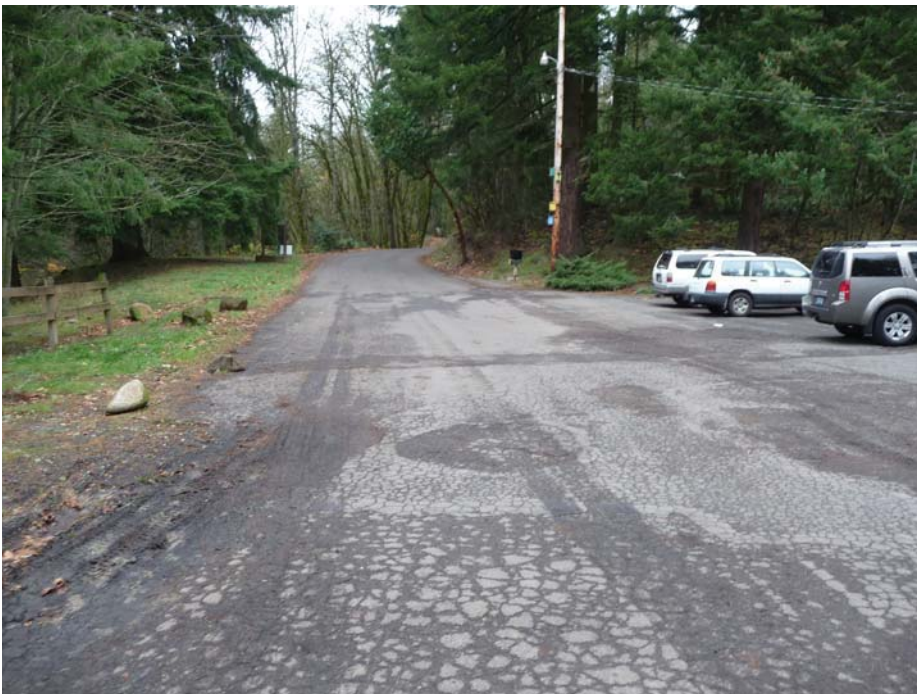
Pavement base failure (cracking) at main entrance
