Concord Property Building Assessment

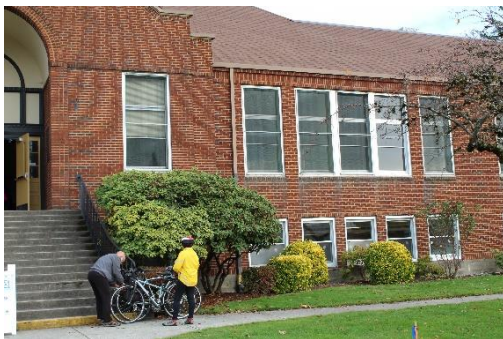
The existing Concord building was constructed as a 2-story wood-framed structure with double-wythe unreinforced masonry (URM) exterior bearing walls (hollow-clay tile and brick veneer), without insulation. The foundation is reinforced concrete. Light wood-framed joists comprise floor and roof structures, which are supported by interior stud bearing walls, steel pipe columns and exterior URM walls. Limited seismic strengthening was provided in 2001 by metal stud framing anchored to the interior face of the URM walls at entry/exit egress pathways (east, west, north and south), and along east wall of the gymnasium in 2001. Brick mortar is in fair condition and repointing of brick mortar should be accommodated in further upgrades.

Primary (west) entry elevation

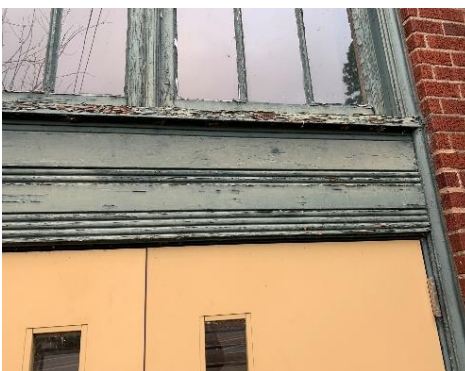
Windows are a mixture of single-pane aluminum frame and double-pane vinyl units, with a small number of original, wood divided-lite windows on the east facade and at north and south side exits. Existing wood window trim is in poor condition, needing repair/replacement. Lower level openings/vents on the east/south facades are often damaged or in poor condition, in need of repair.

Original wood transom windows, south facade

- Addition of exterior wall insulation.
- Exterior window and door restoration and/or replacement, including hardware.
- Mitigation of hazardous materials as identified.

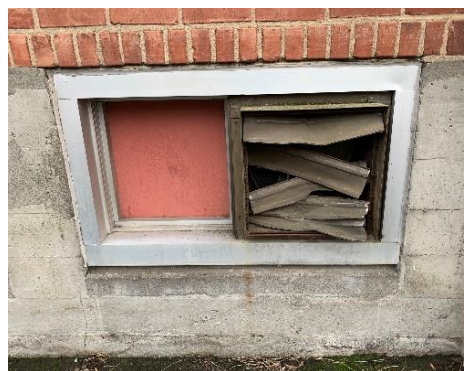
Louver into mechanical space

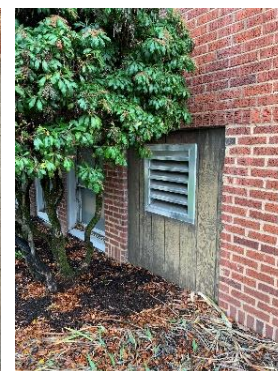
Louver/panel, south facade

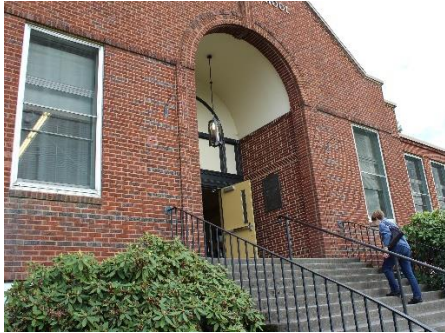
By nature of the building placement on a significantly sloped site, accessibility within the site, into the building and within, is challenging. The primary entry to the building, prominent in both placement and symbolism, requires ascent up a large staircase to the main building level. Prior to 2010 ADA upgrades, no accessible entry to the building was possible, as all required the use of stairs to reach all levels of the building. The addition of a passenger elevator in 2010 at the south entry stair landing enabled access but was not able to provide accessibility at the primary building entry.

Main entry, west façade

- A main entrance which provides welcoming access to all. Assuming the main entrance would continue to face west toward an expanded parking lot with an accessible route, a modified or new accessible on-grade entry is recommended.

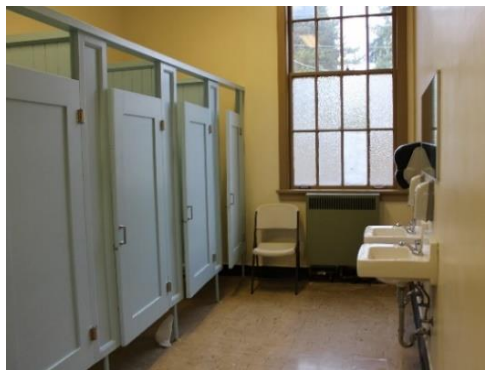
Accommodations have been made through past efforts to provide a minimal level of accessibility on each floor, most notably with the addition of the passenger elevator and select restroom upgrades to meet minimum requirements for elementary students on each floor level, however many areas of the building remain inadequate. Previous design alternates for improved access to the building from the sidewalk and the upgrade of the upper south boy and girl restrooms were never realized, which results in a building with widely varying states of accommodation.

Original 1936 girl's restroom, upper level

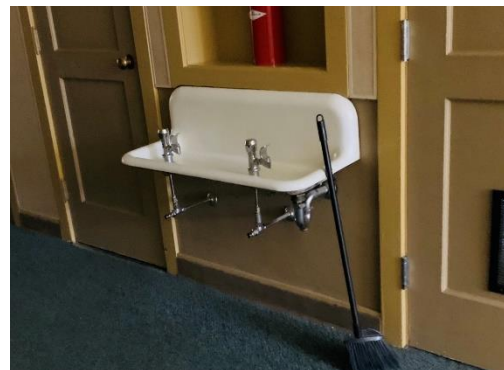
Original drinking fountain, lower level hallway
