## Concord School Historic Resource Assessment

Opsis Architecture  
Portland, Oregon

Architectural Resources Group, Inc.  
Portland, Oregon

January 2020

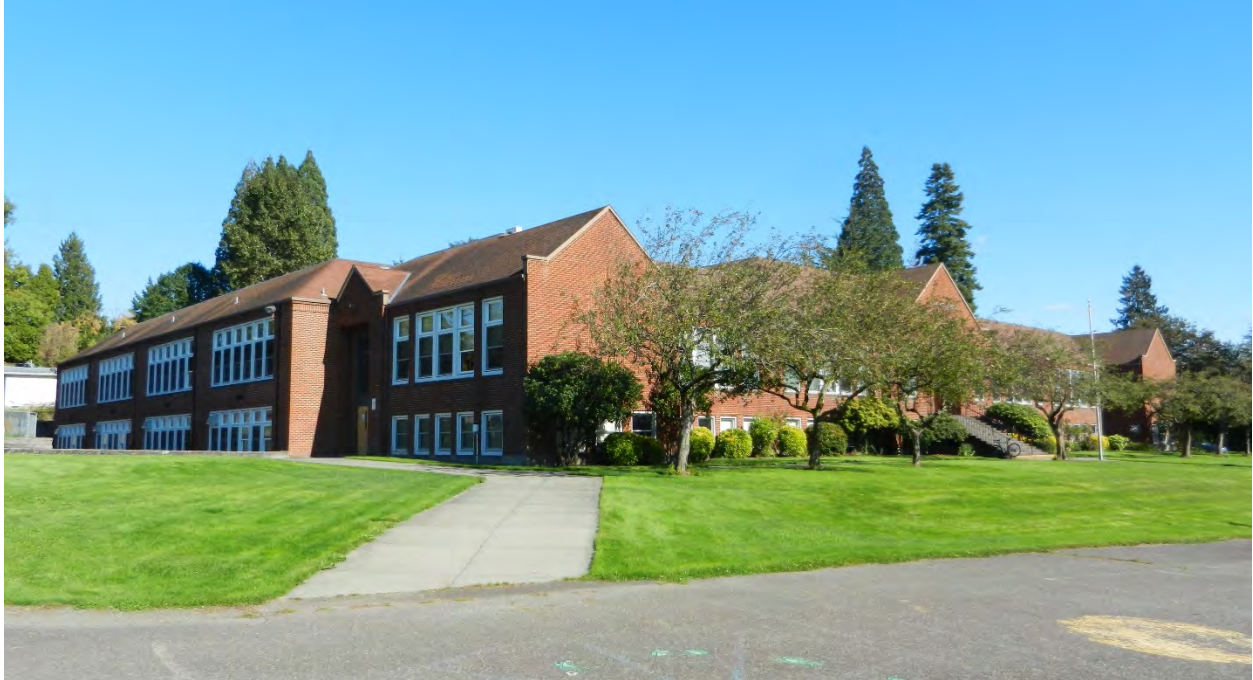
*Lateral view of the Concord School showing the primary (western) façade of the 1936 building (right) and the 1948 addition (left), camera facing southeast (ARG, October 2019).*

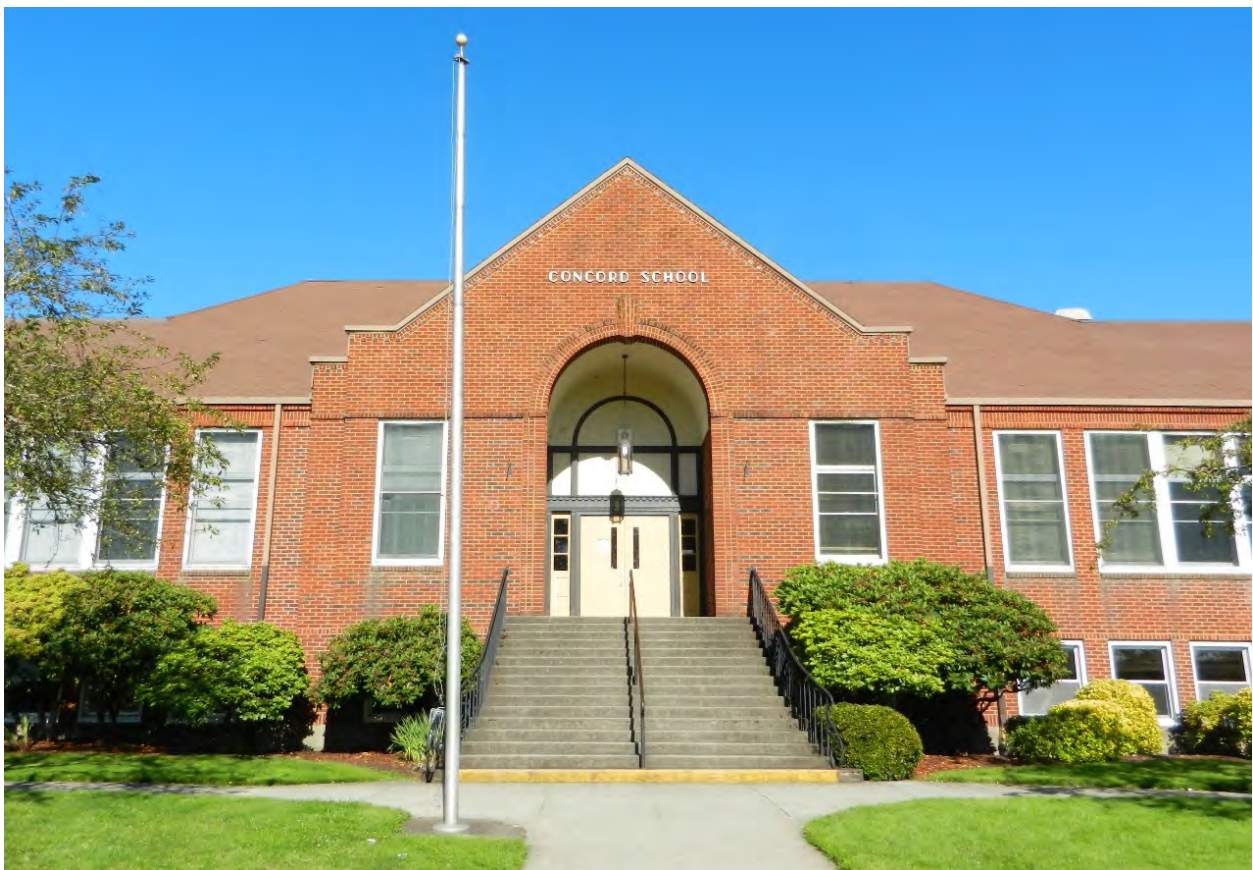
*Primary entrance, western façade, camera facing east (ARG, October 2019).*

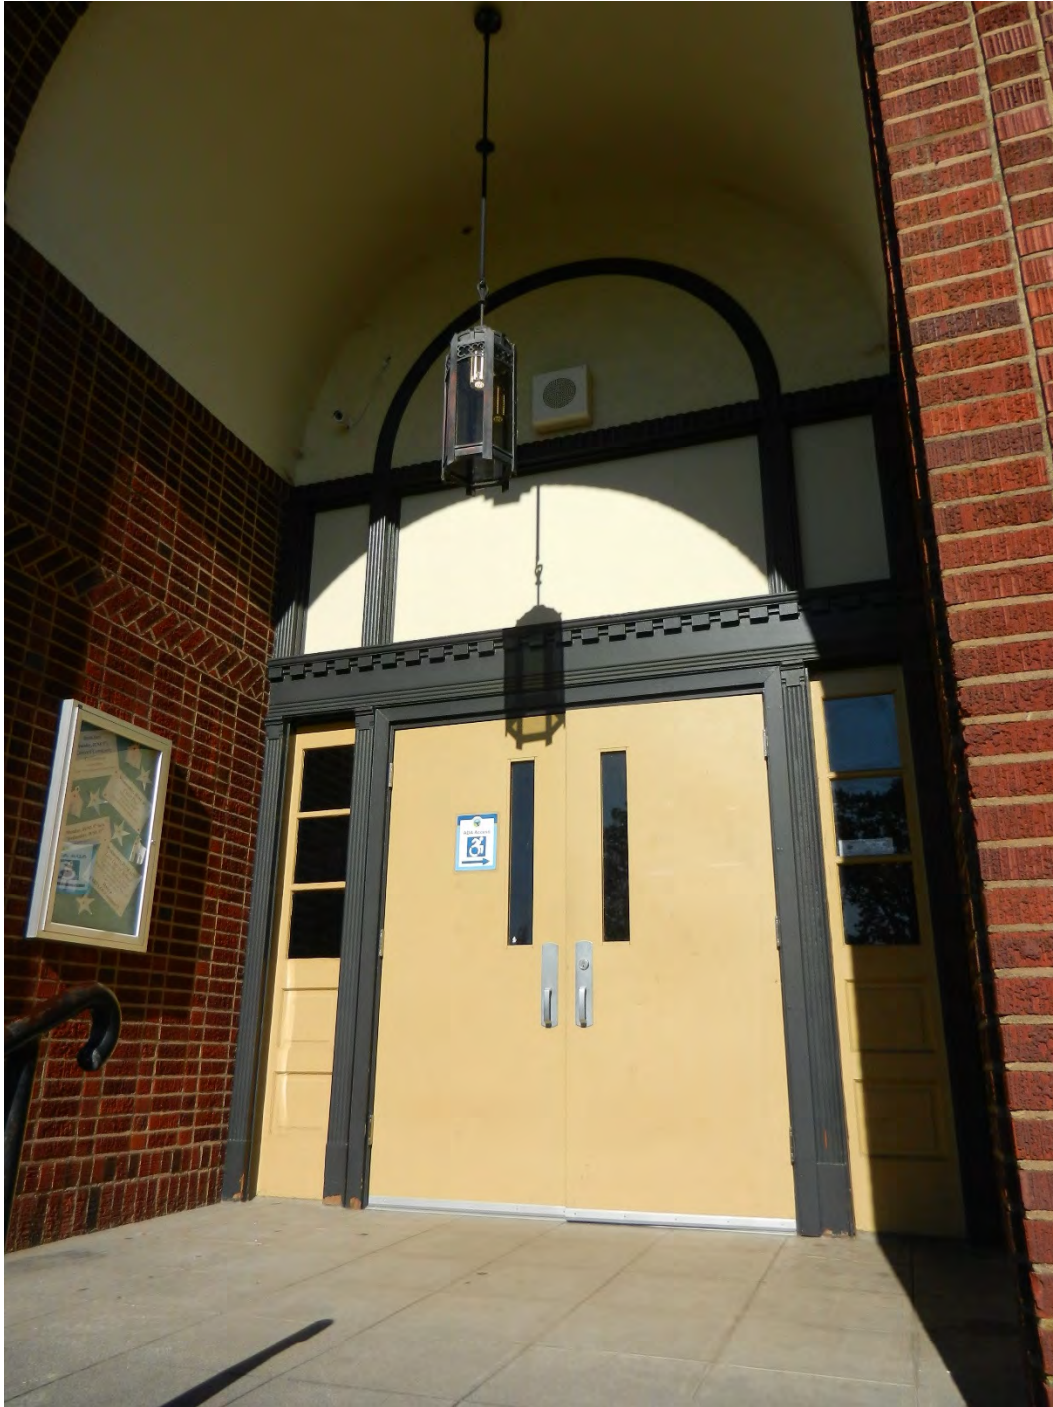
*Primary entrance, western façade, camera facing east-northeast (ARG, October 2019).*

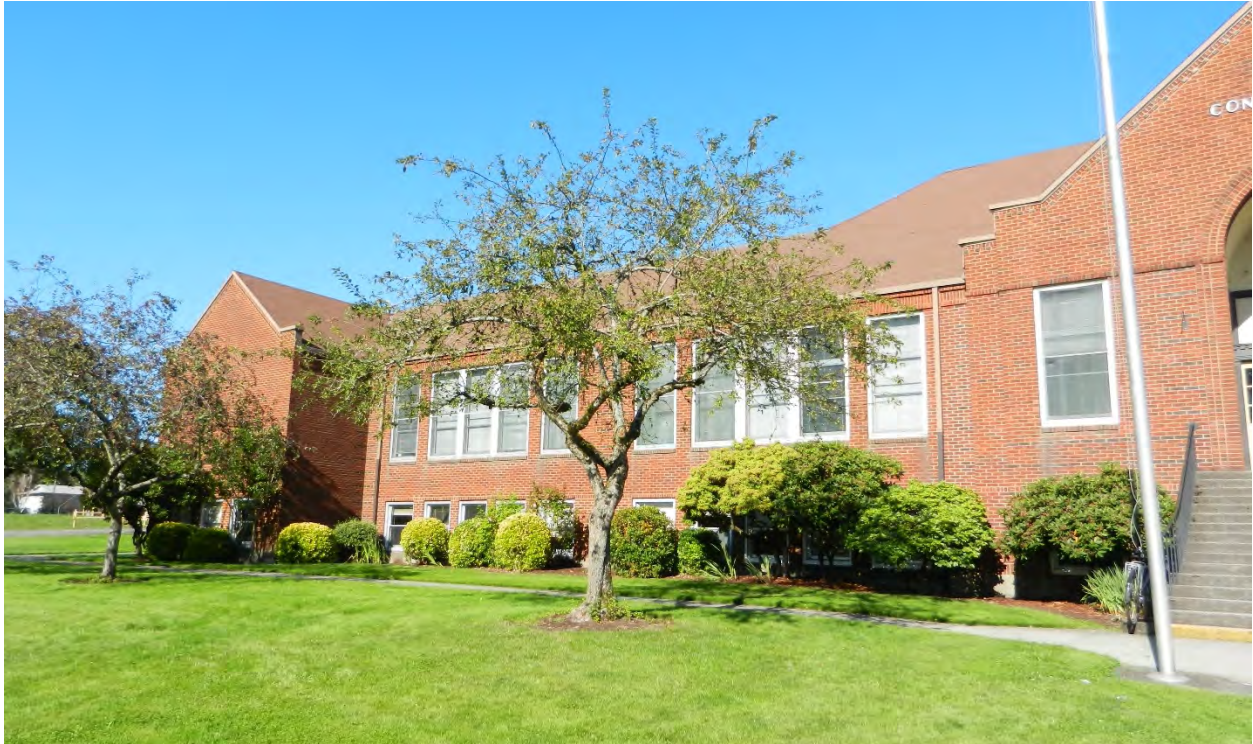
*Northern portion of the primary (western) façade, camera facing east-northeast (ARG, October 2019).*

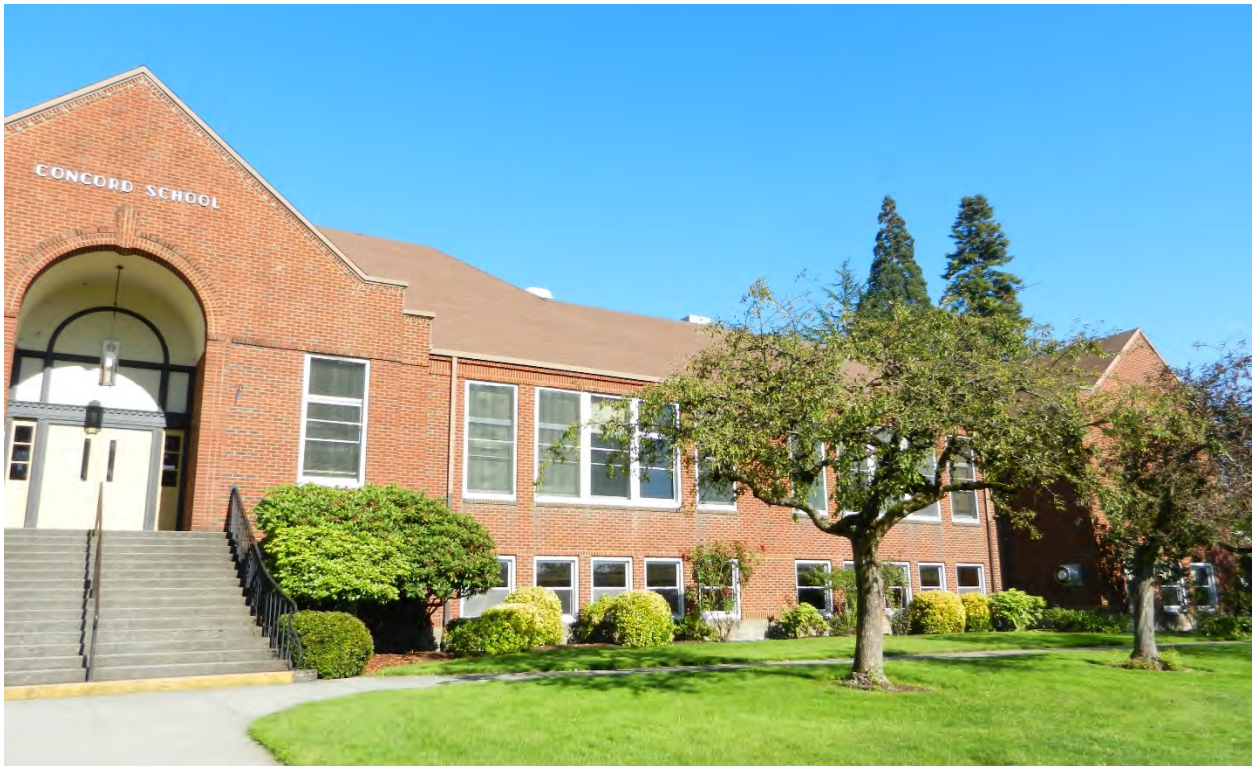
*Southern portion of primary (western) façade, camera facing east-southeast (ARG, October 2019).*

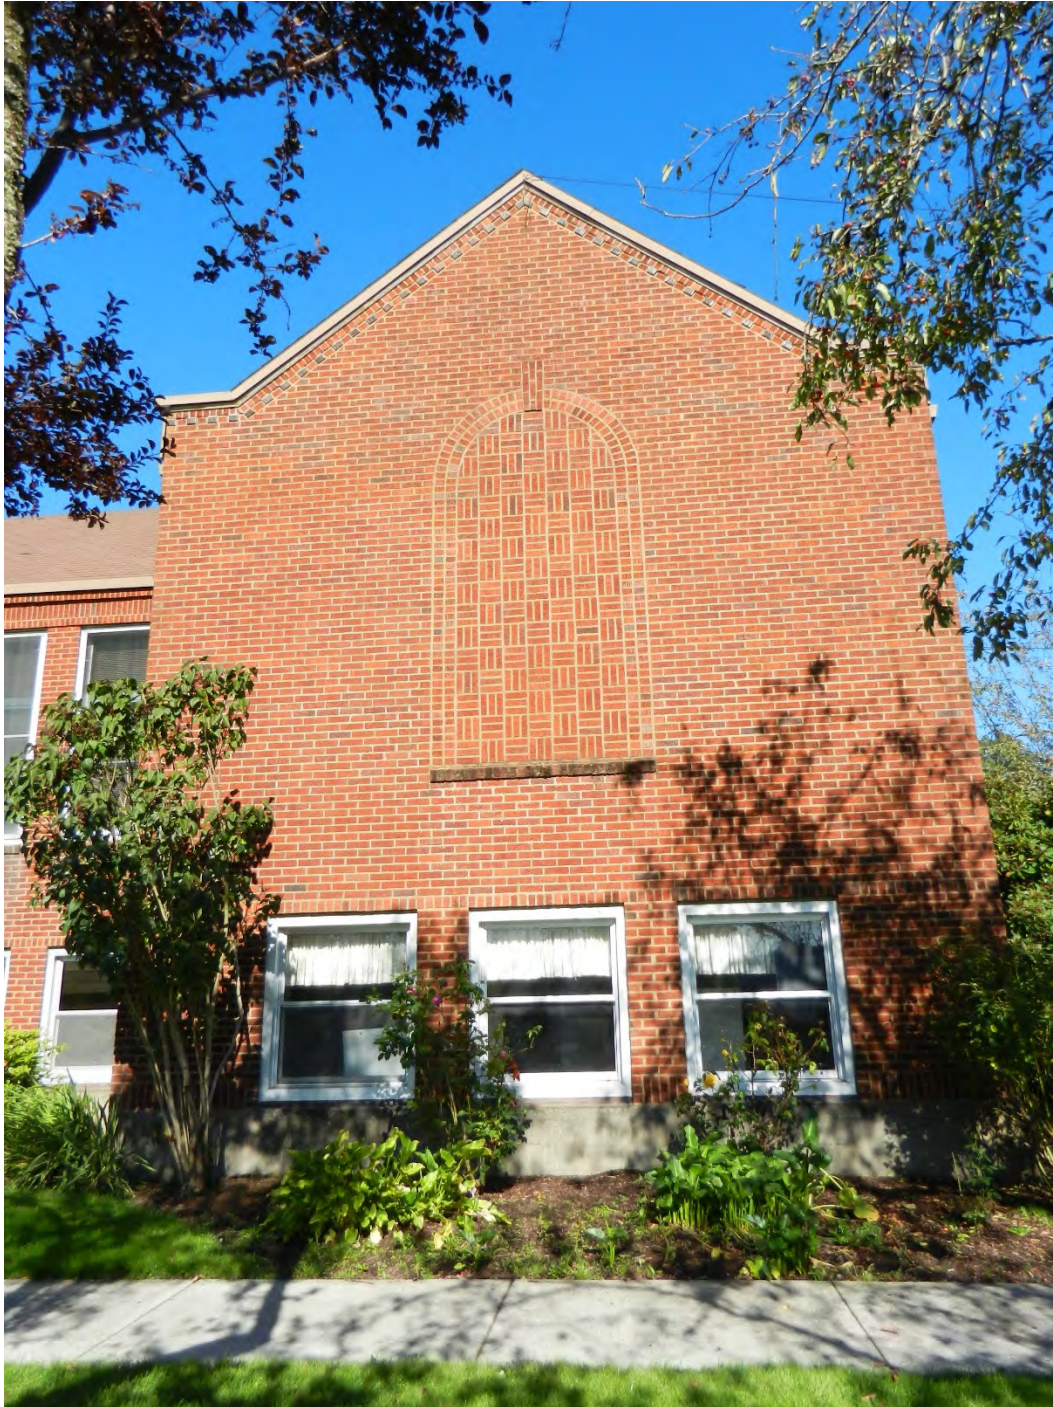
*Projecting end bay at the southern end of the primary (western) façade, camera facing east (ARG, October 2019).*

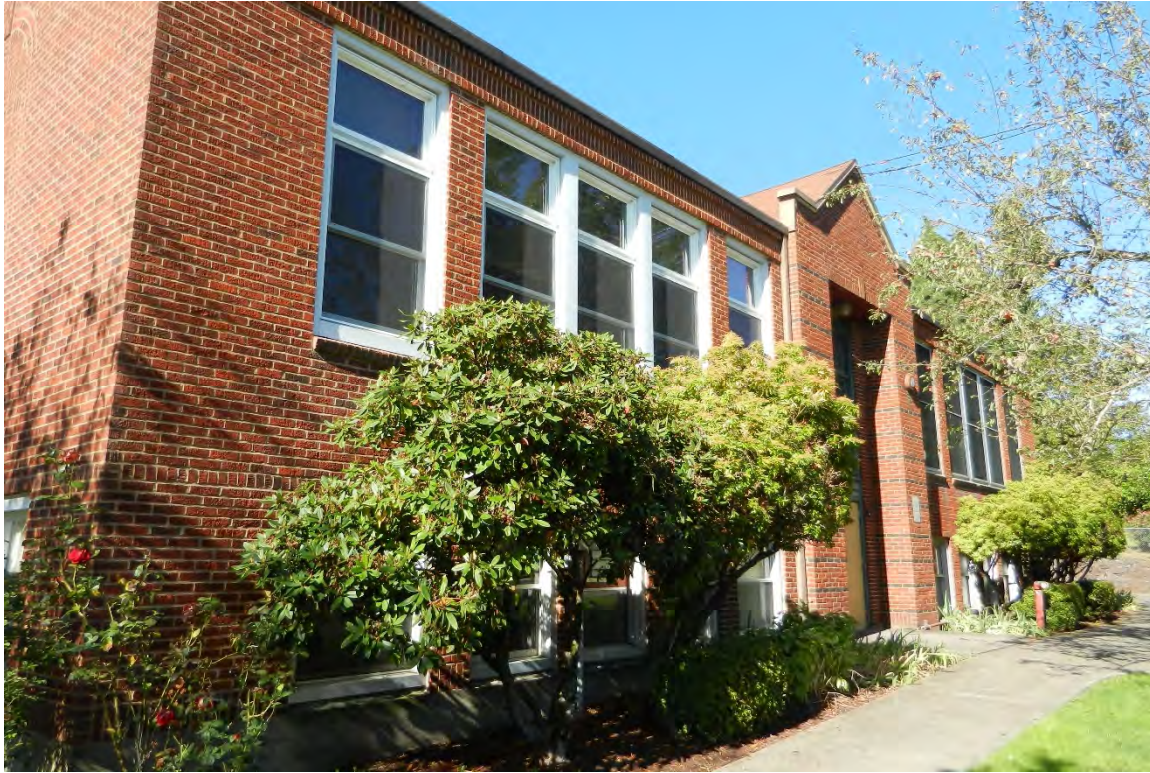
*Southern façade, camera facing northeast (ARG, October 2019).*

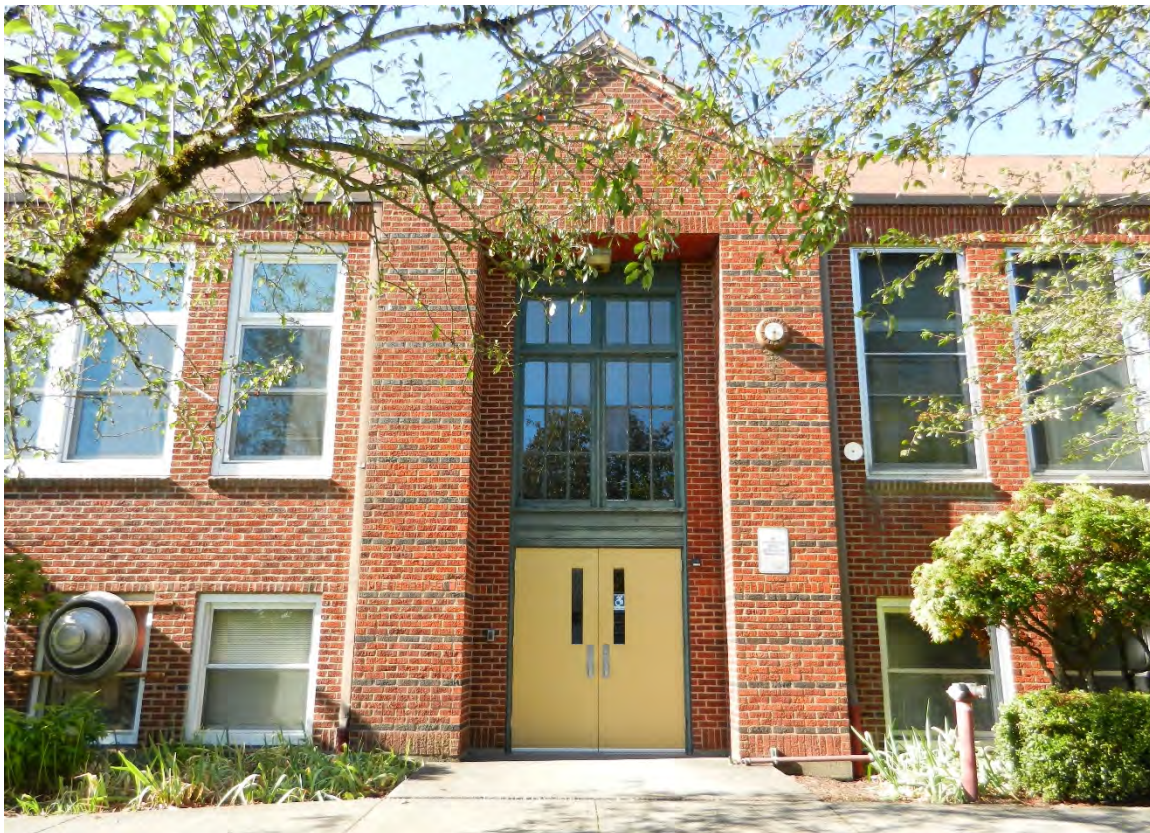
*Southern façade, camera facing north (ARG, October 2019).*

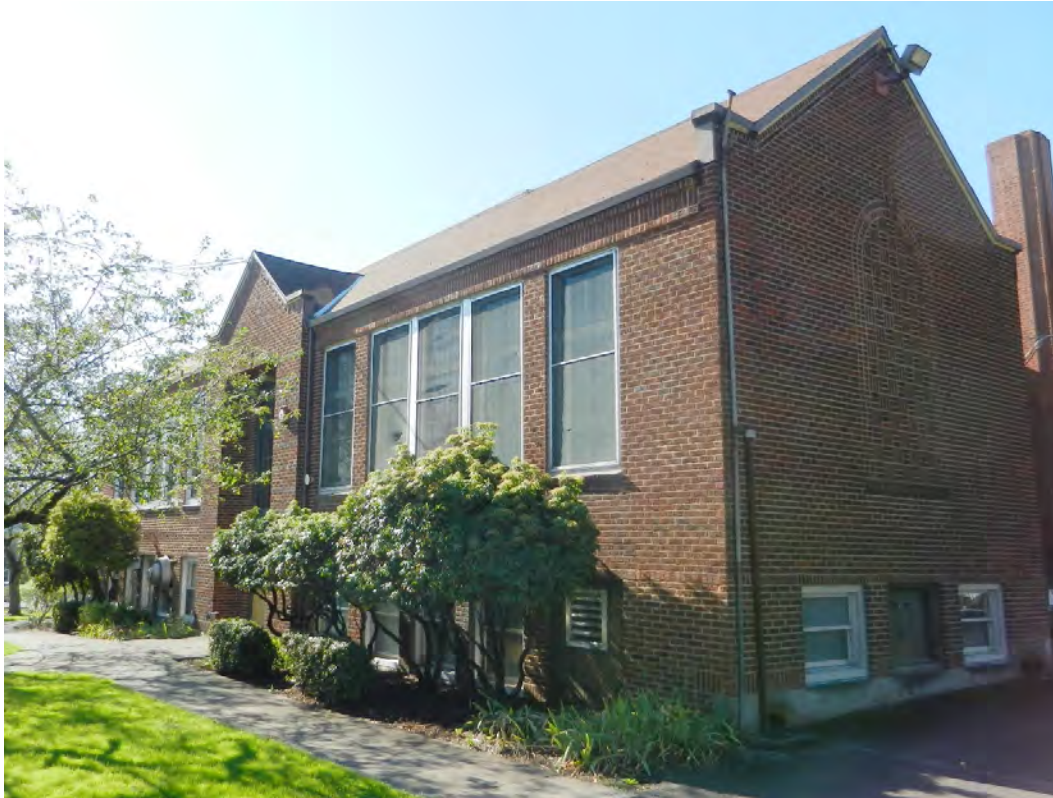
*Southern façade, camera facing northwest (ARG, October 2019).*

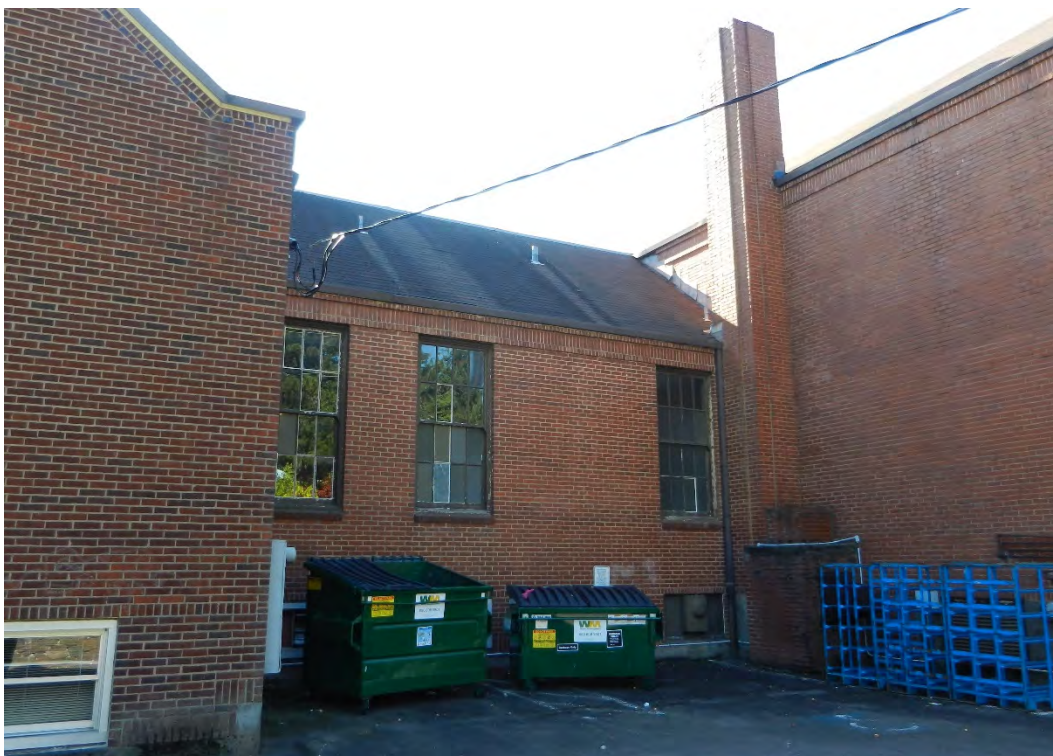
Three original eight-over-eight wood windows with ogee lugs are located at the upper level north of the end bay. These appear to be the building's only intact original windows. Four smaller window openings, including three vinyl slider windows and one metal utility vent, are located beneath these windows.

*Original wood windows on rear (eastern) façade, camera facing west-northwest (ARG, October 2019).*

With the exception of three eight-over-eight wood windows at the rear of the building and the wood transom at the north, south and east entrances, all windows have been replaced. If the non-original windows are to be replaced, SHPO will be interested in reviewing the proposed design for the replacement windows. In replacing the windows, the building owner is not obligated to use replacement windows that are exact reproductions of the remaining historic windows. Instead, SHPO will review the virtues of the proposed windows versus the existing (non-historic) windows, posing the question whether the proposed windows are more compatible with the historic windows than the current windows are. Given that, replacement windows that take cues from the historic windows (such as divided lights, one-over-one functionality and white or green coloration) would likely be deemed to not pose an impact. Regardless of the chosen design, the new windows should fit within the existing window openings, which are themselves historic. If different window designs are proposed for different façades of the building, it should be noted that the windows at the primary (western) façade will be subjected to the highest level of SHPO scrutiny. As a result, of the window types that are ultimately proposed, those that have the greatest degree of similarity to the historic windows should be used on the west façade.

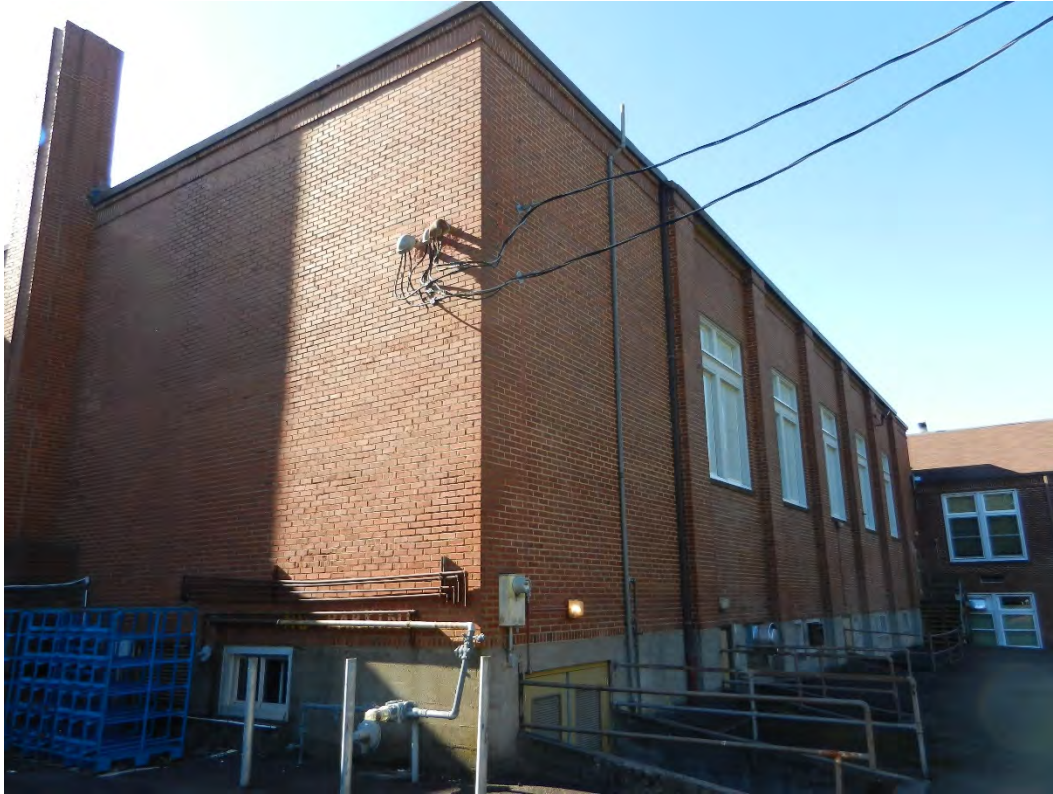
*Rear (eastern) façade, camera facing northwest (ARG, October 2019).*

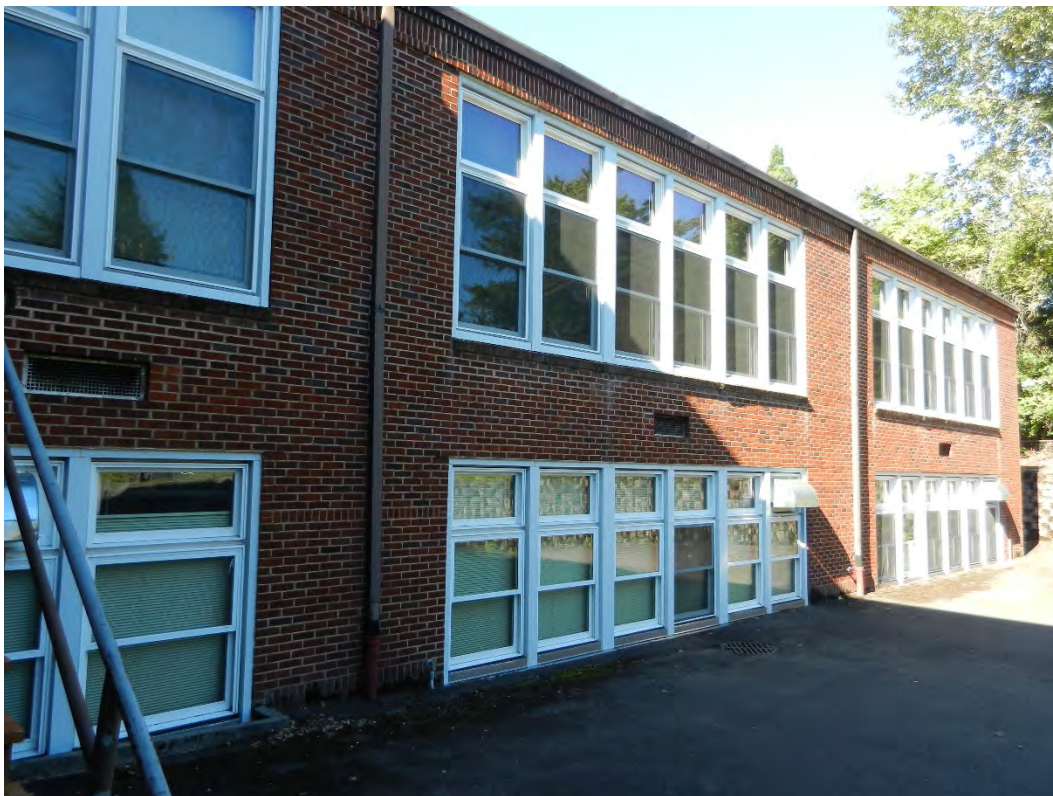
*Southern façade of rear wing addition, camera facing northeast (ARG, October 2019).*

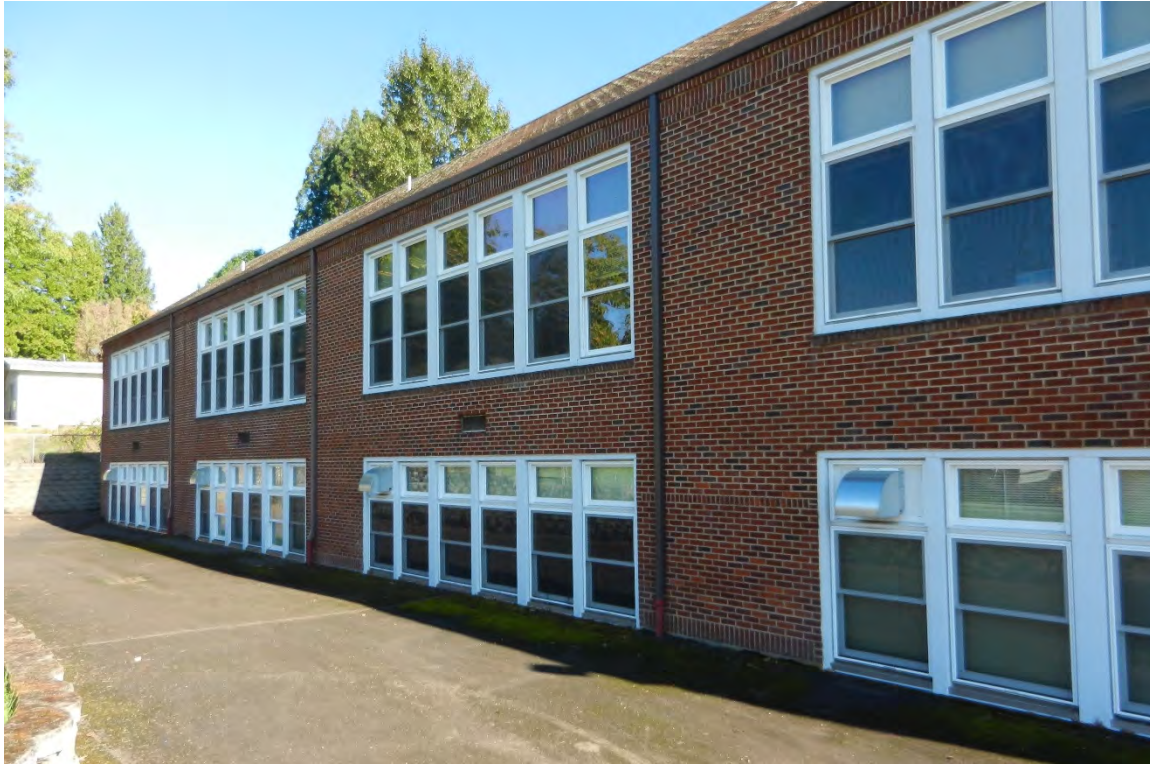
*Northern façade of rear wing addition, camera facing southeast (ARG, October 2019).*

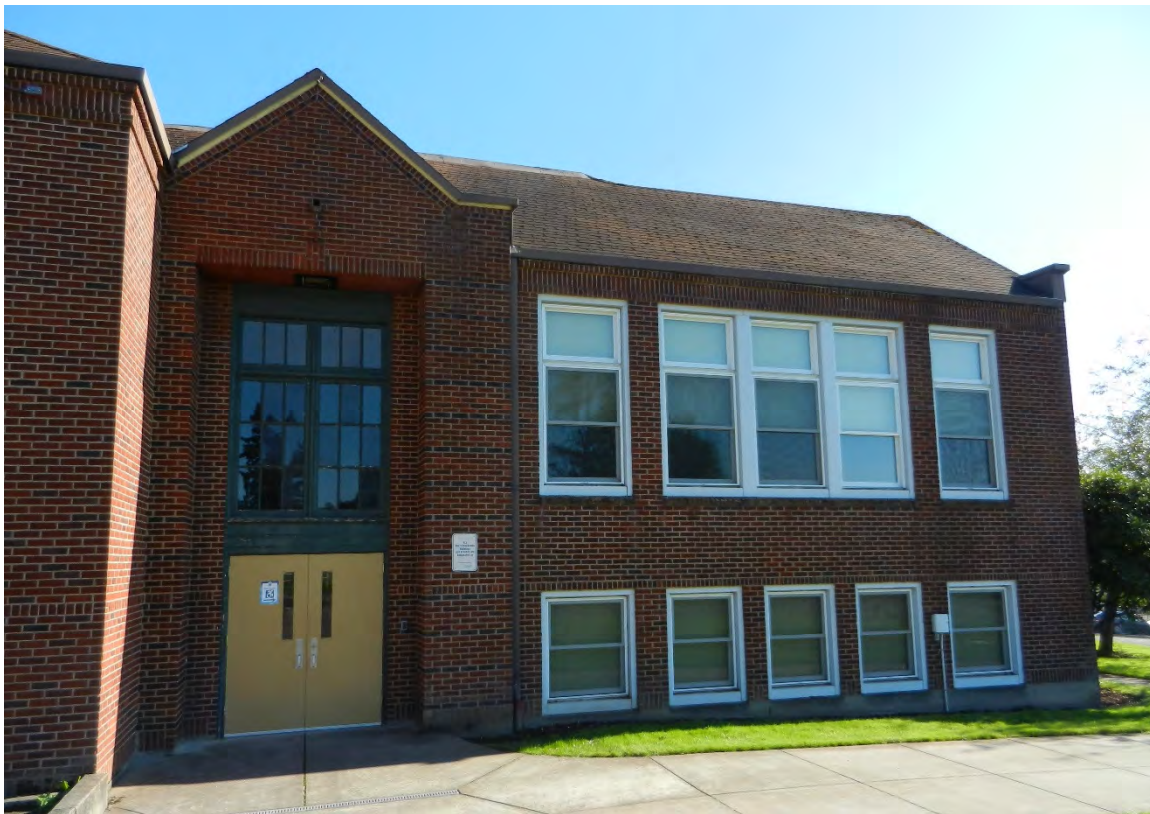
*Northern façade, camera facing south (ARG, October 2019).*

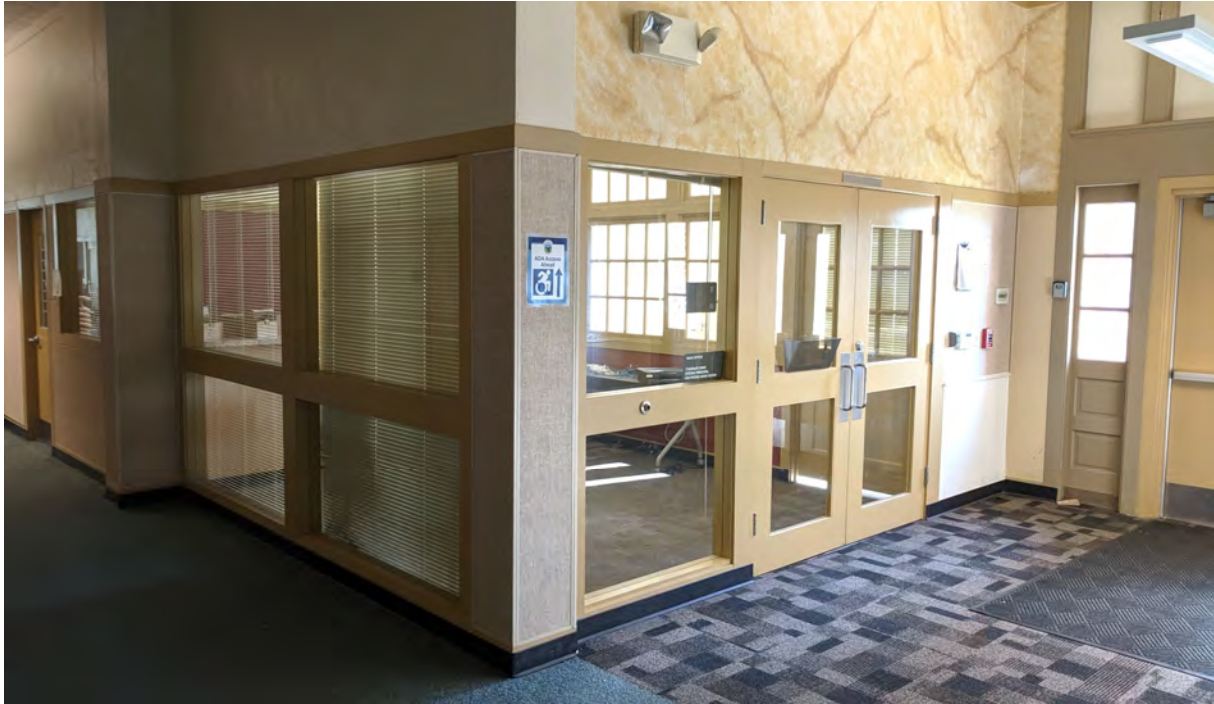
*Upper-floor office space in 1936 building (ARG, October 2019).*

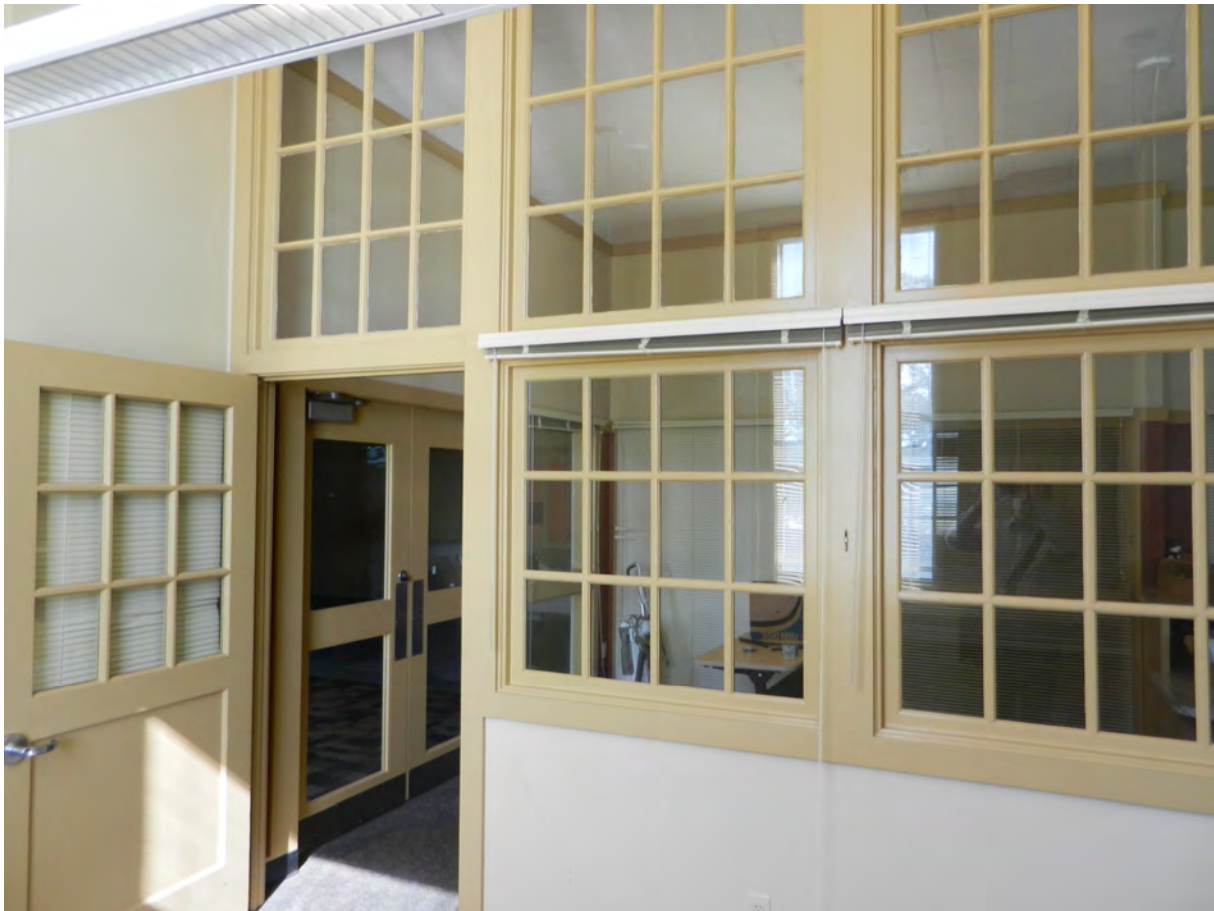
*View from principal's office into additional office space in upper floor of 1936 building (ARG, October 2019).*

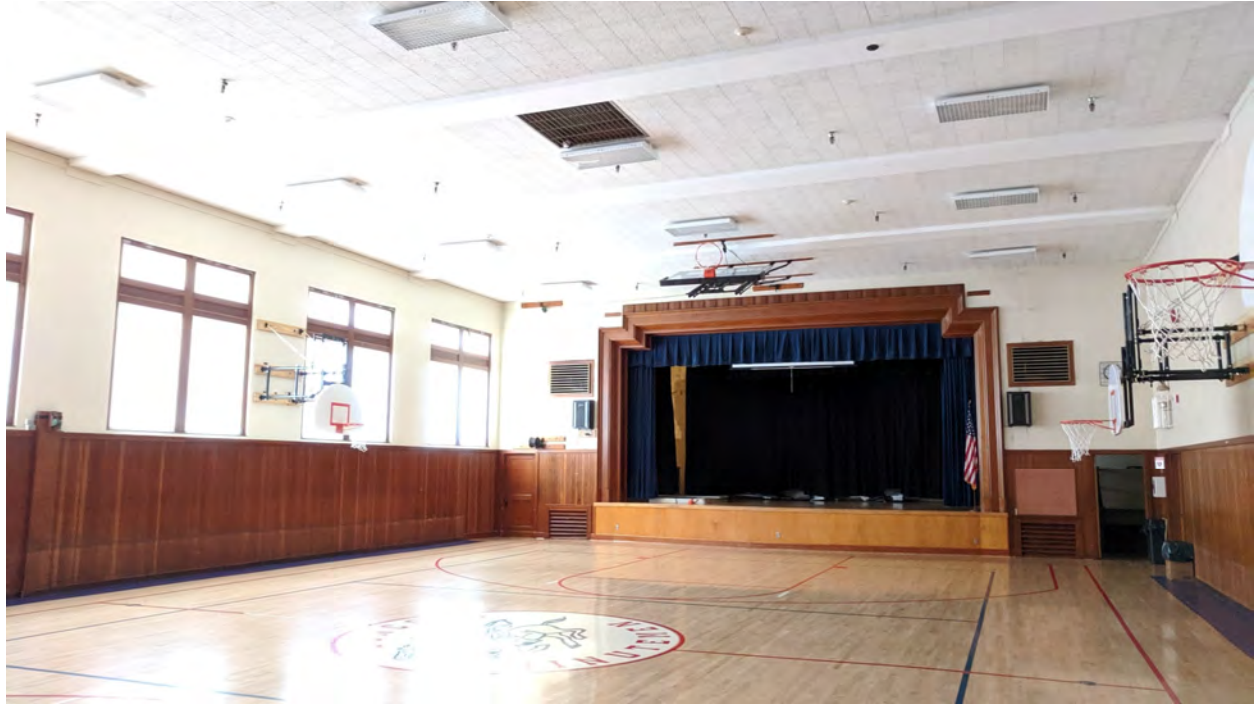
*Representative view of wainscot and molding in gymnasium/auditorium in upper floor of 1936 building (ARG, October 2019).*

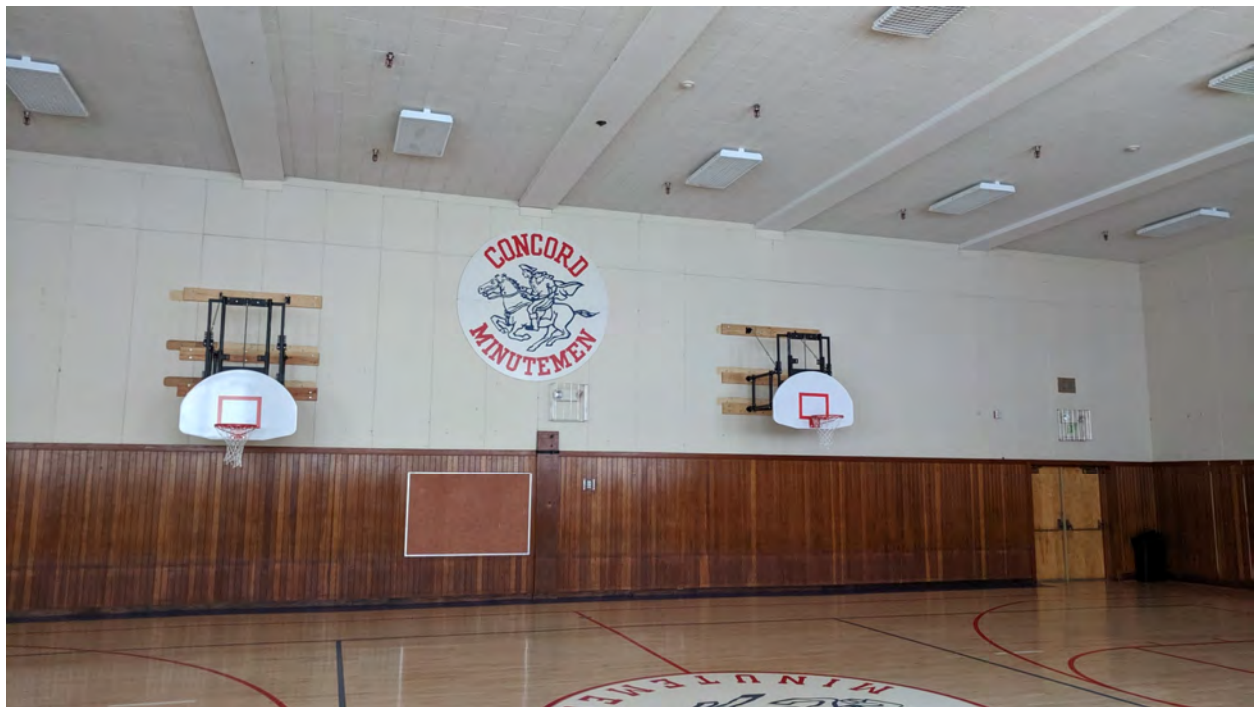
*Representative view of wainscot in gymnasium/auditorium in upper floor of 1936 building (ARG, October 2019).*

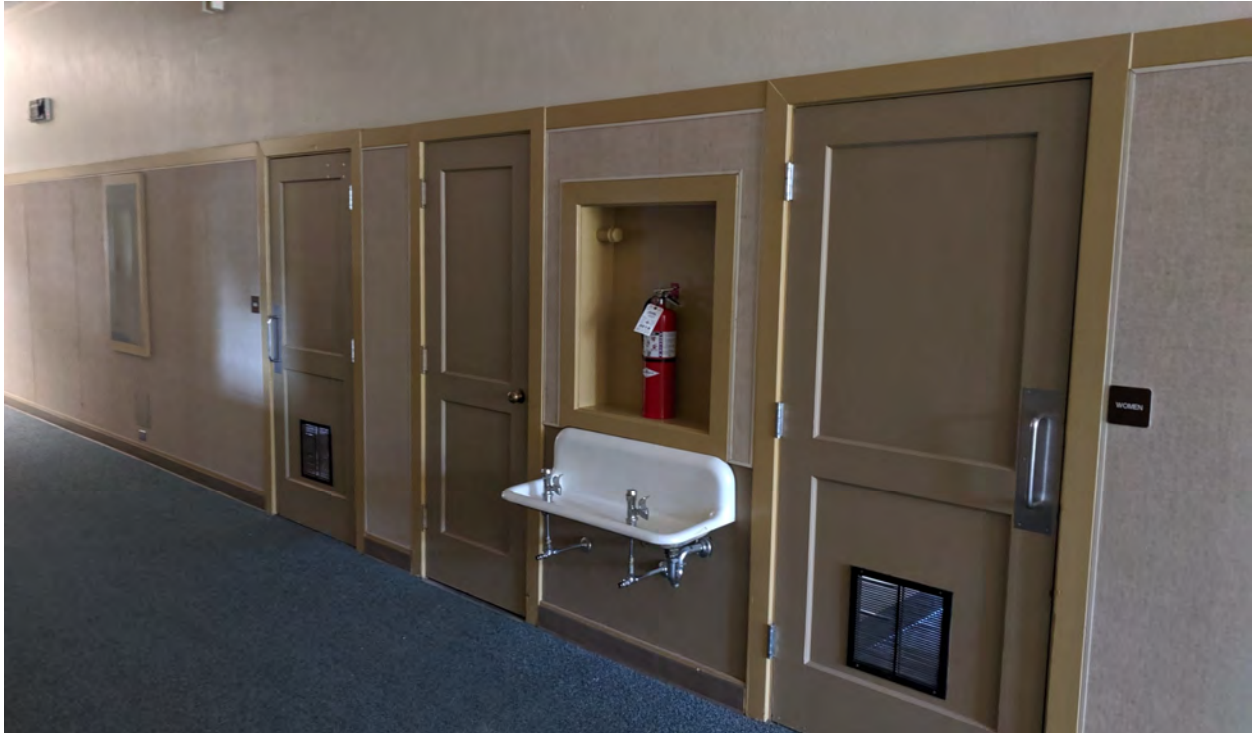
*Representative view of paneled wood doors and drinking fountain in upper-floor central corridor in 1936 building (ARG, October 2019).*

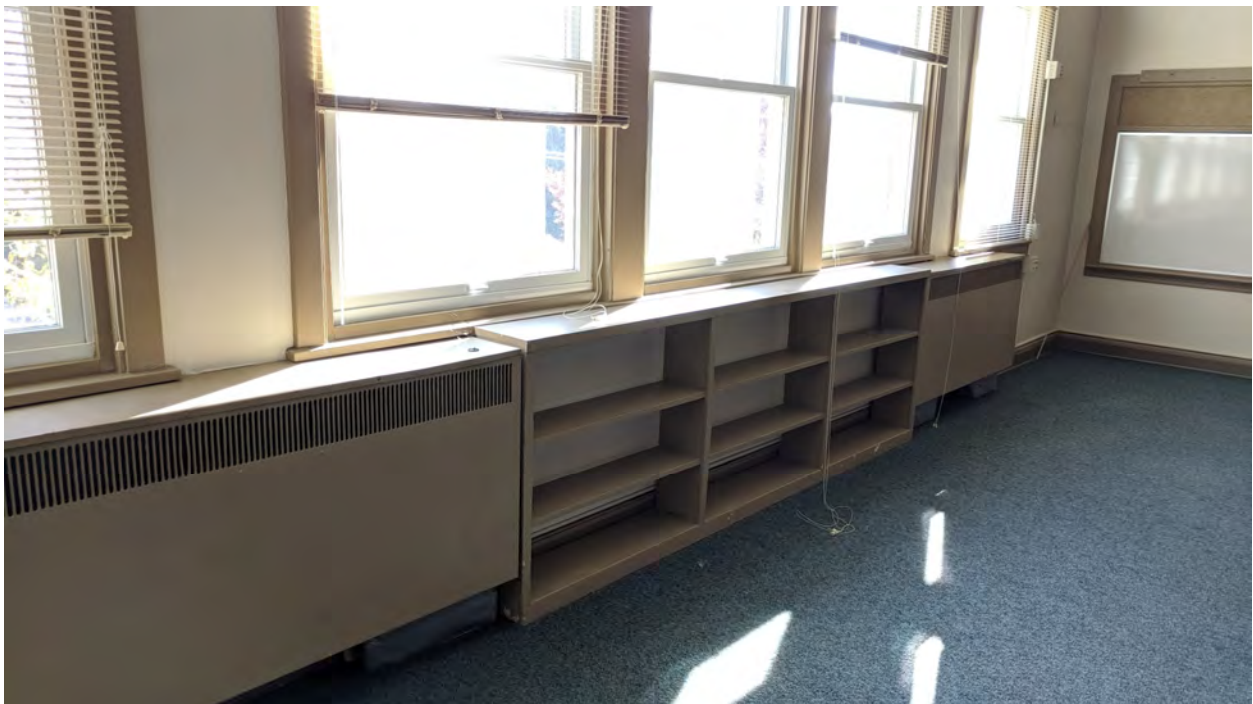
*Representative view of built-ins in upper-floor classroom in 1936 building (ARG, October 2019).*

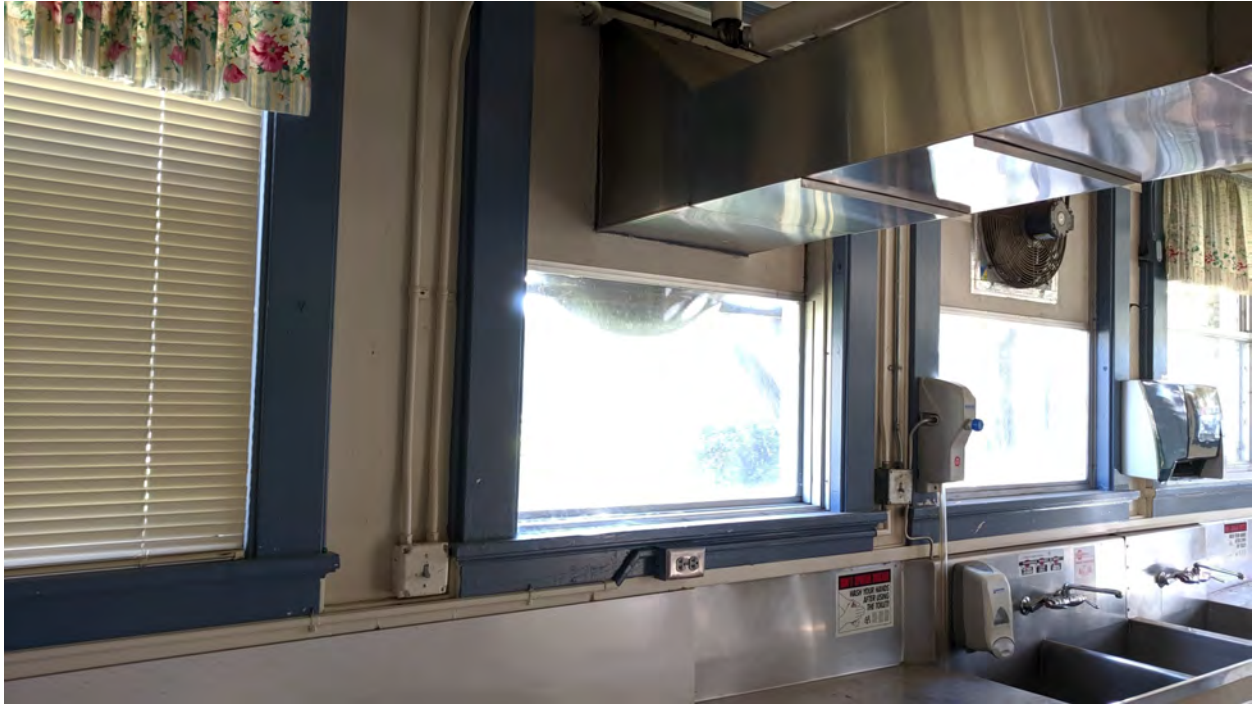
*Window casings in kitchen in basement of 1936 building (ARG, October 2019).*

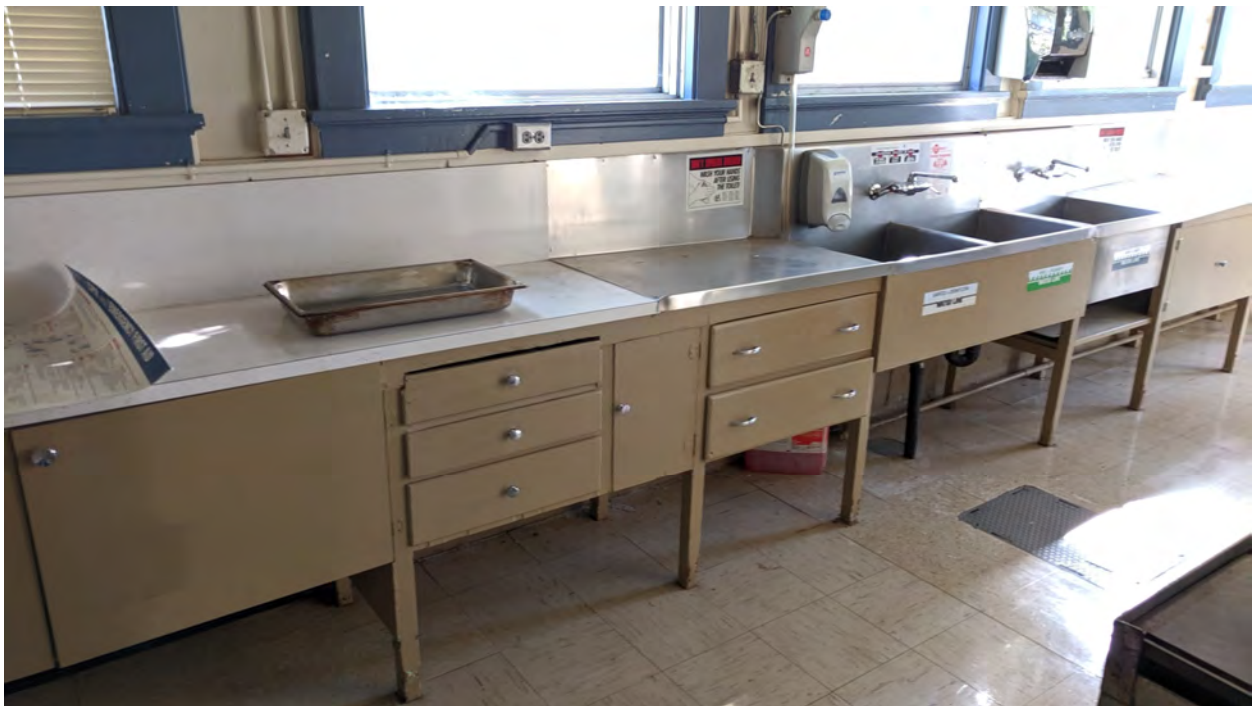
*Counters and food prep area in kitchen in basement of 1936 building (ARG, October 2019).*

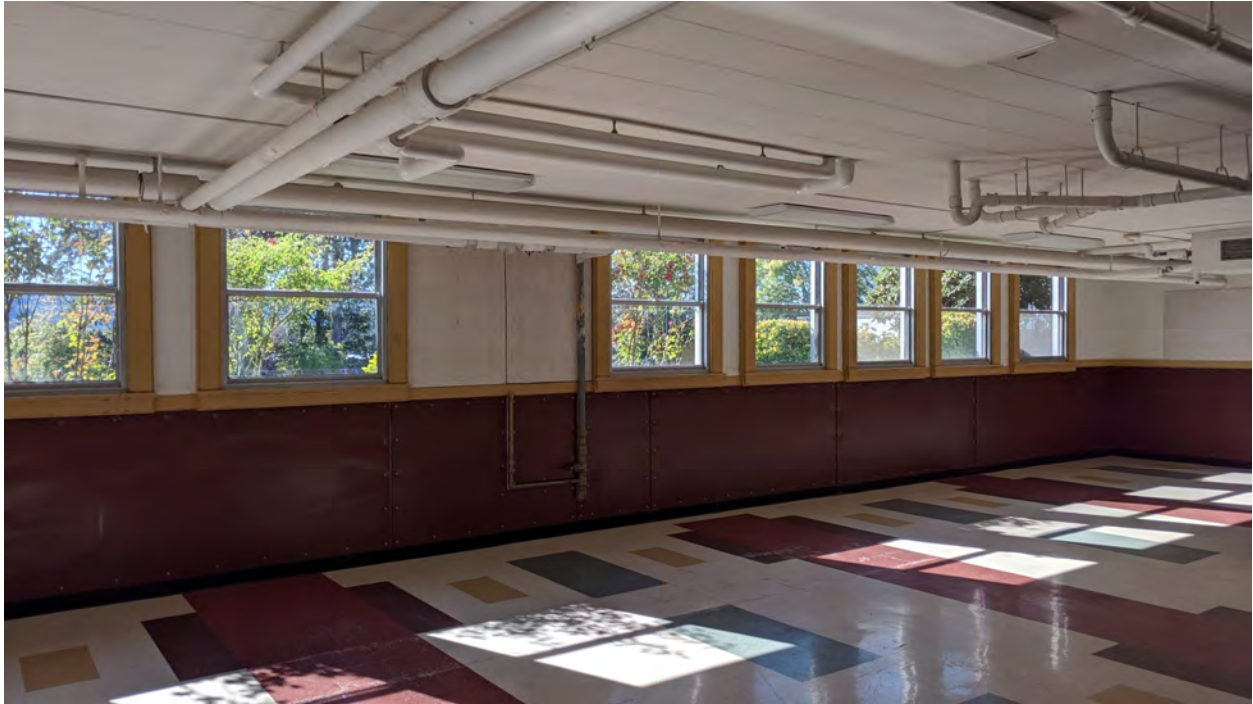
*Cafeteria in basement of 1936 building (ARG, October 2019).*
