## Concord School Historic Resource Assessment

Opsis Architecture  
Portland, Oregon

Architectural Resources Group, Inc.  
Portland, Oregon

January 2020

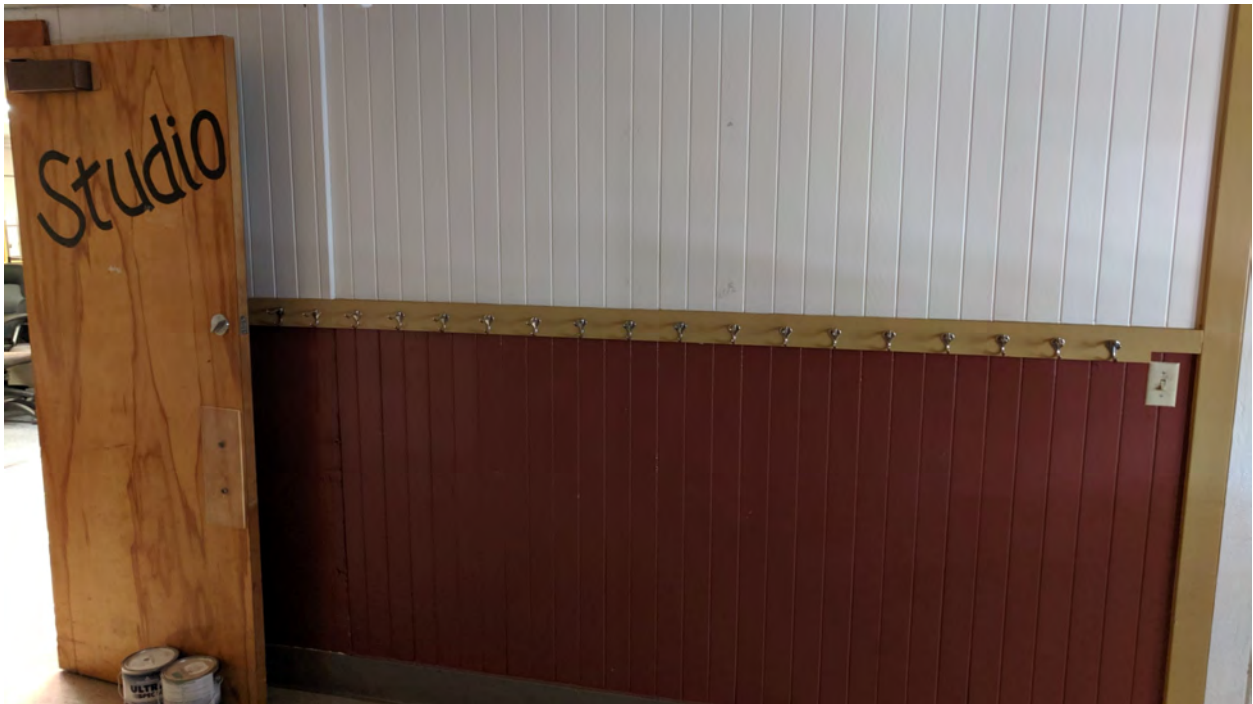
*Representative view of beadboard wall paneling in basement of 1936 building (ARG, October 2019).*

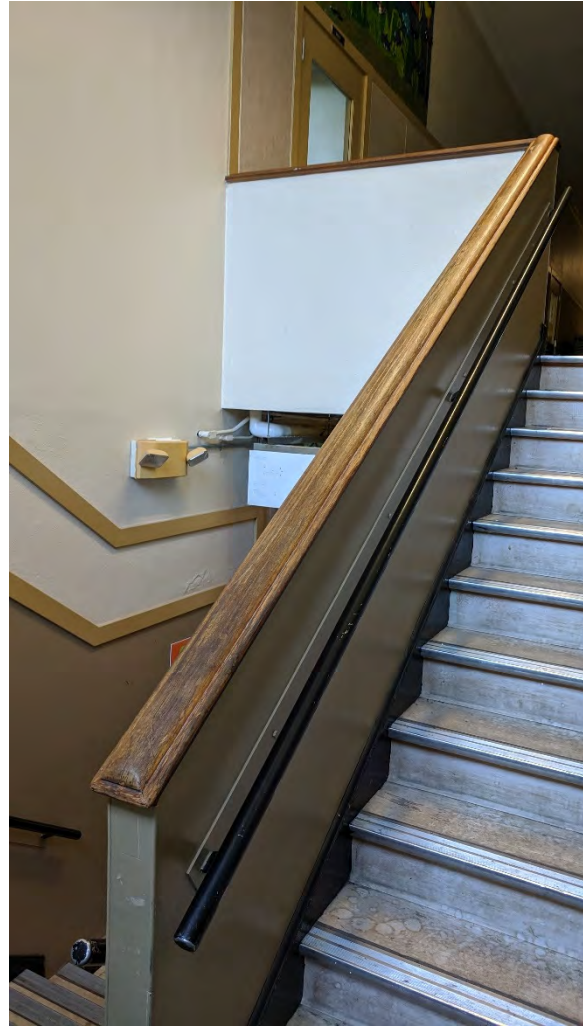
*View of stair in 1936 building (ARG, October 2019).*

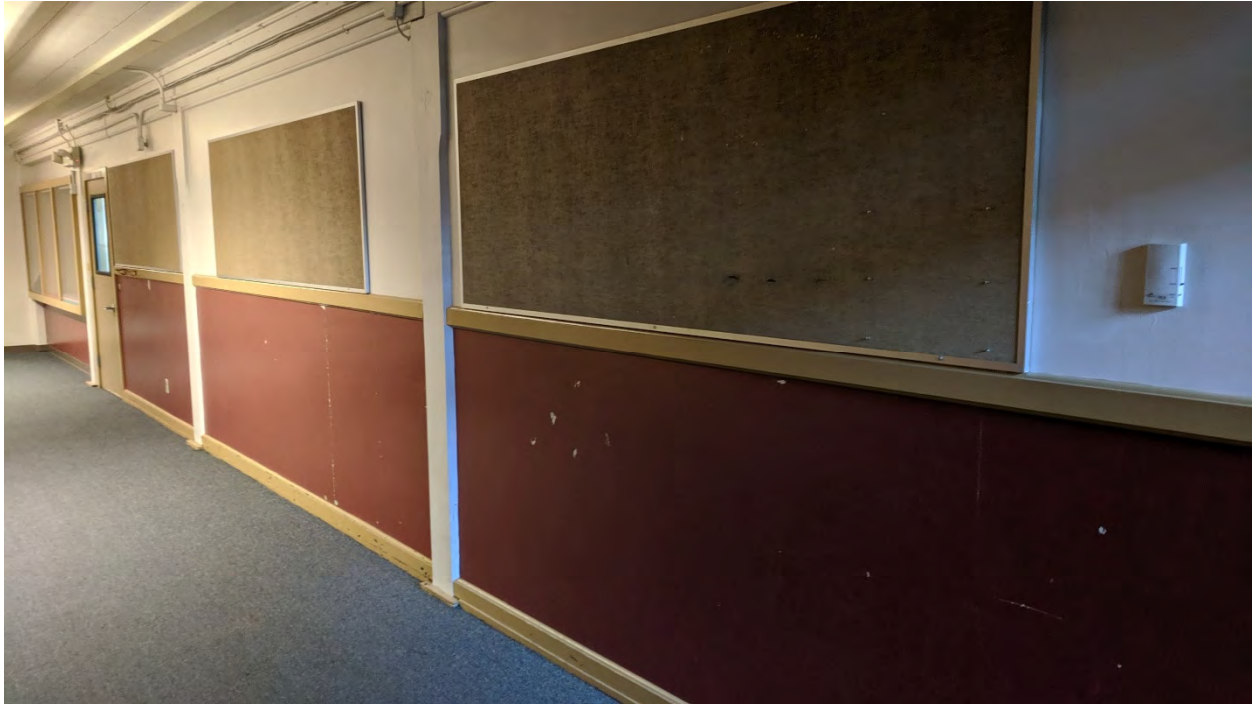
*Representative view of corridor in 1948 addition (ARG, October 2019).*

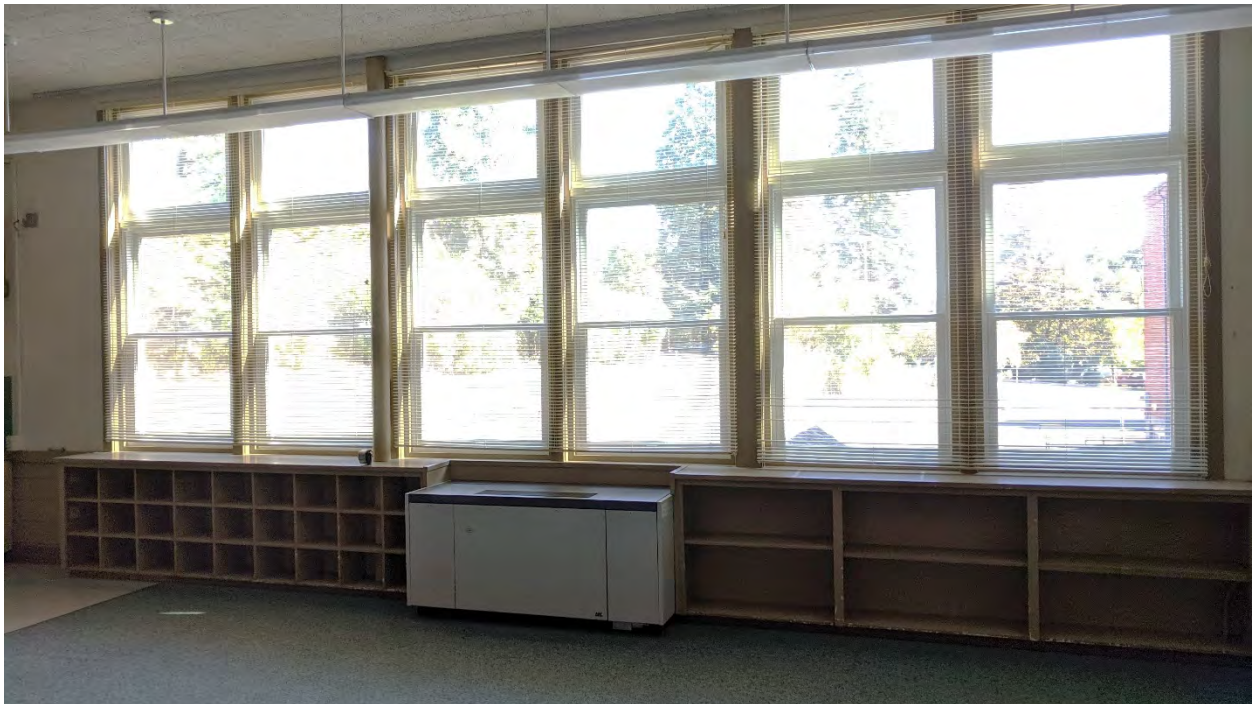
*Representative view of built-ins in upper-floor classroom in 1948 addition (ARG, October 2019).*

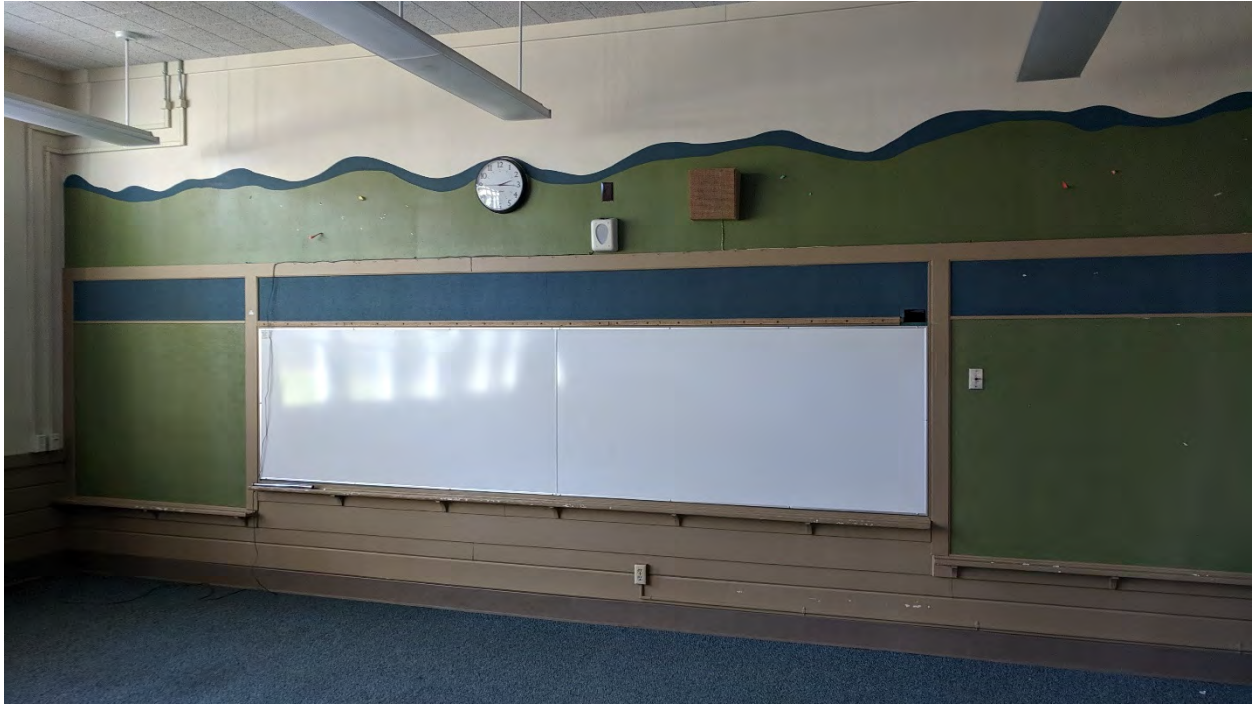
*Representative view of chalkboard surrounds in classroom in 1948 addition (ARG, October 2019).*

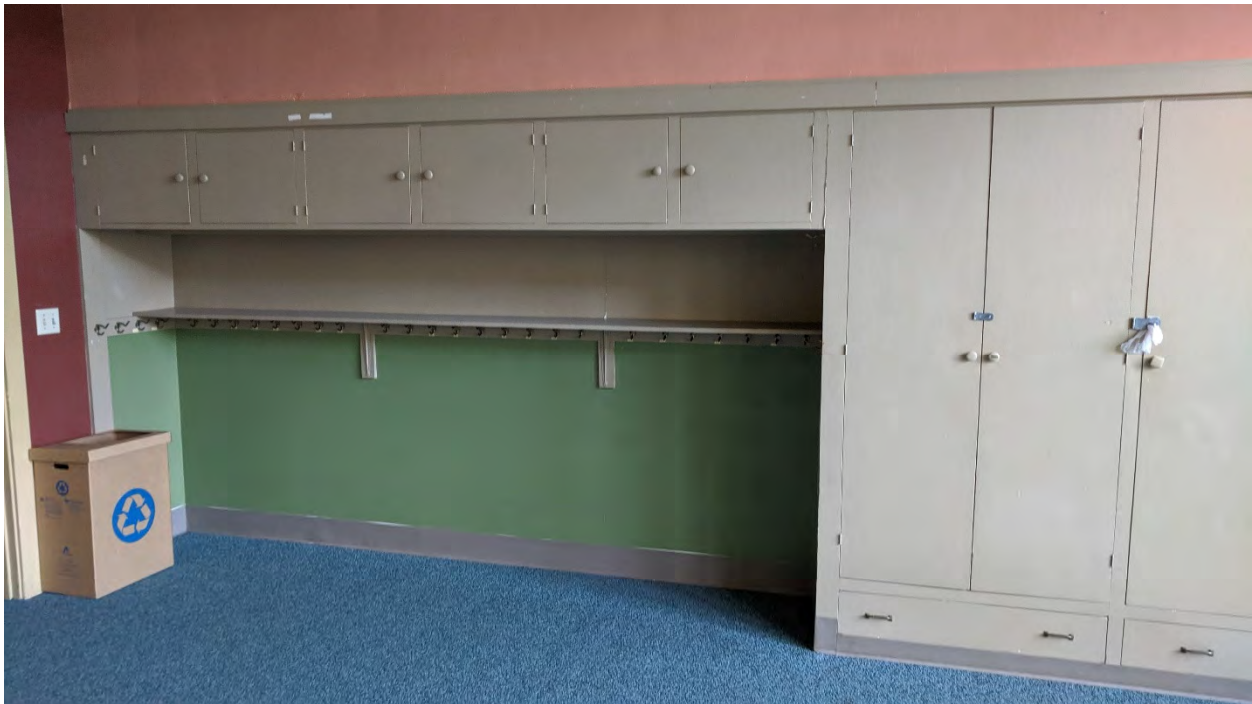
*Representative view of built-ins in classroom in 1948 addition (ARG, October 2019).*
