September 19, 2001

RE: Concord Elementary School Seismic Upgrade

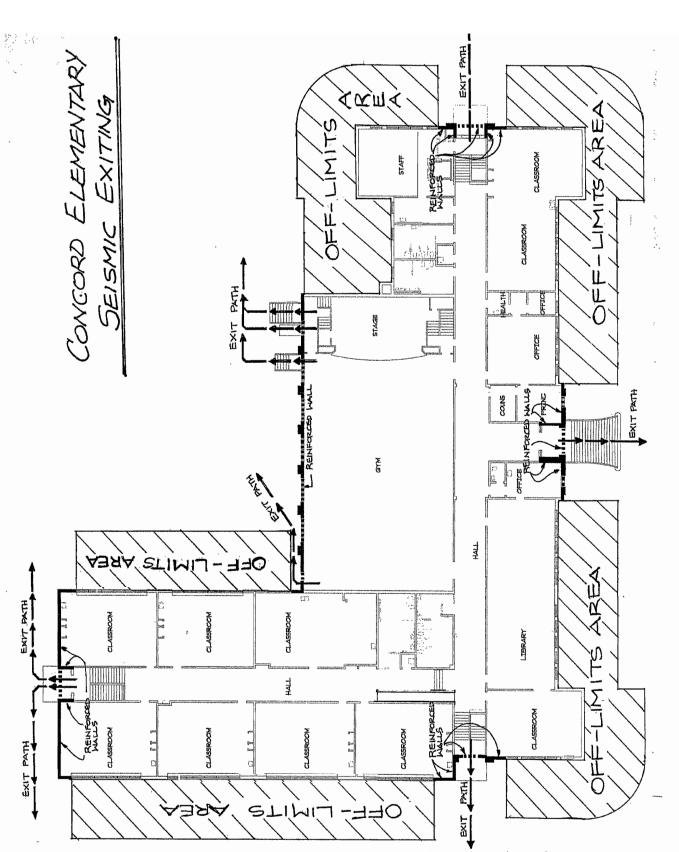
The school's emergency exiting plan should involve leaving the building through a predetermined path through the reinforced exit areas. That includes every exit door from the building. In all cases except for the east wall of the east wing addition, persons exiting the building should move directly away from the building and stay outside of the off-limits area which extends as far away from the building as the brick walls are tall (approximately). At the east end of the east wing, site grading prevents moving directly away from the building, but walls both to the north and south of the exit door have been reinforced to allow persons exiting the building to turn either right or left after proceeding through the exit doors. Again, those persons should continue either due north or due south after exiting the building and turning north or south. They should continue to a distance away from the building which is outside the off-limits area. Persons exiting the doors in the east side of the gymnasium should turn to the south and proceed out toward Concord Street. Additionally, students, staff and school visitors should be informed that during an earthquake, persons outside of the building should immediately move outside of the off-limits area.

We have attached a sketch which graphically denotes the recommended exit paths which we have described in this letter. We would appreciate it if you would review this information and pass it along to the school district with your comments. Please do not hesitate to call if you have any questions.
