Architectural
Resources Group

Concord School Historic Resource Assessment

January 2020

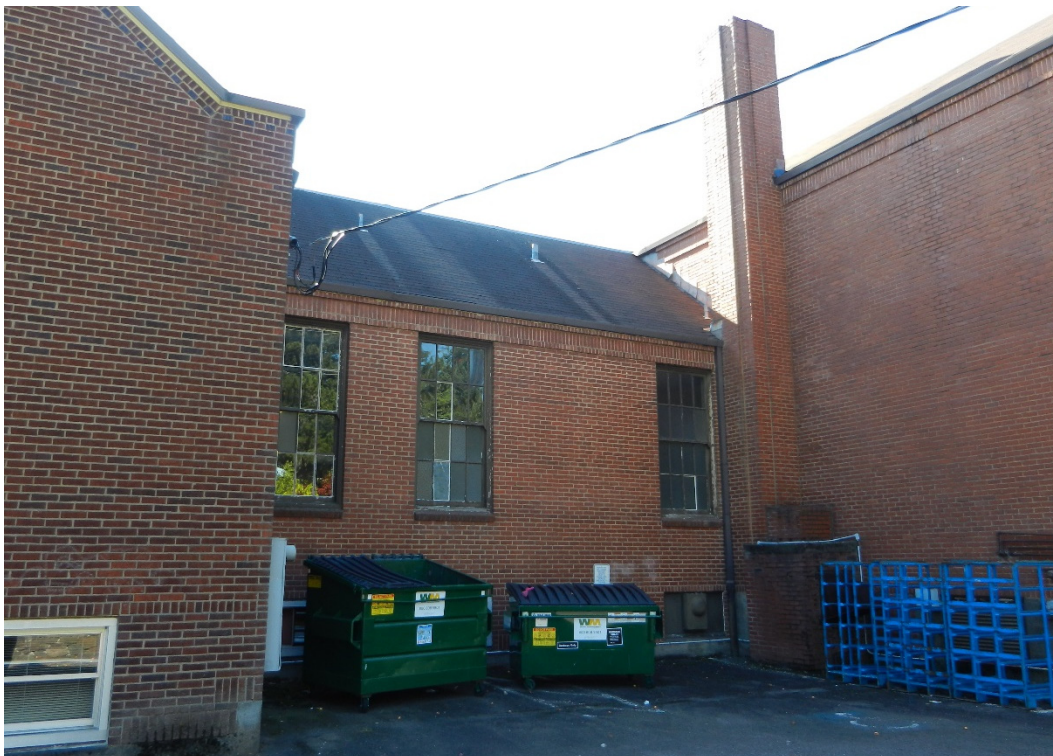
Three original eight-over-eight wood windows with ogee lugs are located at the upper level north of the end bay. These appear to be the building's only intact original windows. Four smaller window openings, including three vinyl slider windows and one metal utility vent, are located beneath these windows.

Original wood windows on rear (eastern) façade, camera facing west-northwest (ARG, October 2019).

With the exception of three eight-over-eight wood windows at the rear of the building and the wood transom at the north, south and east entrances, all windows have been replaced. If the non-original windows are to be replaced, SHPO will be interested in reviewing the proposed design for the replacement windows. In replacing the windows, the building owner is not obligated to use replacement windows that are exact reproductions of the remaining historic windows. Instead, SHPO will review the virtues of the proposed windows versus the existing (non-historic) windows, posing the question whether the proposed windows are more compatible with the historic windows than the current windows are. Given that, replacement windows that take cues from the historic windows (such as divided lights, one-over-one functionality and white or green coloration) would likely be deemed to not pose an impact. Regardless of the chosen design, the new windows should fit within the existing window openings, which are themselves historic. If different window designs are proposed for different façades of the building, it should be noted that the windows at the primary (western) façade will be subjected to the highest level of SHPO scrutiny. As a result, of the window types that are ultimately proposed, those that have the greatest degree of similarity to the historic windows should be used on the west façade.
