# Watershed Action Plan

## Kellogg-Mt. Scott Watershed

June 2009

Prepared by Brown and Caldwell, Ellis Ecological, and Waterways Consulting

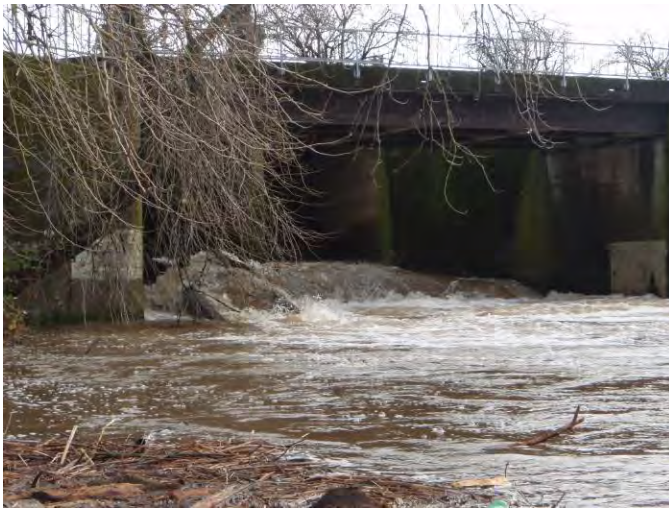
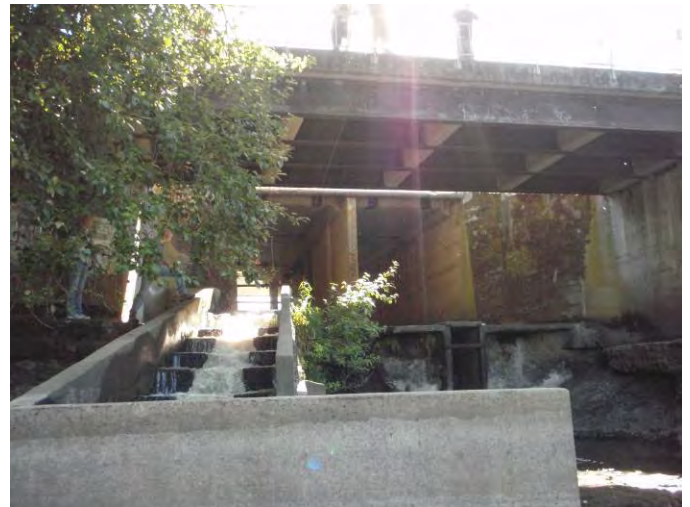
Photos 2-1 and 2-2. Kellogg Creek at confluence with Willamette River on January 2, 2009 and August 13, 2008

There have been several large storm events in the KMS watershed that created significant stream flows in Kellogg and Mt. Scott Creeks and the tributaries. Photos 2-1 through 2-14 follow. Some from the January 2, 2009 event are compared to photos of lower flow conditions where available.
