Presentation Title: Flood Recovery & Risk Management Update

Community Resilience Upper Sandy River

Board of County Commissioners
Policy Session

October 10, 2017

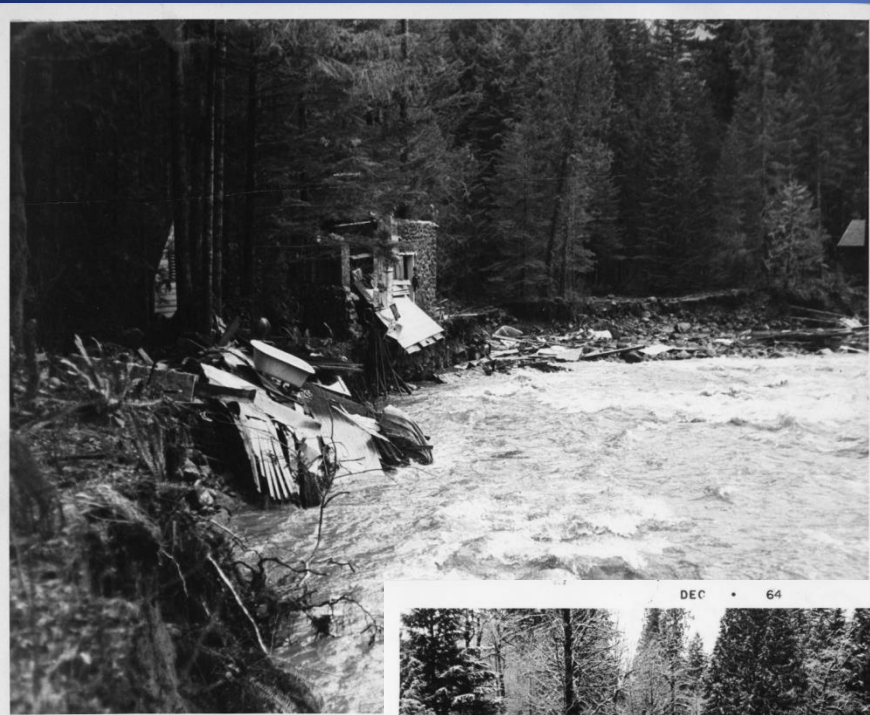
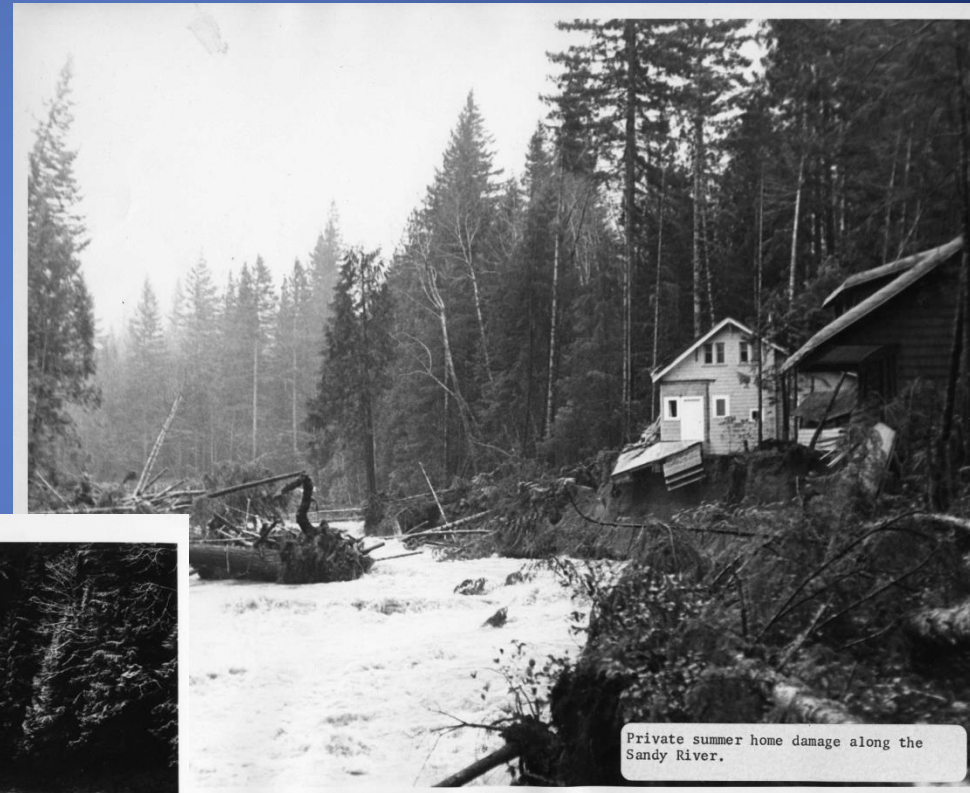
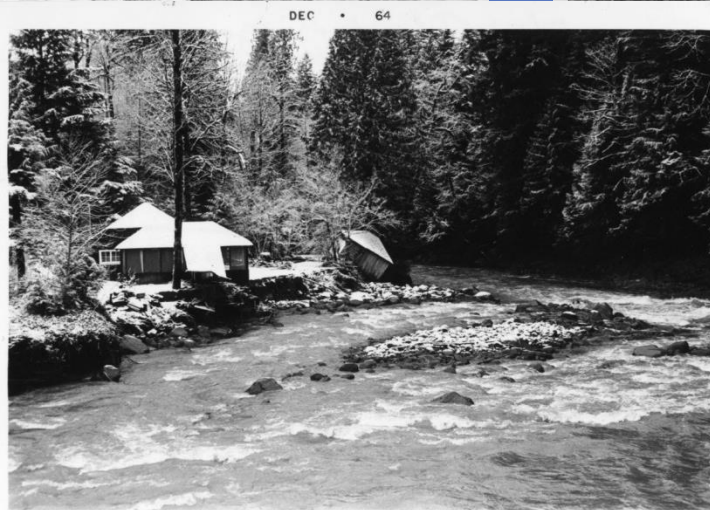
Upper Sandy River Basin – December 1964

The flood volume on the Sandy was the greatest of record. The river gradient is very steep, and the river bottom soil is a gravely silt which offers little resistance to erosion. The result was an action on the valleys and lower slope that was glacier-like. Complete changes in appearance of the valley resulted in many places; for example, the north bank of the Sandy just upstream from Brightwood showed no indication of buildings, vegetation or topsoil where a group of 40 houses existed prior to the flood. These conditions were repeated to a lesser extent throughout the upper basin.

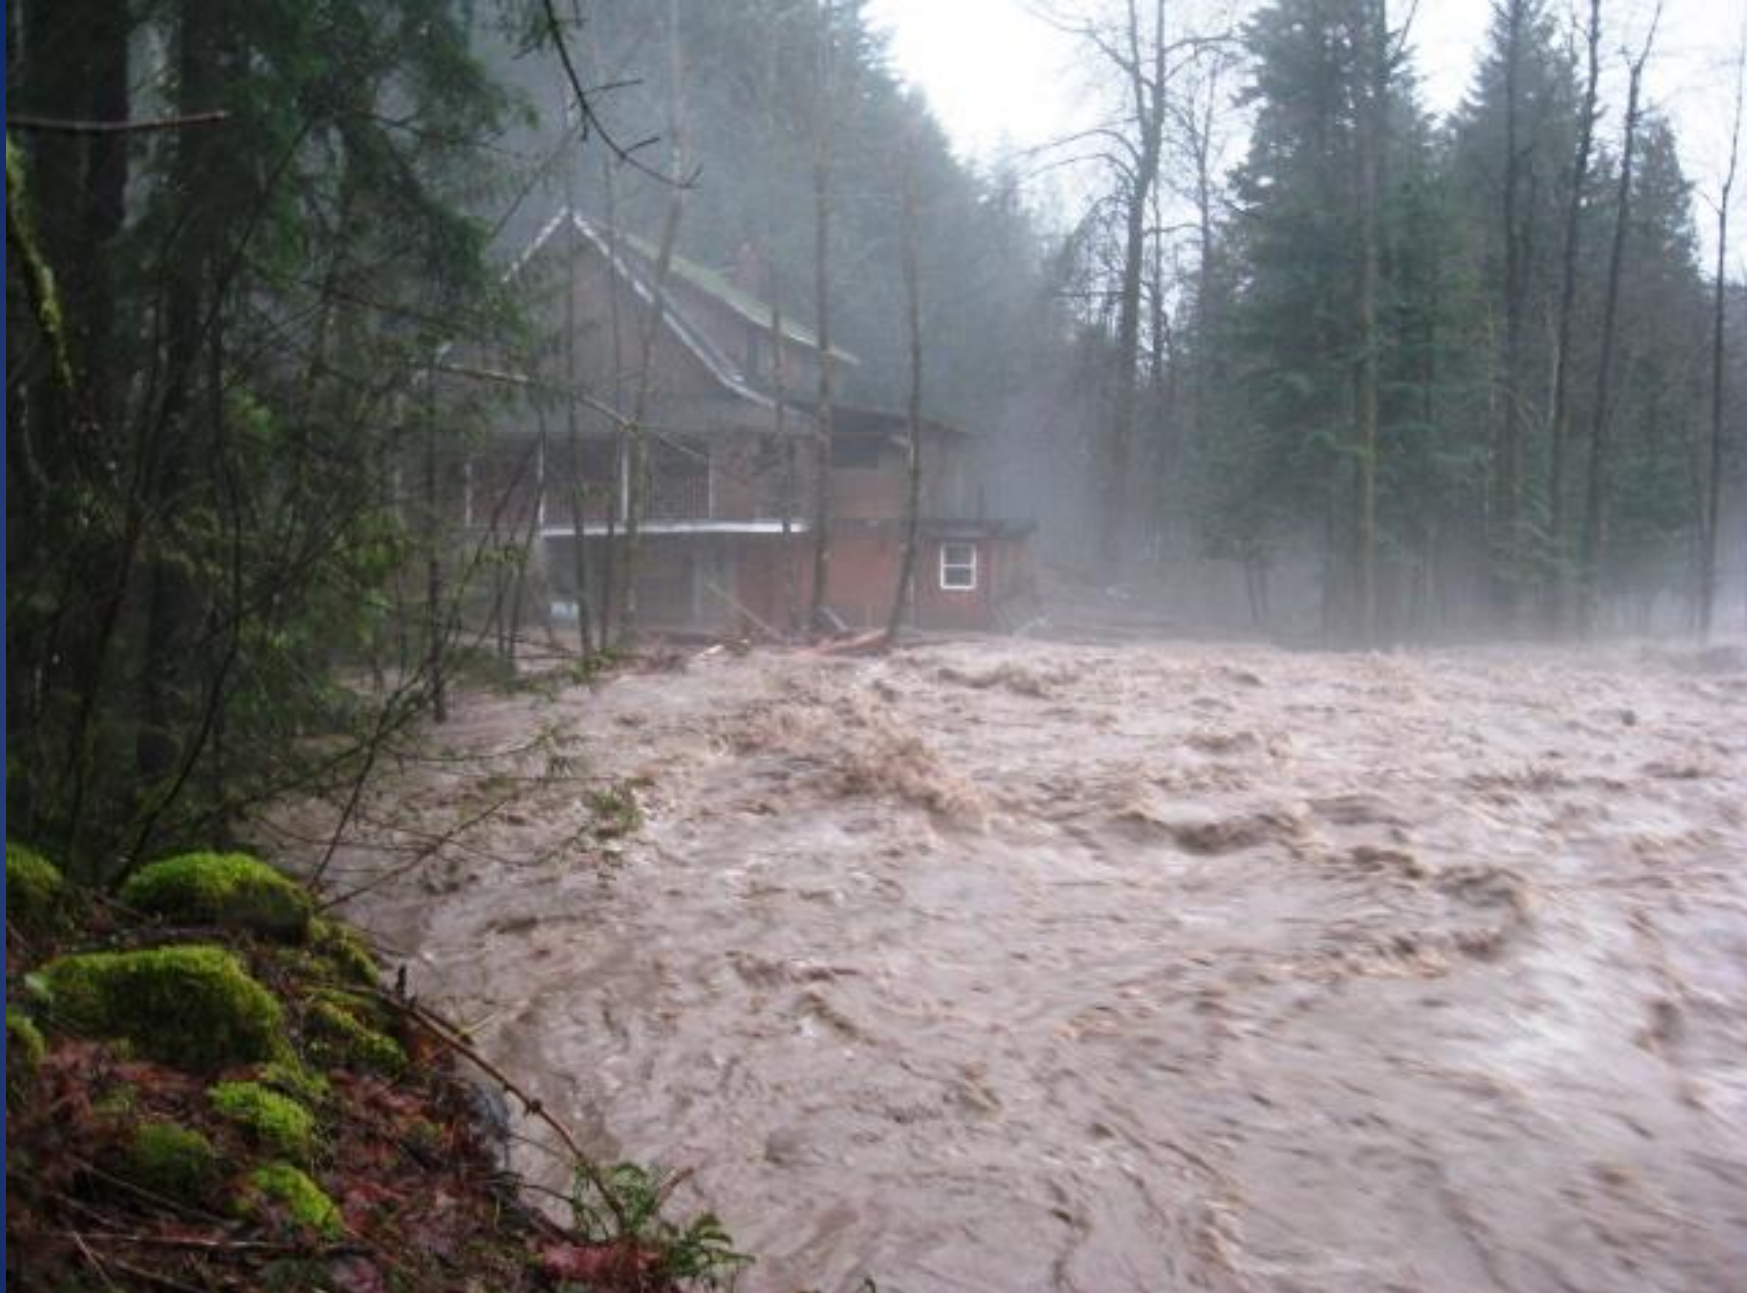
January 2011 - Lower Lolo Pass Road Area

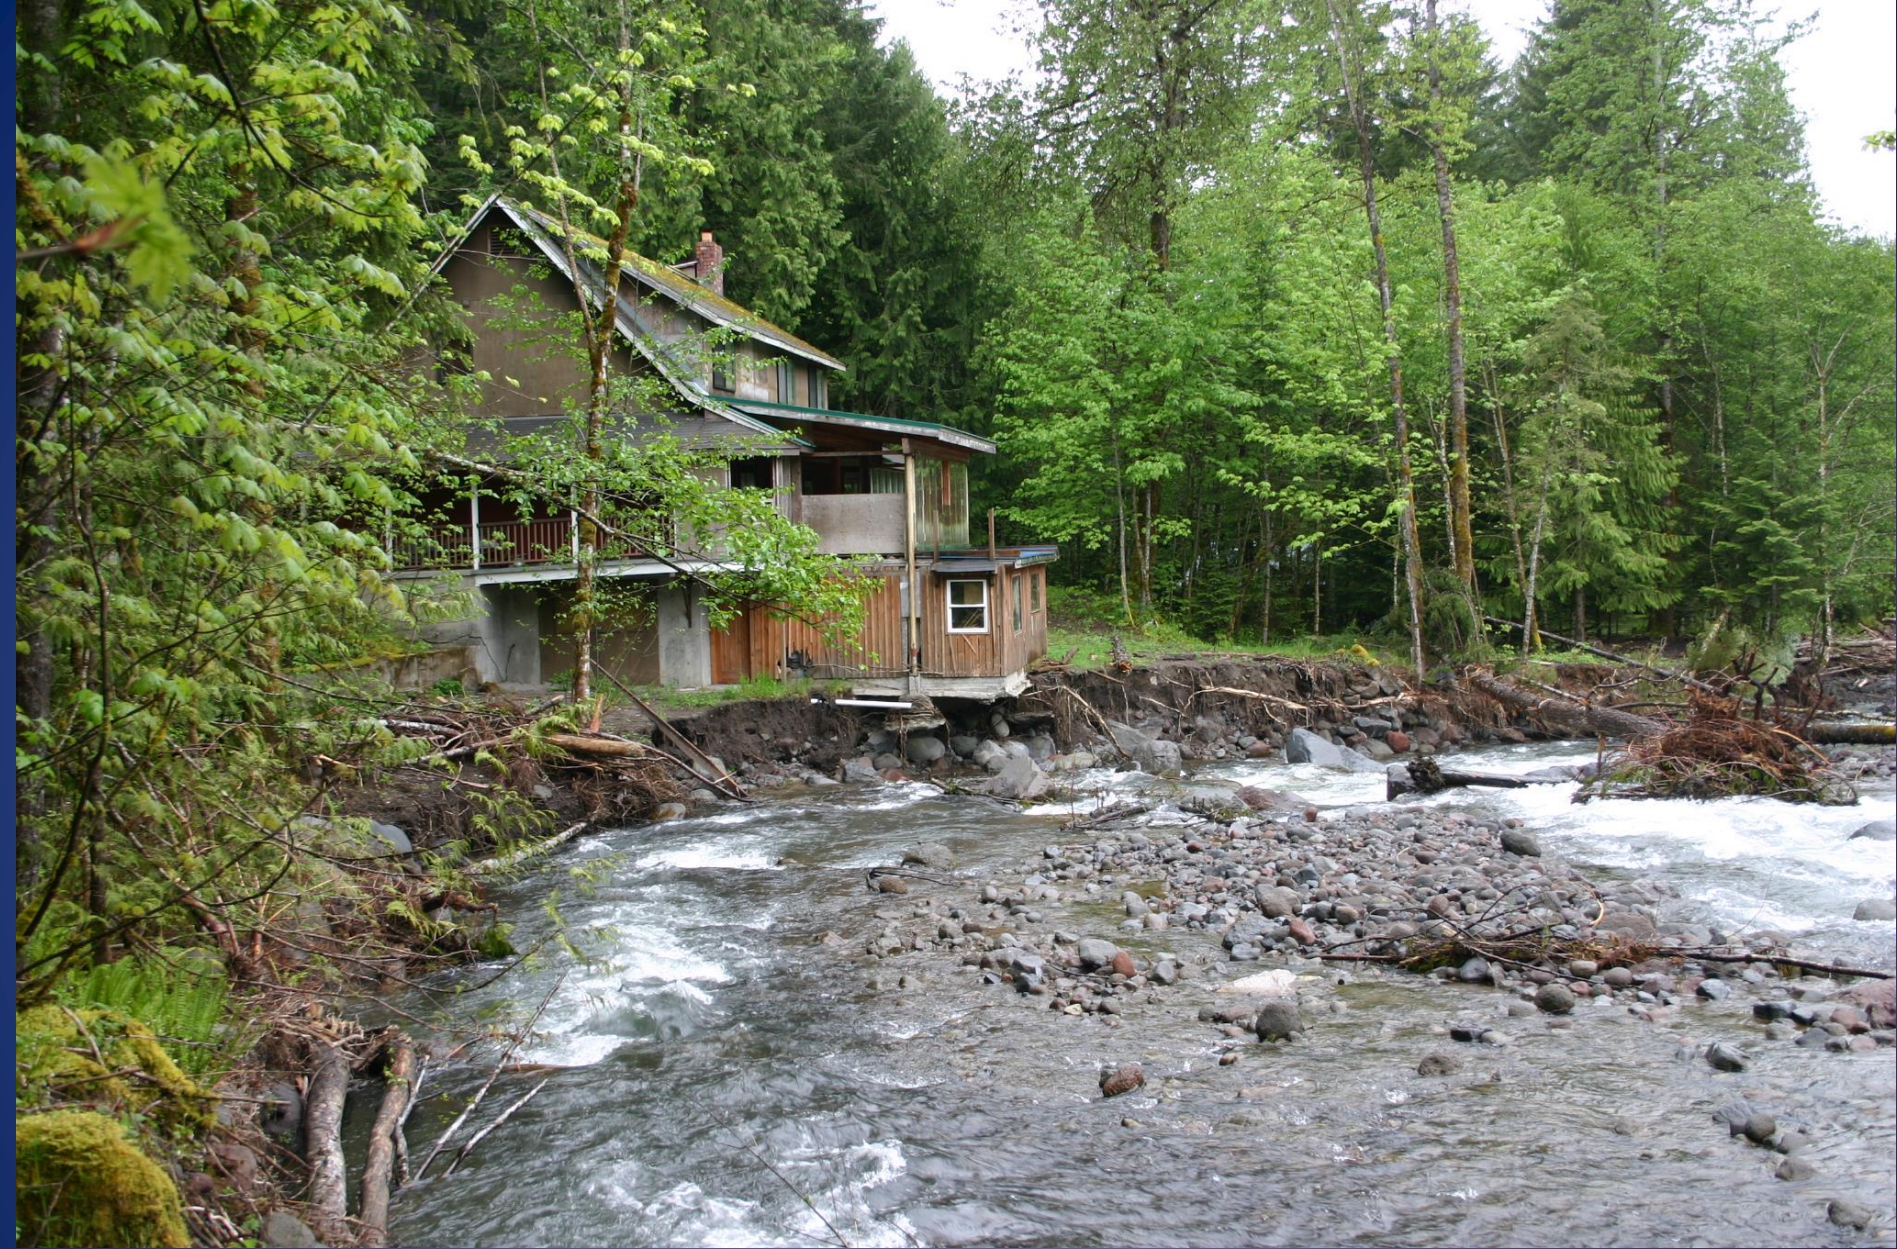
June 2011 - Lower Lolo Pass Road Area

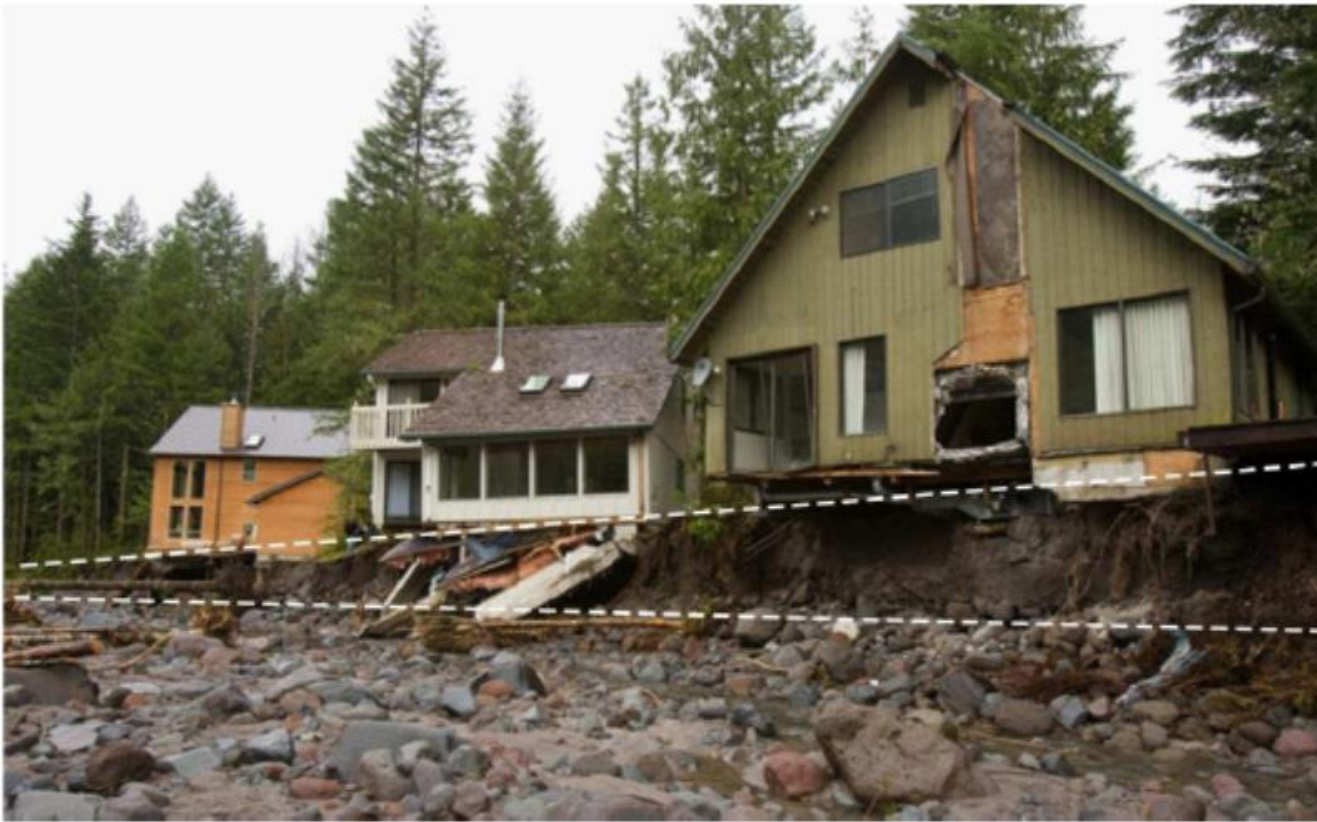
**Damages resulting from
January 16, 2011 flood,
Zig Zag Village, Upper
Sandy River**

Bank of sand

River bed of boulders

- River Bank is Softer than the River Bed
- Doesn't need to "Flood" to Cause Damage
- Historic protection (riprap) causes problems
- The Sandy River needs more room

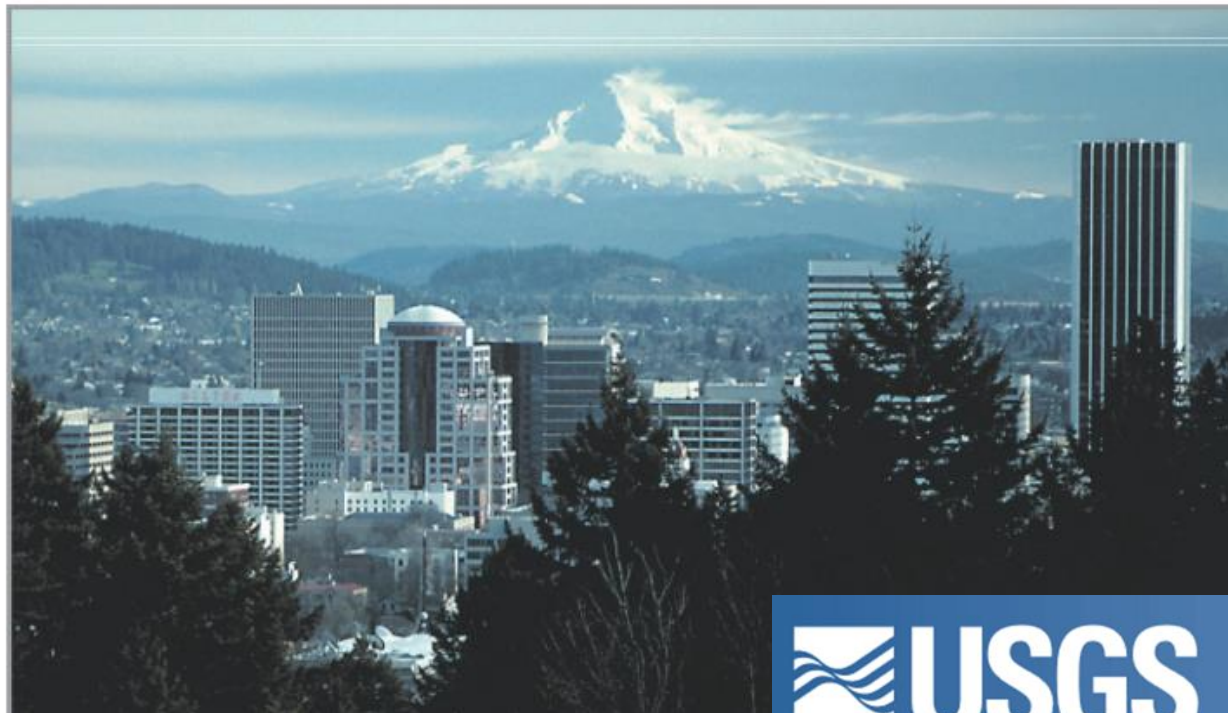
Sandy River
Valley

is a
Layer Cake of

Volcanic
Mud Flows

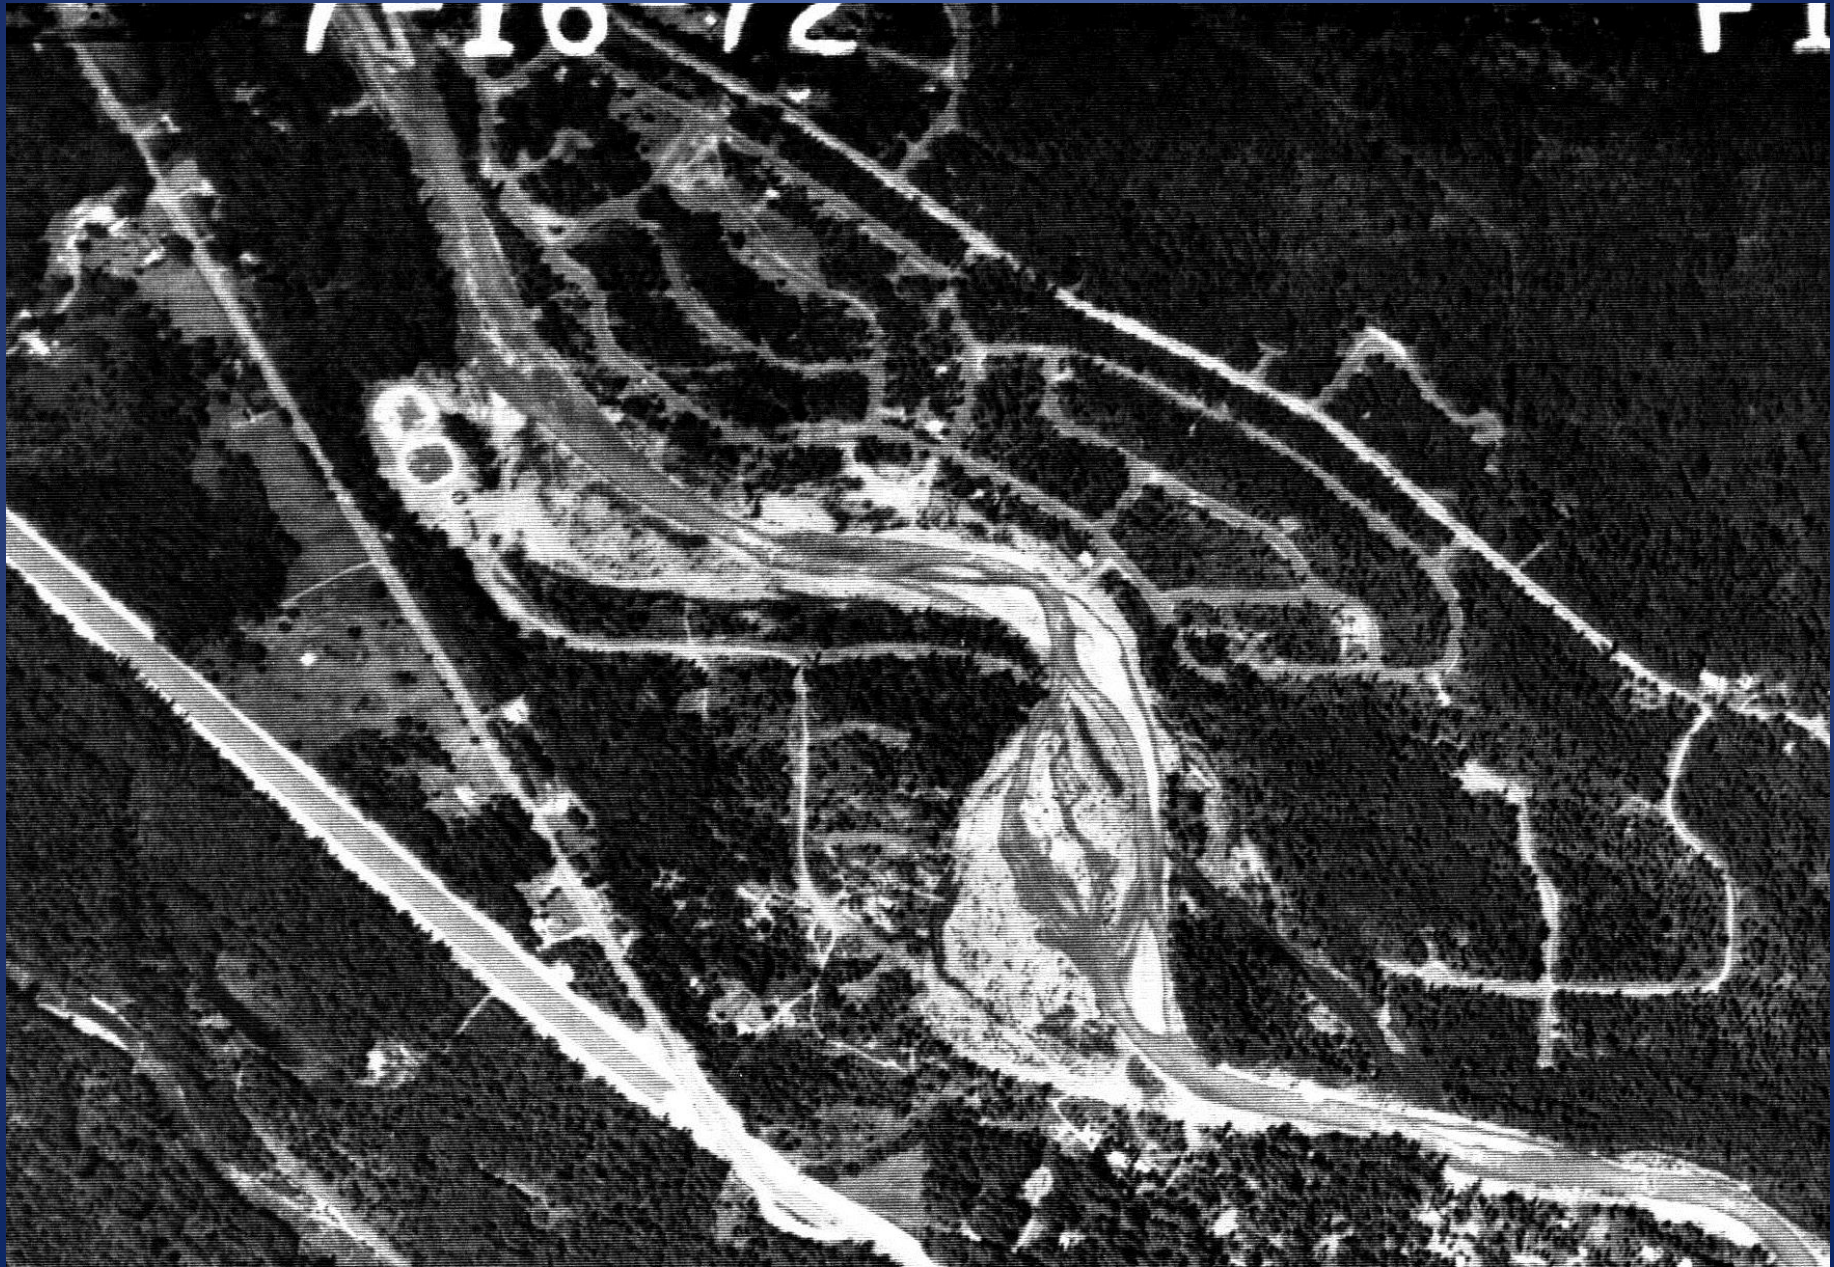
Figure 23. Timberline Rim Channel Migration. This group of air photos shows the lateral and downstream migration of the large bend adjacent to the Timberline Rim community. Note the remnant channel traces showing the distance of migration from 2005 to 2008 to 2012. Note also the size of the bend relative to property plats. Data sources: University of Oregon Libraries, USDA NAIP.

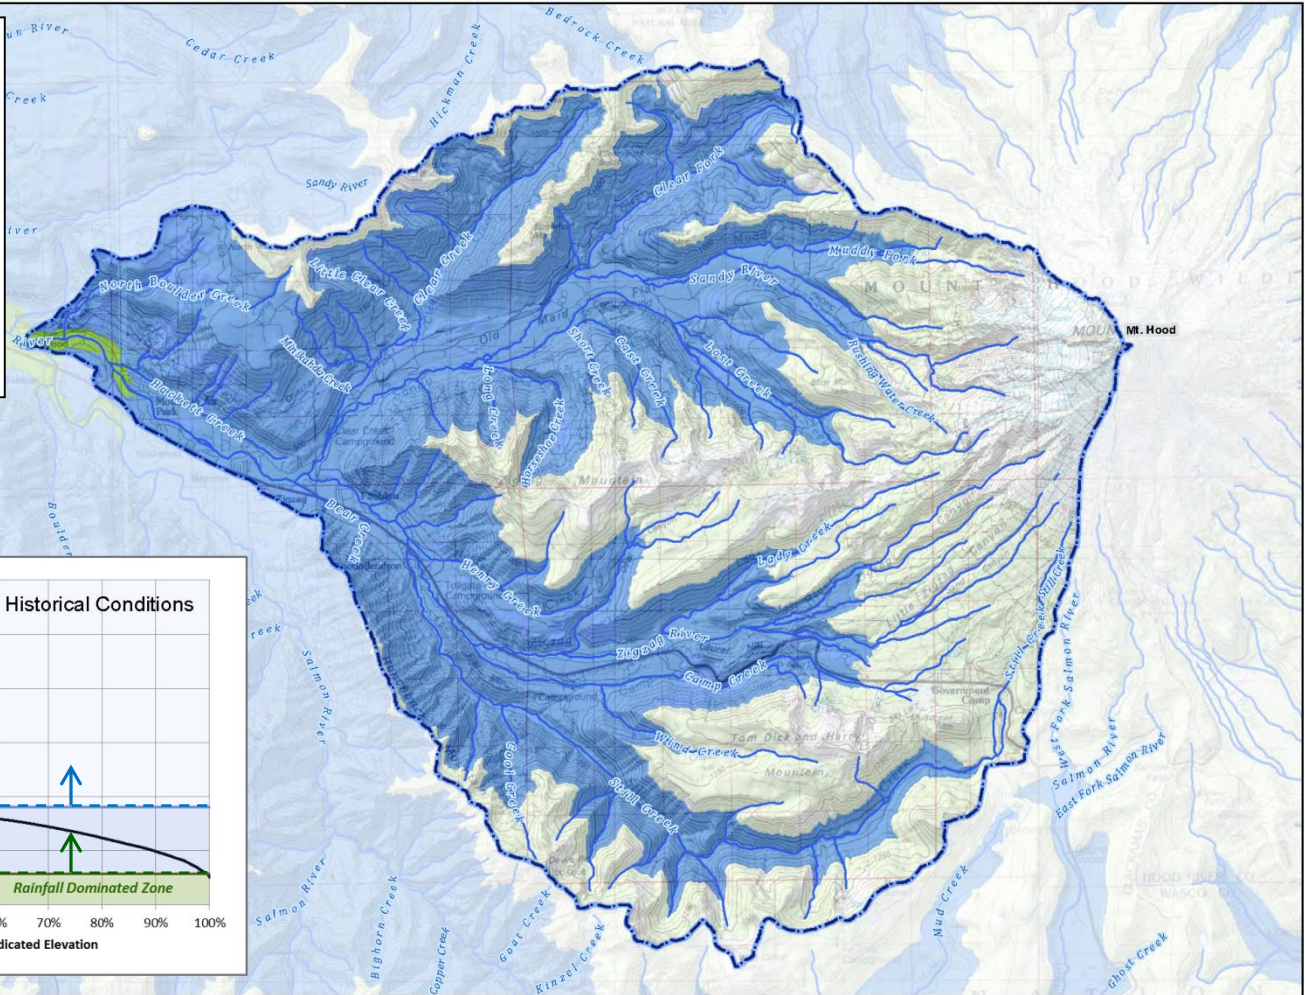
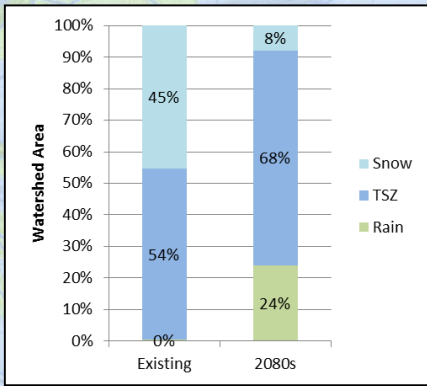
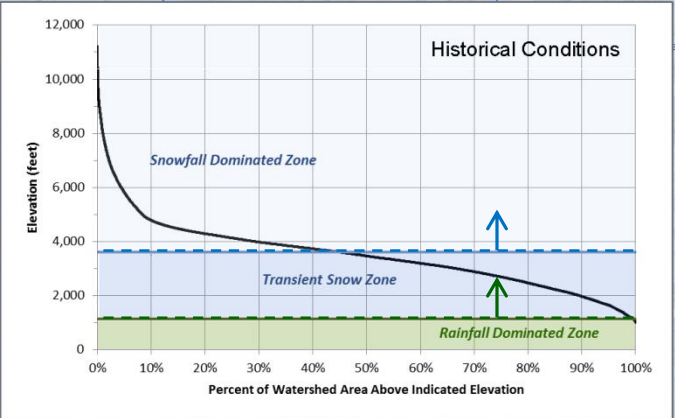
Upper Sandy River - Flood and Erosion Hazard Mitigation Evaluation Project
Hydrologic Zones of the Upper Sandy River Watershed

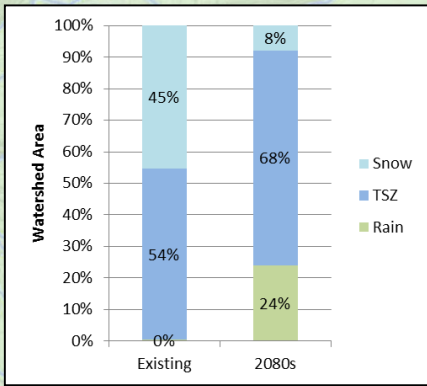
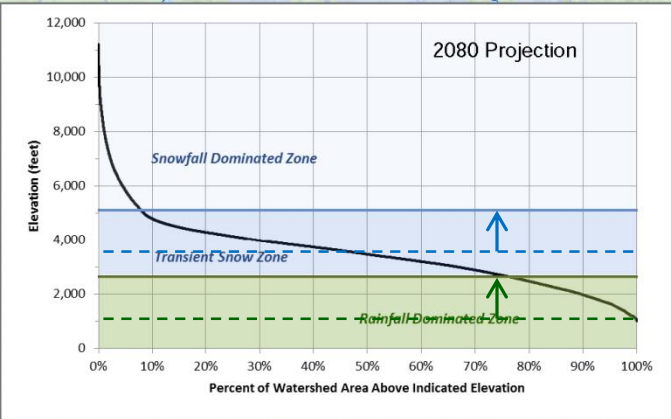
Upper Sandy River - Flood and Erosion Hazard Mitigation Evaluation Project
Hydrologic Zones of the Upper Sandy River Watershed
