# Watershed Action Plan

## Rock Creek Watershed

June 2009

Prepared by Brown and Caldwell, Ellis Ecological Services, and Waterways Consulting

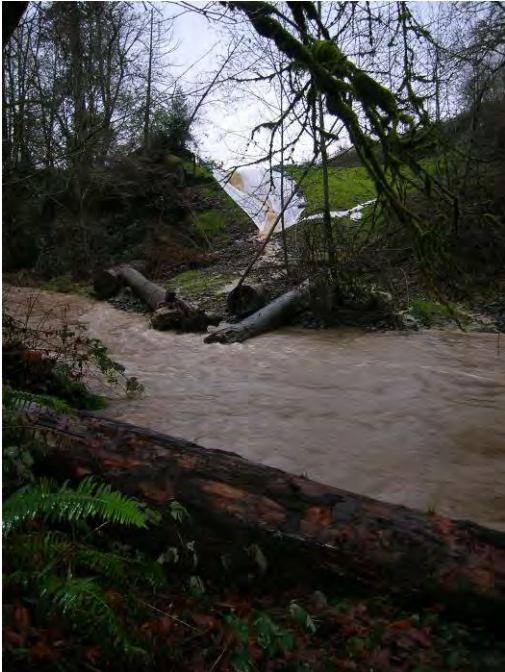
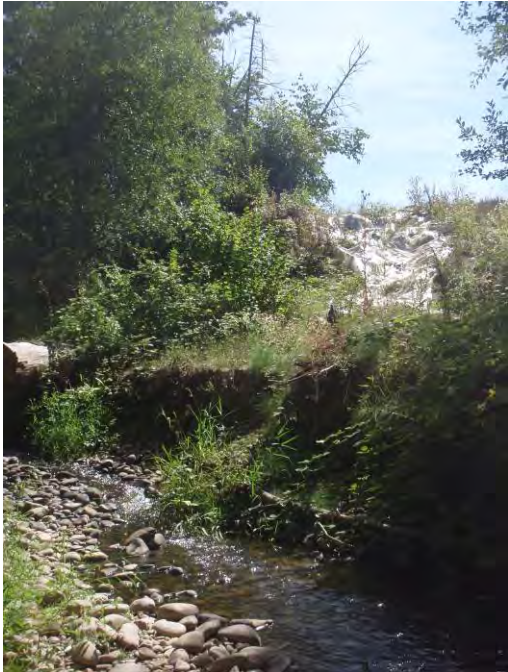
Photos 2-1 and 2-2. Lower Rock Creek on January 3, 2007 and September 5, 2008

On January 3, 2007 and January 2, 2009, there were large storm events in the RC watershed that created significant stream flows in Rock Creek and its tributaries. Photos 2-1 through 2-7 from these events follow and show comparisons to lower flow conditions where possible.

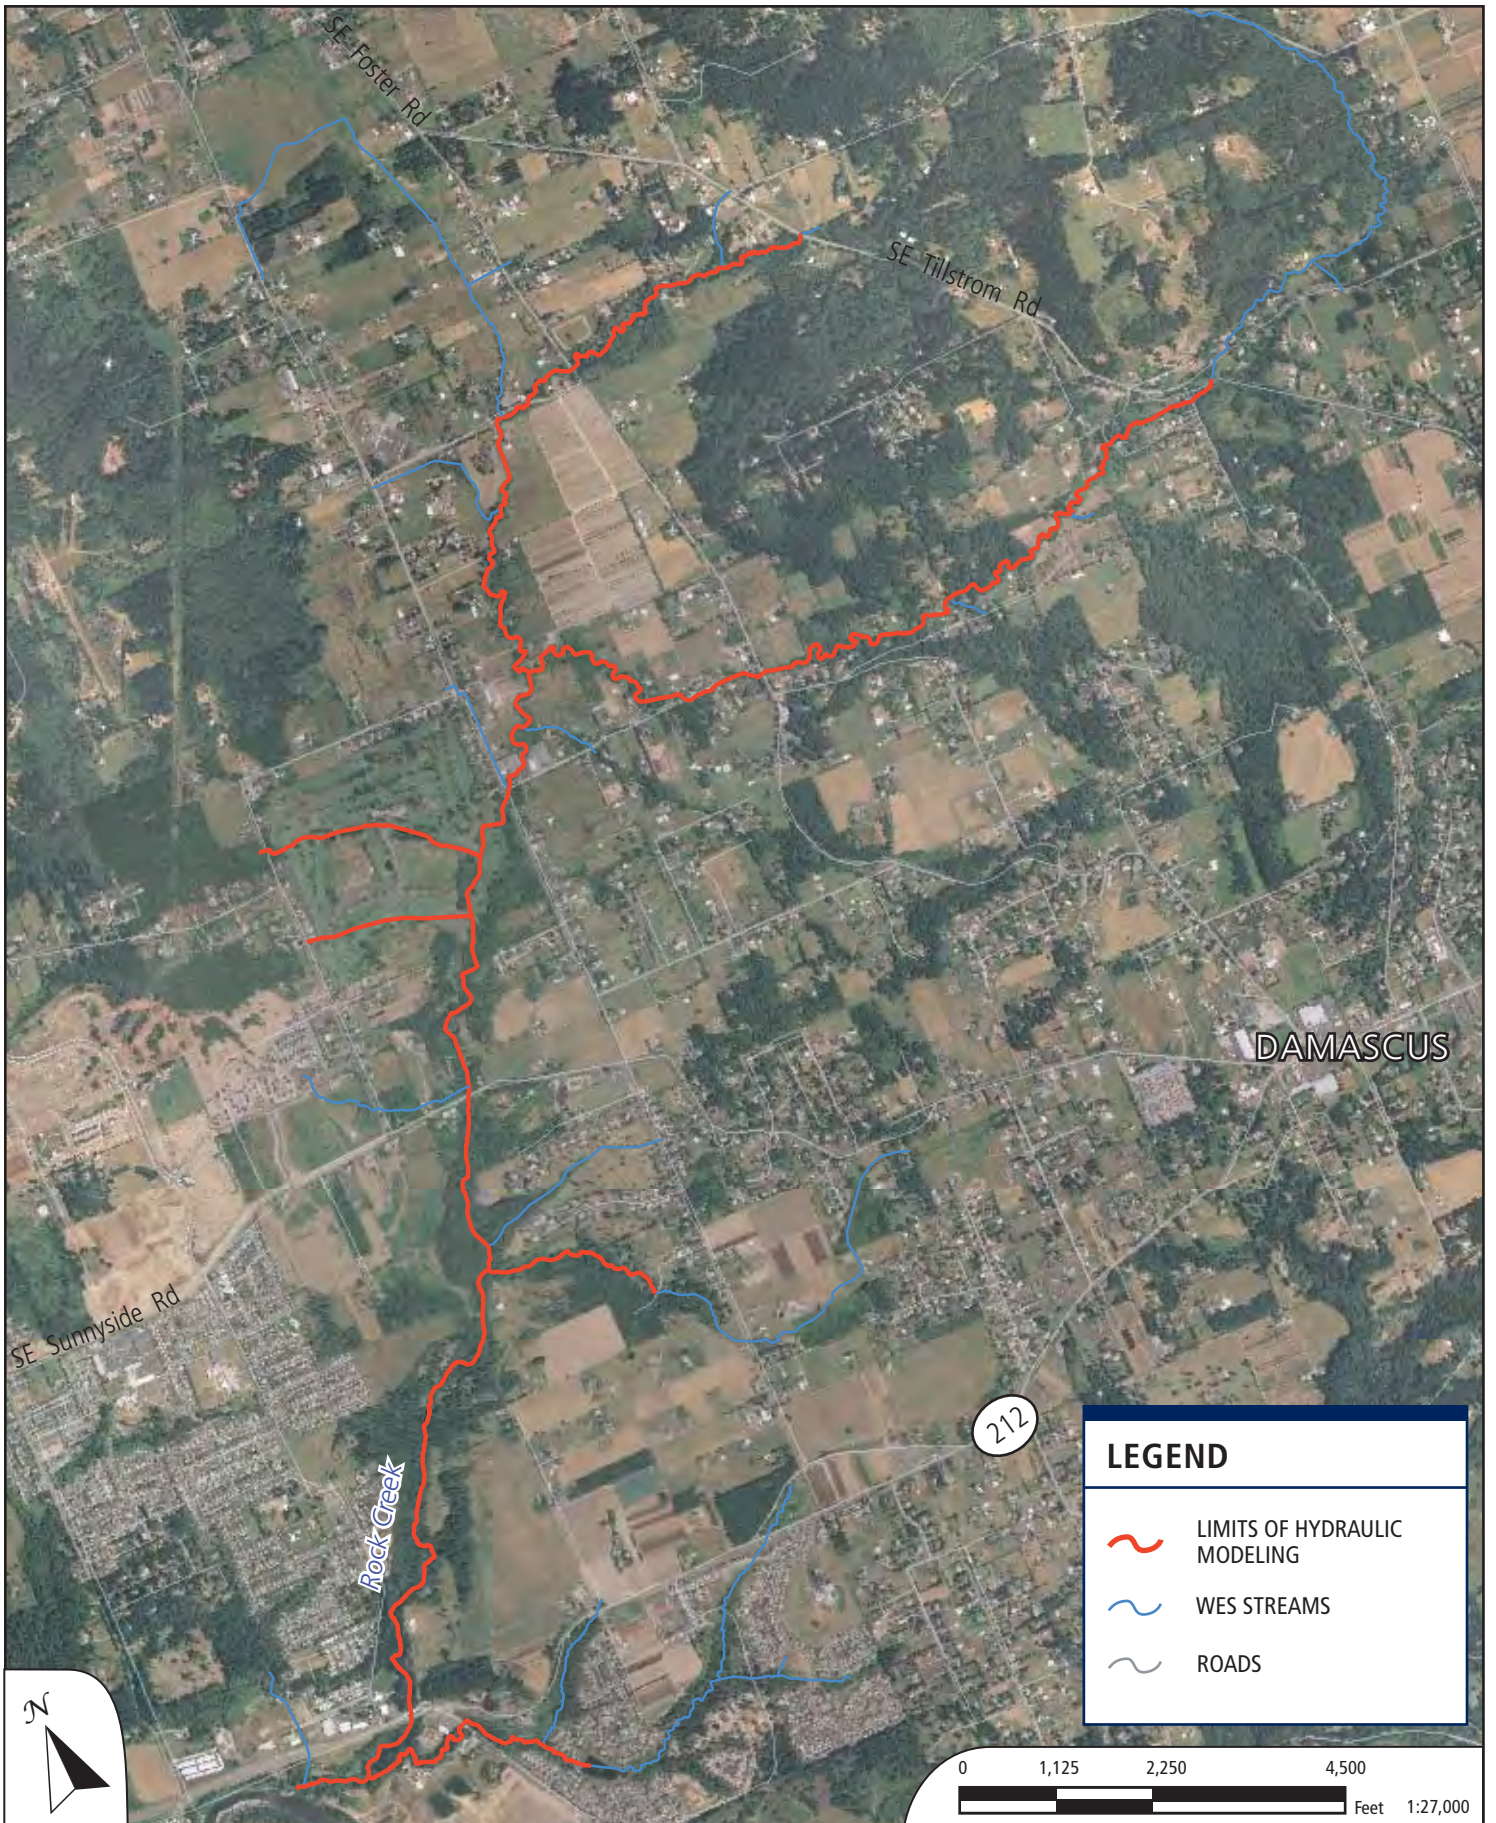
Figure 2-1  
 Rock Creek - Hydraulic Modeling Extents  
 WES WATERSHED ACTION PLAN

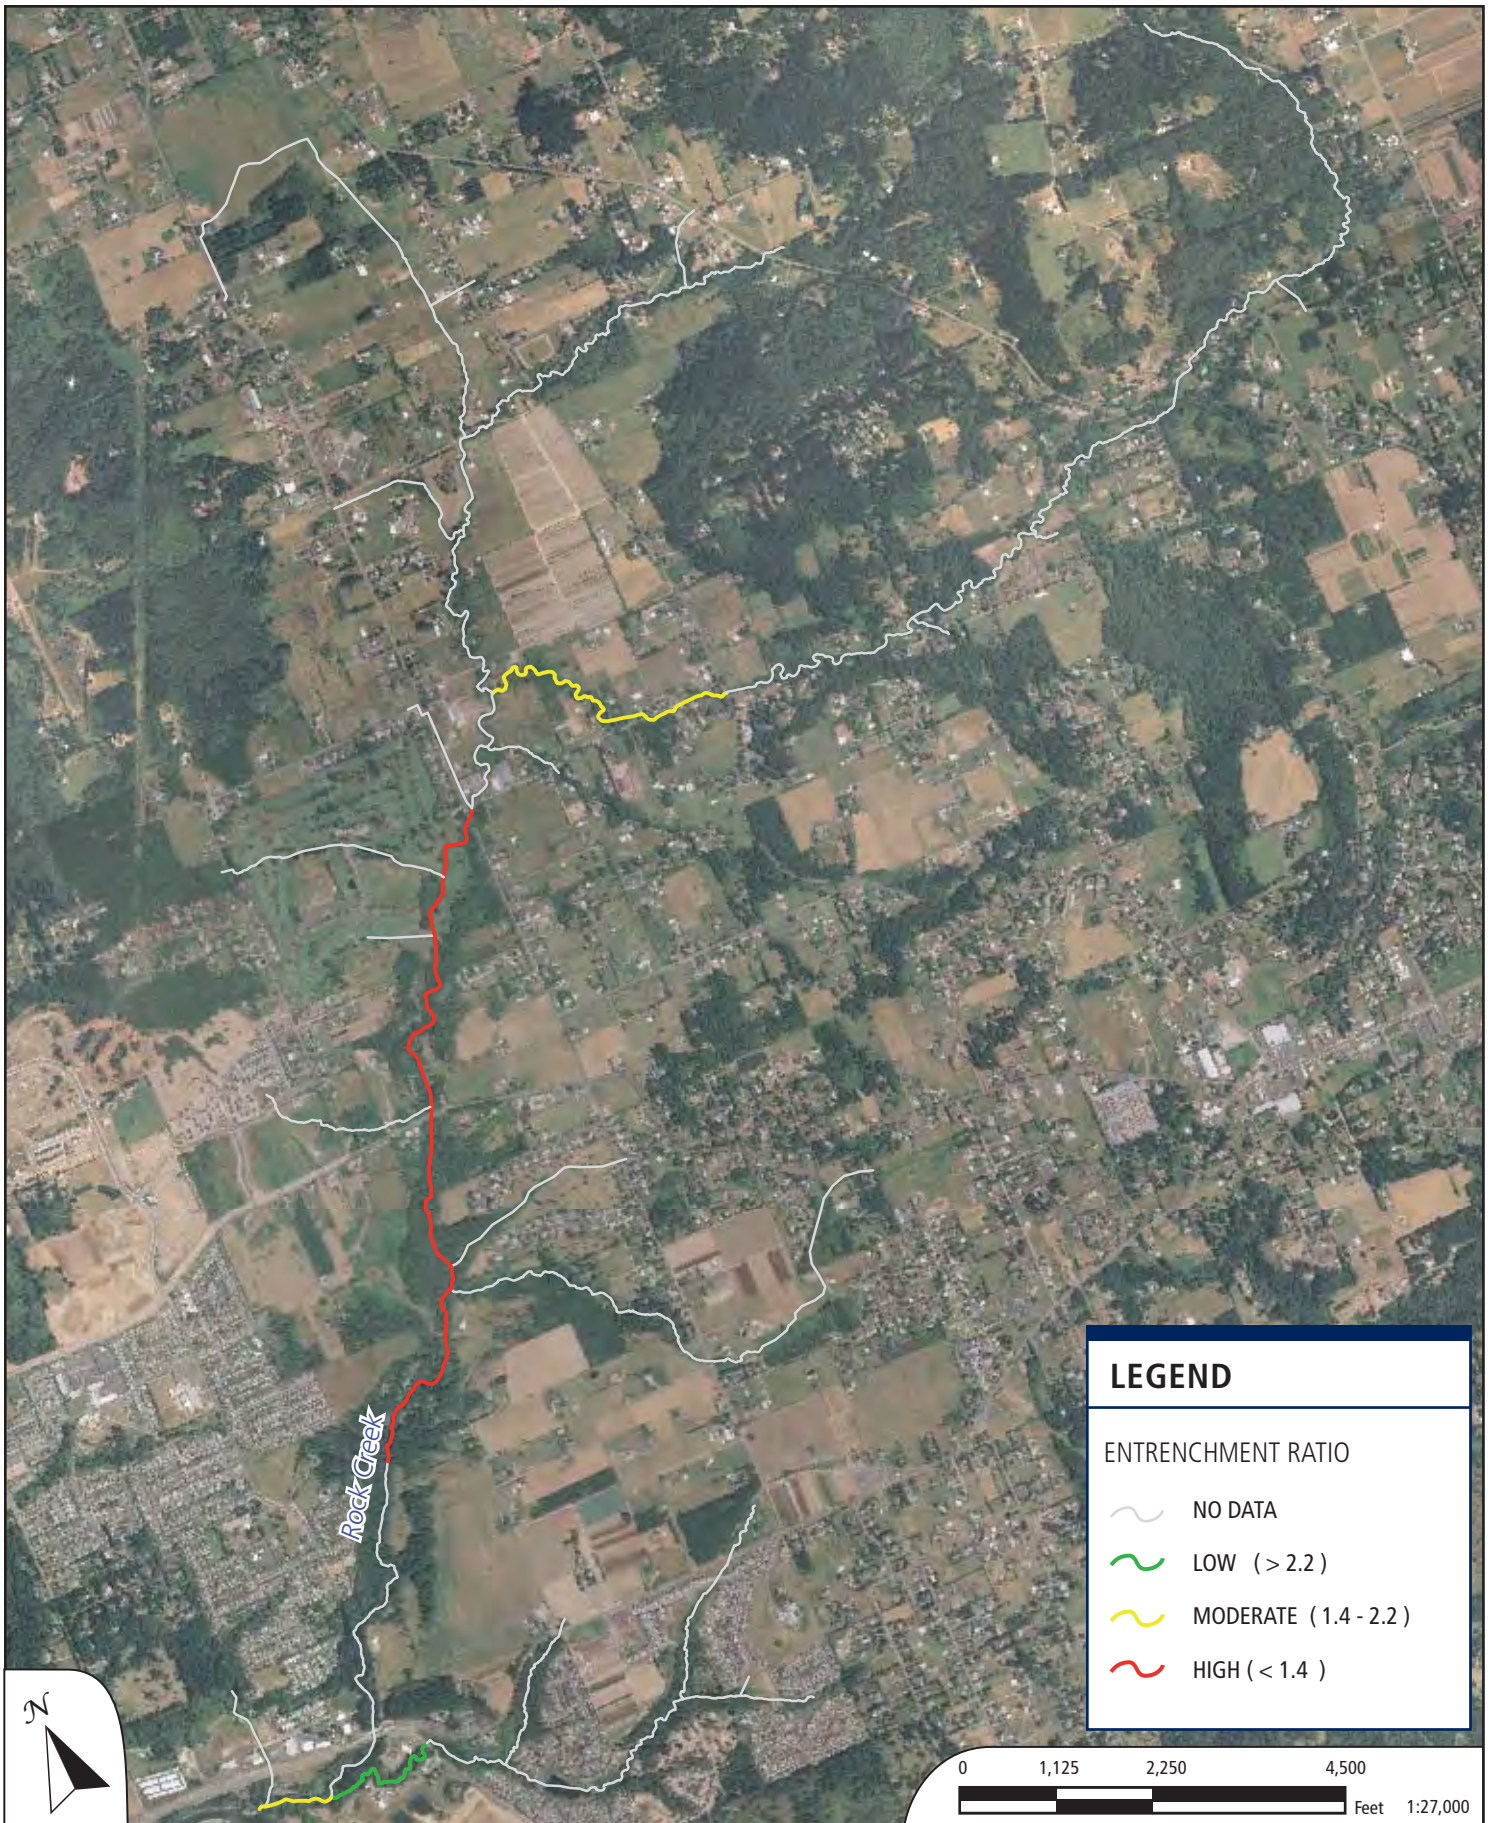
Figure 2-9  
 Rock Creek - Entrenchment Ratio  
 WES WATERSHED ACTION PLAN

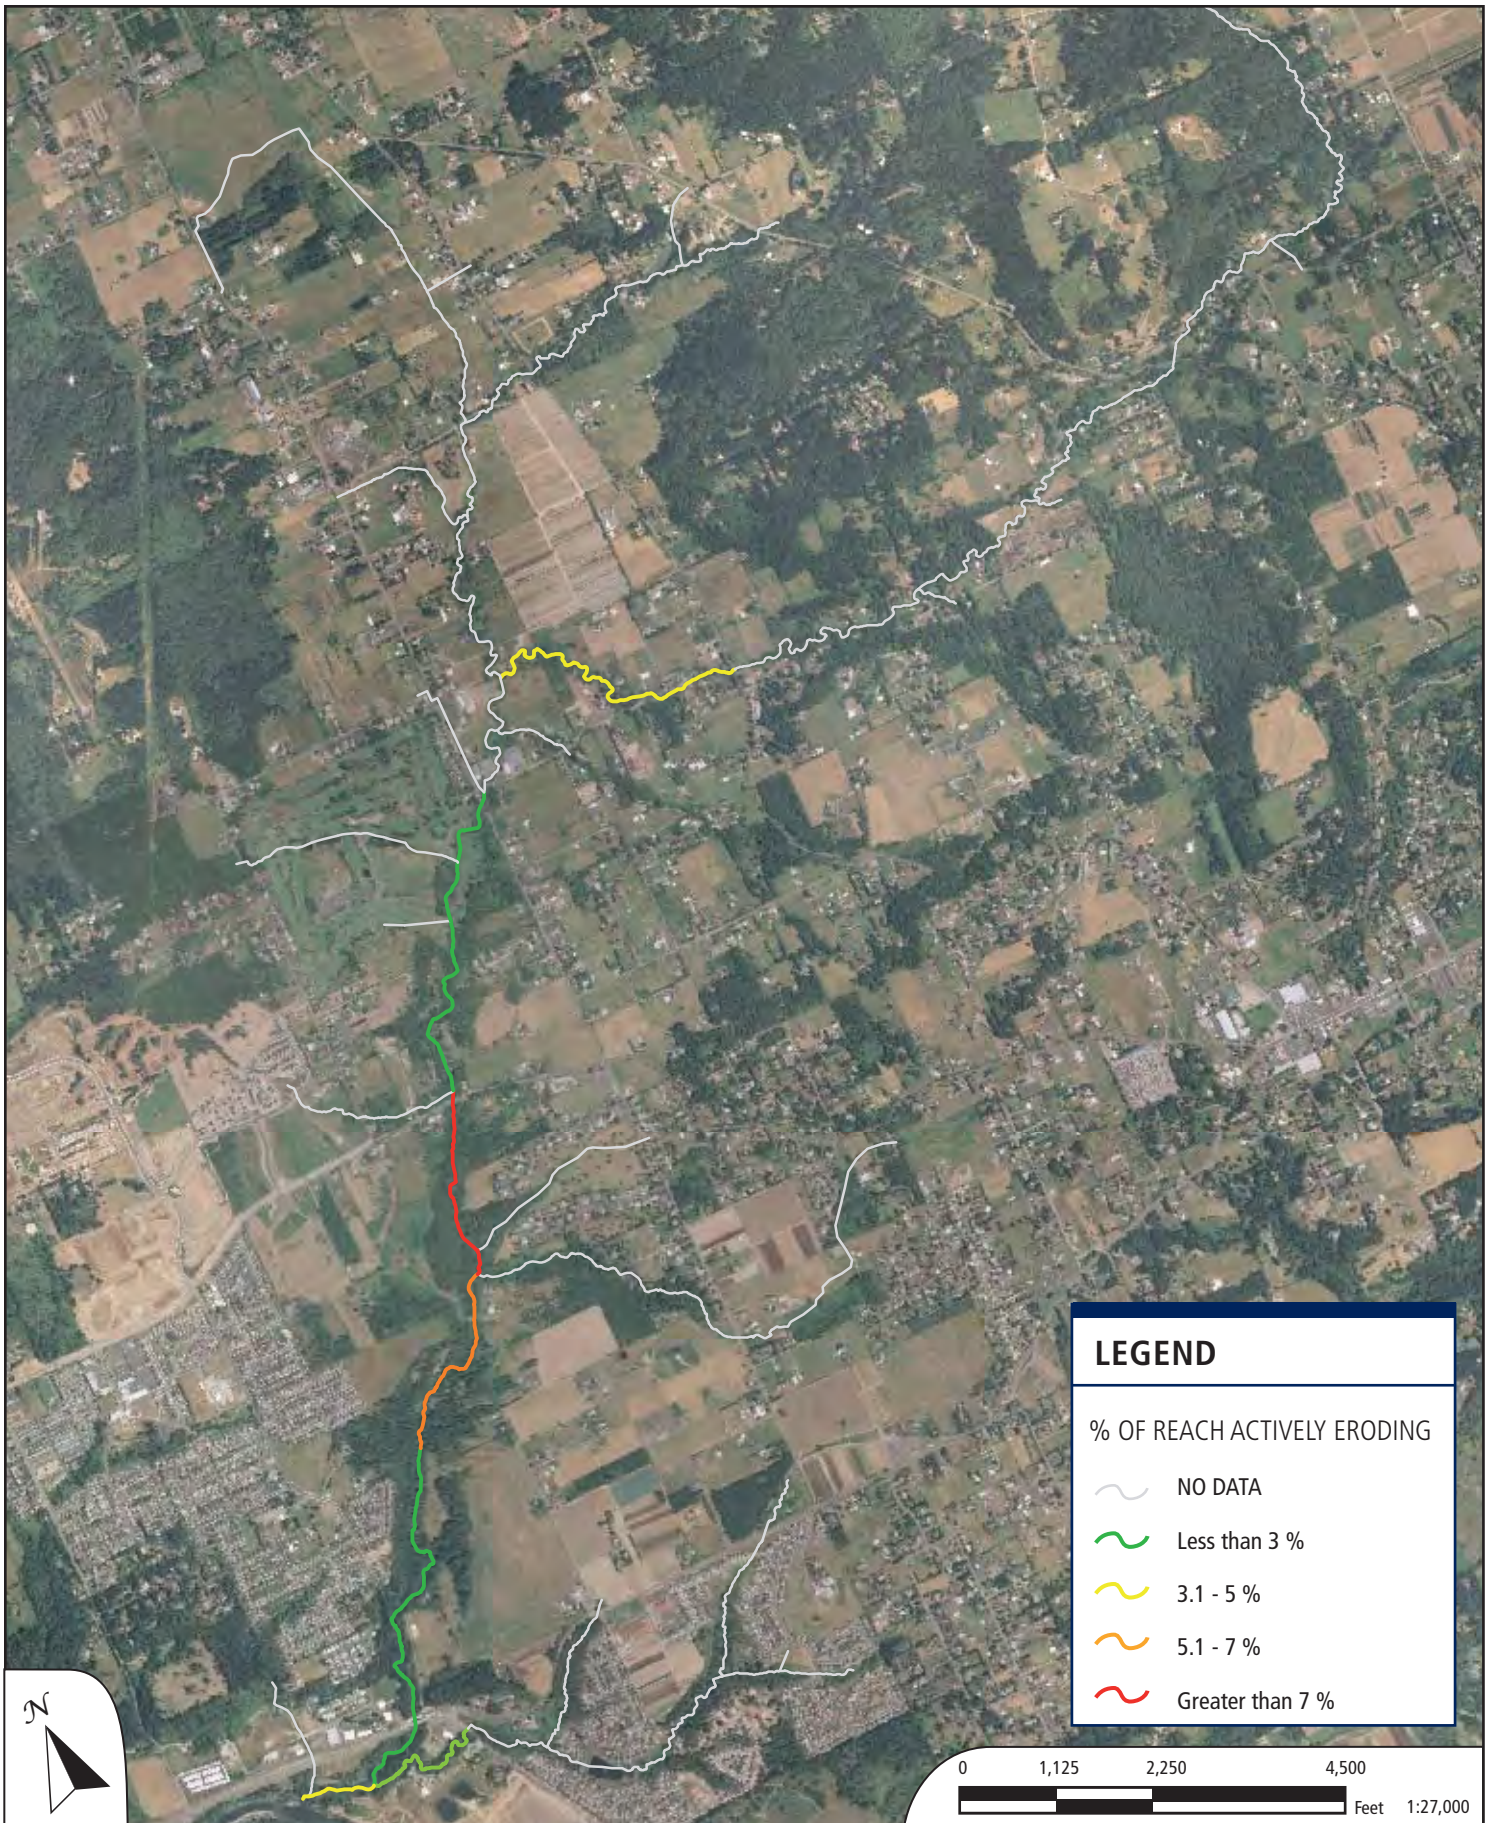
Figure 2-11  
 Rock Creek - Bank Erosion by Reach  
 WES WATERSHED ACTION PLAN

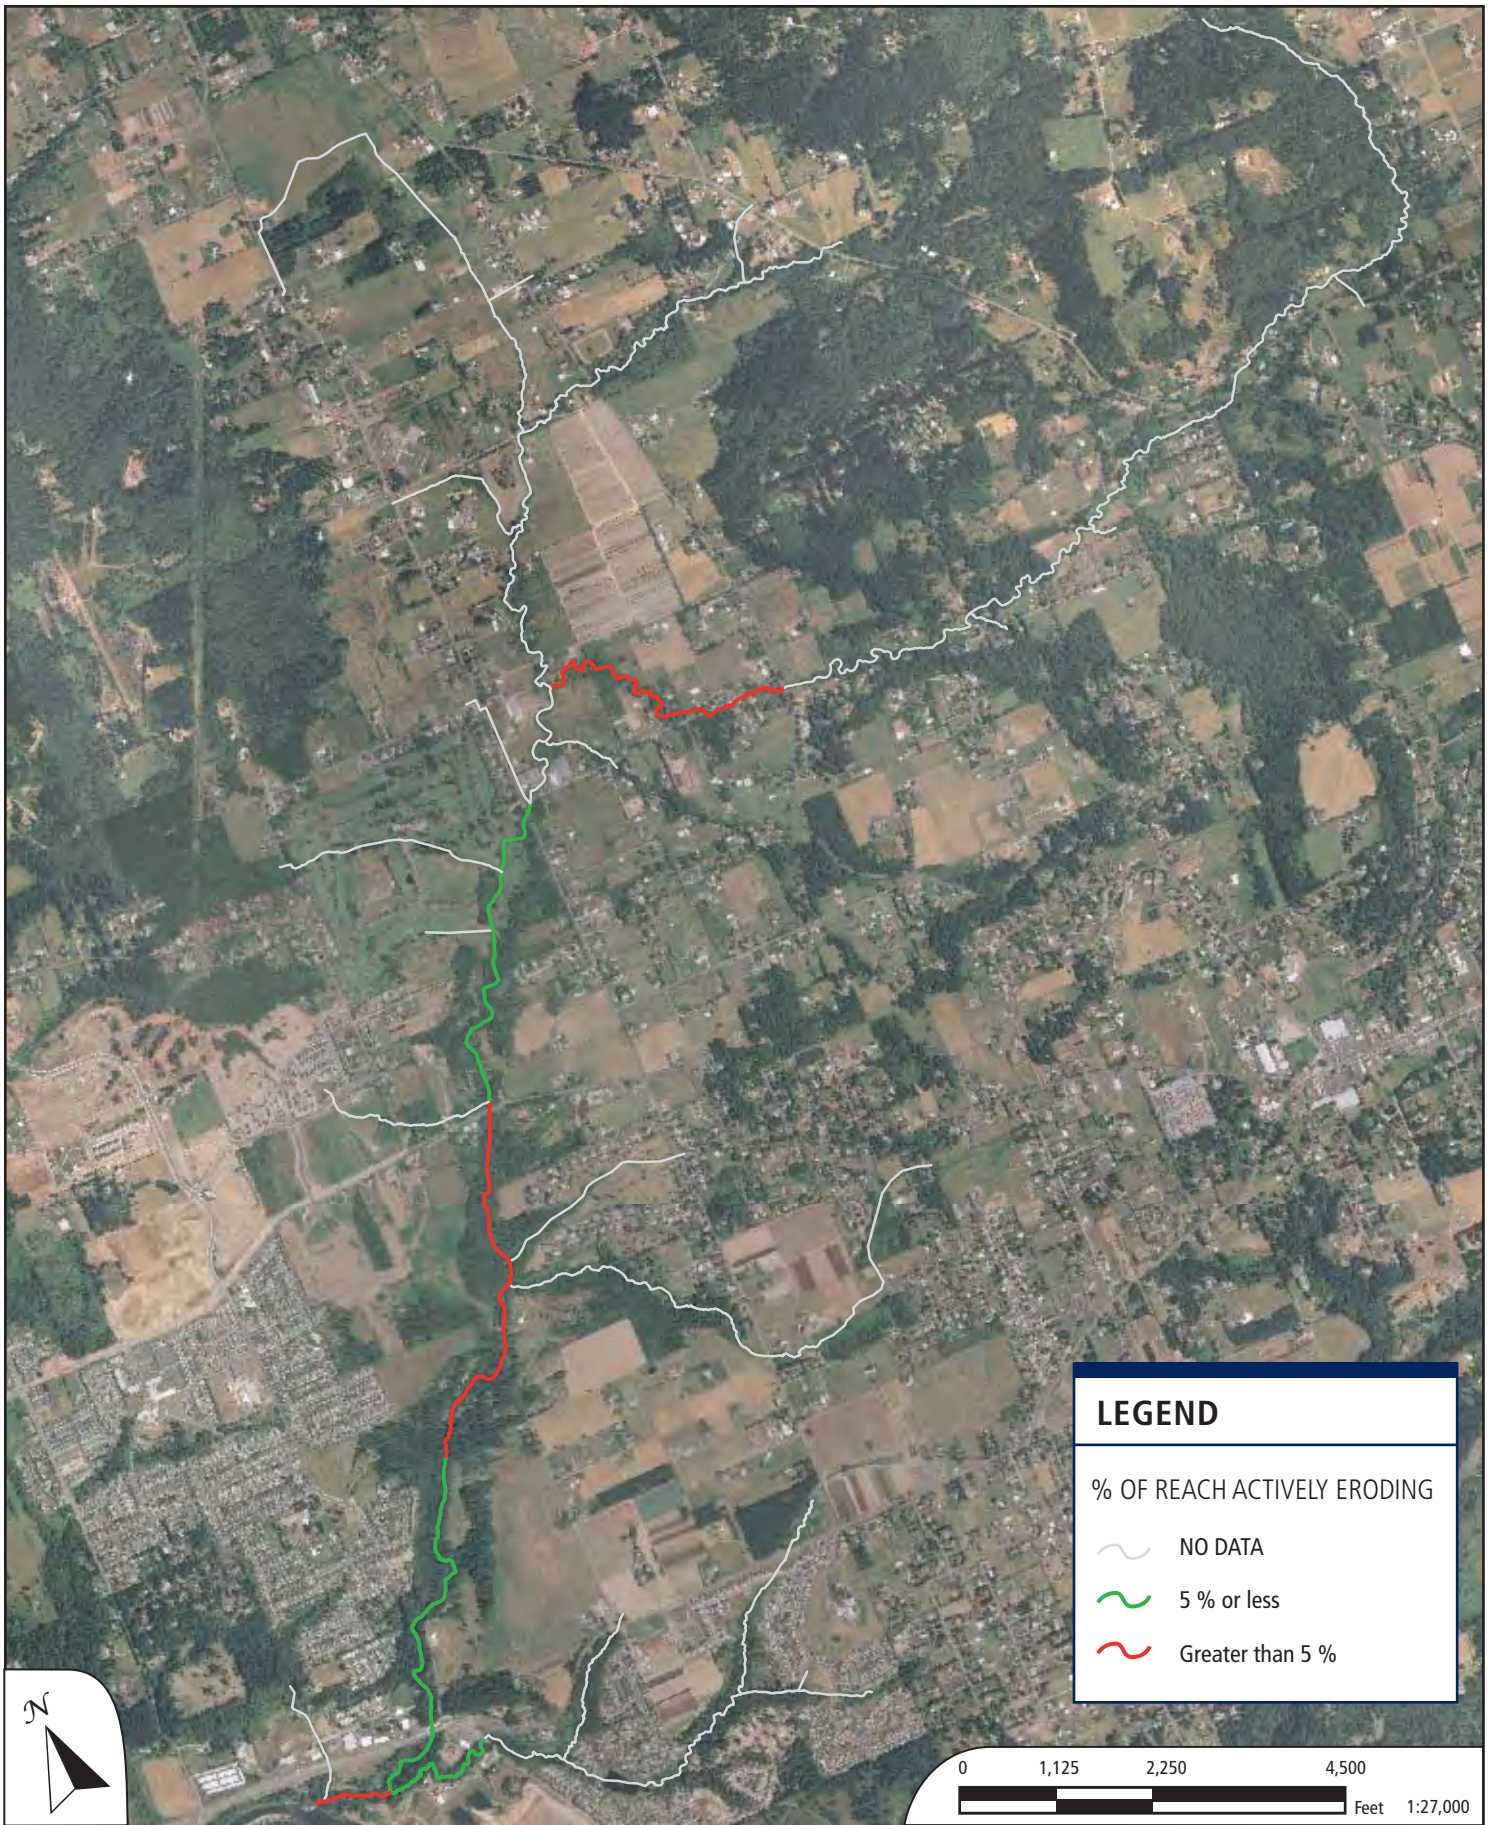
Figure 2-14  
 Rock Creek - At Risk Channels due to Bank Erosion  
 WES WATERSHED ACTION PLAN

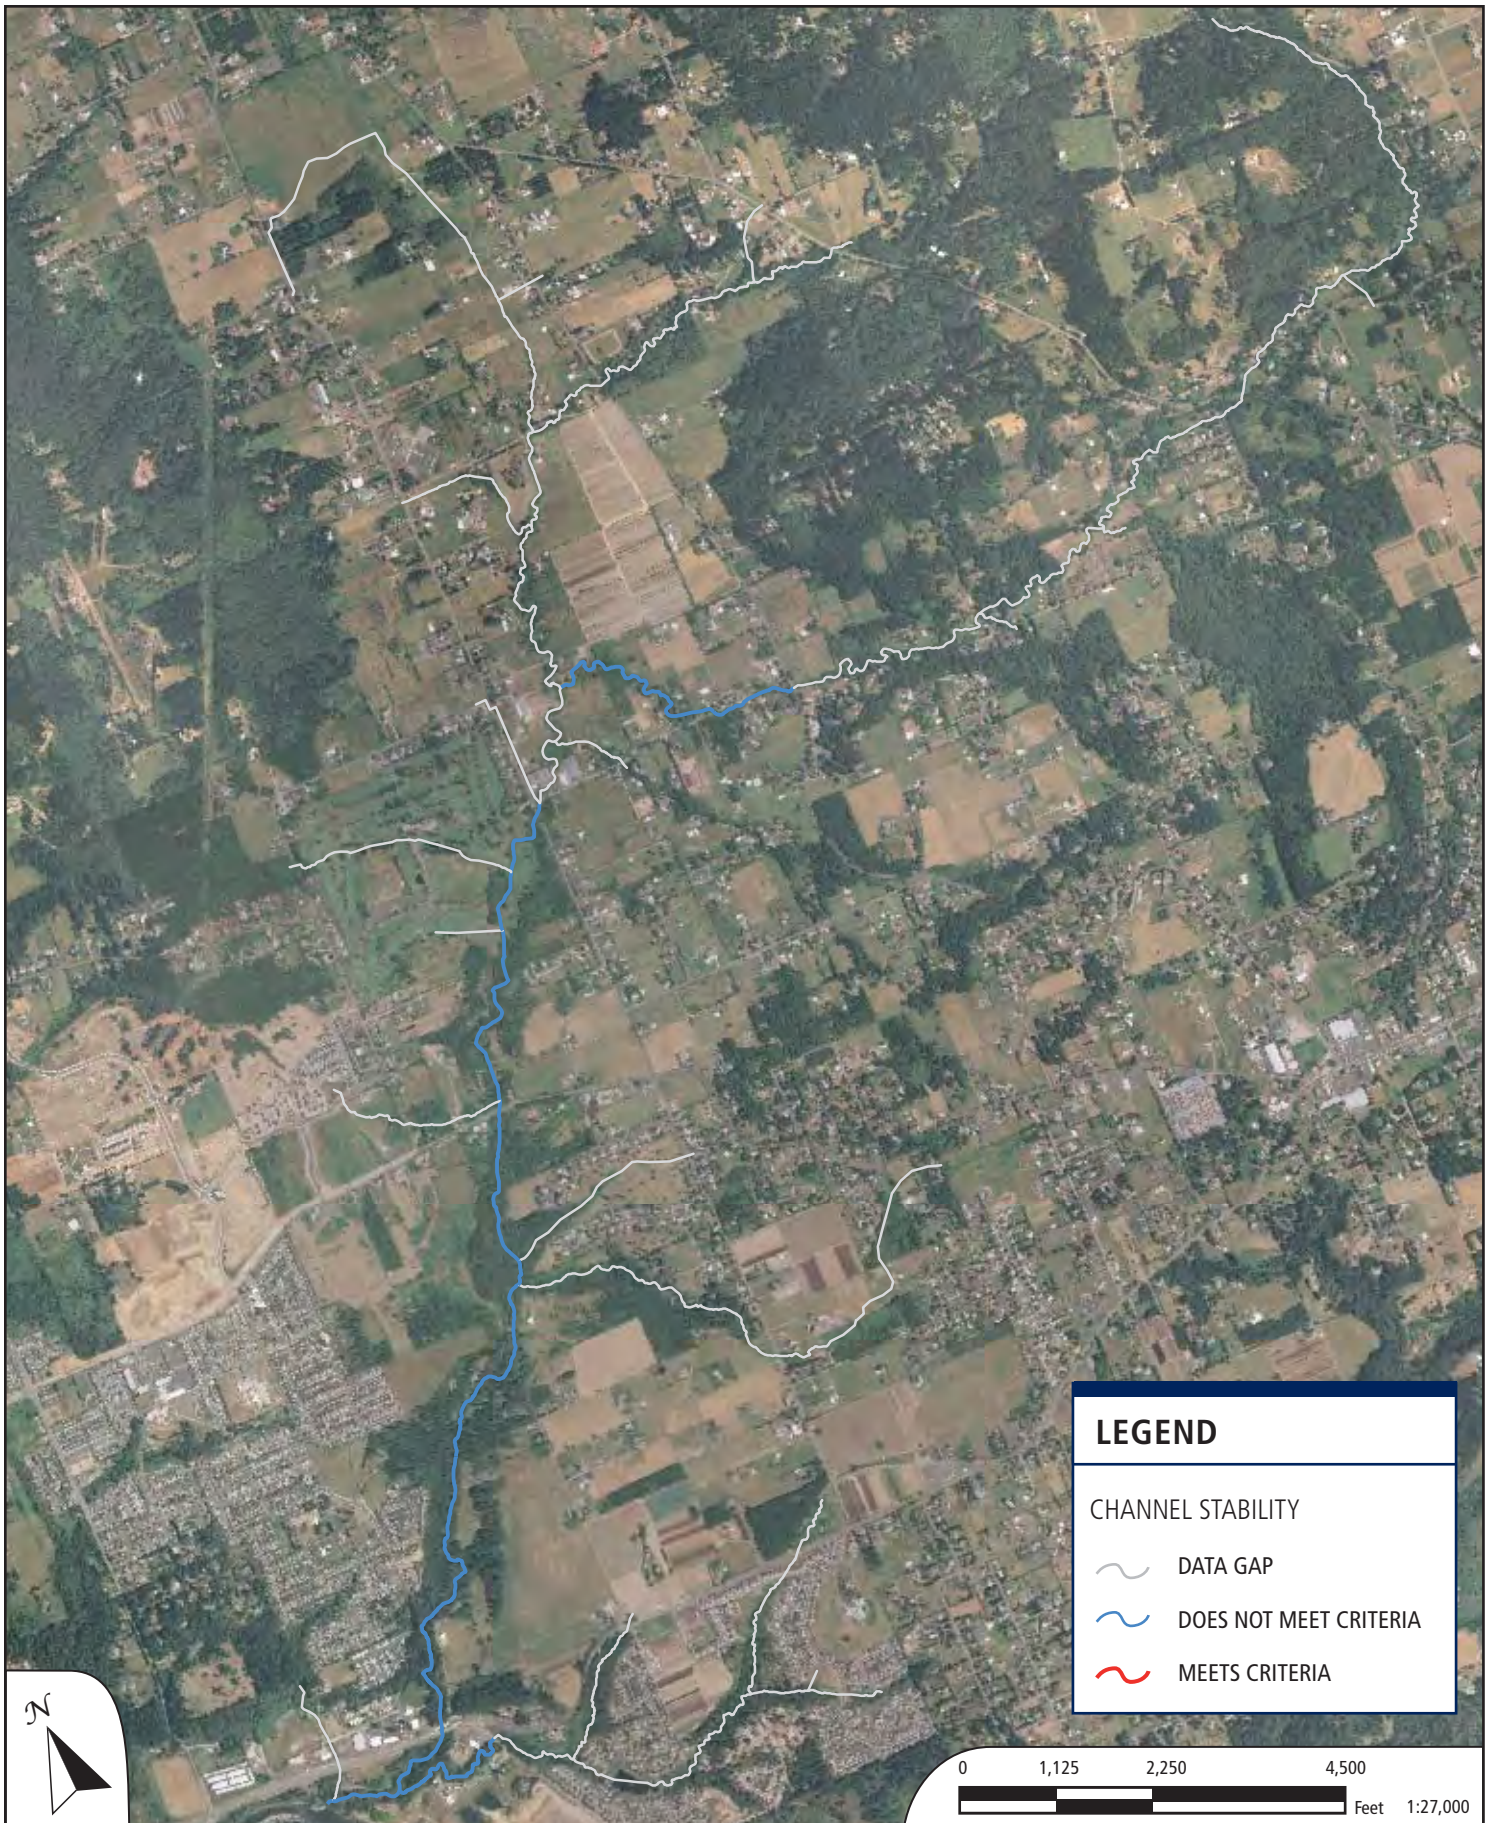
Figure 2-16

At Risk Channels due to Channel Stability  
WES WATERSHED ACTION PLAN

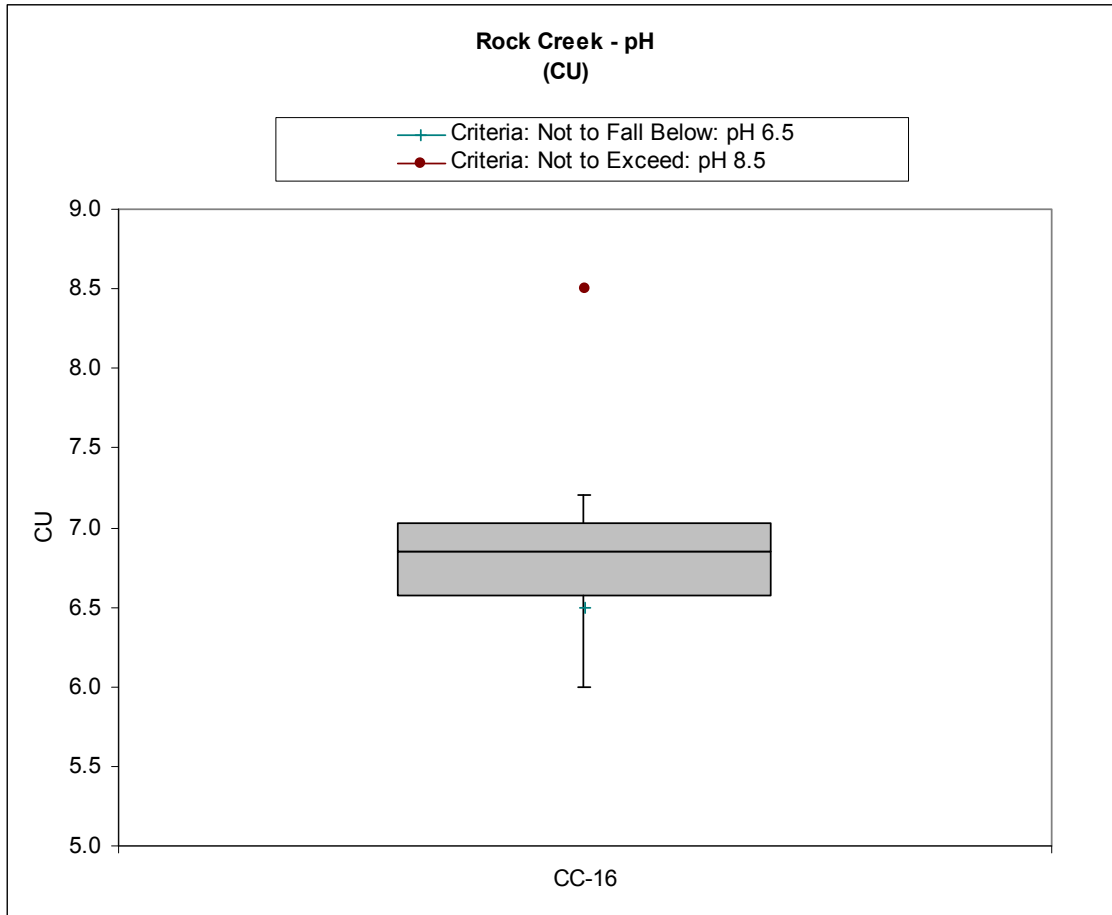
Figure 3-10. pH data for Site CC-16

Table 3-7. Boxplot Data for Rock Creek pH	
	CC-16
Maximum	7.2
Upper quartile	7.0
Median	6.9
Lower quartile	6.6
Minimum	6.0
Count	8
Dates	2007 to 2008
Criterion: not to exceed	8.5
Criterion: not to fall below	6.5

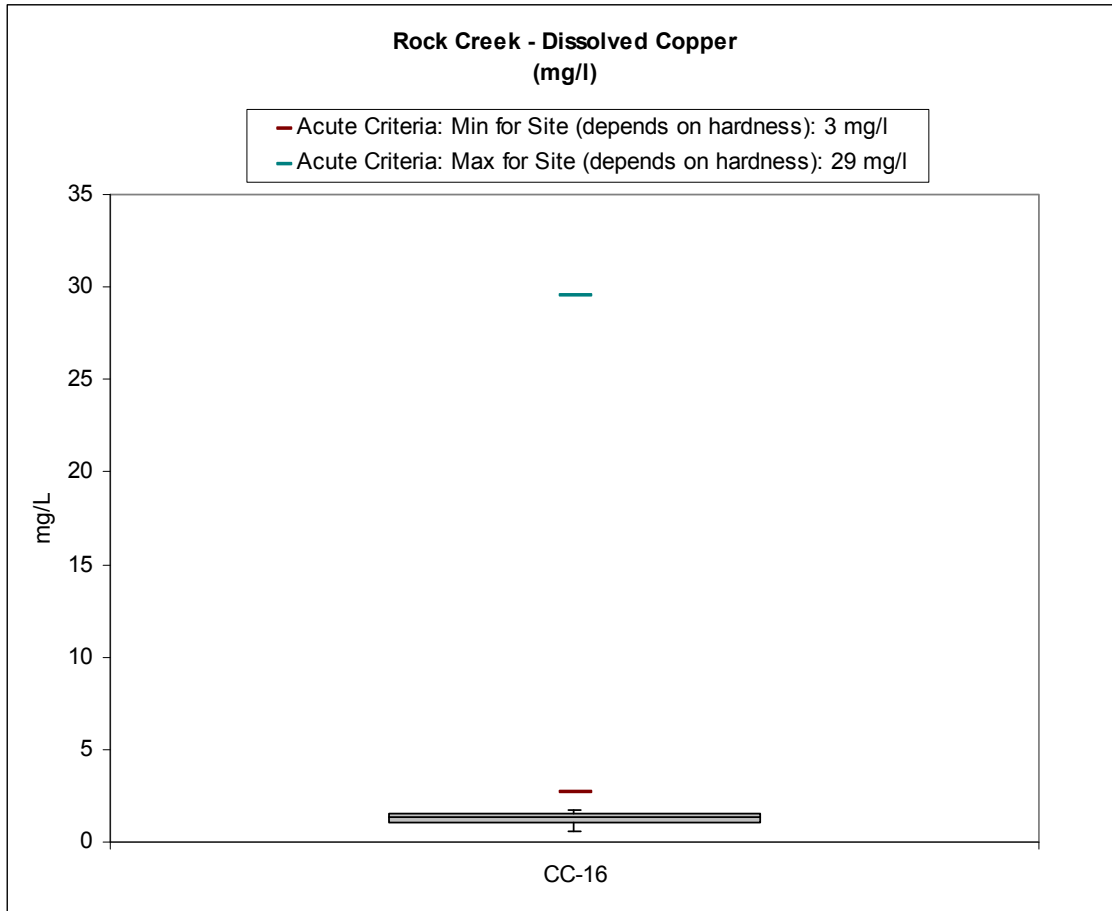
Figure 3-15. Dissolved Copper data at Site CC-16

Table 3-12. Boxplot Data for Rock Creek Dissolved Copper, mg/L	
	CC-16
Maximum	0.6
Upper quartile	1.6
Median	1.3
Lower quartile	1.0
Minimum	0.6
Count	6
Dates	2007 to 2008
Acute criteria: mg/L	DNE <sup>1</sup>
