CLACKAMAS  
WATER  
ENVIRONMENT  
SERVICES

WATERSHED PROTECTION – GEOMORPHIC AND BENTHIC  
MACROINVERTEBRATE MONITORING

# Stream Health in Surface Water Areas Served by WES

Client: Clackamas Water Environment Services  
Date: June 2022

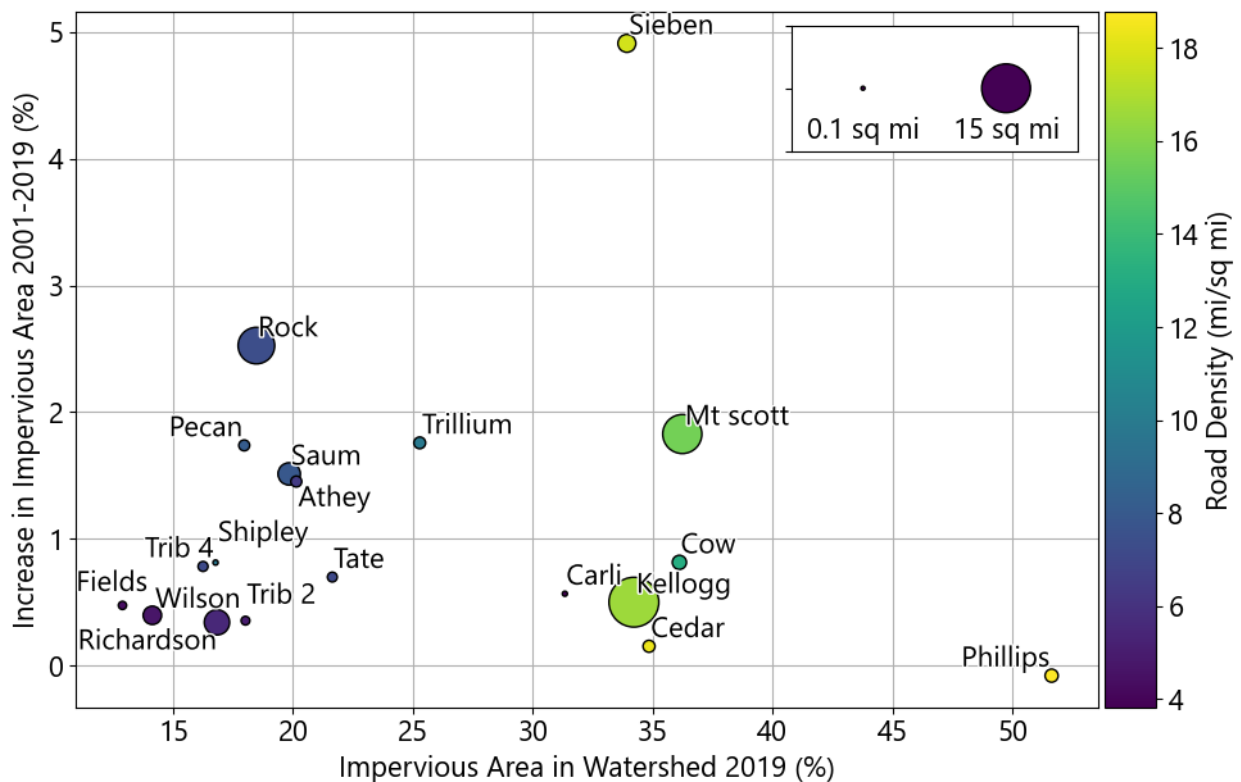
Figure 2: Impervious areas and their changes, and road density in the study watersheds. Marker size corresponds to the size of the watershed and color corresponds to road density within the watershed.

Patterns of imperviousness and road density across the 19 streams of interest reveal varying patterns of total watershed development and more recent pressure. On the basis of total imperviousness, Figure 2 reveals a grouping of watersheds with relatively low imperviousness (i.e., less than about 30% imperviousness), and a second cluster of more developed watersheds (i.e., greater than about 30% imperviousness). The cut-off at 30% imperviousness is a convenient natural break that defines observed clusters in the data. There also appears to be a direct relationship between imperviousness and road density across the watersheds. In general, the west-side watersheds have lower total imperviousness, while the east side streams have higher total imperviousness, except for Rock, Trillium, and Richardson creeks.

The most rapidly developing watersheds from 2001–2019 are Sieben (+5%) and Rock (+2.5%) Creeks. Most watersheds experienced growing impervious area between 0–2% in the same period. The only watershed to lose impervious area is Phillips Creek, where the percent decrease (-0.07%) is minor and potentially within the margin of error in the NCLD source data.

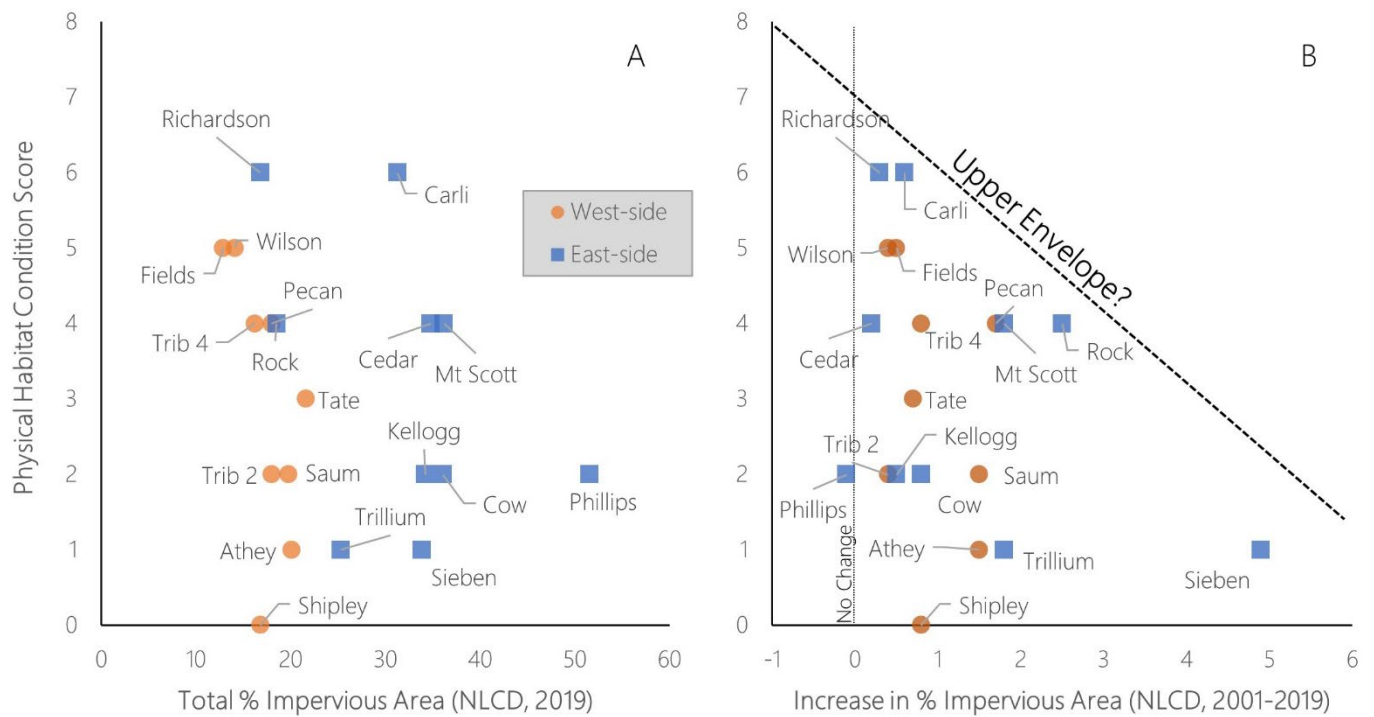
Figure 4: Charts showing the relationship between calculated physical habitat condition scores and watershed development intensity, as measured by total percentage impervious area (A) and change in percentage impervious area from 2001-2019 (B). The potential upper envelope observed in chart B implies that more recent development intensity may be the more important driver of physical habitat health.

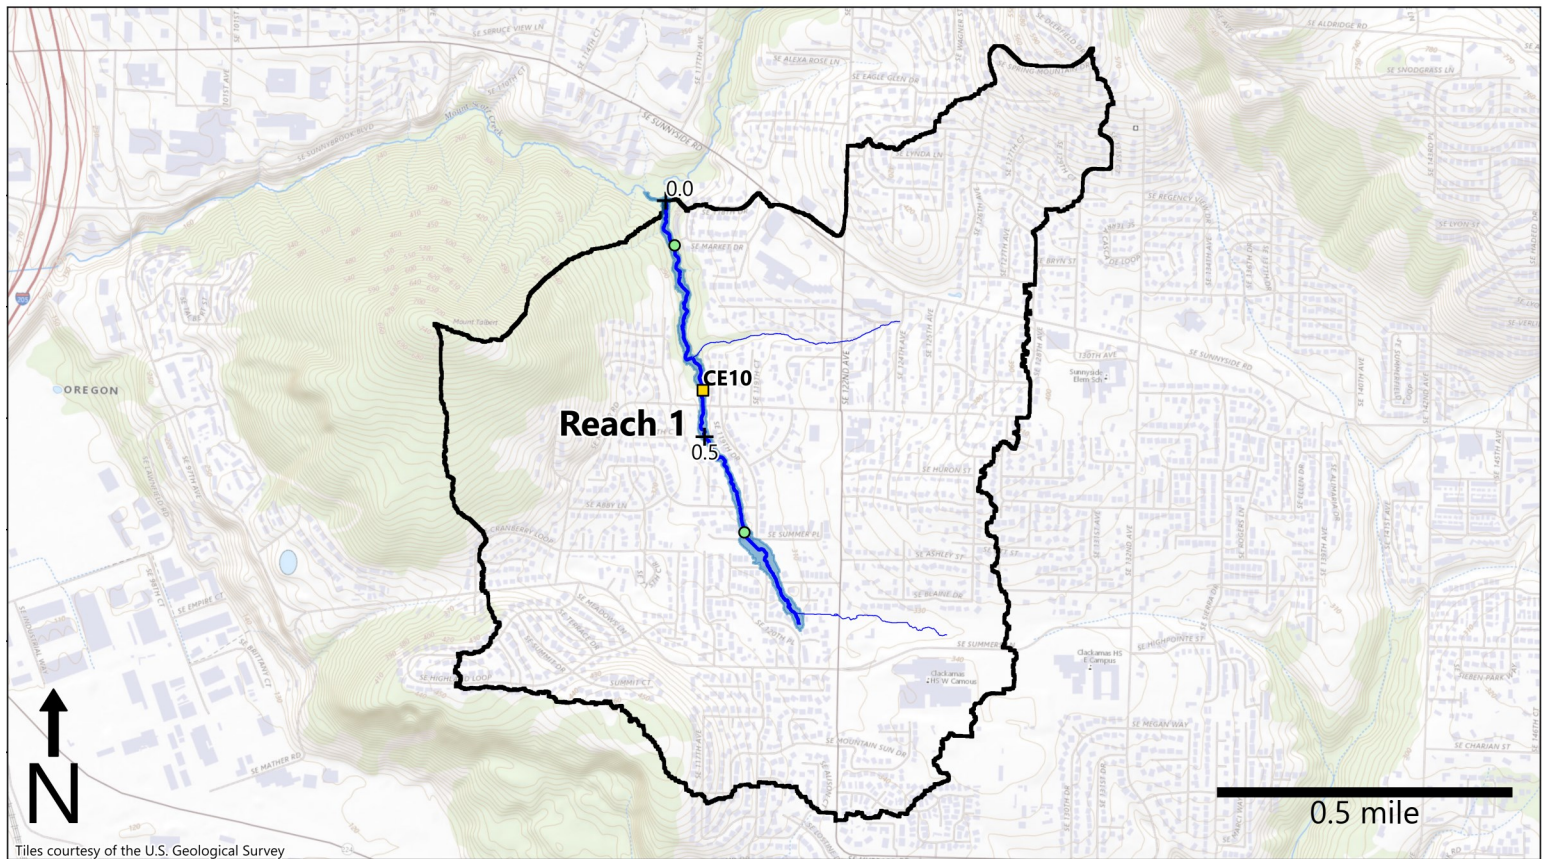
## Context and Overview—Map and Profile

- Watershed Area
- Centerline
- Level 2 (Macros and Geomorph)
- Valley Bottom
- + River Miles
- Level 3 (Rapid Geomorph)
- Tributaries

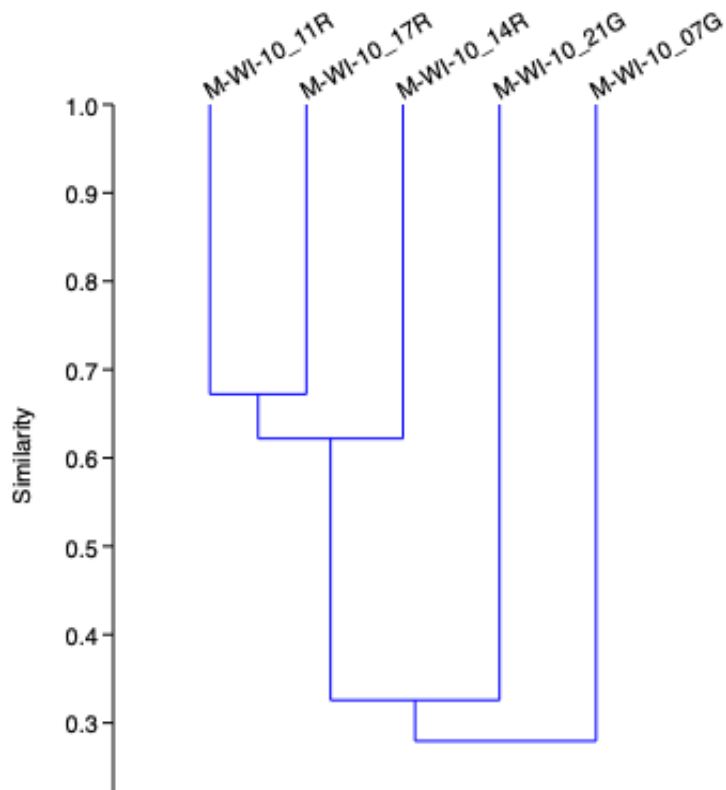
Figure 93. CLUSTER dendrogram of macroinvertebrate community similarity at Wilson Creek. The number and letter at the end of each site label indicate sampling year and whether a riffle (R), glide (G), or pool (P) was sampled.

Despite the differences described above, the dominant taxon in the 2021 sample was a more sensitive type (the caddisfly *Micrasema*), but it occurred at much higher abundance (38%) than the top taxon in the prior sampling year (*Sweltsa* stonefly; 13% of total abundance), indicating a less balanced, more disturbed community (Figure 92). The 2021 community differed more from communities in other years except for 2007, which was an outlier (Figure 93). These differences are influenced in part by the fact that both the 2007 and 2021 samples were taken in glides while other years sampled riffle habitat, but the depauperate nature of the sample in 2021 makes larger differences in overall community composition expected. This reach had very low flow despite being sampled within a week of a rain event, and so it remains to be seen whether the 2021 habitat conditions and altered community are a weather-related anomaly or the result of some greater hydrologic disturbance.
