# Geomorphic and Macroinvertebrate Monitoring Kellogg-Mt Scott Creek

Gail Shaloum & Chris Desiderati

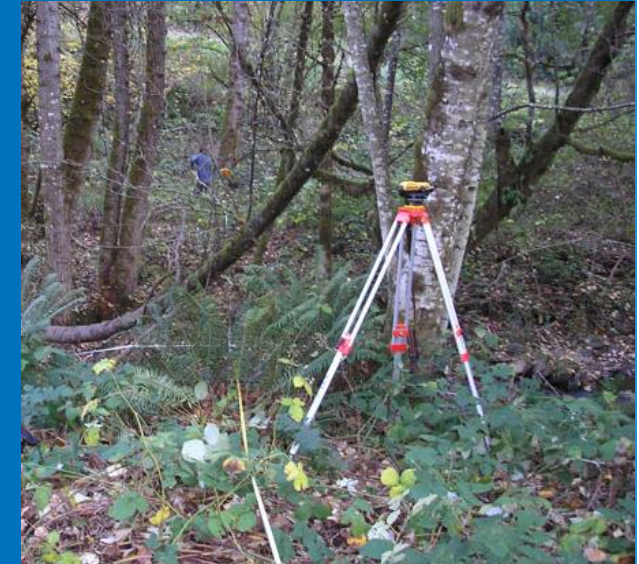
# METHODS: Geomorphology

## Level 1: 6 sites

- Detailed status and trends sites
- Detailed cross-sections
- Locations coincide with previous geomorphic monitoring stations

## Level 2: 23 sites

- Moderate-detail level
- Locations coincide with macroinvertebrate monitoring stations

## Level 3: approx. 80 sites

- Distributed (rapid) geomorphic characterization
- Gain a broad geographic understanding of stream conditions

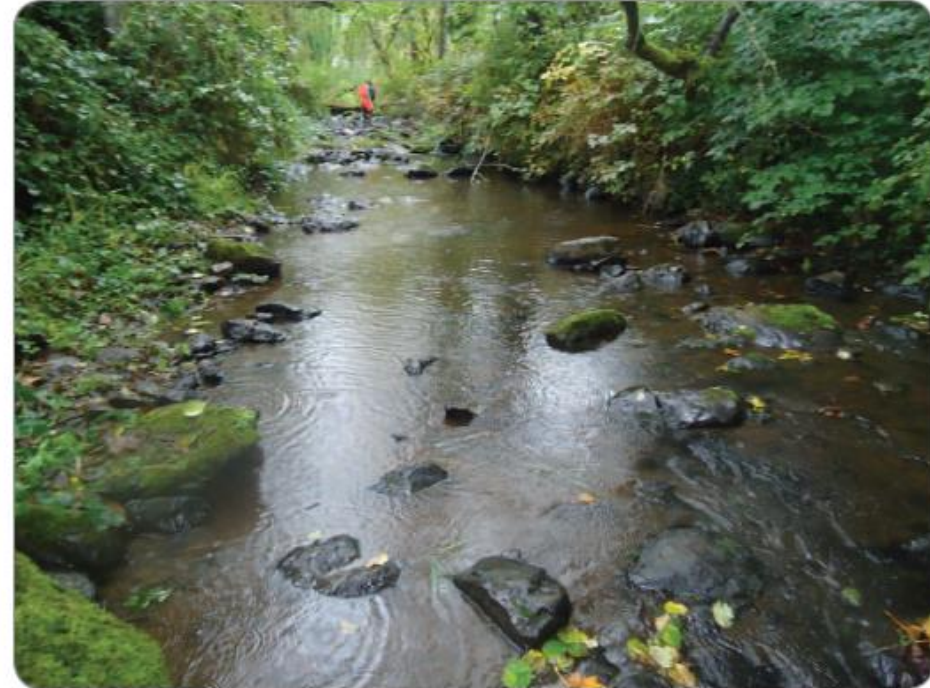
# Findings Geomorphology

## Entrenchment

- Mixed throughout study area
- MSC streams-high incision potential

## Stream complexity

- Almost all low to moderate, reaches of Mt Scott & Carli Creeks are high

## Floodplain connectivity

- Most low to moderate, none high in MSC watershed

## Riparian condition

- Generally low to moderate, partly due to hi invasive cover
- Canopy cover stable to increasing

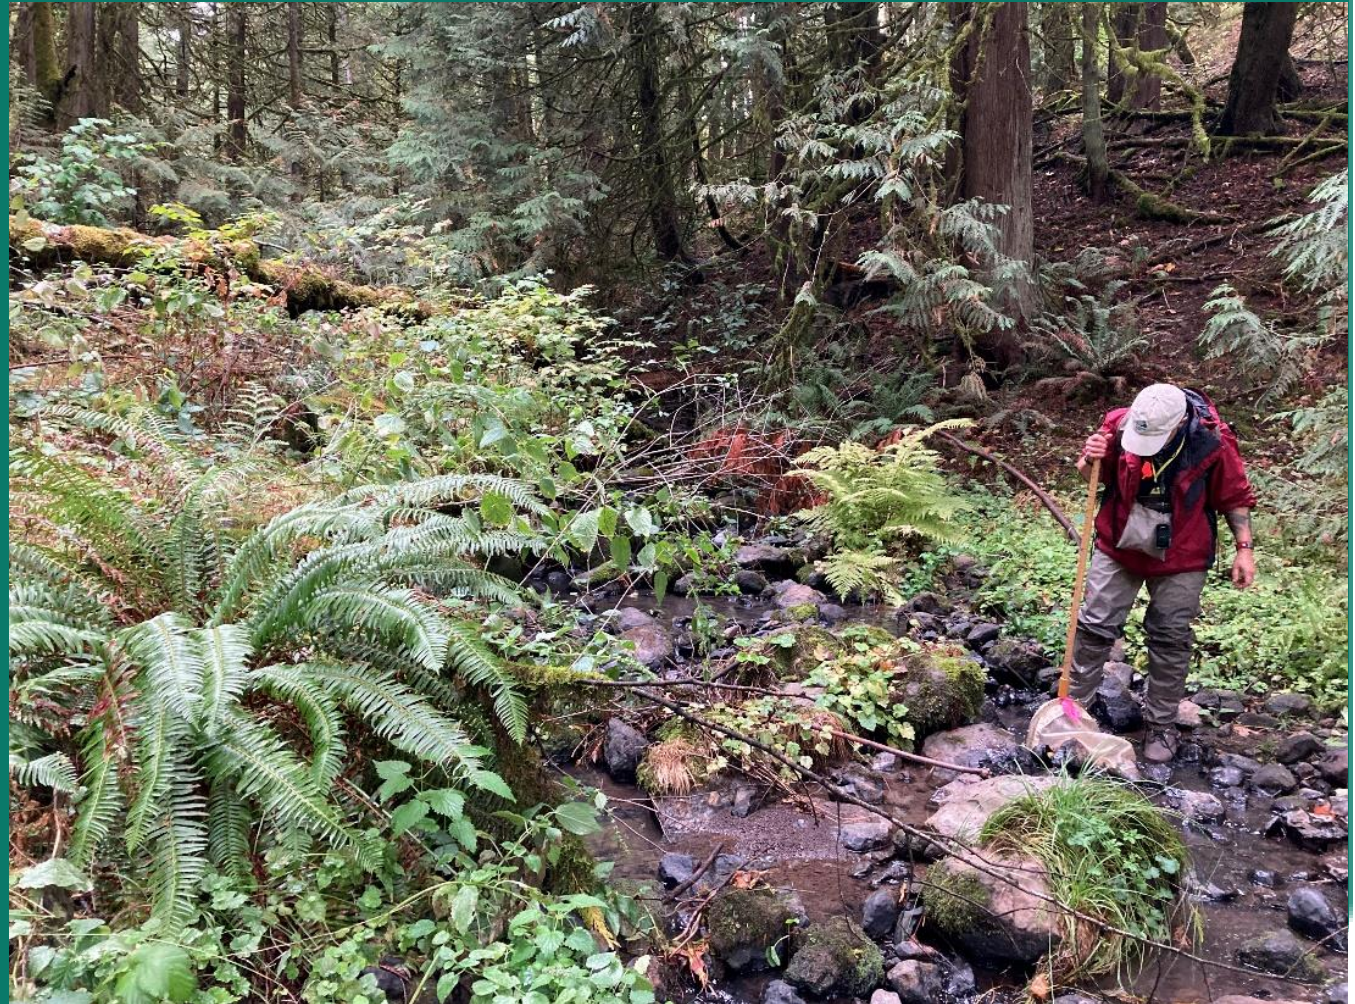
# METHODS: Macroinvertebrates

## Macroinvertebrate collection

- Field sampling
- Sample sorting and i.d.
- DEQ protocols for samples collected in riffles only
