South End Road Landslide Repairs

Stabilizing slope to prevent future slide activity
Canemah Neighborhood Association

April 15, 2021

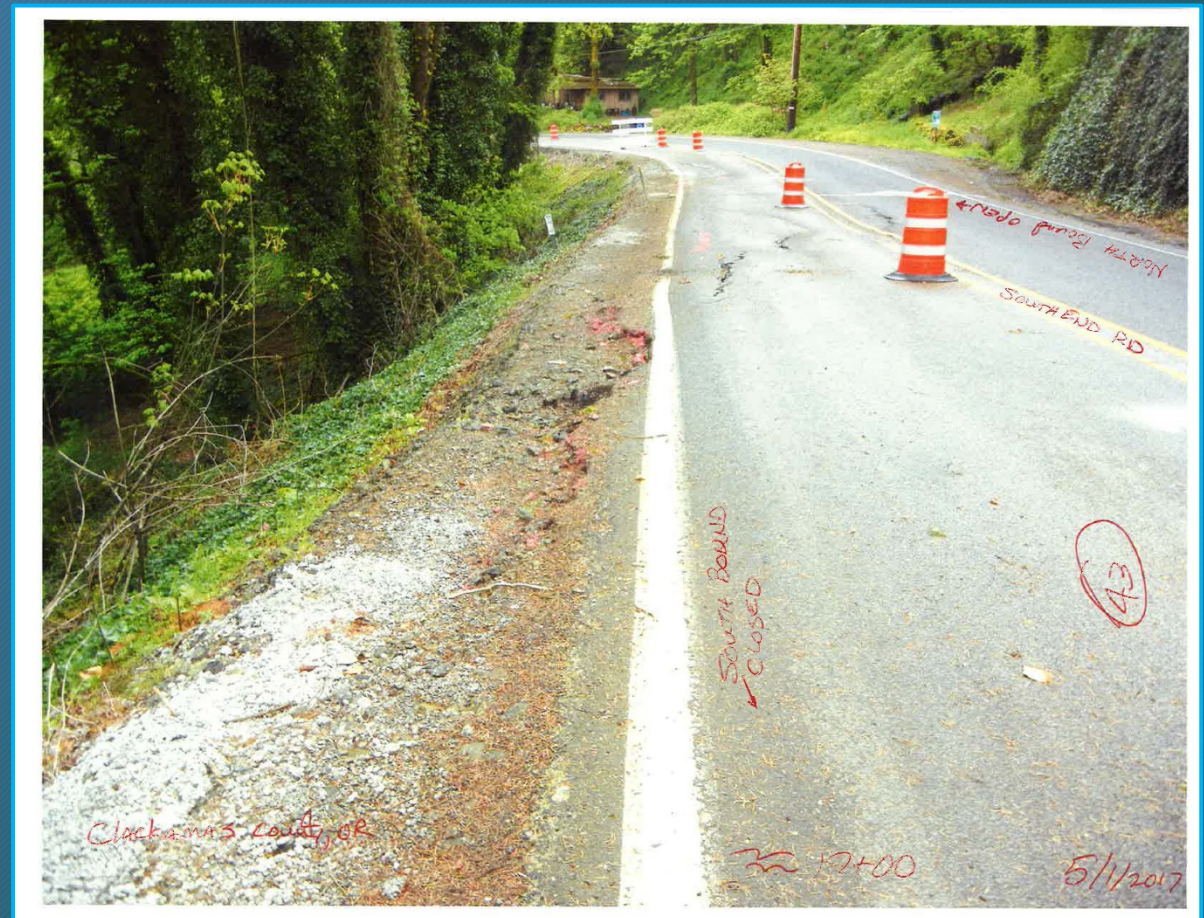
Damage from heavy rains in Spring 2017

- Temporary repairs in summer 2017
- Geotechnical exploration and landslide monitoring over the last couple of winters to identify solutions to stabilize slope

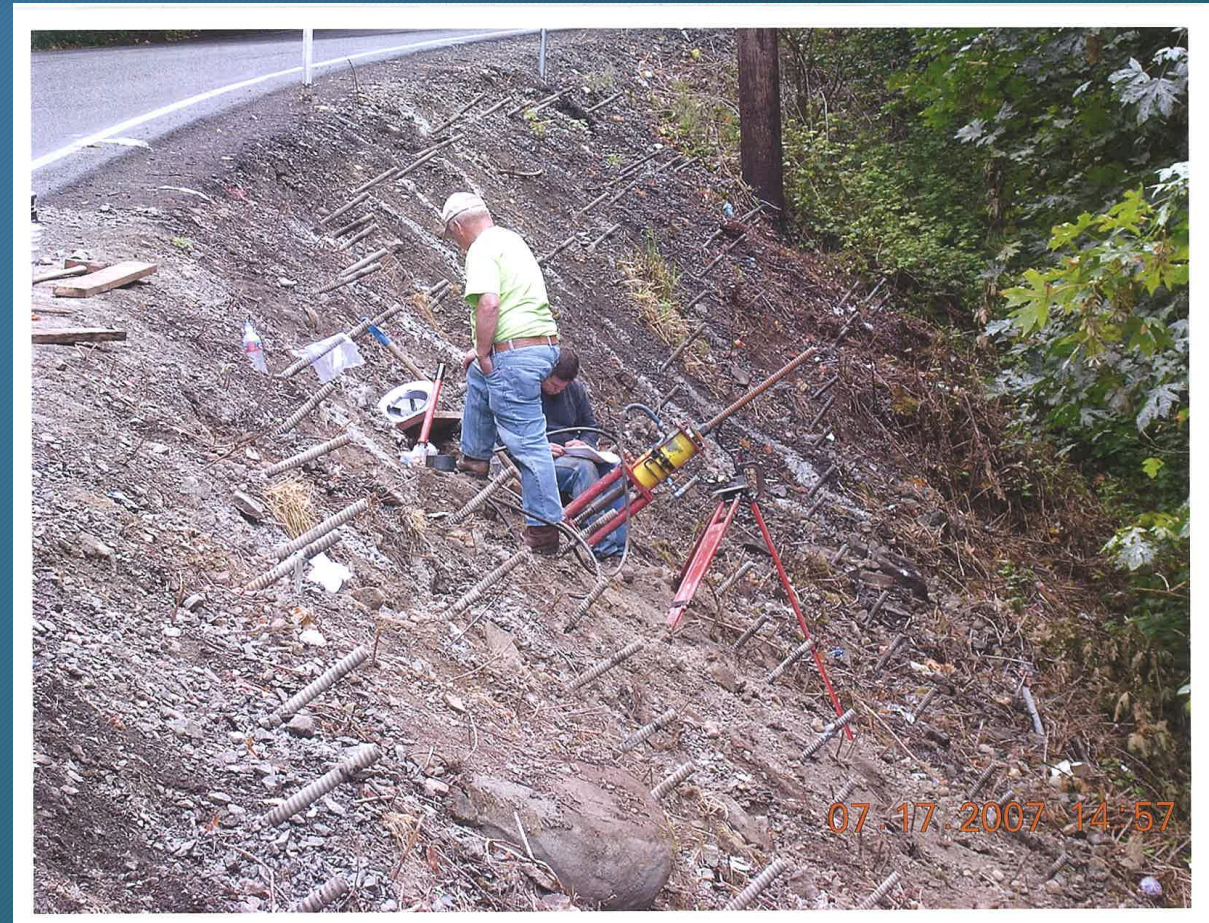
- Build two retaining walls to prevent future slide activity on the embankment along the north side of South End Road
- North project limits will extend to soil nail embankment stabilization project performed in 2007 (shown in photo).
