REQUEST FOR QUOTES (RFQ) #2017-31

Project Name:	Mt. Scott Creek – Oak Bluff Reach Water Resource Engineering Services		
Quote Due Date/Time:	May 17, 2017, 2:00 PM		
Project Coordinator	Gail Shaloum	Phone:	503-742-4597
		Email:	
Contract Analyst:	Ryan Rice	Phone:	503-742-5446
		Email:	rrice@clackamas.us

Mt Scott Creek . 211369.04
Mt. Scott Creek Oak Bluff Reach
Regional Overview
Clackamas County, Oregon

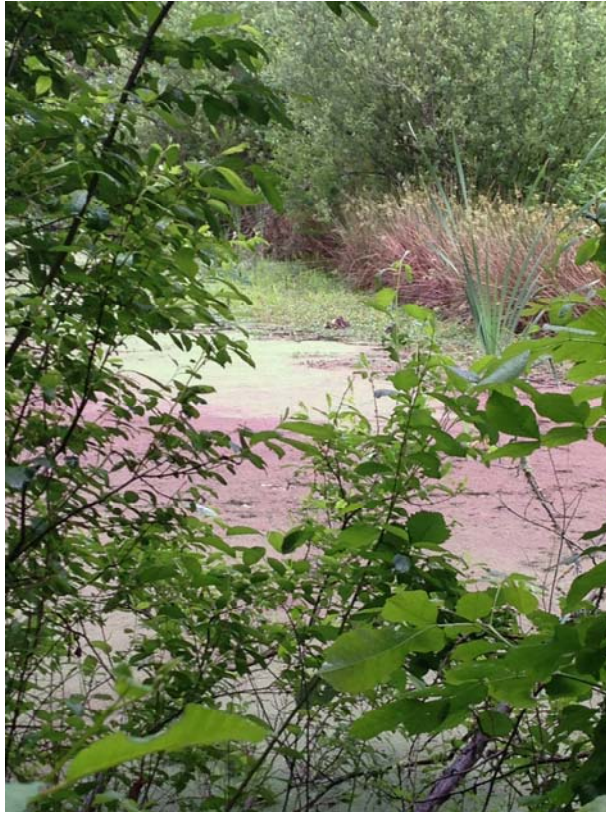
Photo 1: Wetland 1 looking northwest. 6/2/2015

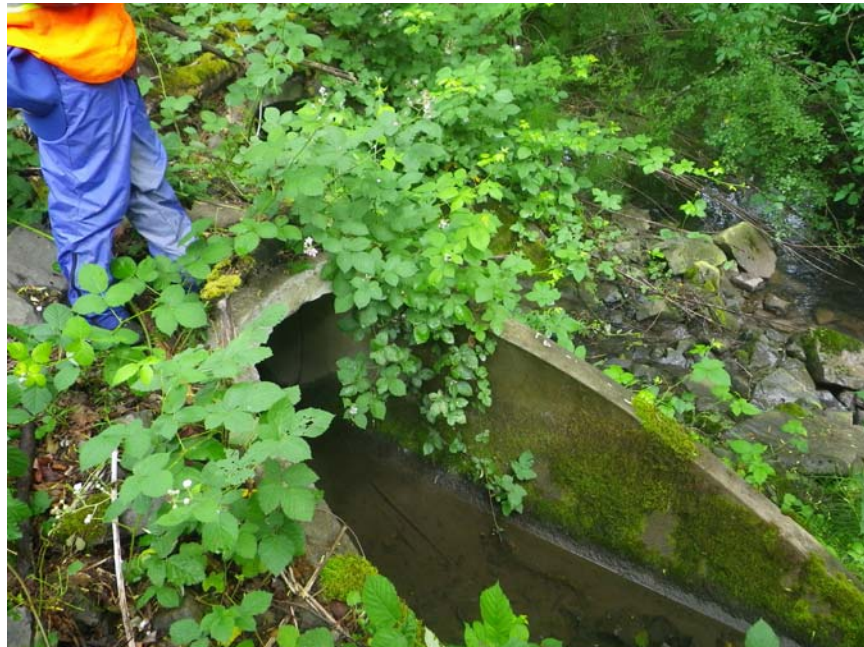
Photo 2: Outlet of Tributary 1 into Mt. Scott Creek (southwest of Wetland 1). This photo shows one of two side-by-side culvert outlets. 6/2/2015

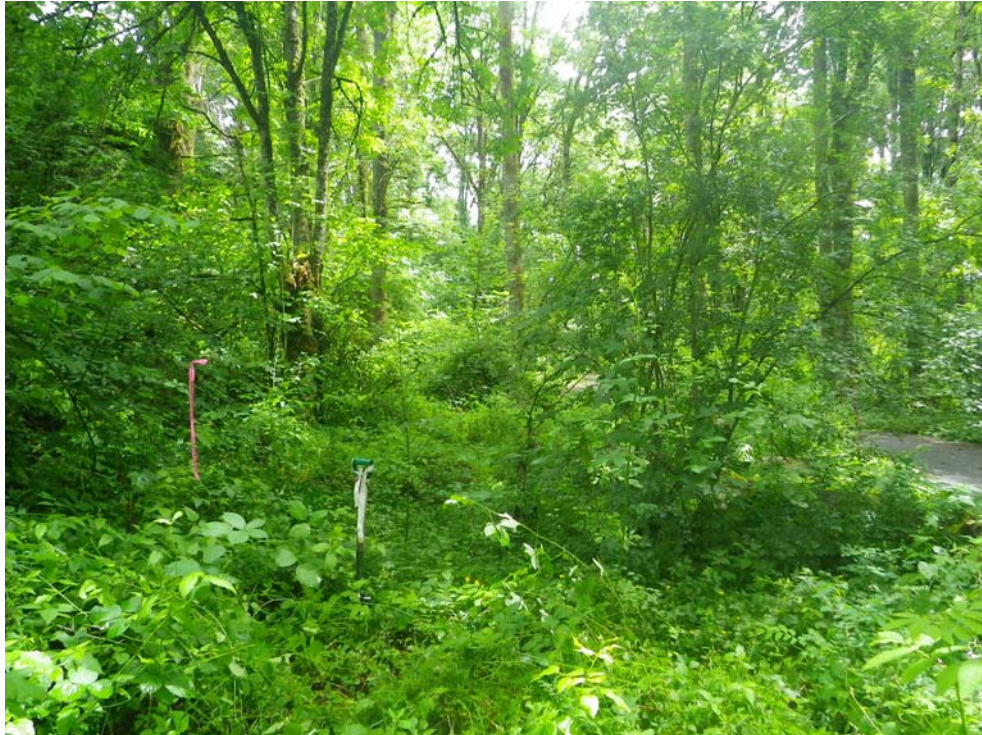
Photo 3: Wetland 2 facing southeast. This northern section of Wetland 2 is north of a paved multi-use, seen at the far right hand side of the photo. 6/3/2015

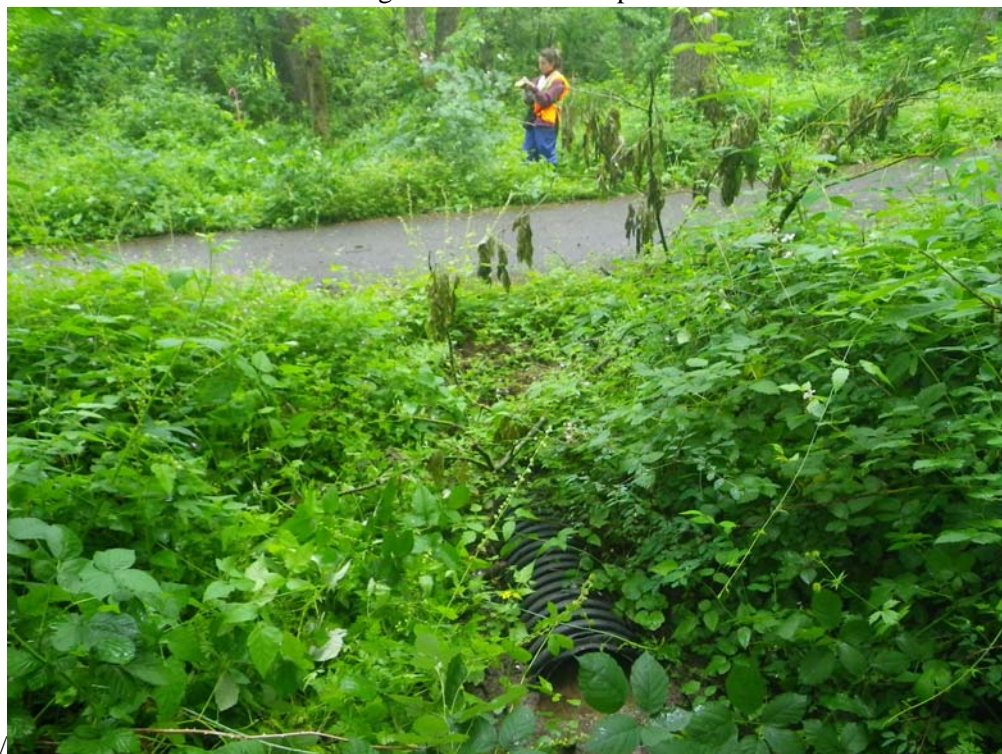
Photo 4: Wetland 2 facing north. A paved multi-use trail divides Wetland 2. Culvert outlet is seen in bottom of photo. 6/3/2015

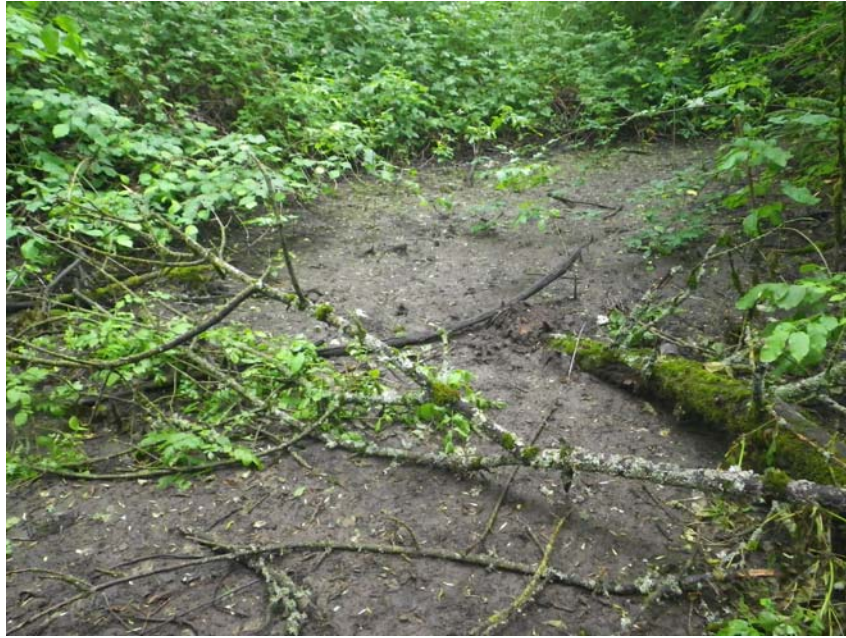
Photo 5: Depressional forested floodplain of Wetland 3. Herbaceous layer vegetation is sparse to none. Surface soil cracks are common. 6/3/2015

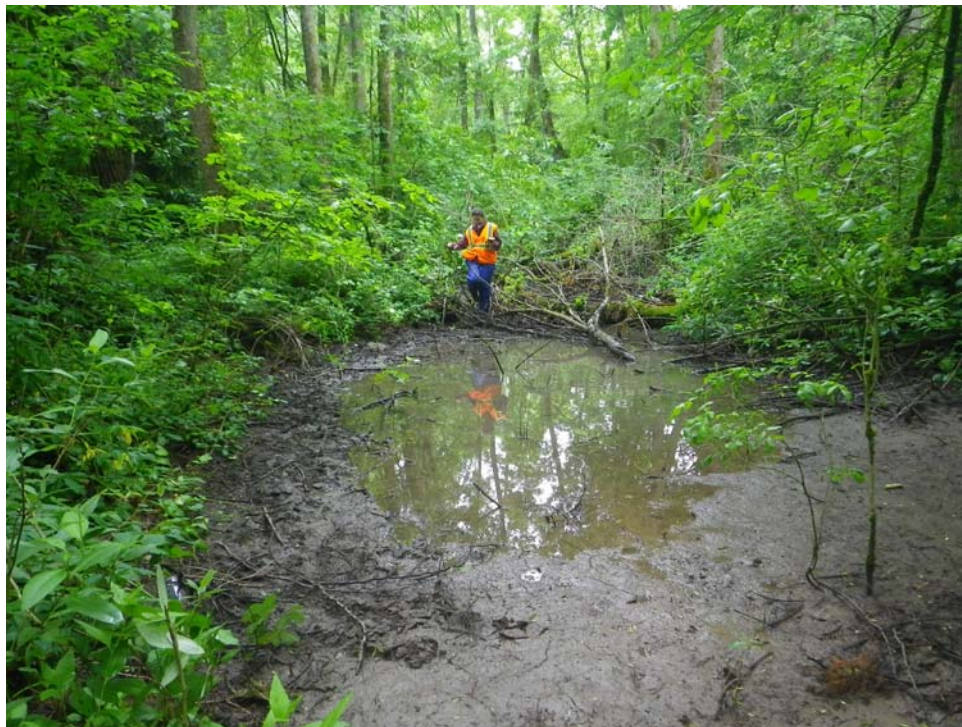
Photo 6: Depressional forested floodplain of Wetland 3. Herbaceous layer vegetation is scarce to none. Ponding and surface soil cracks are common. 6/3/2015

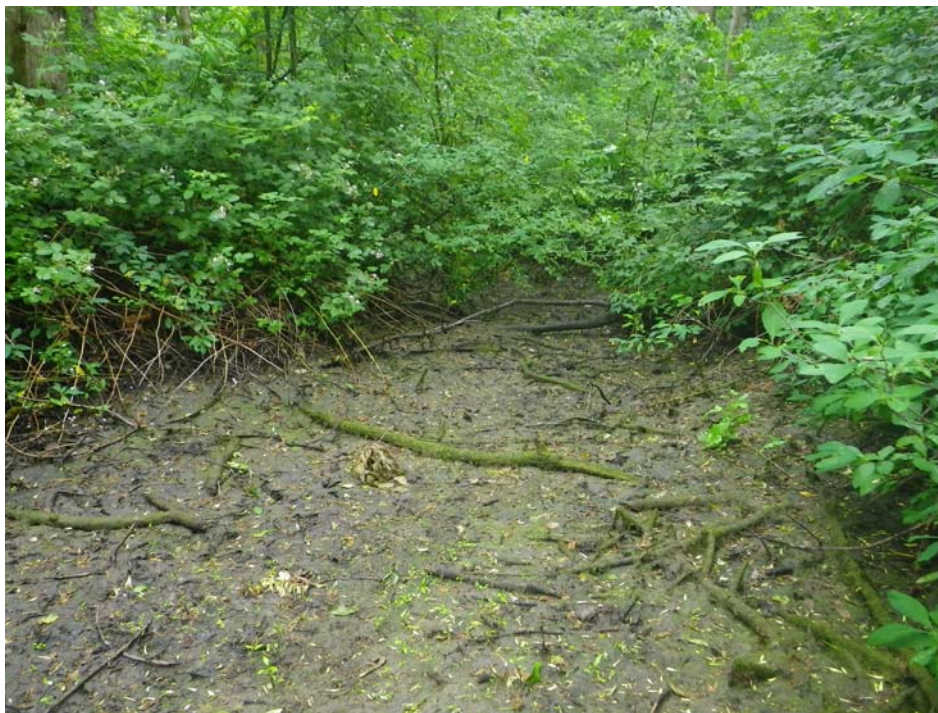
Photo 7: Depressional forested floodplain of Wetland 4. Herbaceous layer vegetation is scarce to none. Ponding and surface soil cracks are common. 6/3/2015

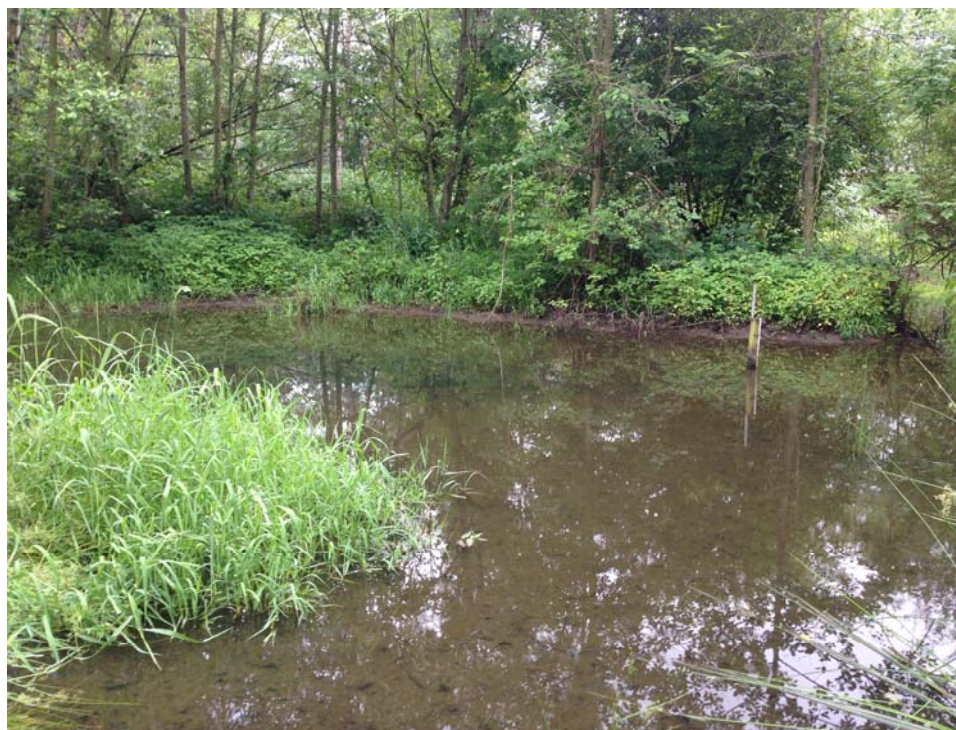
Photo 8: Wetland 5 with a reed canarygrass (*Phalaris arundinacea*) and soft rush (*Juncus effusus*) lined pond (looking north toward SE 84th Ave/Oak Bluff Boulevard). Outlet drains south into Mt. Scott Creek. 6/2/2015

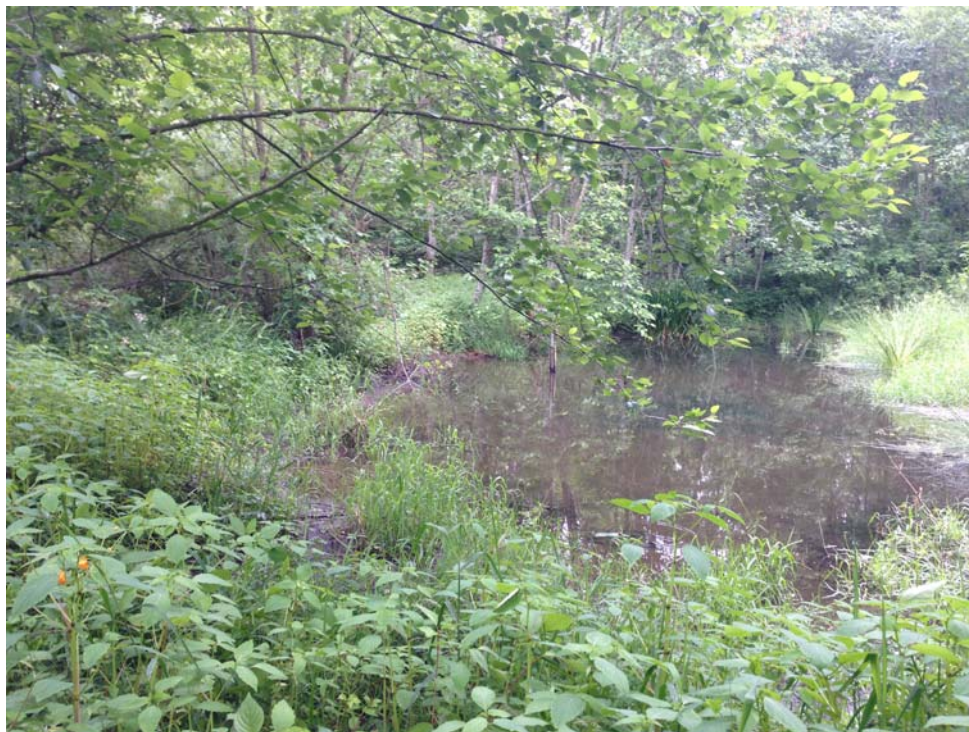
Photo 9: Wetland 5 with touch-me-not (*Impatiens noli-tangere*), red alder (*Alnus rubra*), and reed canarygrass in the foreground. Pond is surrounded by red alder. 6/2/2015

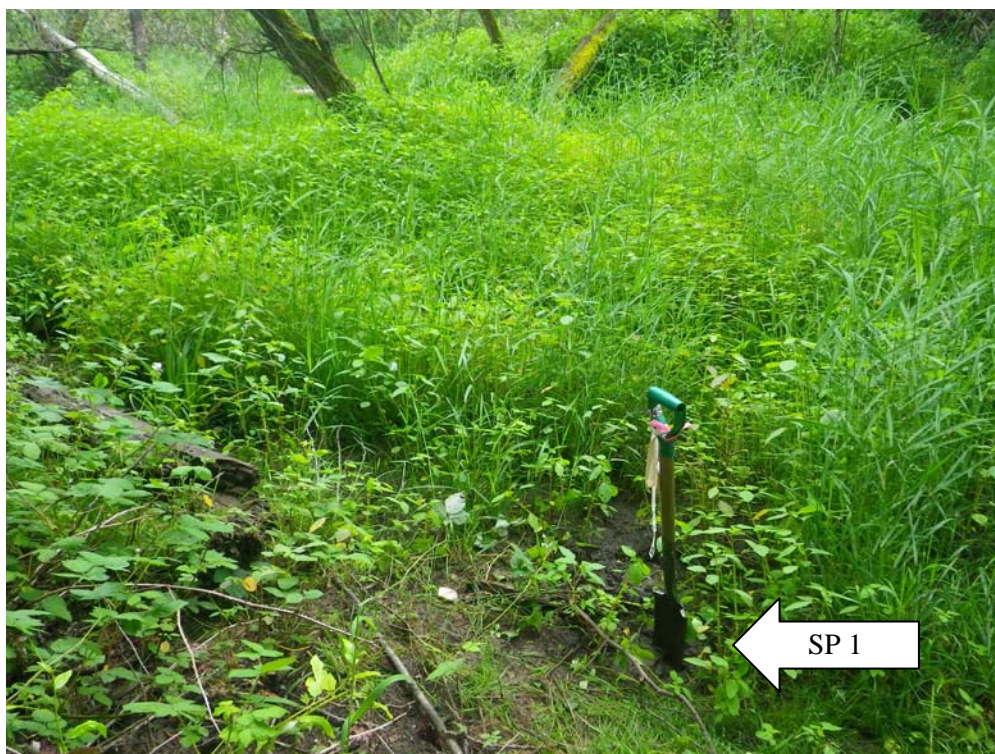
Photo 10: Wetland 6. Shovel denotes location of SP 1. Dominant vegetation in Wetland 6 includes reed canarygrass, western touch-me-not, and red alder. 6/2/2015

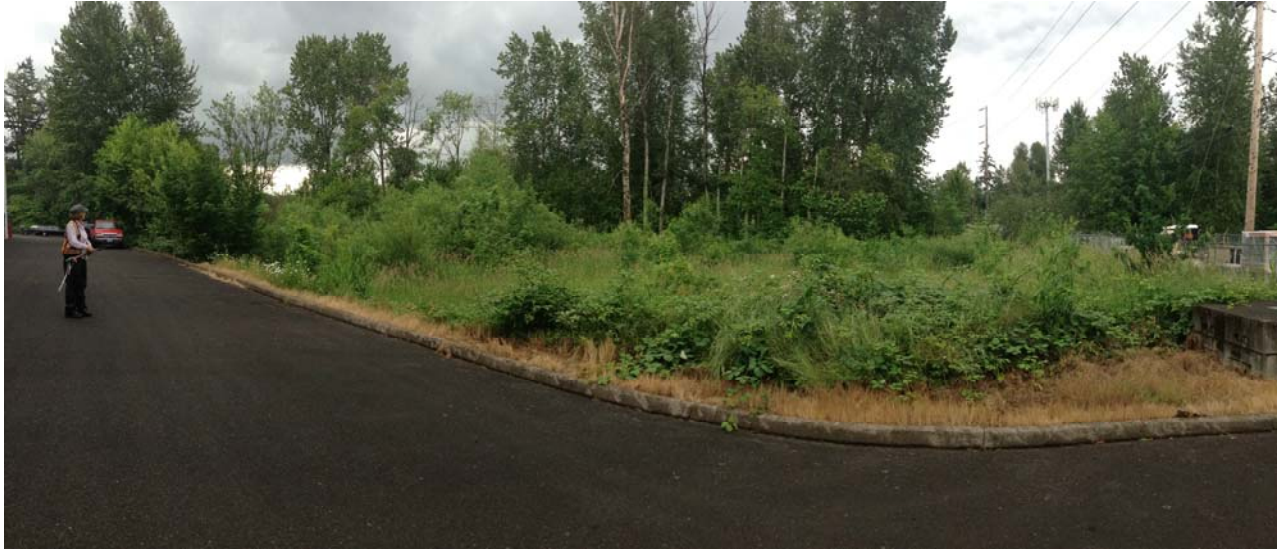
Photo 11: Asphalt access road to SE Jasmine Lane, looking south toward top of berm of Wetland 7.
6/3/2015

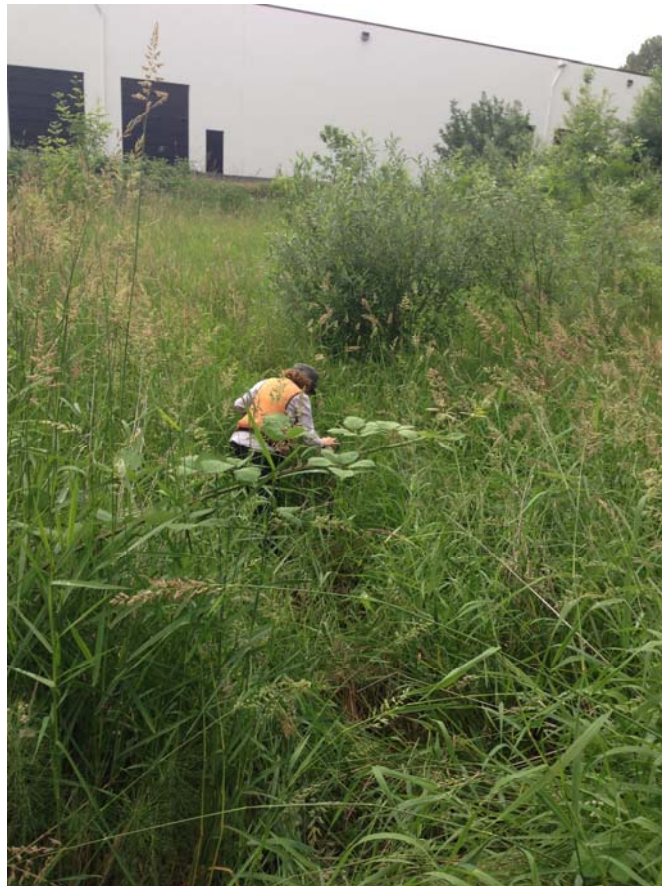
Photo 12: Wetland 7 looking north, standing on top of berm looking down into wetland basin. 6/3/2015
ESA Vigil-Agrimis

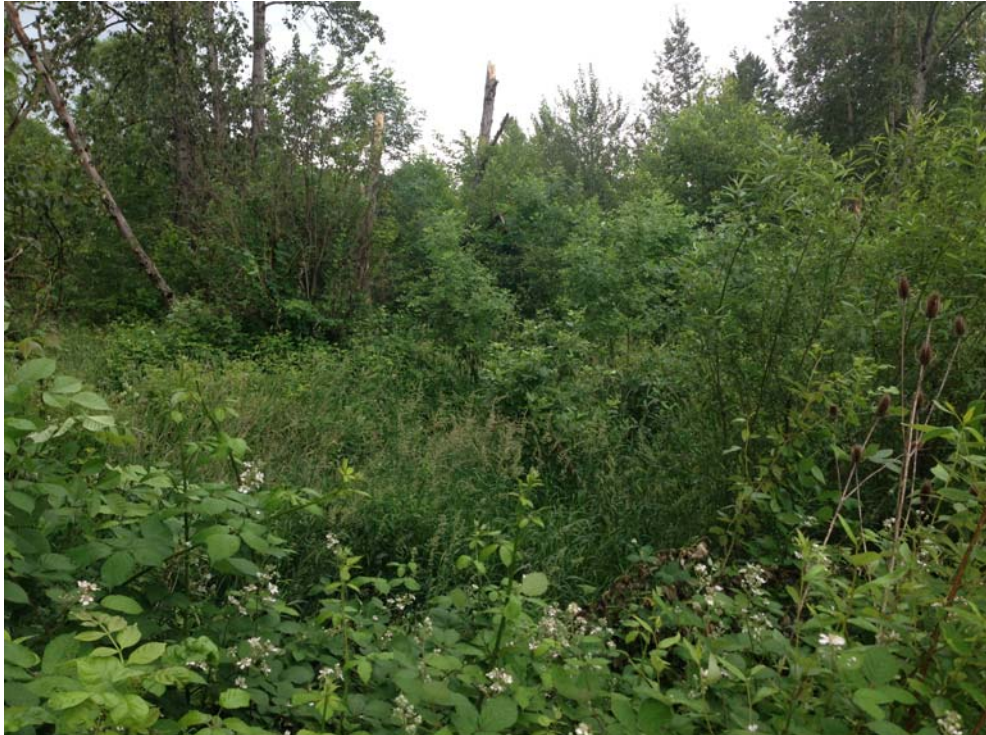
Photo 13: Wetland 7 looking south into upland area. 6/3/2015

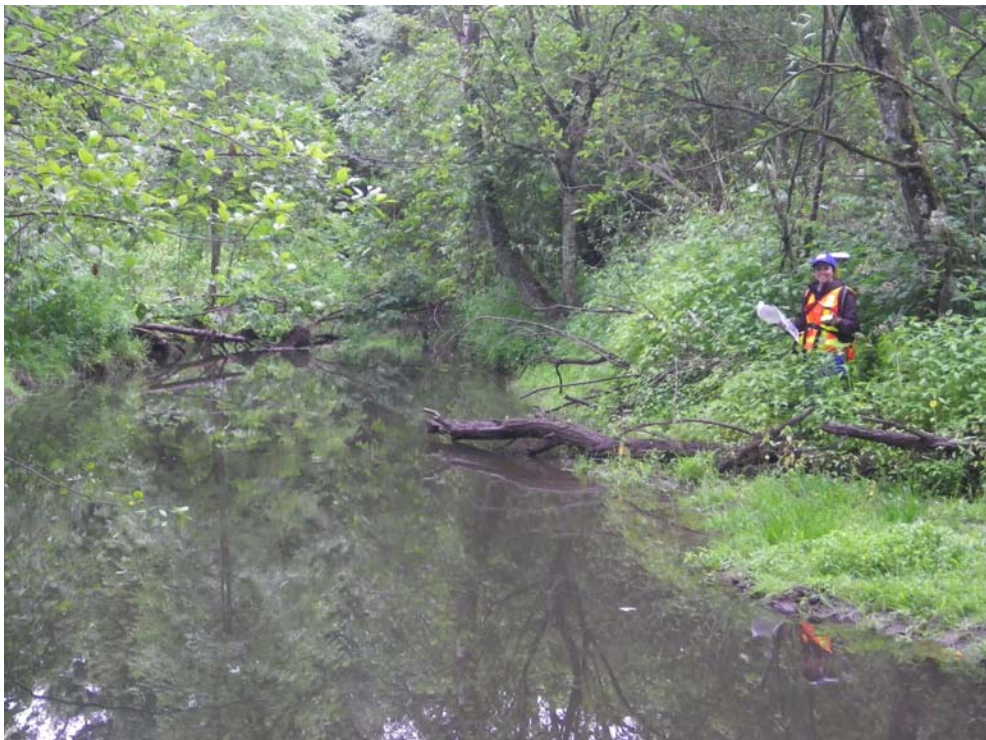
Photo 14: Downstream view of Mt. Scott Creek. Top and bottom of bank differ significantly in vegetative community. 6/2/2015

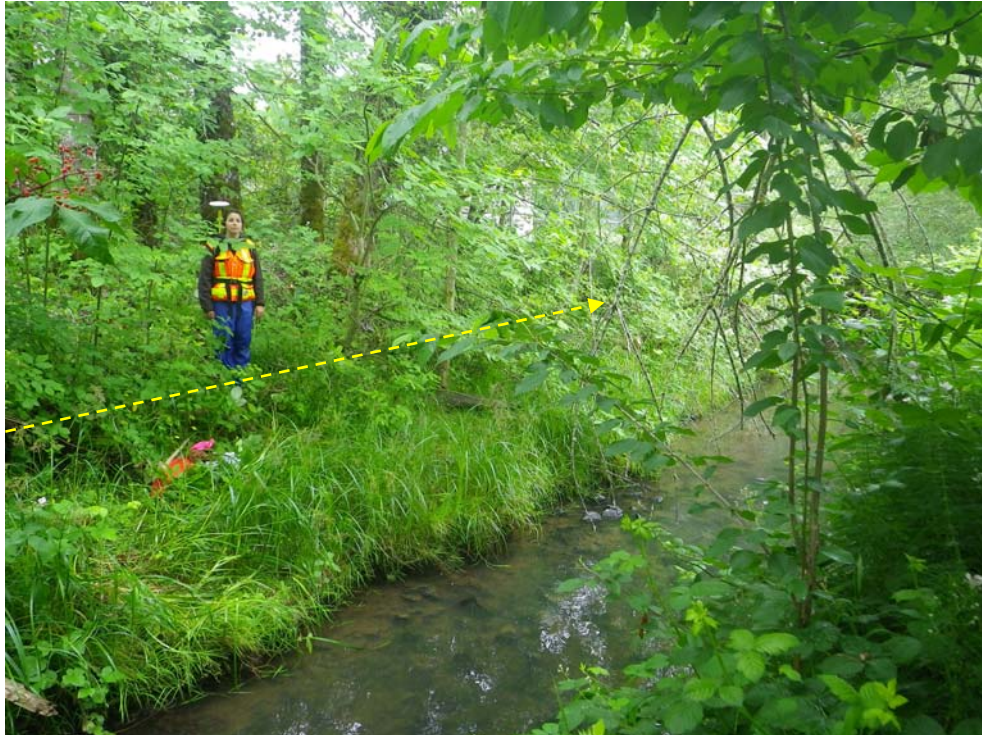
Photo 15: Mt. Scott Creek looking downstream. Low terrace on left bank dominated by reed canary grass. Shift in plant community above low terrace where OHWL is approximated (yellow line). 6/2/2015

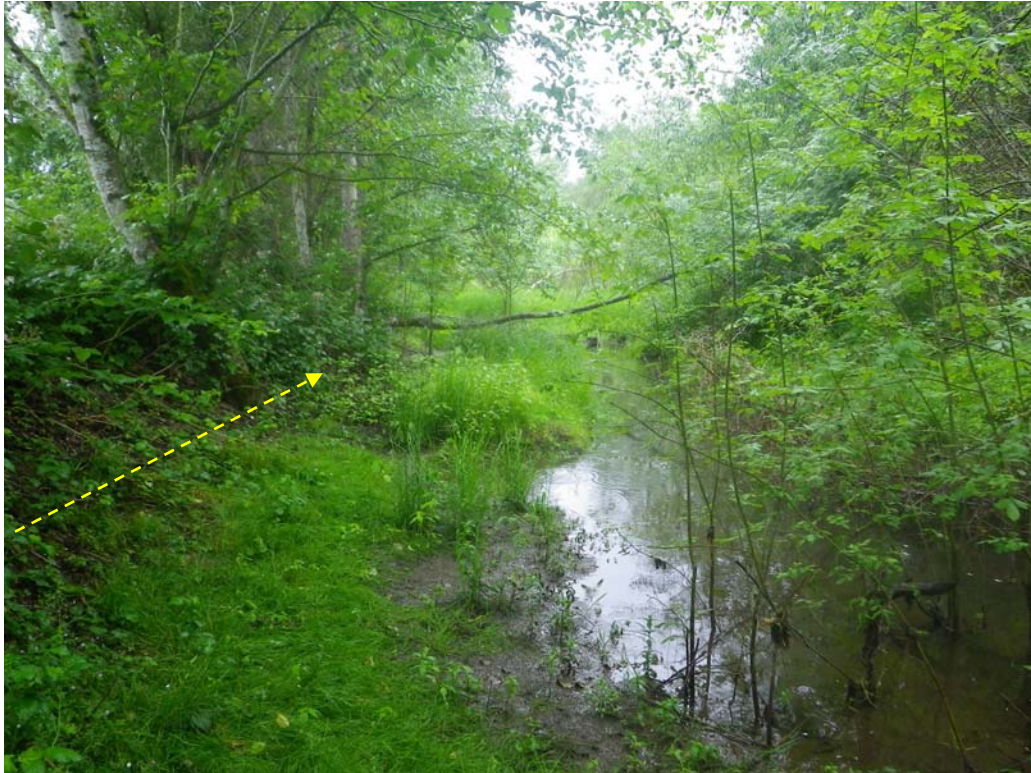
Photo 17: Looking west at the backchannel that connects Wetland 5 pond (boundary approximated in yellow) and Mt. Scott Creek main stem to Wetland 6. 6/2/2015

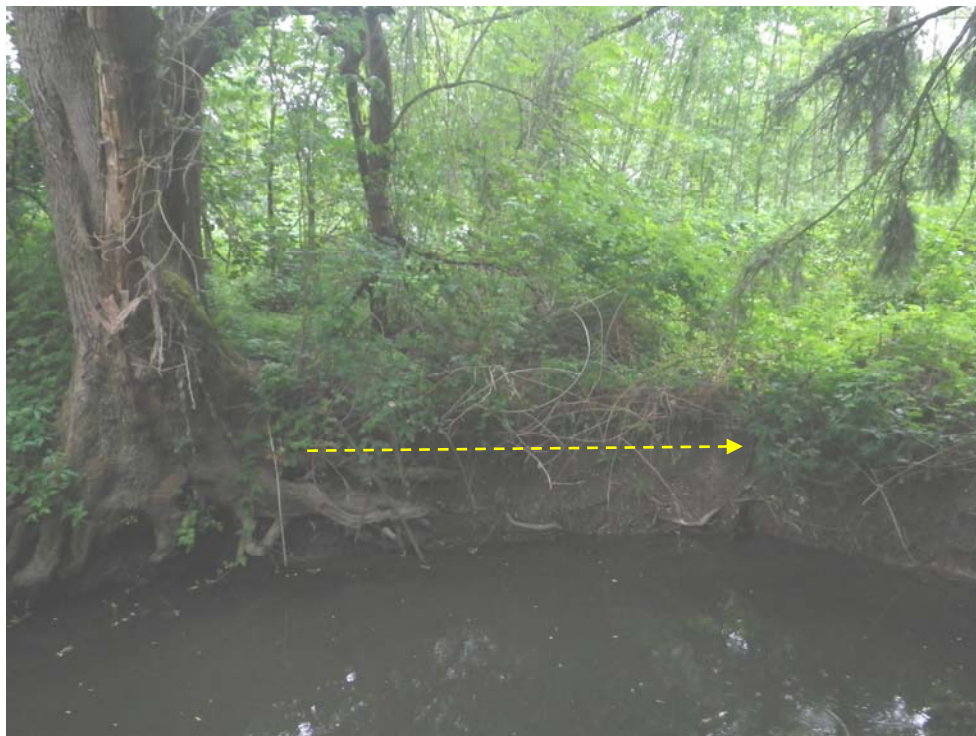
Photo 18: Mt. Scott Creek north of Wetland 6 and east of Wetland 7, erosion of vertical banks. OHWL is just below top of bank (yellow dotted line). 6/2/2015

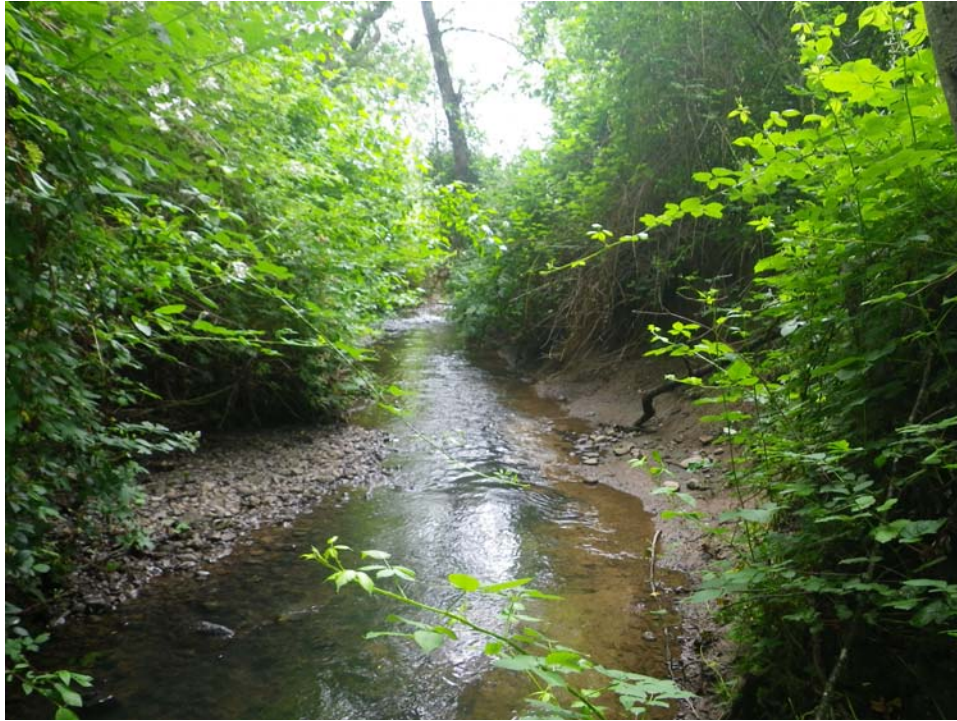
Photo 19: Downstream view of Mt. Scott Creek. Photo location is at the outlet of two culverts that connect Tributary 1 to Mt. Scott Creek. 6/3/2015

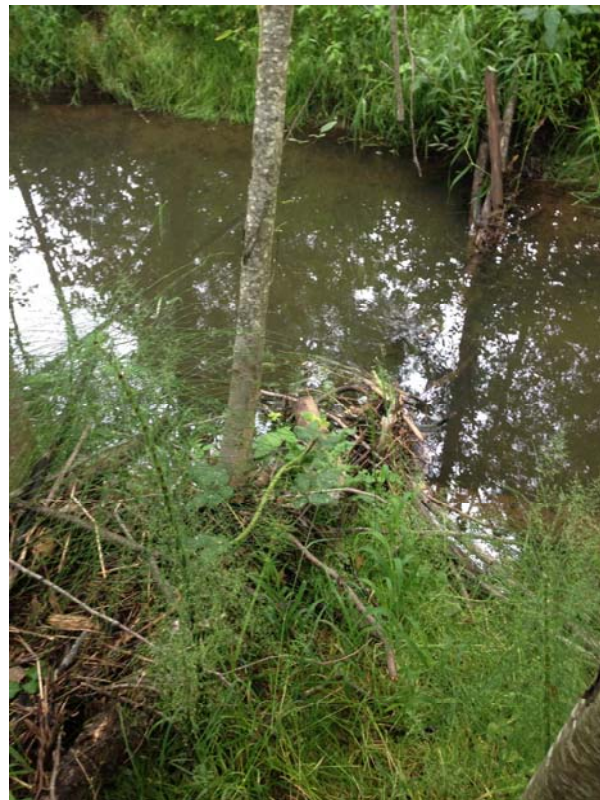
Photo 20: Left bank of Mt. Scott Creek by railroad crossing; Wrack line. 6/3/2015

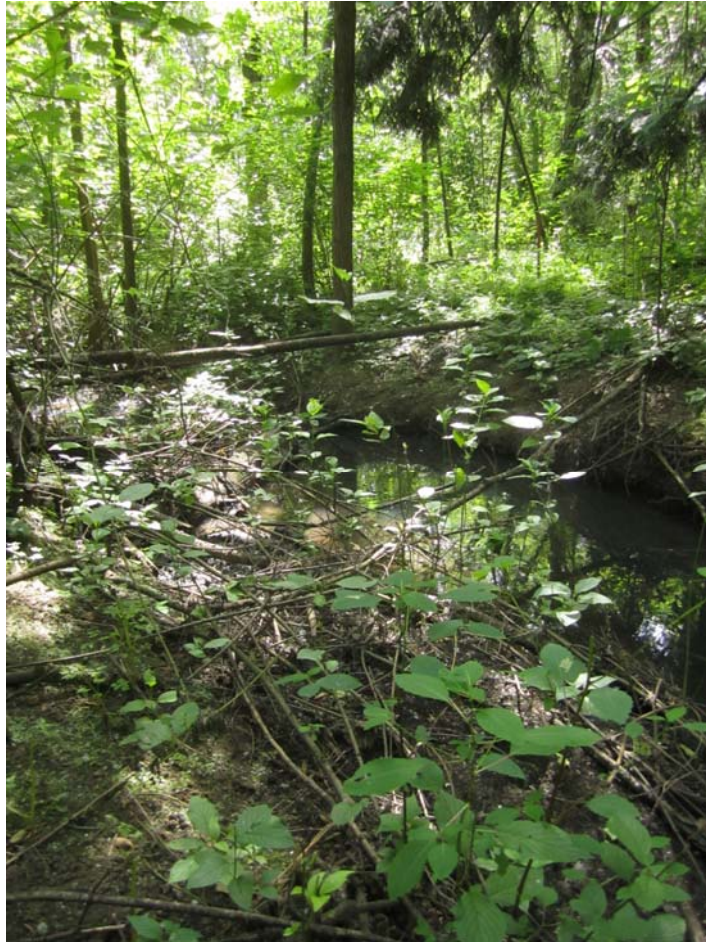
Photo 21: Dean Creek looking upstream. Photo shows sloping banks on right and left creek sides, and low bench with wrack line on right bank. 6/15/2015

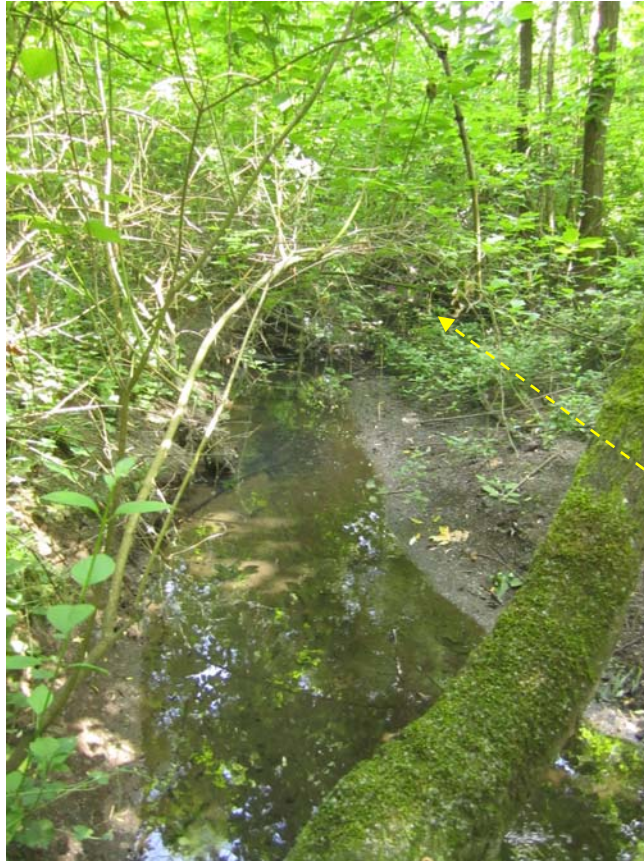
Photo 22: Dean Creek, looking downstream. Right bank shows change in soil color related to saturation gradient. OHWM is approximated by the dotted yellow line. 6/15/2015

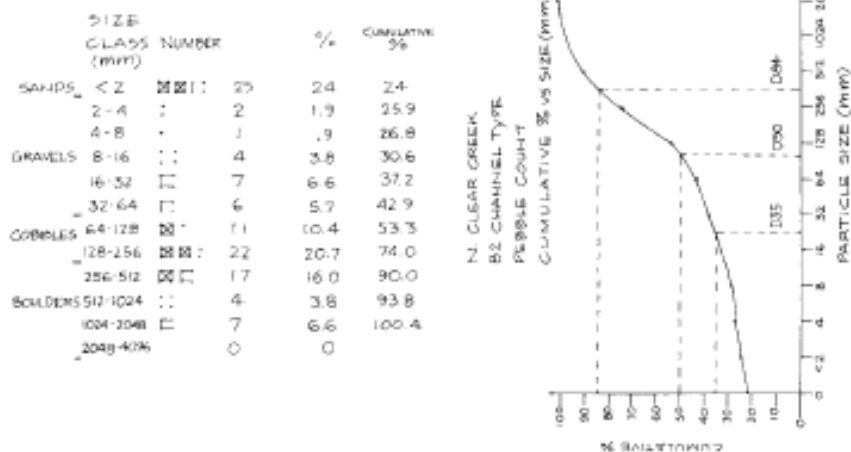
N. CLEAR CREEK - BIGHORN N.F. 8/10/93
 PEBBLE COUNT ON RIPPLE AT
 CROSS-SECTION (BFA D=75)
 J. POTYONDY J. MEIMAN
 - WOLMAN PEBBLE COUNT USING THE
 WENTWORTH SCALE FOR SIZE CLASSES

Figure 2. Example of particle size distribution analysis method (Harrelson et al. 1994)
