# Clackamas County Main Street Courthouse Property Disposition

## REQUEST FOR EXPRESSIONS OF INTEREST for Real Estate Acquisition for Development Concepts

# Clackamas County Courthouse Evaluation: MEP Building Assessment

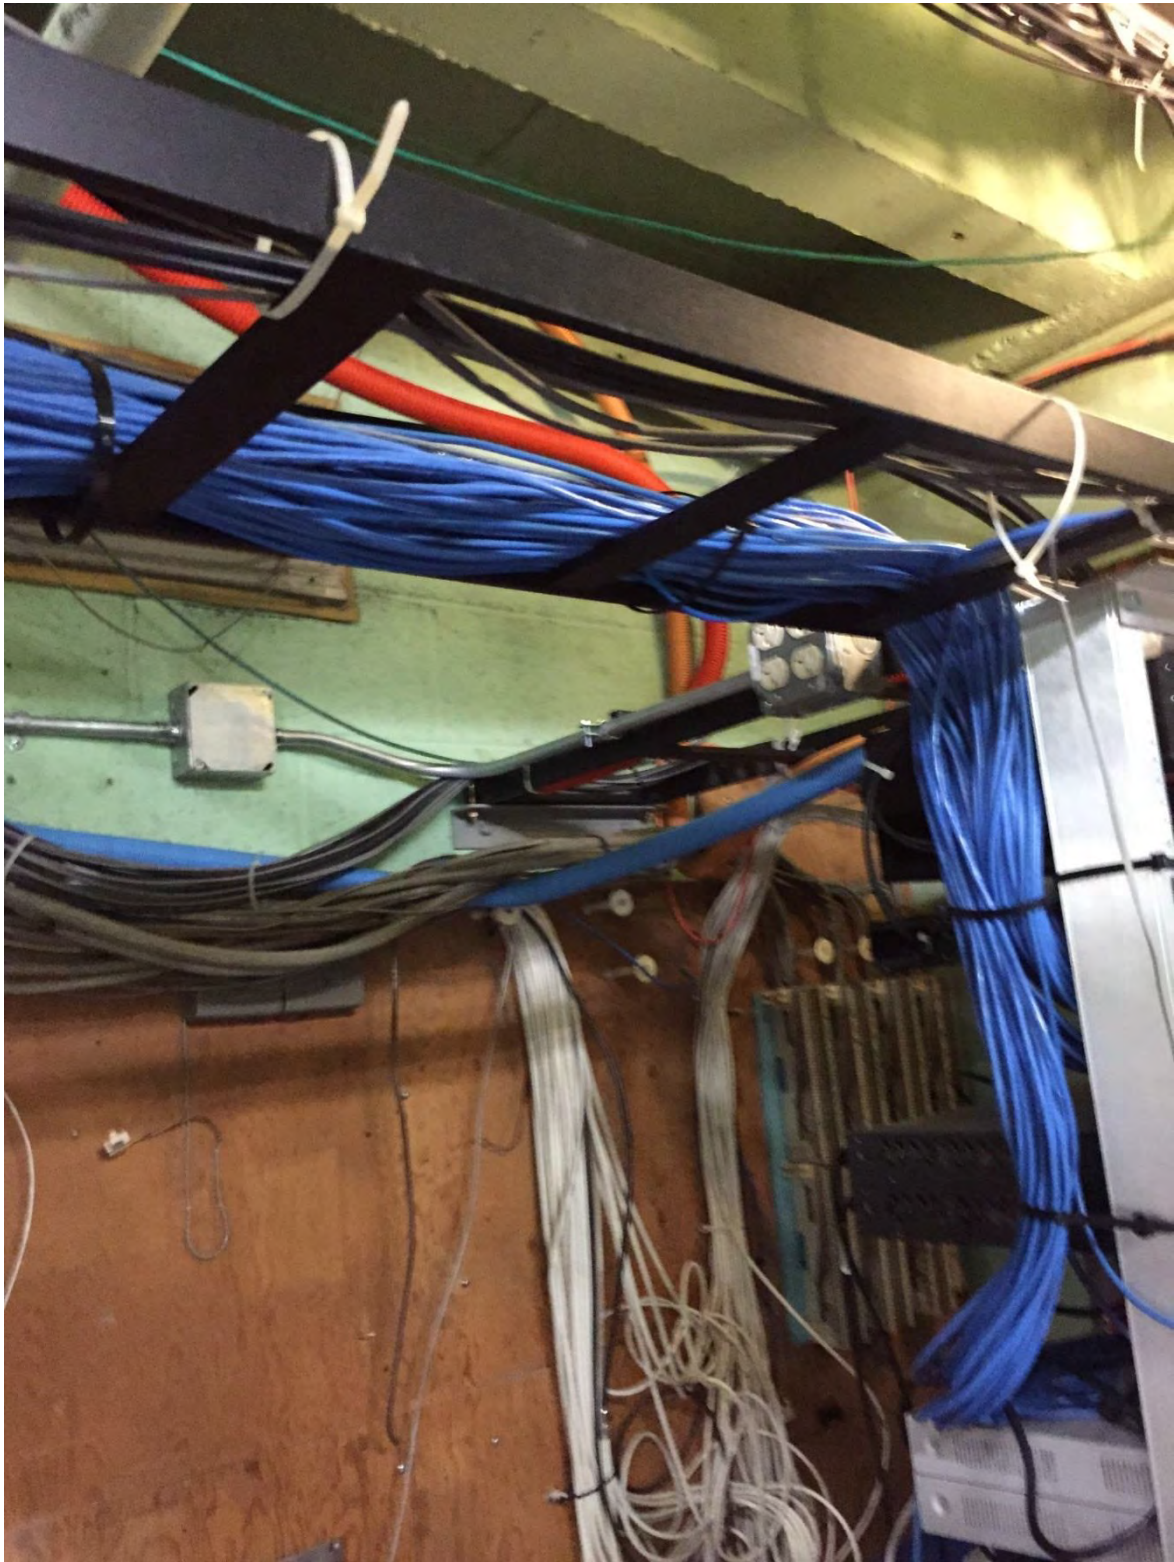
### 4.1 Photo #E1: Cable distribution in basement tele/data room.

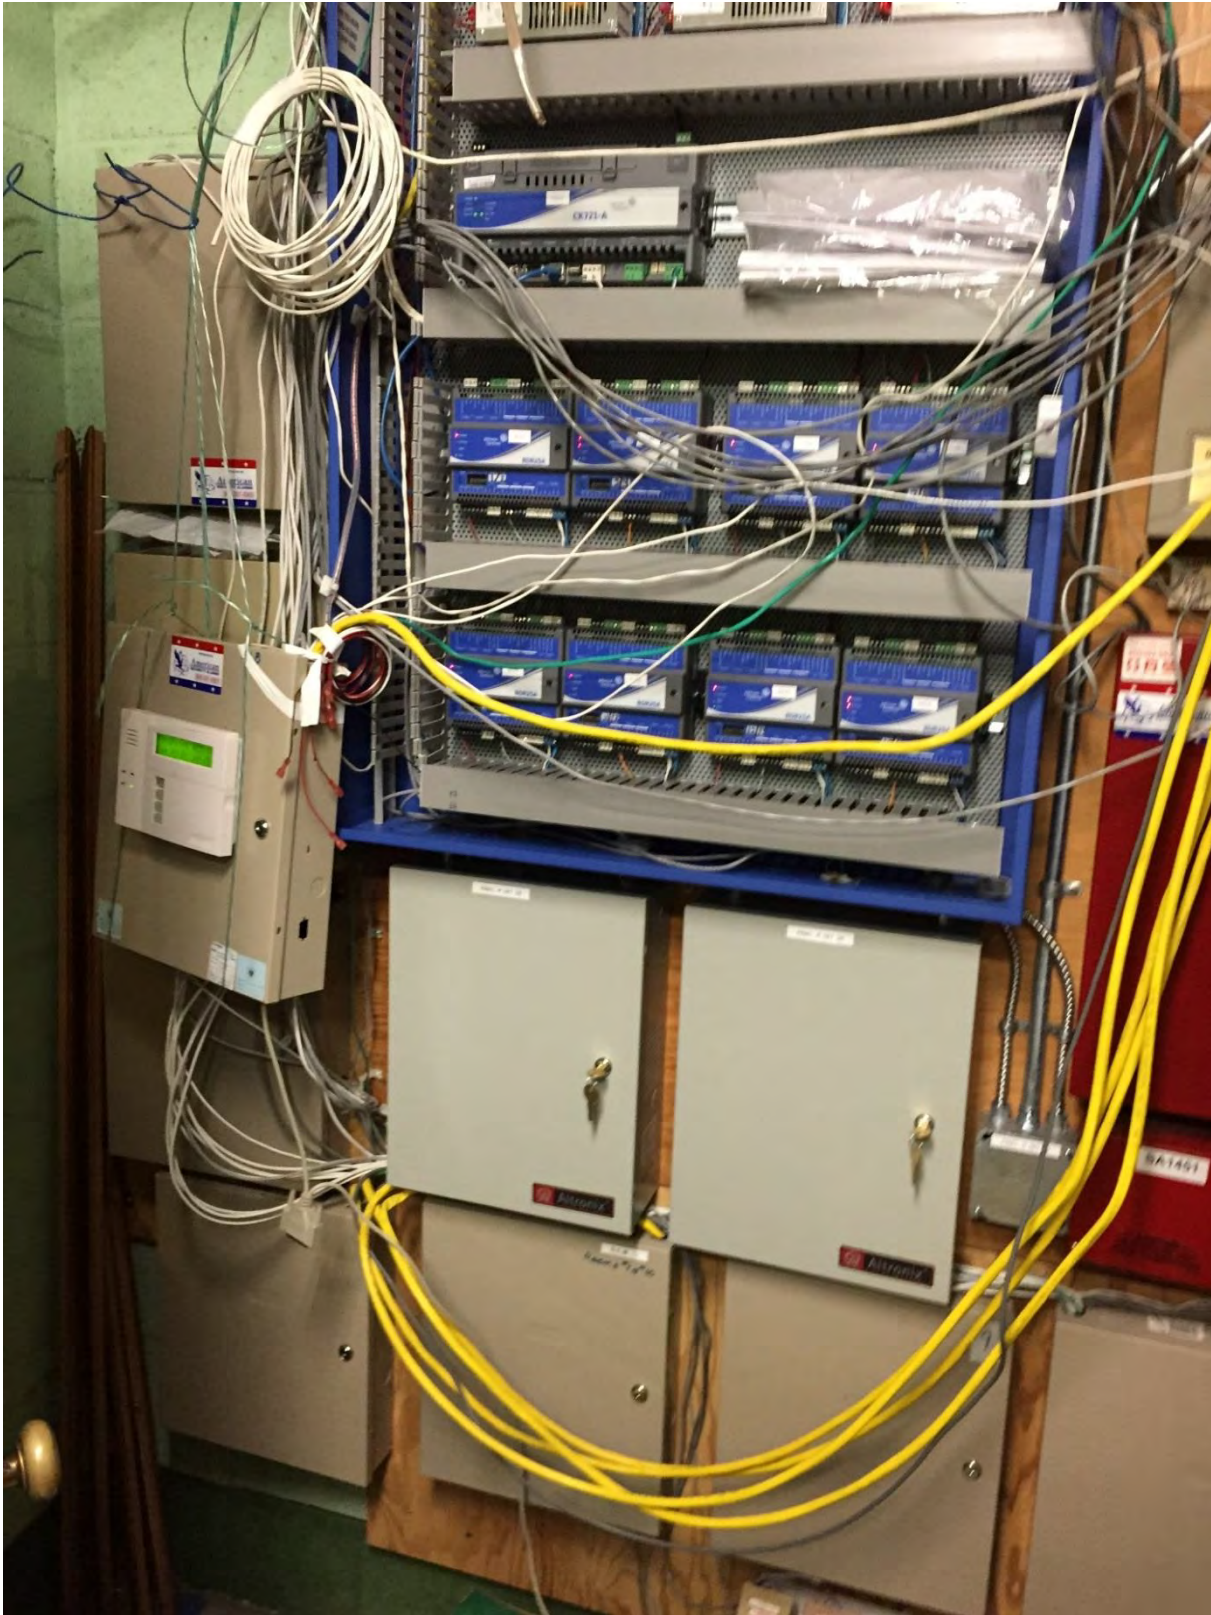
**4.2 Photo #E2: New Johnson Controls door security system transition.**

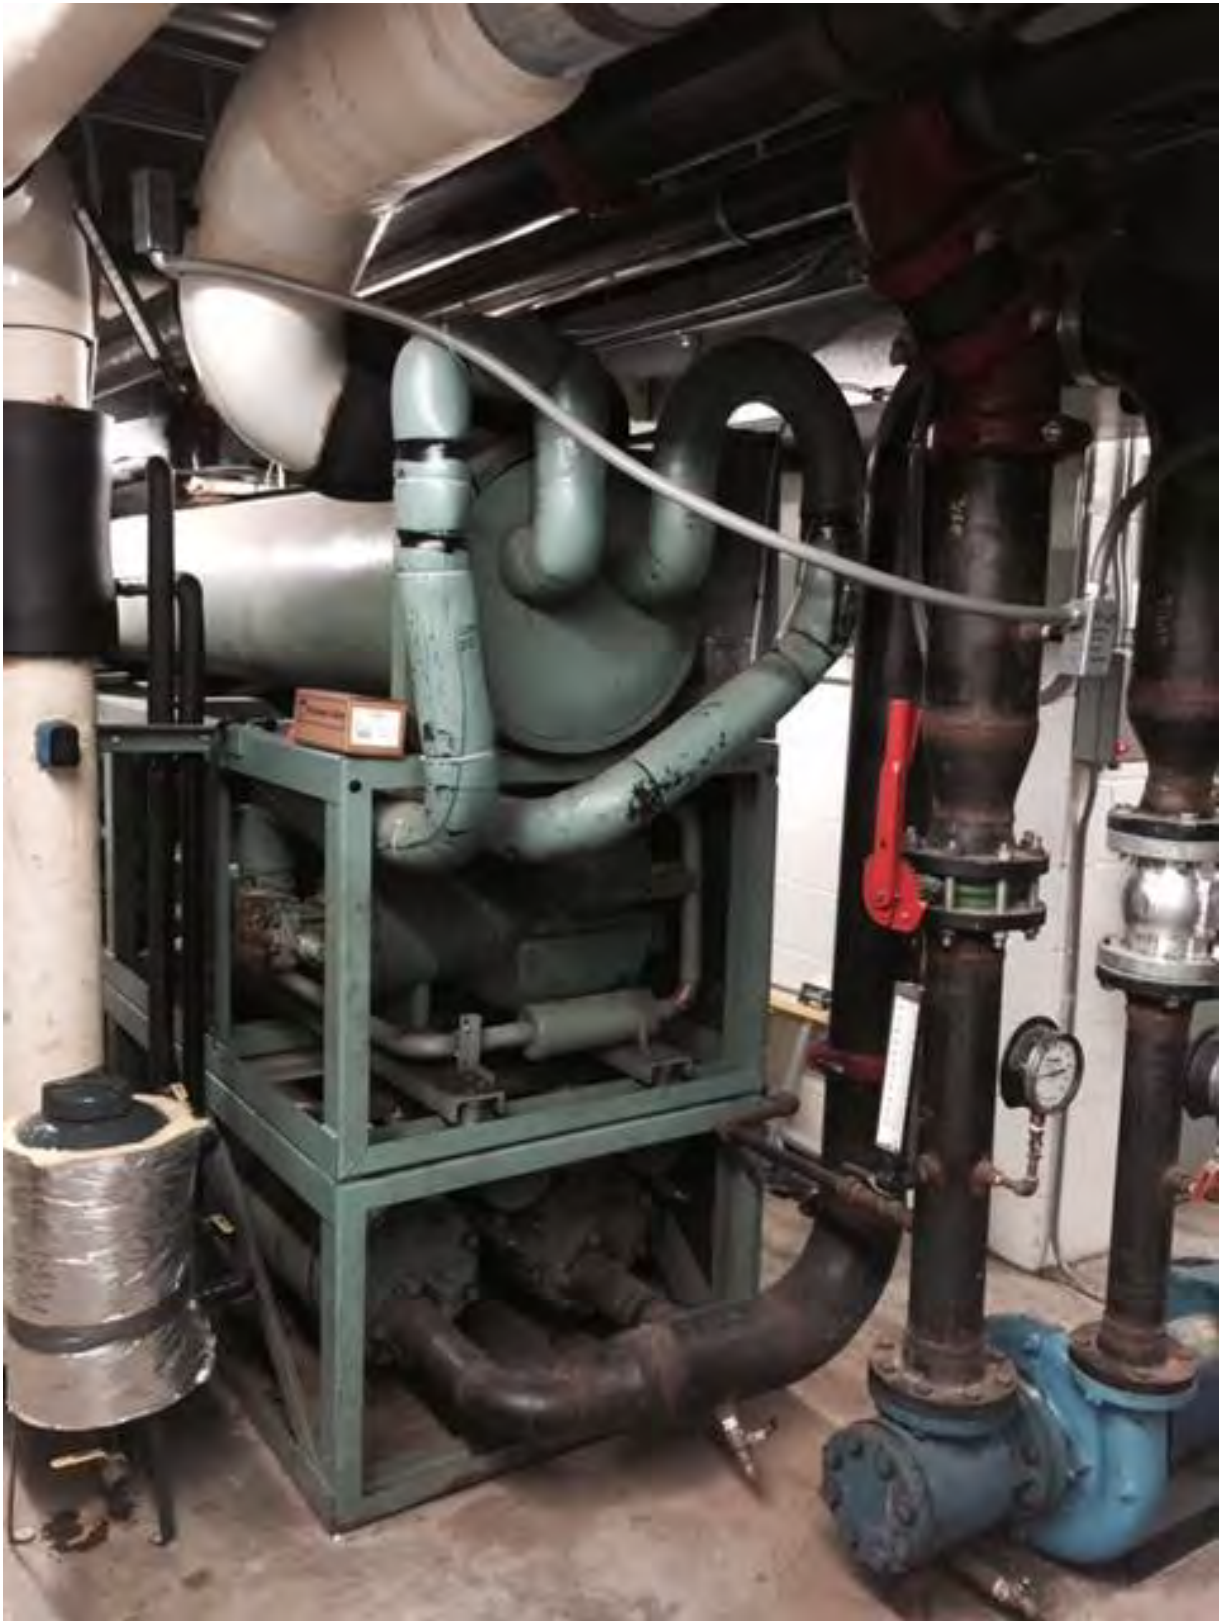
**4.3 Photo #M1: Chiller**

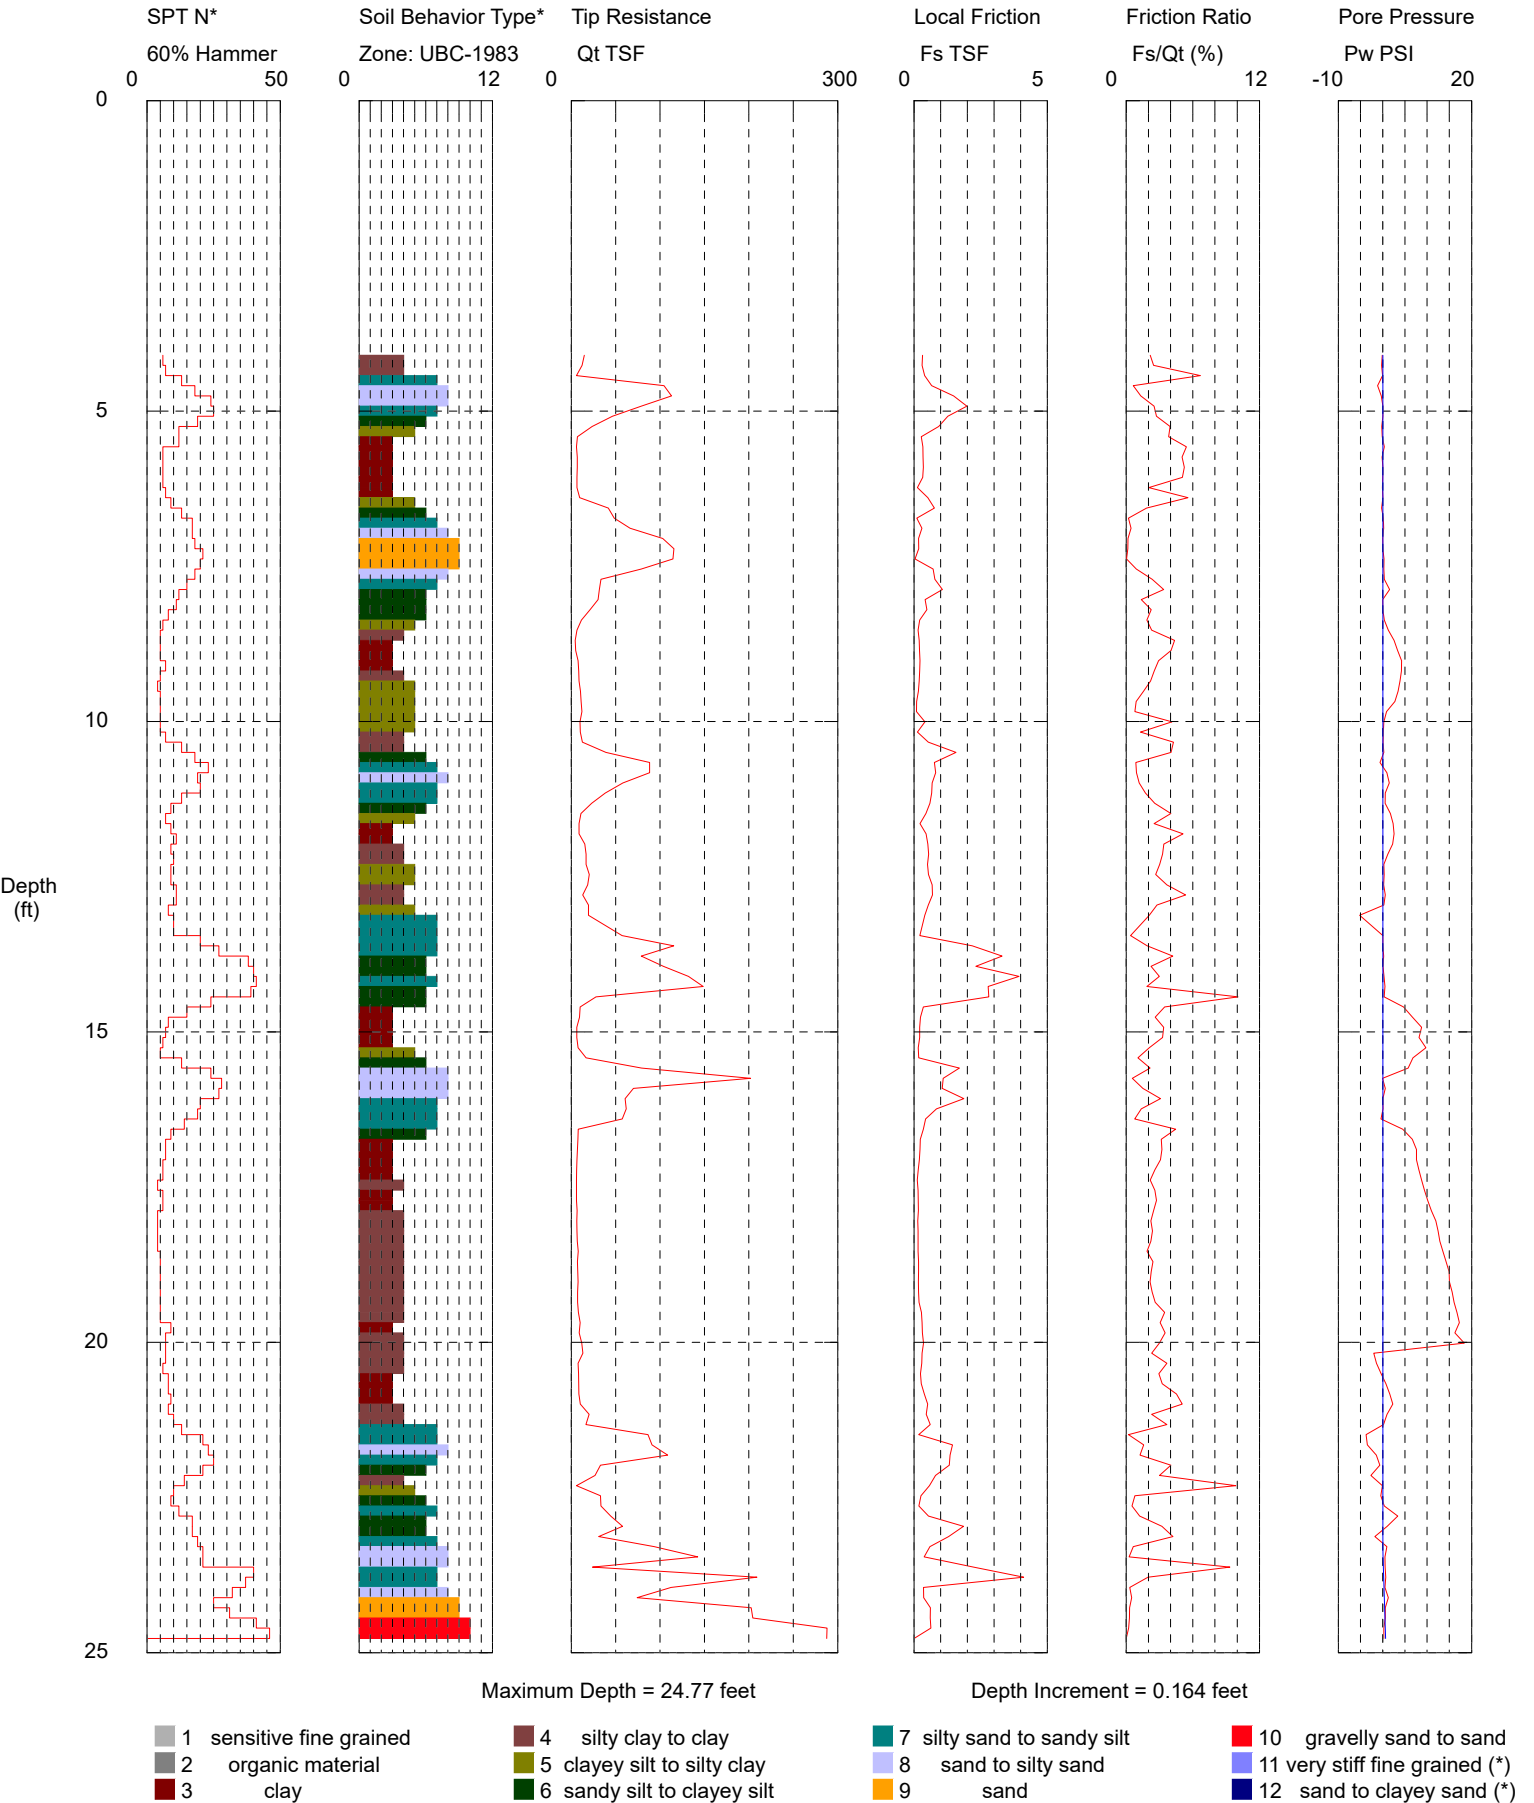
CPT Date/Time: 9/12/2015 3:49:02 PM  
 Location: GeoDesign / CPT-1a / Clackamas Co Courthouse Oregon City  
 Job Number: 15065 / GeoDesign / CPT-1a / Clackamas County Courthouse

\*Soil behavior type and SPT based on data from UBC-1983

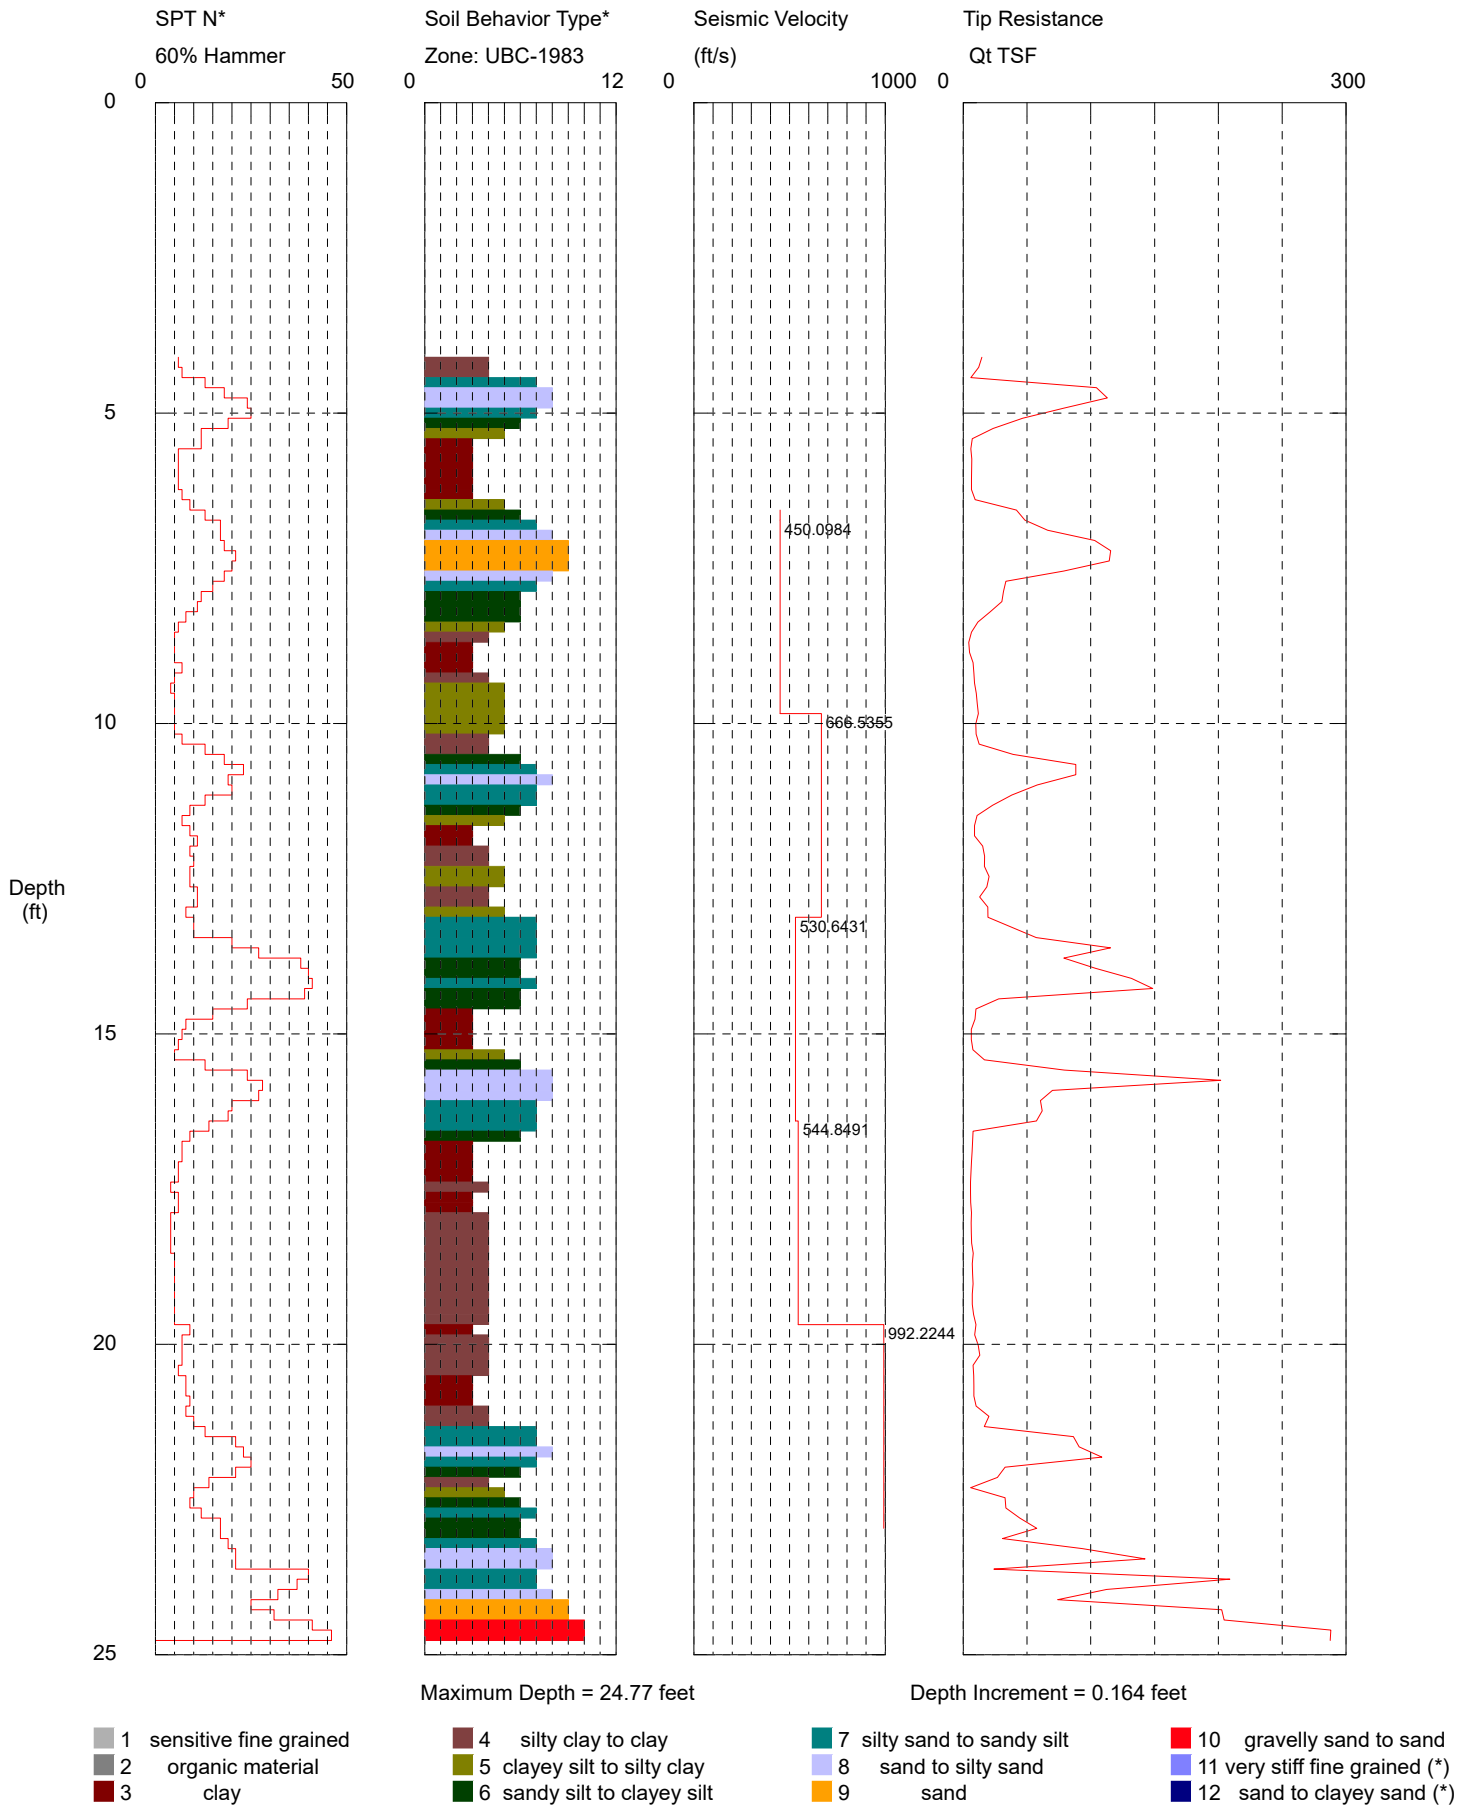
CPT Date/Time: 9/12/2015 3:49:02 PM  
 Location: GeoDesign / CPT-1a / Clackamas Co Courthouse Oregon City  
 Job Number: 15065 / GeoDesign / CPT-1a / Clackamas County Courthouse

\*Soil behavior type and SPT based on data from UBC-1983
