RE: WES (Clackamas County Service District No. 1 and Surface Water Management Agency of Clackamas County) and the Cities of Happy Valley and Rivergrove NPDES MS4 Discharge Permit 2017-2018 Annual Report

NPDES MS4 Discharge Permit

Annual Report for July 1, 2017 – June 30, 2018

Water Environment Services, a Department of Clackamas County, on behalf of WES (Clackamas County Service District No. 1 and Surface Water Management Agency of Clackamas County) and the cities of Happy Valley and Rivergrove

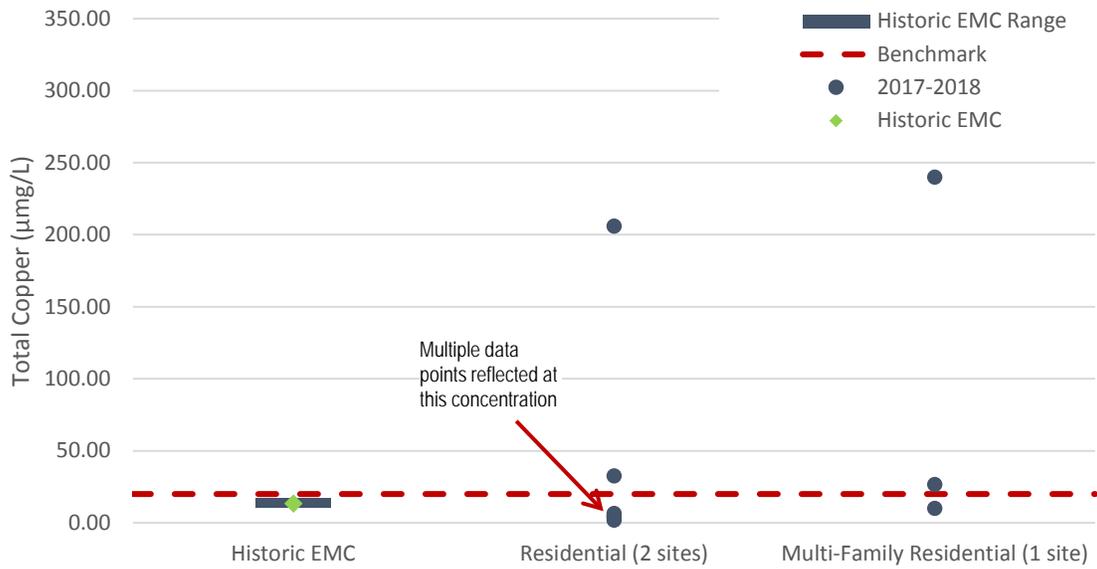
Figure 3-1: Residential Stormwater Monitoring Comparison, Total Copper

- None of the 2017-2018 monitoring data for total lead exceeded the water quality comparison criteria values from Table 2-1.
- Select 2017-2018 monitoring events had data that exceeded the water quality comparison criteria values for total zinc, total copper, *E. coli*, and TSS.
- Total zinc consistently exceeded the water quality comparison for the 2017-2018 monitoring data, with 56% and 100% of all residential and commercial samples, respectively. The 6/8/18 storm event consistently had the highest total zinc concentrations for each monitoring location.
- Figure 3-11 reflects the percent exceedance of 2017-2018 stormwater monitoring data with respect to water quality comparison criteria values from Table 2-1. Note that there were no water quality exceedances for total lead for the residential or commercial land use, or for TSS in commercial land use.

- The 2017-2018 concentration range for both residential and commercial land use sites is markedly higher than historical data for total copper and total zinc. The range in data was not observed in the 2016-2017 monitoring data. The 6/8/18 storm event consistently had the highest total zinc concentrations for each monitoring location.

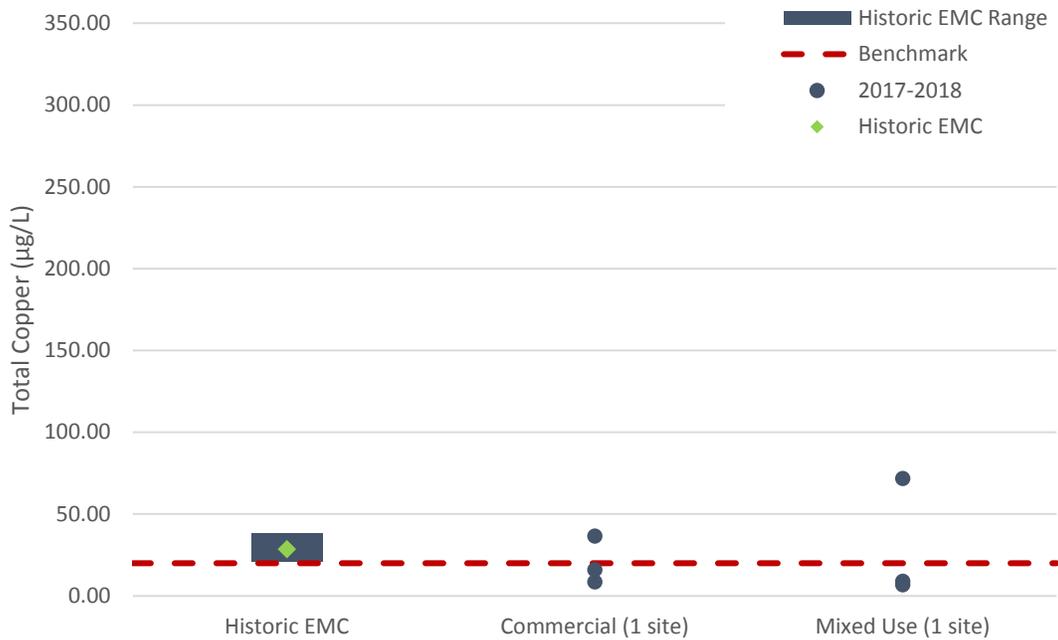
Figure 3-2: Commercial Stormwater Monitoring Comparison, Total Copper

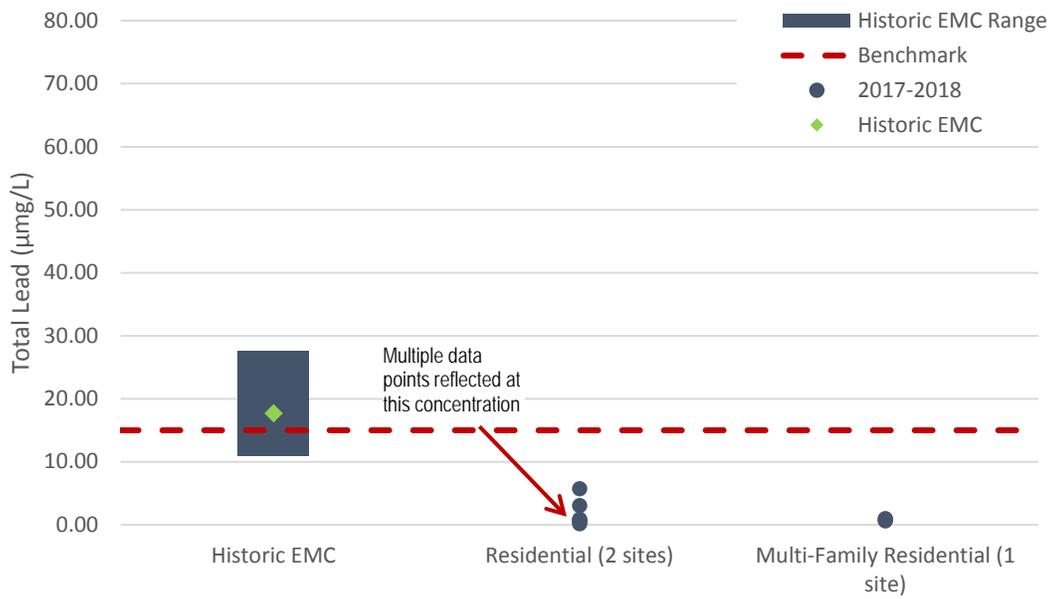
Figure 3-3: Residential Stormwater Monitoring Comparison, Total Lead

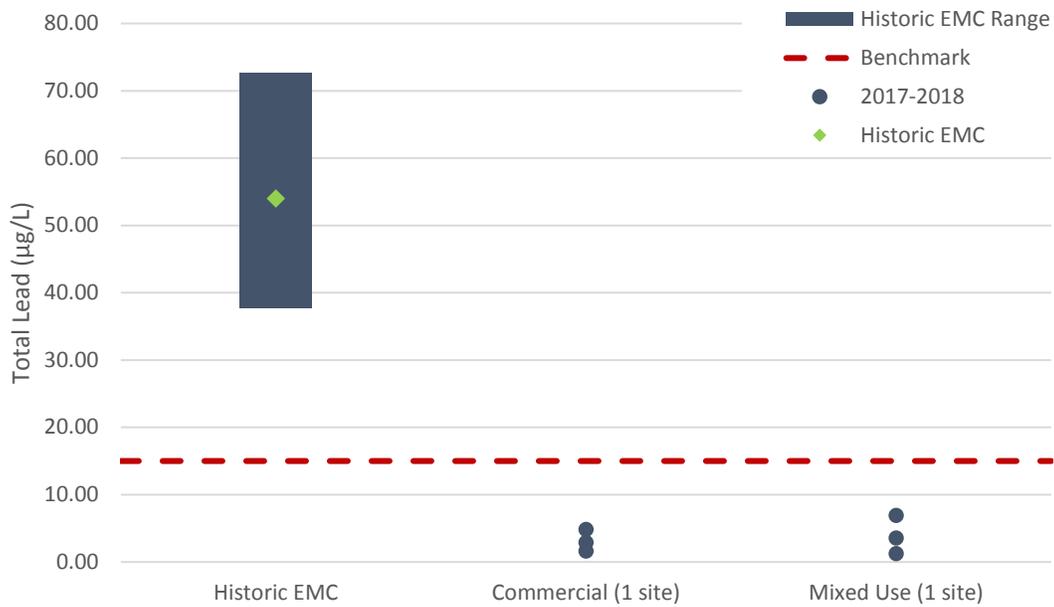
Figure 3-4: Commercial Stormwater Monitoring Comparison, Total Lead

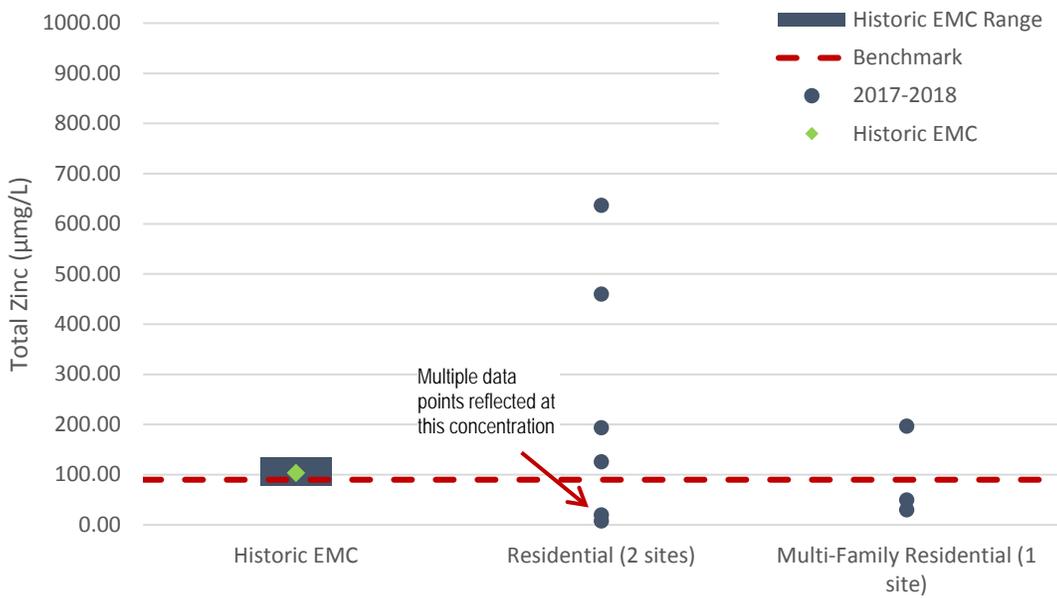
Figure 3-5: Residential Stormwater Monitoring Comparison, Total Zinc

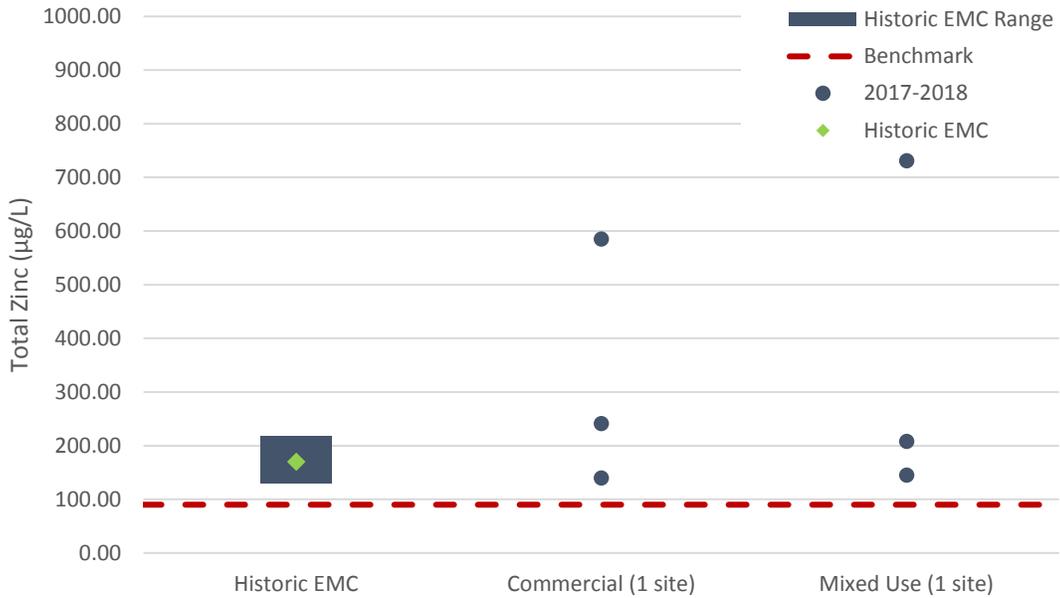
Figure 3-6: Commercial Stormwater Monitoring Comparison, Total Zinc

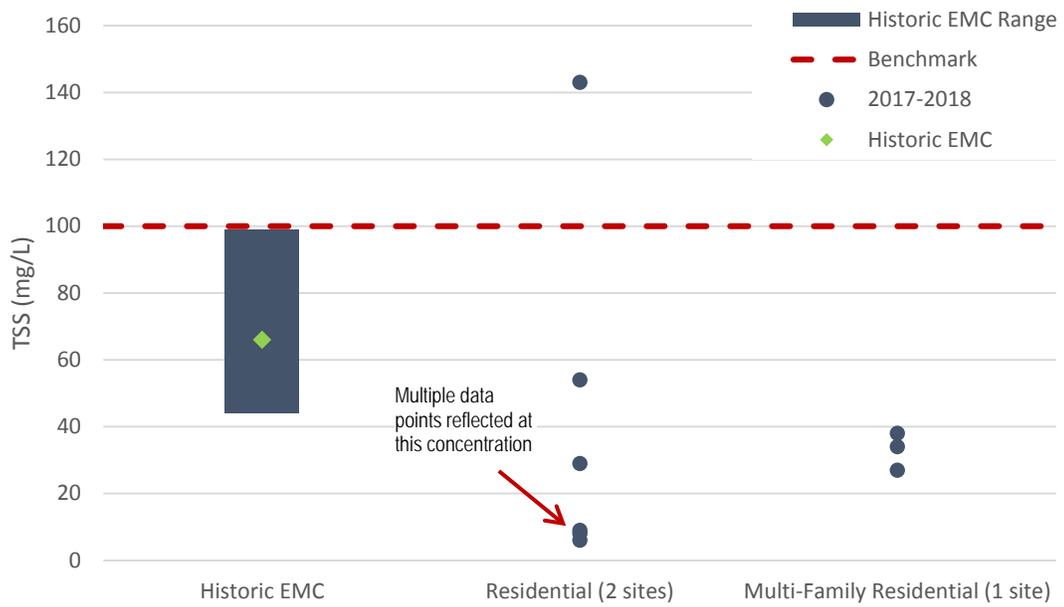
Figure 3-7: Residential Stormwater Monitoring Comparison, Total Suspended Solids

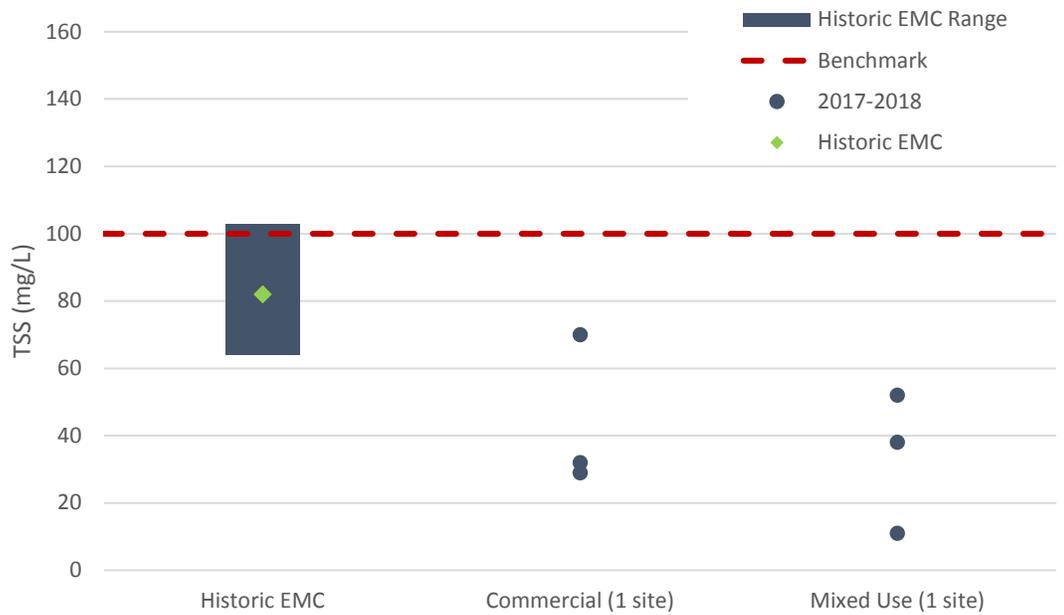
Figure 3-8: Commercial Stormwater Monitoring Comparison, Total Suspended Solids

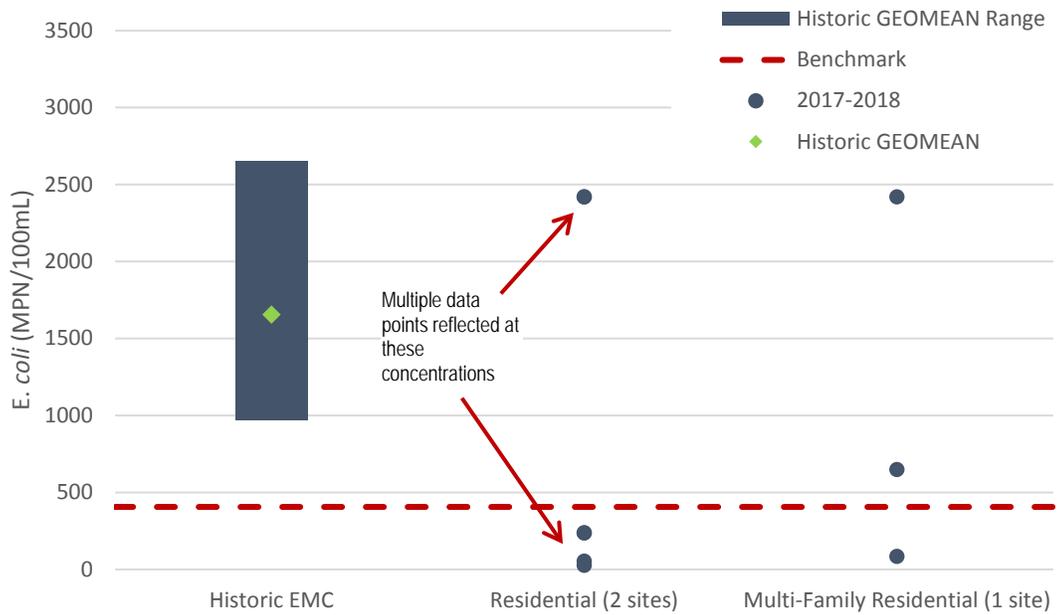
Figure 3-9: Residential Stormwater Monitoring Comparison, Bacteria

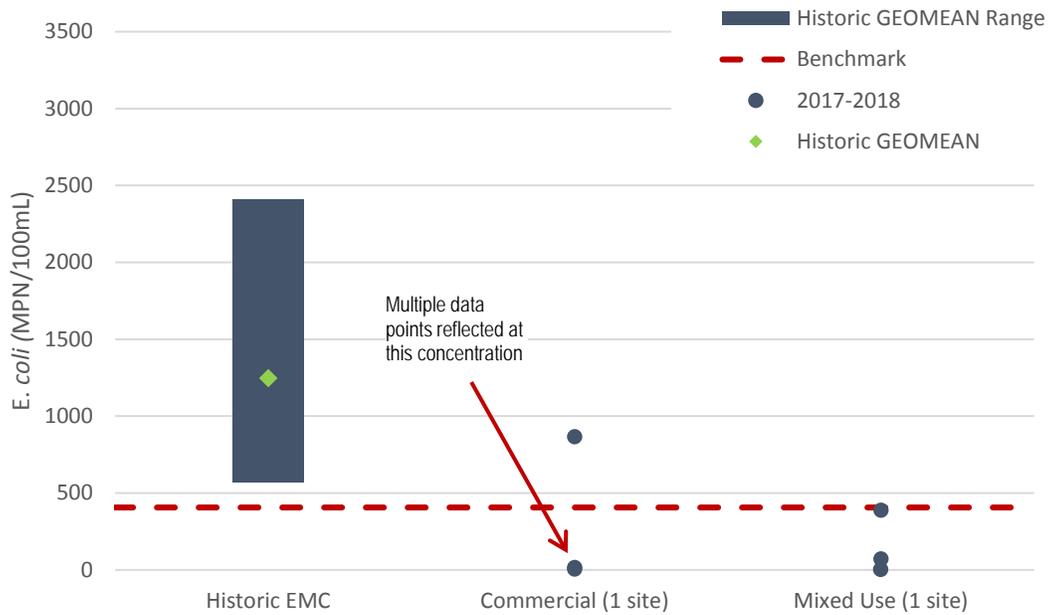
Figure 3-10: Commercial Stormwater Monitoring Comparison, Bacteria

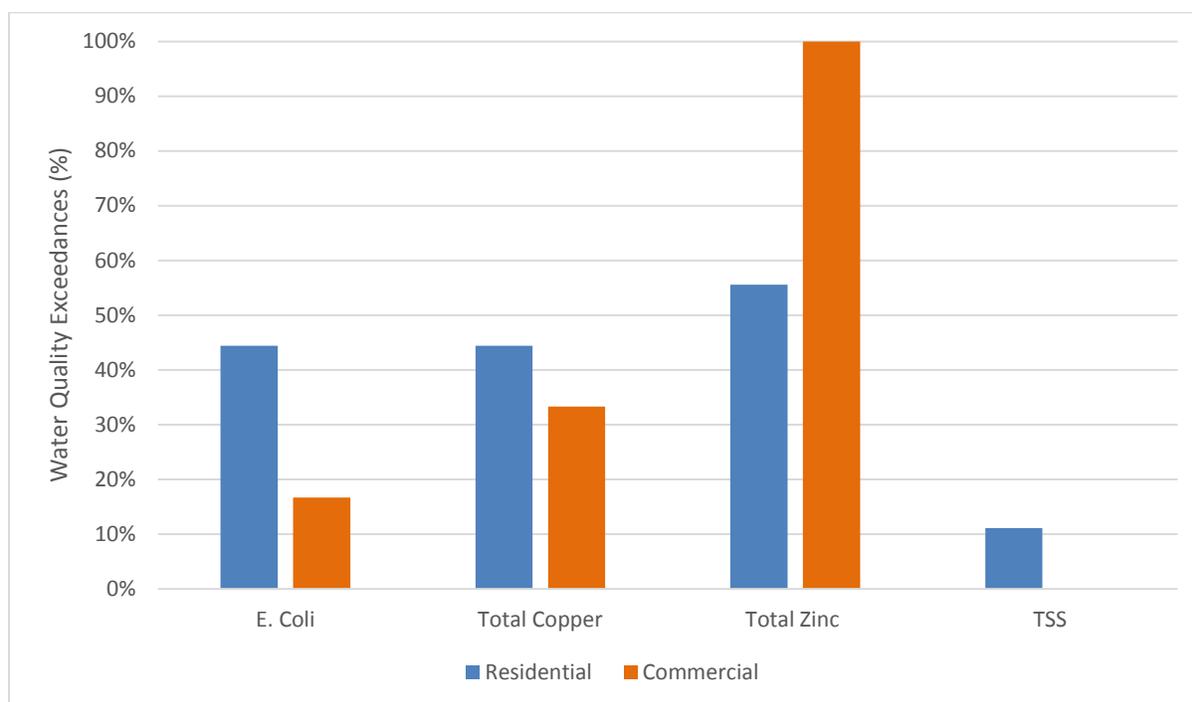
Figure 3-11: 2017-18 Stormwater Monitoring Data Percent Exceedance of Water Quality Comparison Criteria

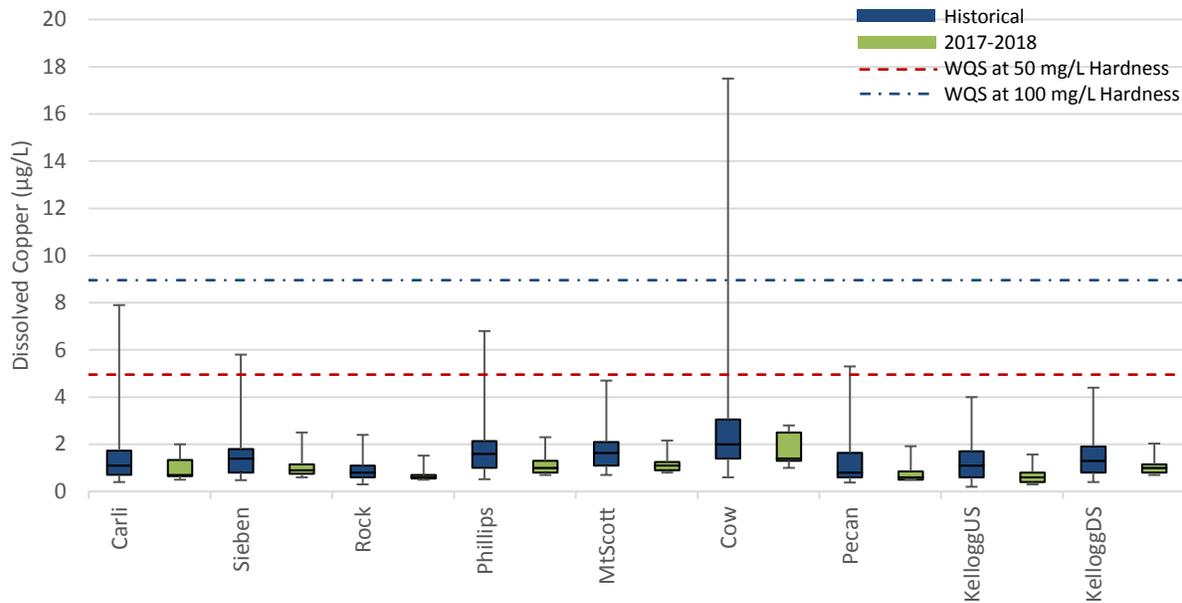
Figure 4-1: Instream Monitoring Historical Comparison, Dissolved Copper

- No current exceedances of the chronic water quality criteria were observed for dissolved copper, lead, or zinc.
- The two Kellogg Creek locations have the overall lowest historical and current metals concentrations and are the only locations with no metal criteria exceedances of both historical and current data.

- Historical data sets are generally consistent between the upstream and downstream Kellogg Creek monitoring locations for all parameters.
- For dissolved copper and bacteria, the current and historical data sets and median values are higher at the downstream location than upstream, indicating the potential for deteriorating water quality. For TSS, although the same observation was observed for the historical data set, the current data set shows a more consistent concentration range for the upstream and downstream locations.
- For dissolved lead, dissolved zinc, and dissolved oxygen, the current and historical data sets and median values at the downstream location are equal to or lower than the upstream location (higher in the case of DO), indicating the potential for improving water quality.

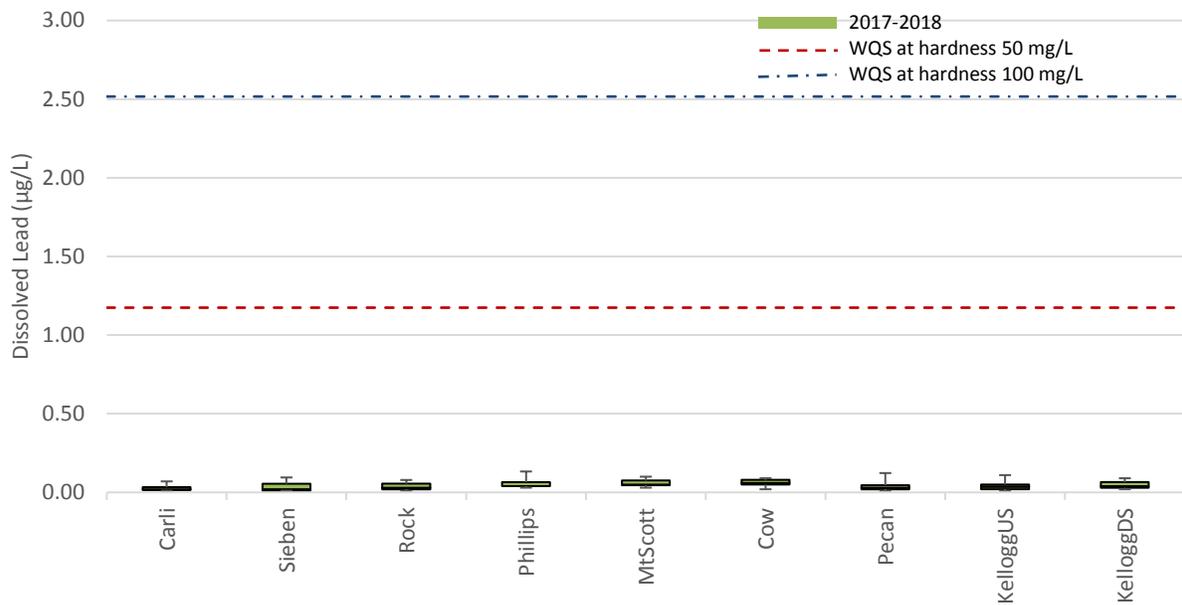
Figure 4-2: Instream Monitoring Comparison, Dissolved Lead

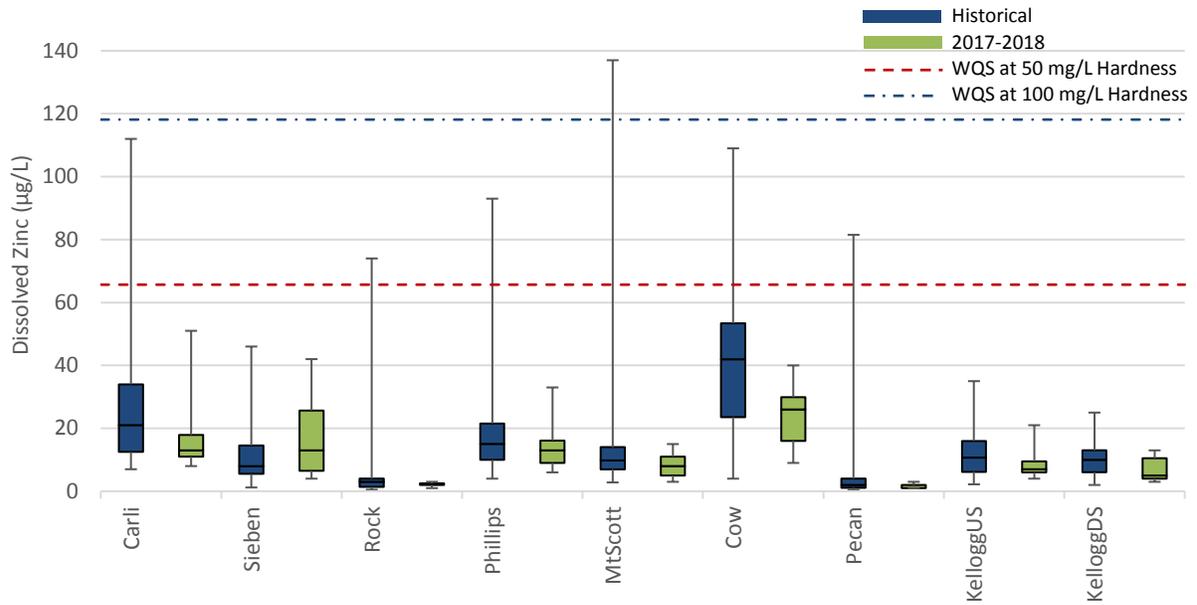
Figure 4-3: Instream Monitoring Historical Comparison, Dissolved Zinc

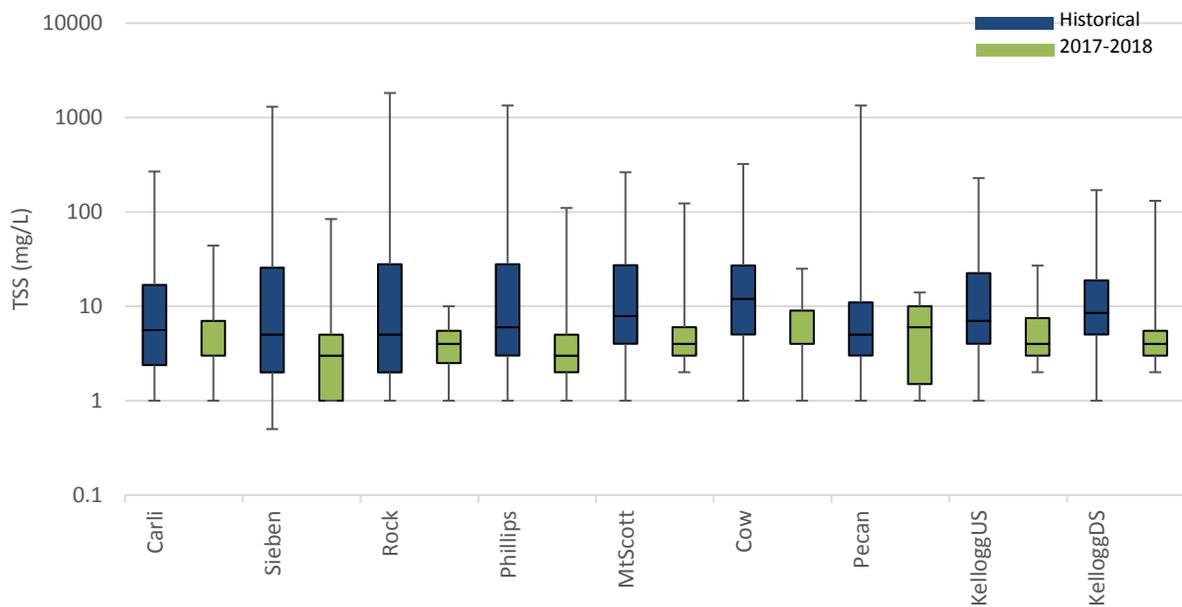
Figure 4-4: Instream Monitoring Historical Comparison, Total Suspended Solids

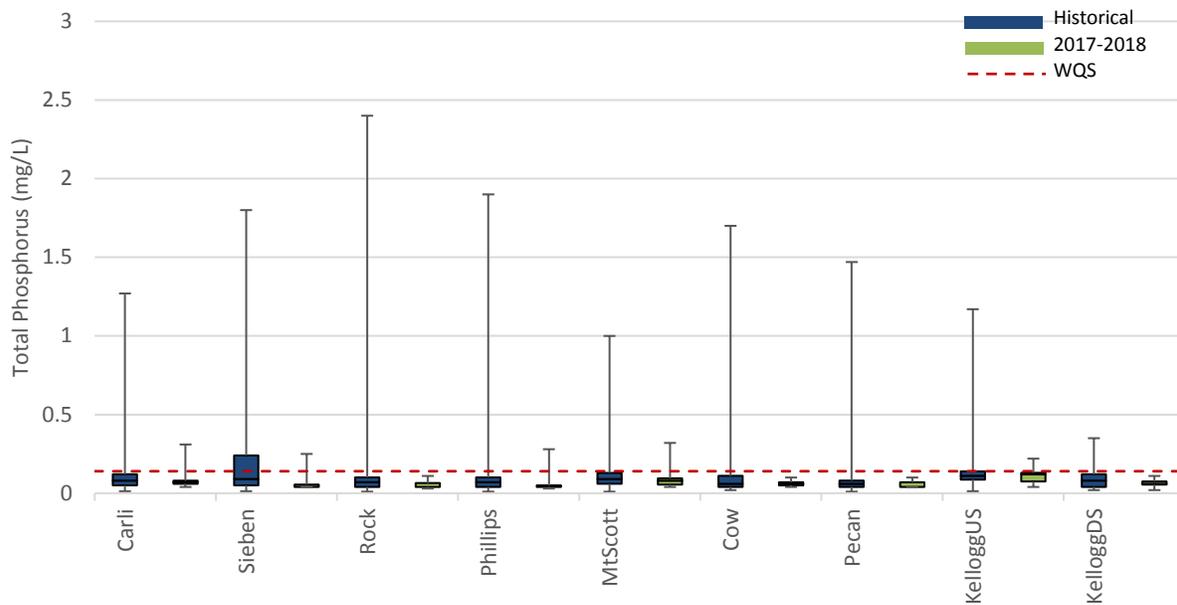
Figure 4-5: Instream Monitoring Historical Comparison, Total Phosphorus

- All locations have historical exceedances of the total phosphorus comparison criteria. Five of the nine locations had current data exceeding the criteria.
- All locations had historical and/or current exceedances of the bacteria criteria; however, for all locations the median value did not exceed the criteria. Rock Creek is the only location observed where no monitoring events during 2017-2018 reporting year were higher than the criteria.
- Based on the 8 streams that were monitored, results indicate that WES' strategic plan goal of having 30% of streams meet/ exceed water quality standards was not met.

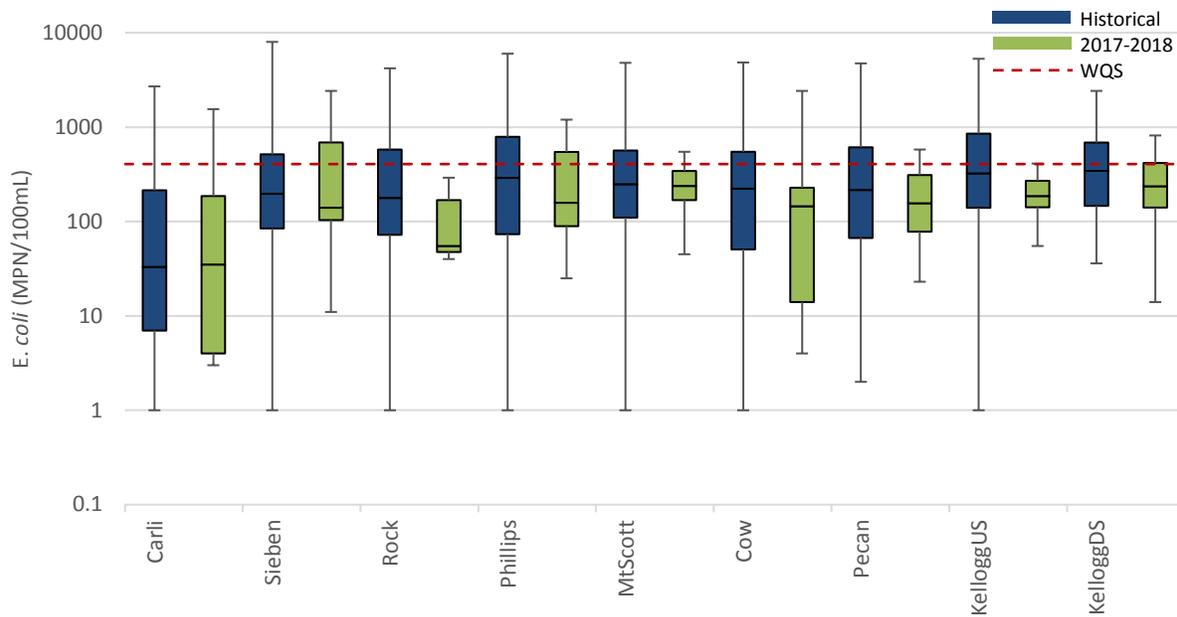
Figure 4-6: Instream Monitoring Historical Comparison, Bacteria

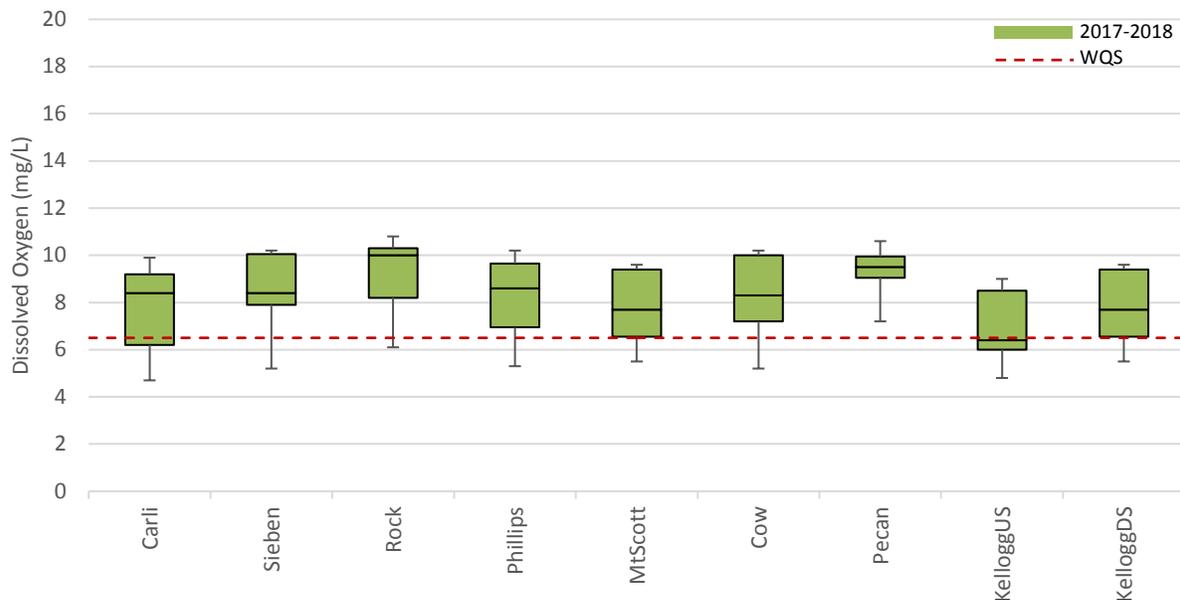
Figure 4-7: Instream Monitoring Comparison, Dissolved Oxygen

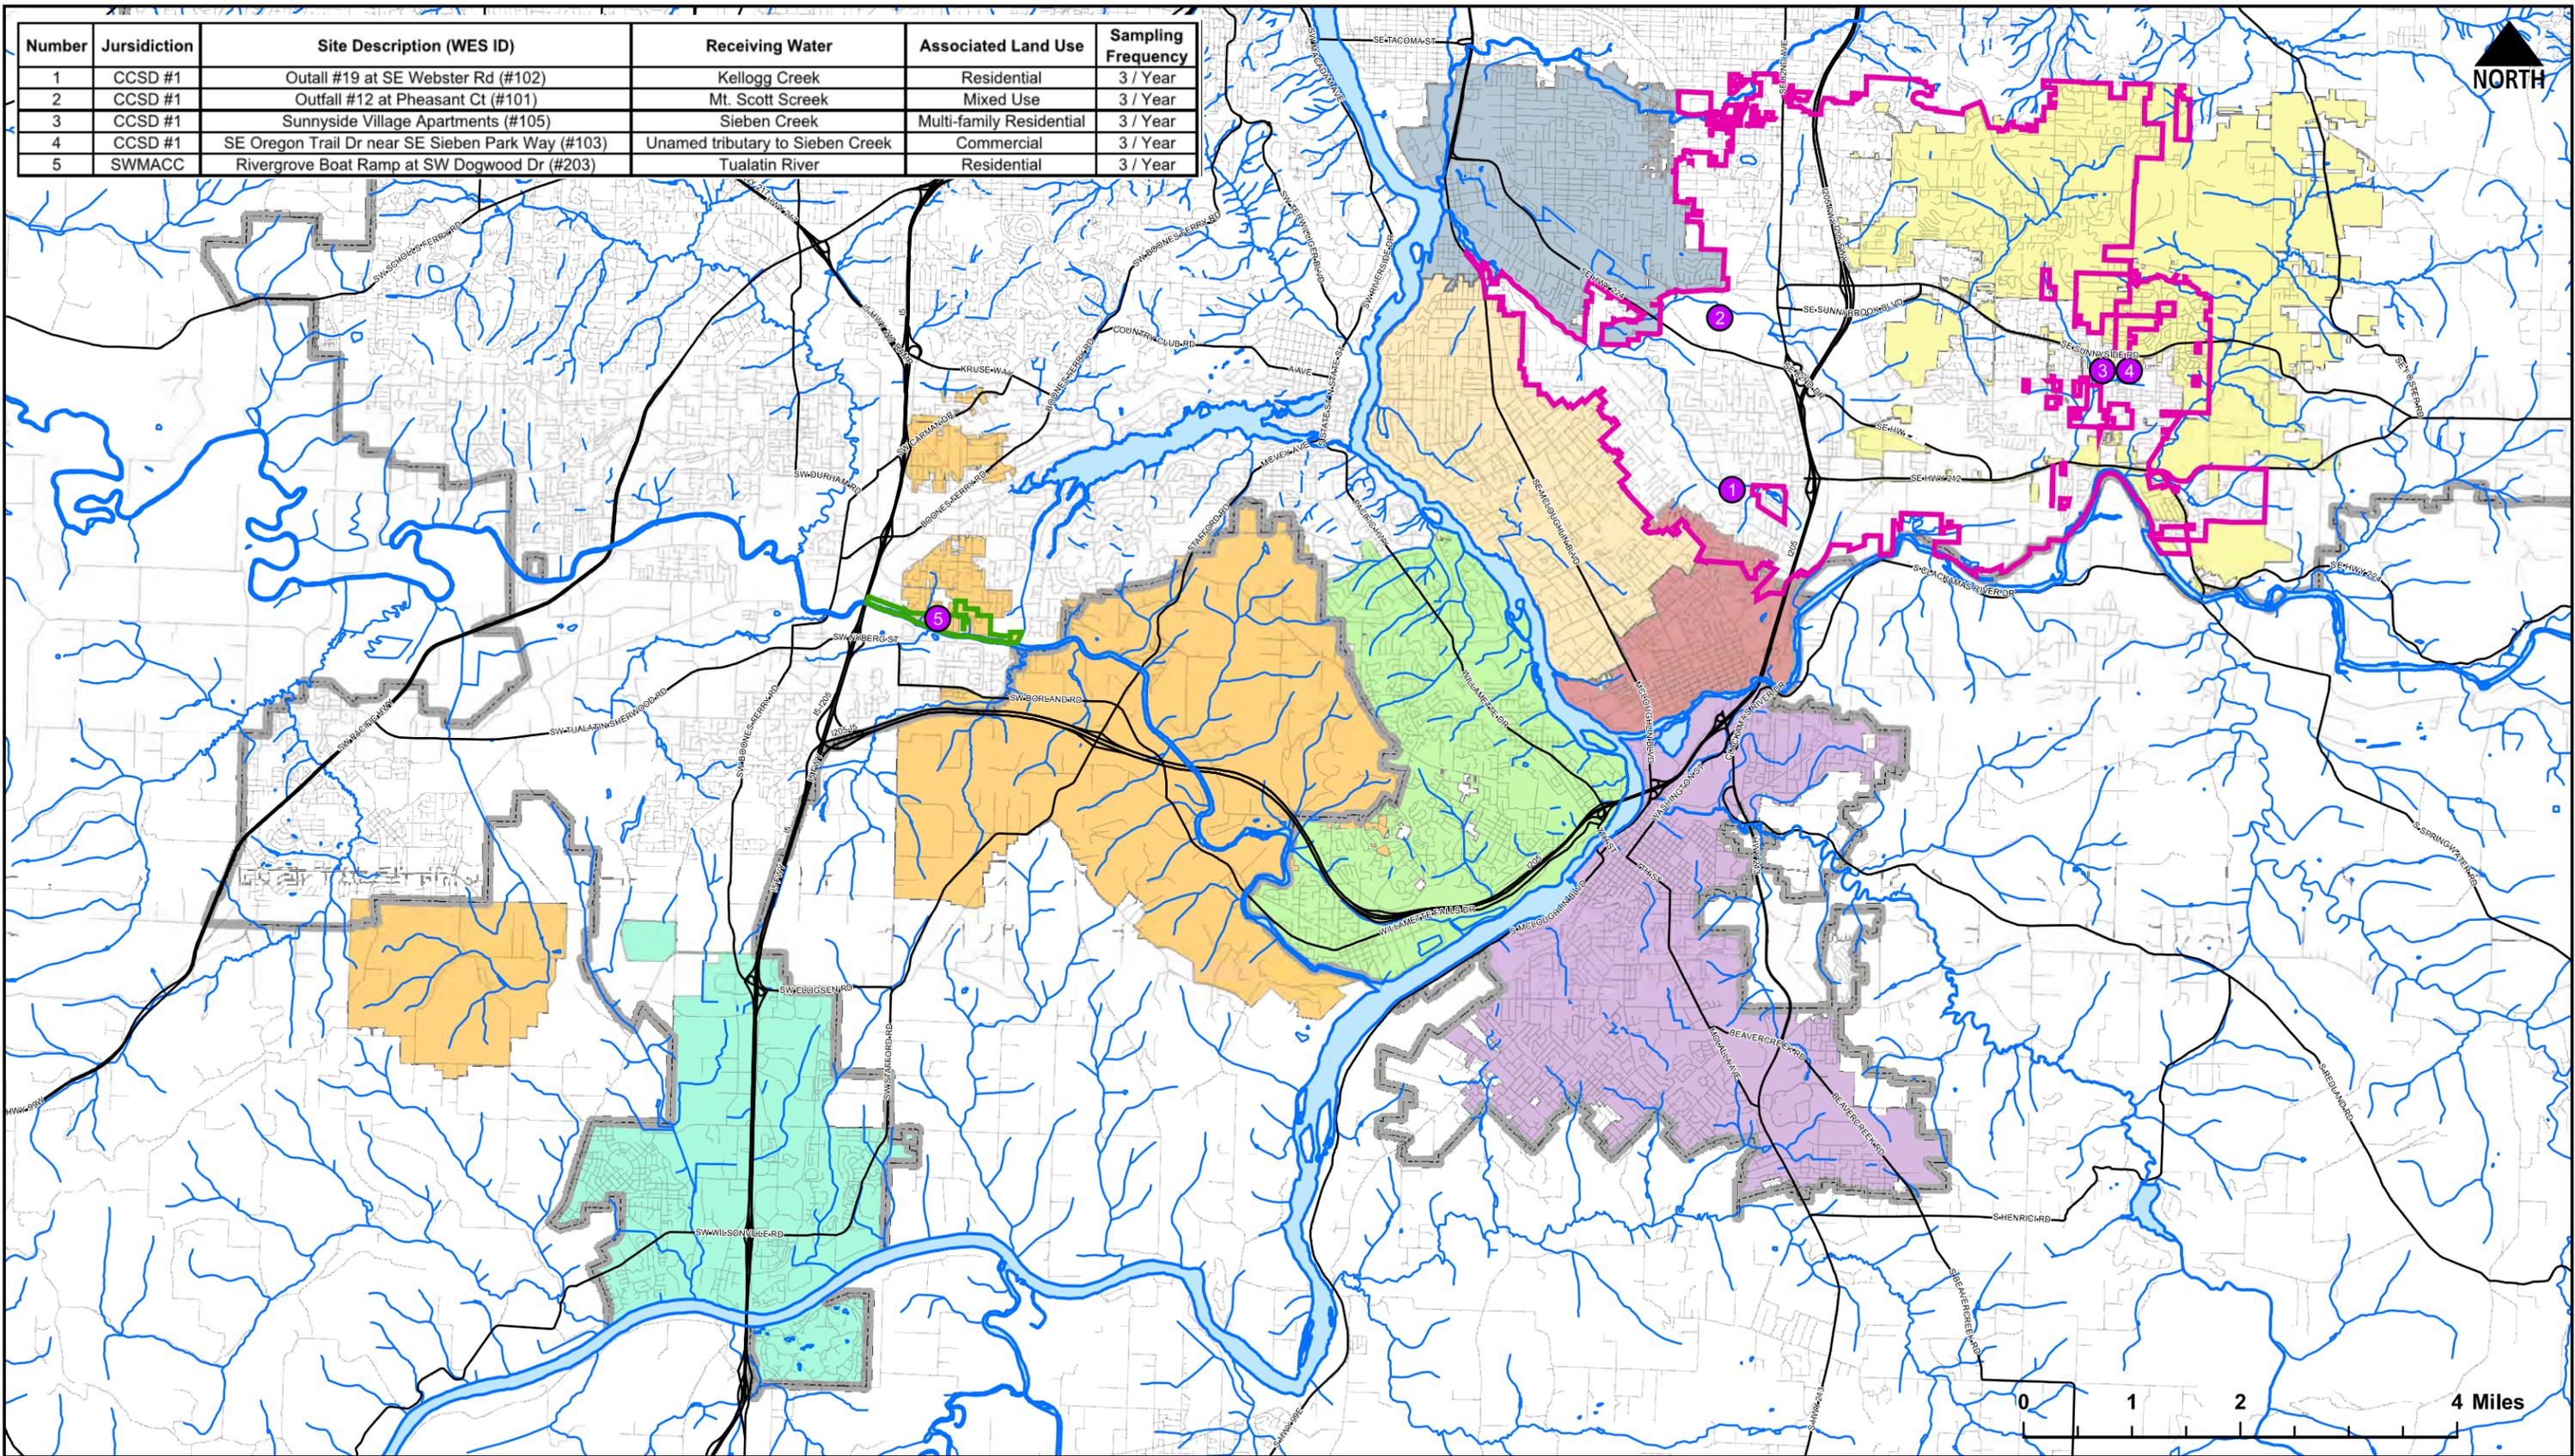
Number	Jurisdiction	Site Description (WES ID)	Receiving Water	Associated Land Use	Sampling Frequency
1	CCSD #1	Outfall #19 at SE Webster Rd (#102)	Kellogg Creek	Residential	3 / Year
2	CCSD #1	Outfall #12 at Pheasant Ct (#101)	Mt. Scott Creek	Mixed Use	3 / Year
3	CCSD #1	Sunnyside Village Apartments (#105)	Sieben Creek	Multi-family Residential	3 / Year
4	CCSD #1	SE Oregon Trail Dr near SE Sieben Park Way (#103)	Unnamed tributary to Sieben Creek	Commercial	3 / Year
5	SWMACC	Rivergrove Boat Ramp at SW Dogwood Dr (#203)	Tualatin River	Residential	3 / Year

FIGURE B-1. STORMWATER MONITORING LOCATIONS

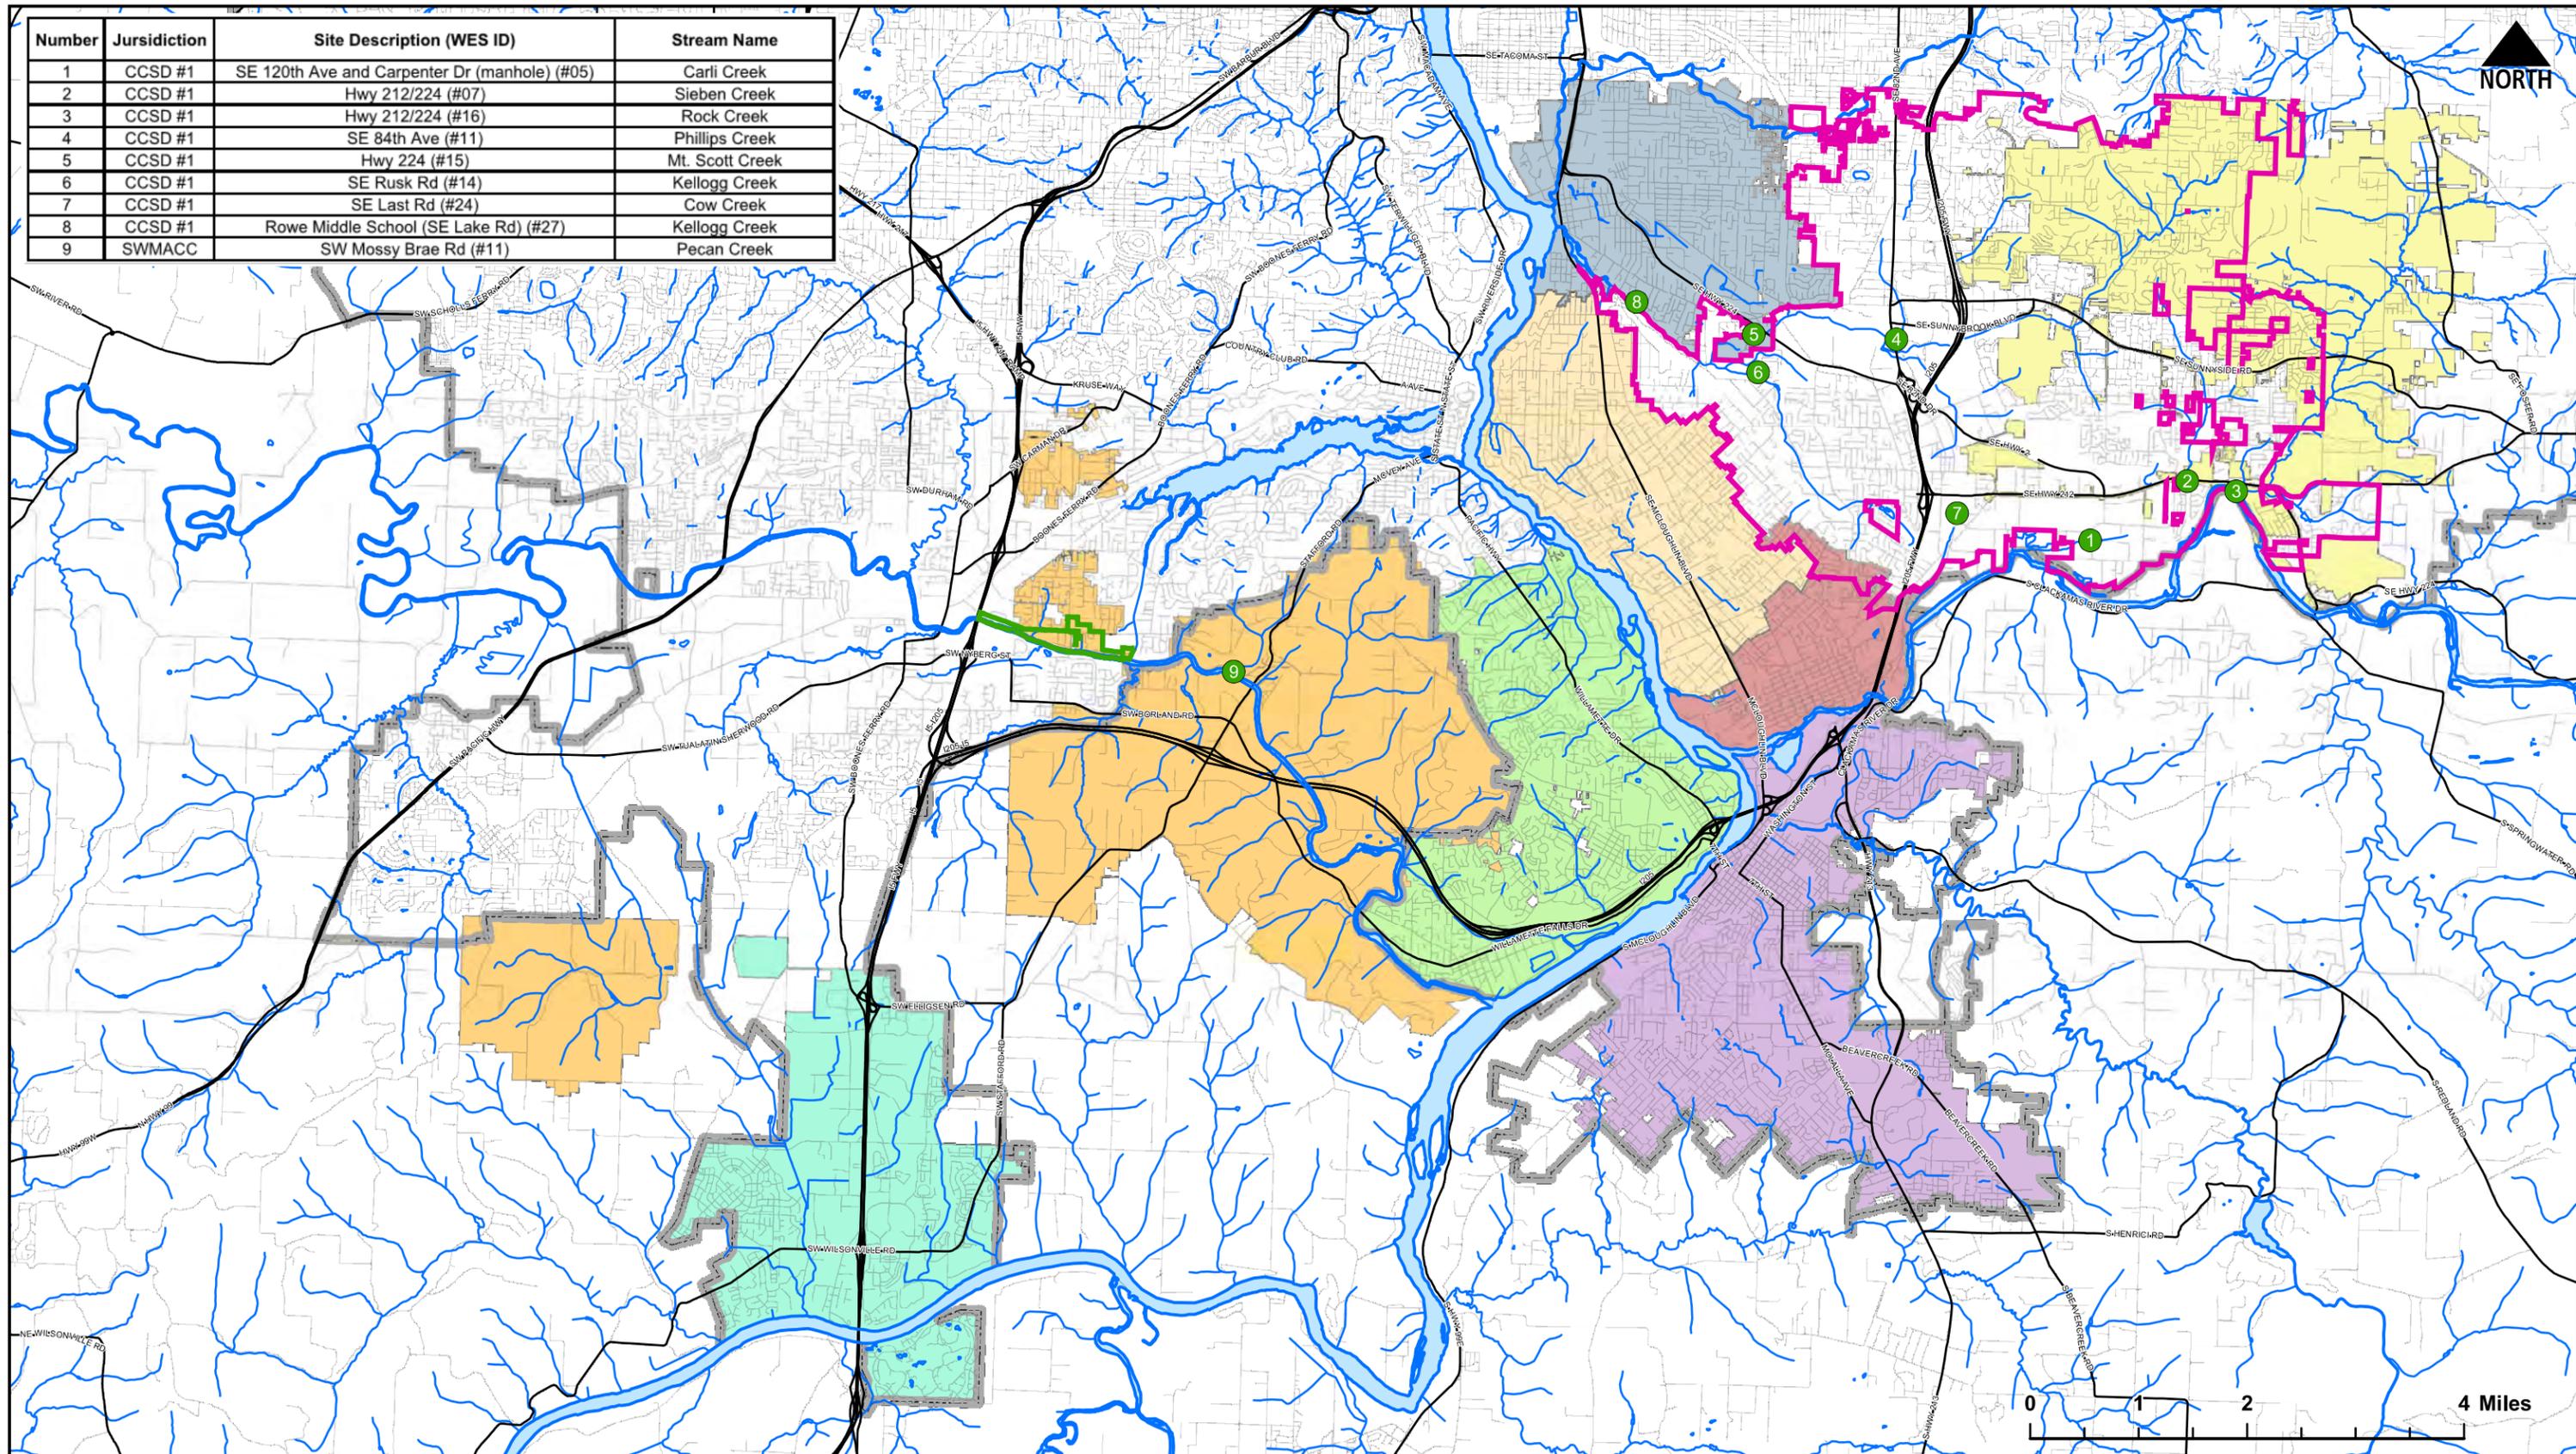
Number	Jurisdiction	Site Description (WES ID)	Stream Name
1	CCSD #1	SE 120th Ave and Carpenter Dr (manhole) (#05)	Carli Creek
2	CCSD #1	Hwy 212/224 (#07)	Sieben Creek
3	CCSD #1	Hwy 212/224 (#16)	Rock Creek
4	CCSD #1	SE 84th Ave (#11)	Phillips Creek
5	CCSD #1	Hwy 224 (#15)	Mt. Scott Creek
6	CCSD #1	SE Rusk Rd (#14)	Kellogg Creek
7	CCSD #1	SE Last Rd (#24)	Cow Creek
8	CCSD #1	Rowe Middle School (SE Lake Rd) (#27)	Kellogg Creek
9	SWMACC	SW Mossy Brae Rd (#11)	Pecan Creek

FIGURE B-2. INSTREAM MONITORING LOCATIONS
