Policy Session Worksheet

Presentation Title: Upper Sandy River Area Flood Erosion Study

Flood Erosion Hazard Mitigation Evaluation

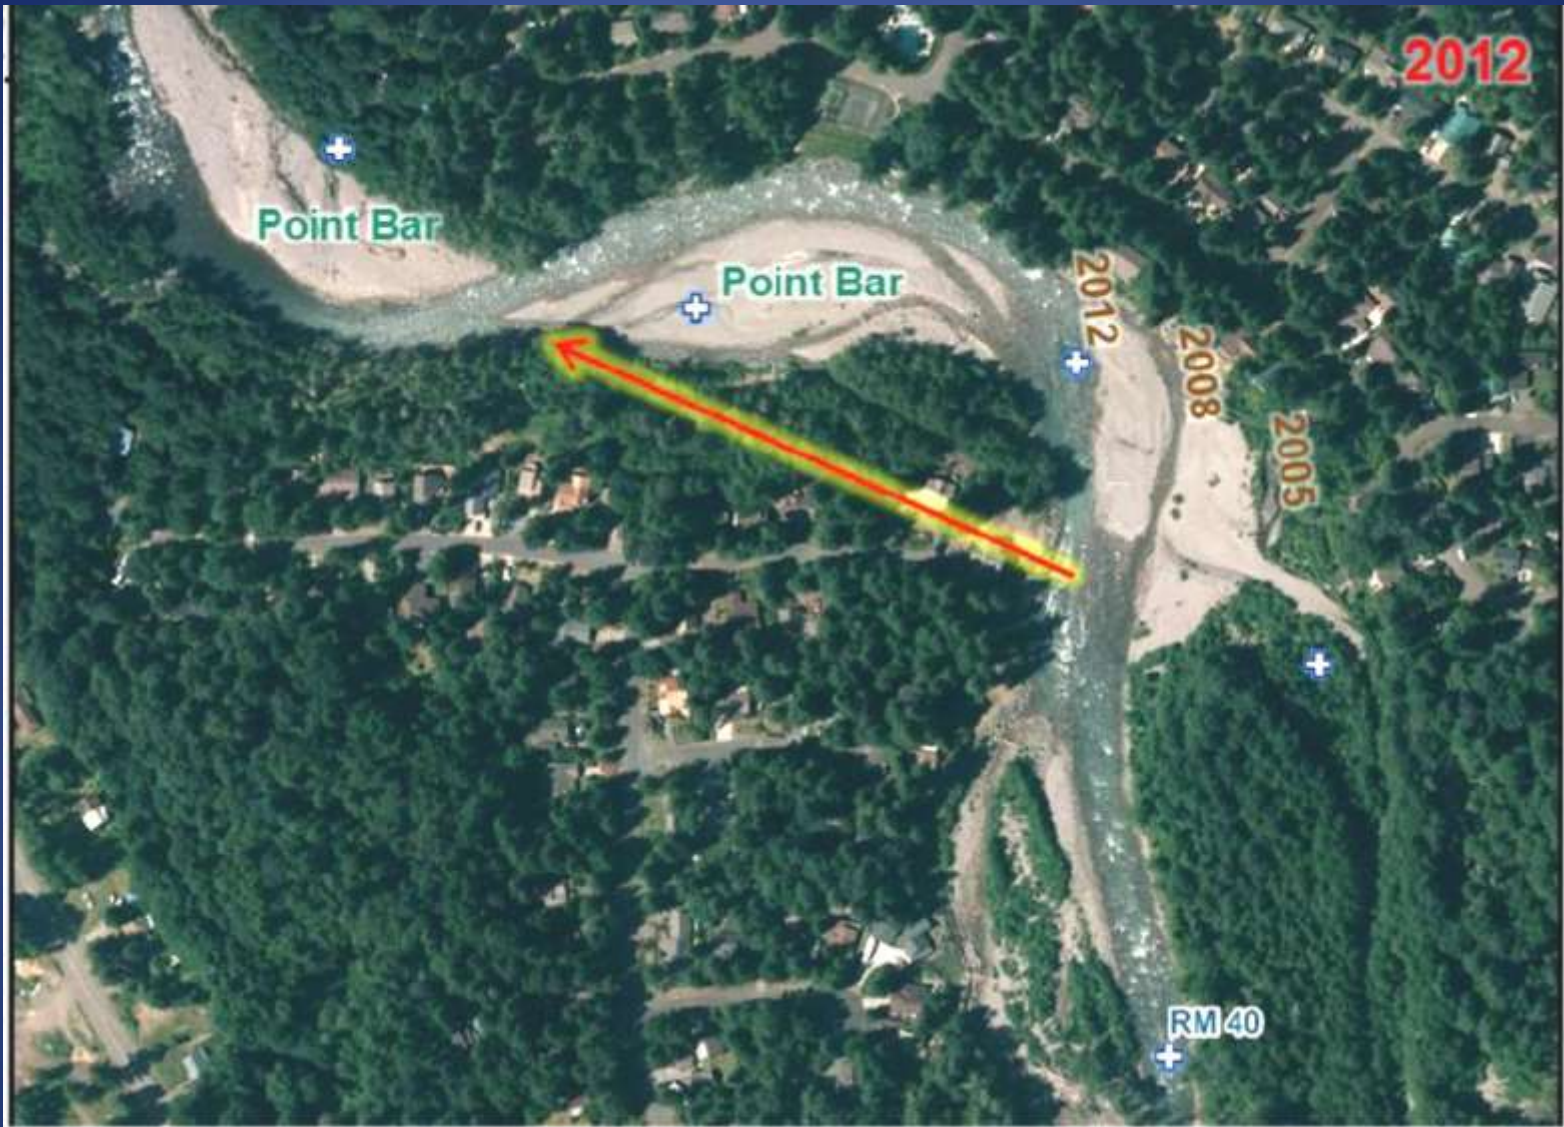
Figure 23. Timberline Rim Channel Migration. This group of air photos shows the lateral and downstream migration of the large bend adjacent to the Timberline Rim community. Note the remnant channel traces showing the distance of migration from 2005 to 2008 to 2012. Note also the size of the bend relative to property plats. Data sources: University of Oregon Libraries, USDA NAIP.

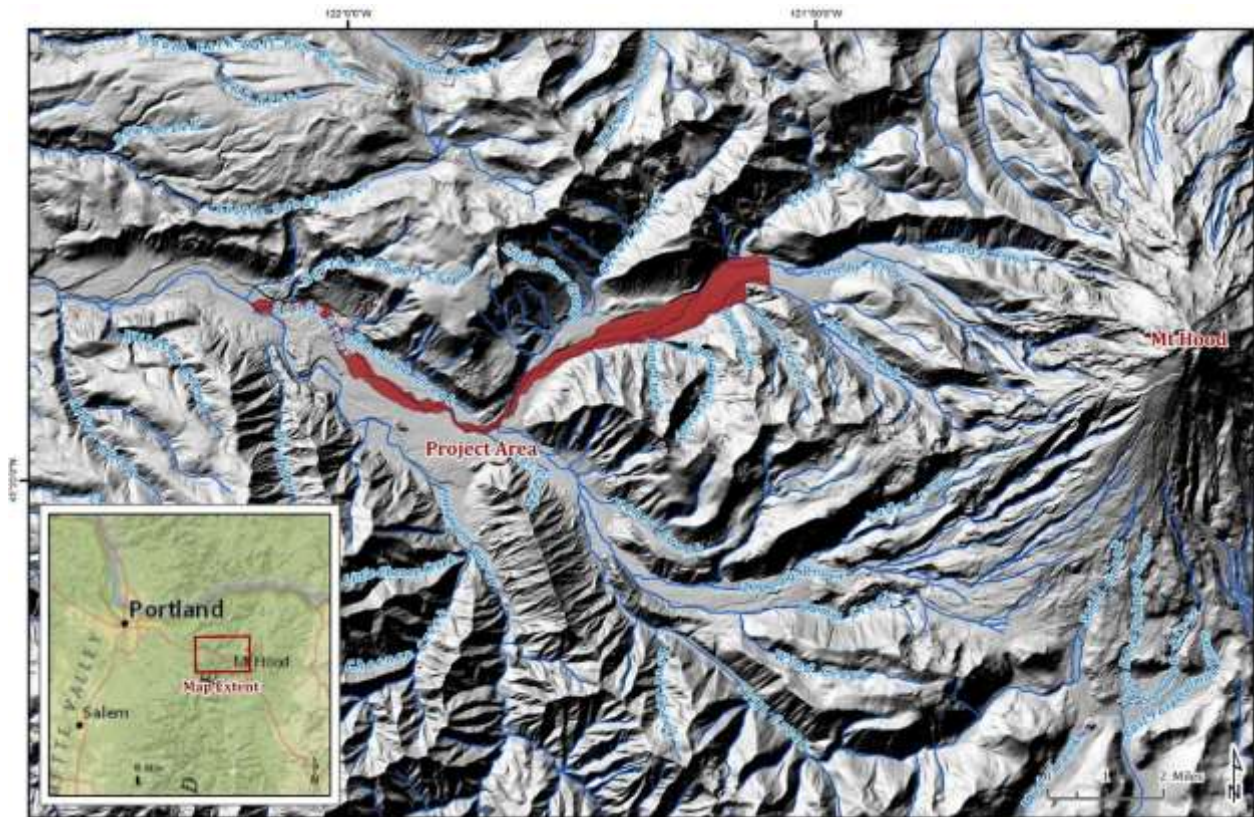
Figure 2. Project Area Map - Upper Sandy River project reach extends from the Salmon River confluence at RM 38 to about RM 49. Data sources: USGS 10m DEM, USGS NHD.

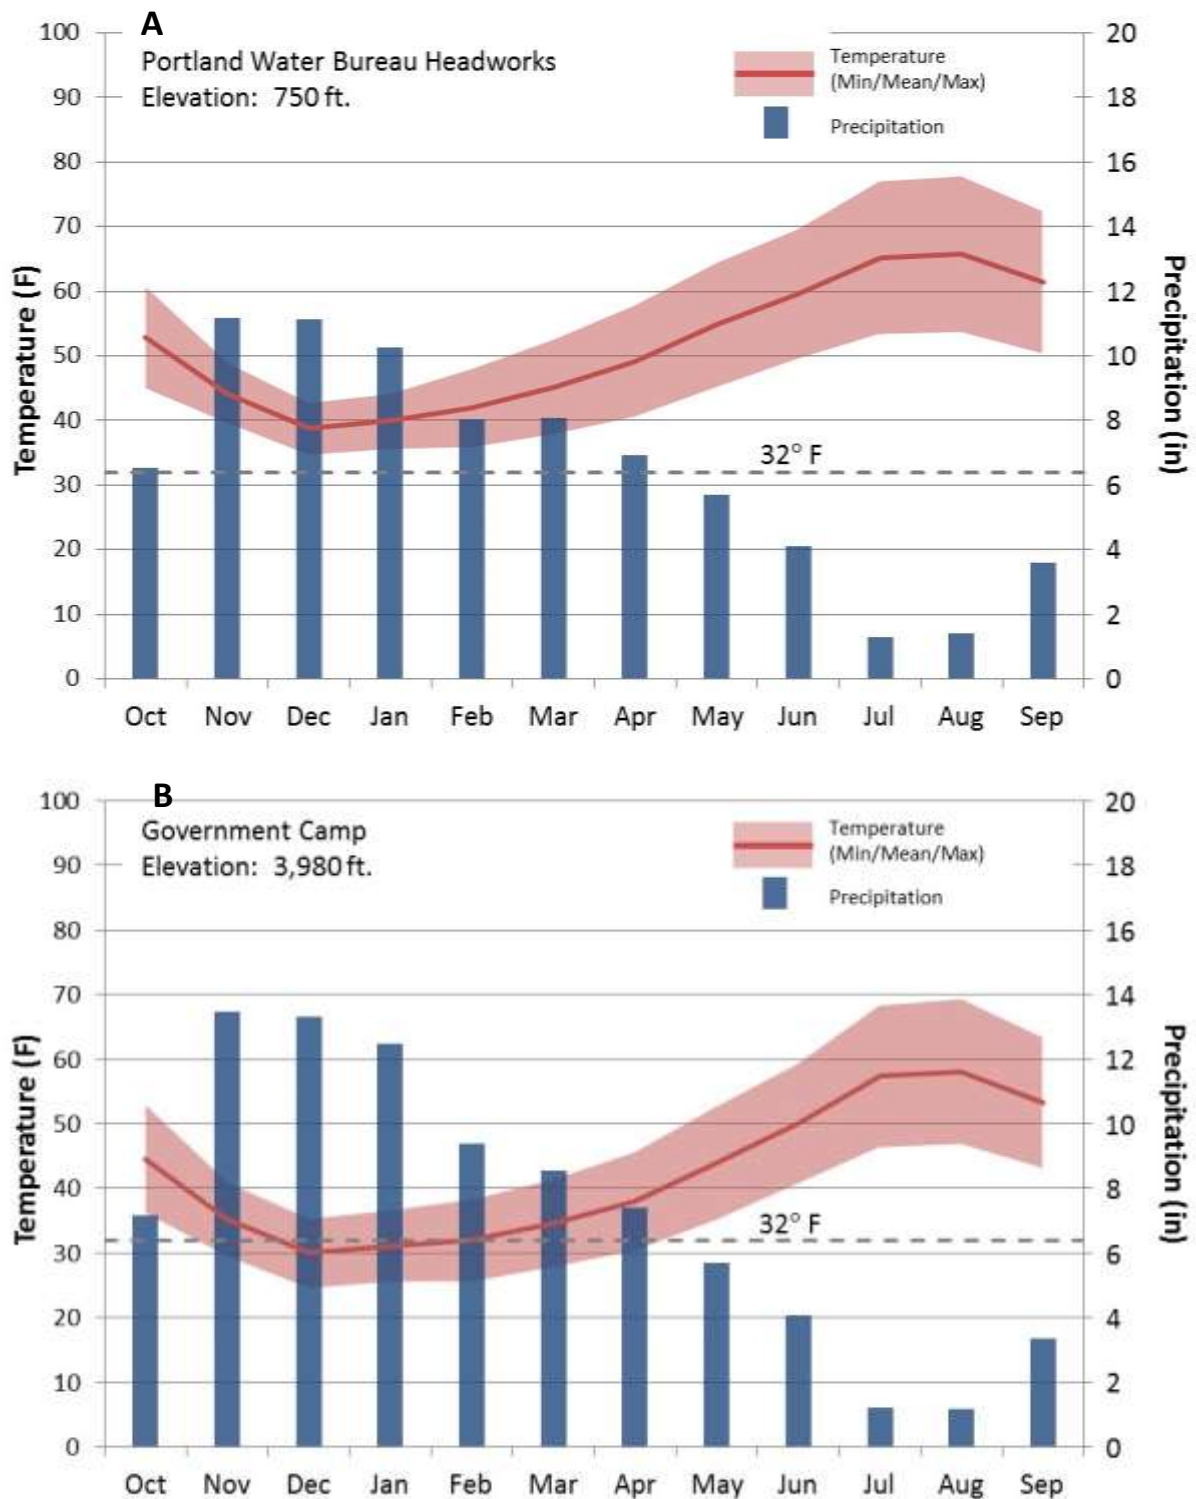
Figure 4A/B. Monthly average temperature and precipitation at the Portland Water Bureau’s Headworks site (elev. 750 feet) and Government Camp (elev. 3,980 feet). Data source: NCDC climatic normals (1981-2010).

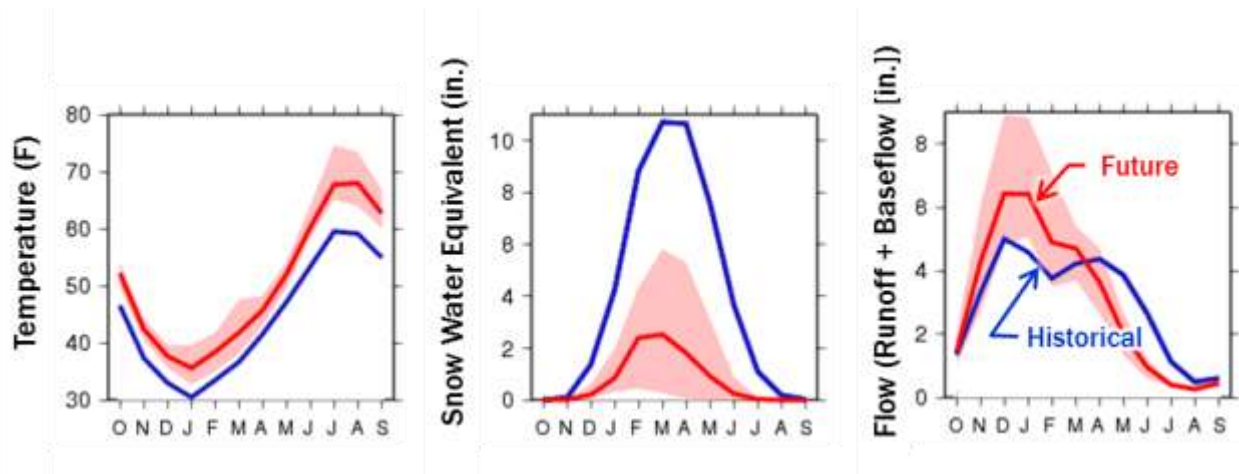
Figure 11. Simulated changes in temperature (left), snowpack (center), and runoff (right) for the Sandy River Watershed. The blue line shows the historical average and the red line shows the ensemble average from 10 climate models. The pink shading shows the range of estimated future conditions derived from the 10 climate models. Figures were downloaded from the Columbia Basin Climate Change Scenarios Project website at <http://warm.atmos.washington.edu/2860/>.

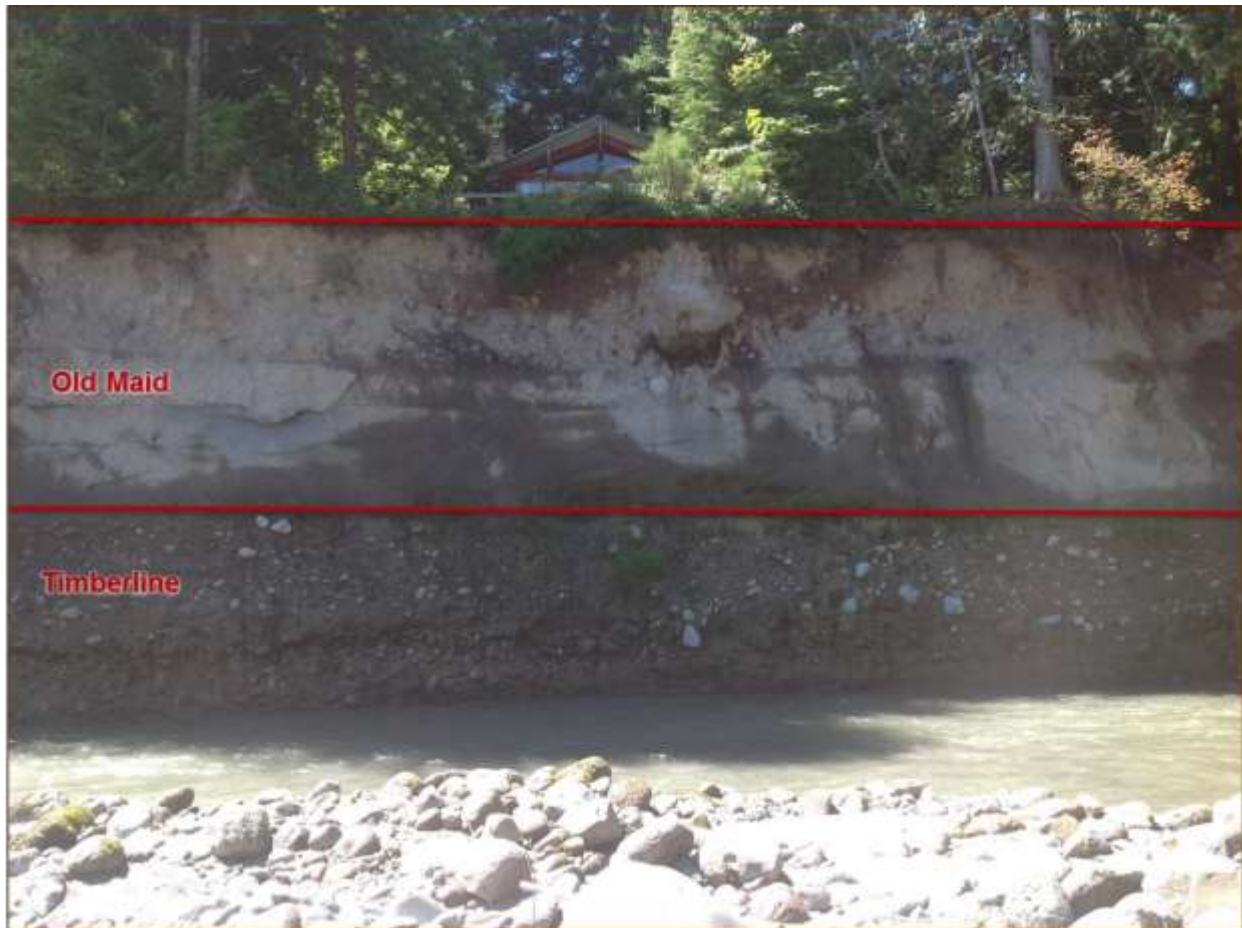
Figure 12. Old Maid and Timberline Lahar Deposits. The cut bank is located on the left bank downstream of the Zigzag confluence at RM 42.3. This site is one of only a few where the river has exposed and is currently eroding the Timberline lahar deposit. As the Timberline erodes, the Old Maid lahar is undermined and fails.

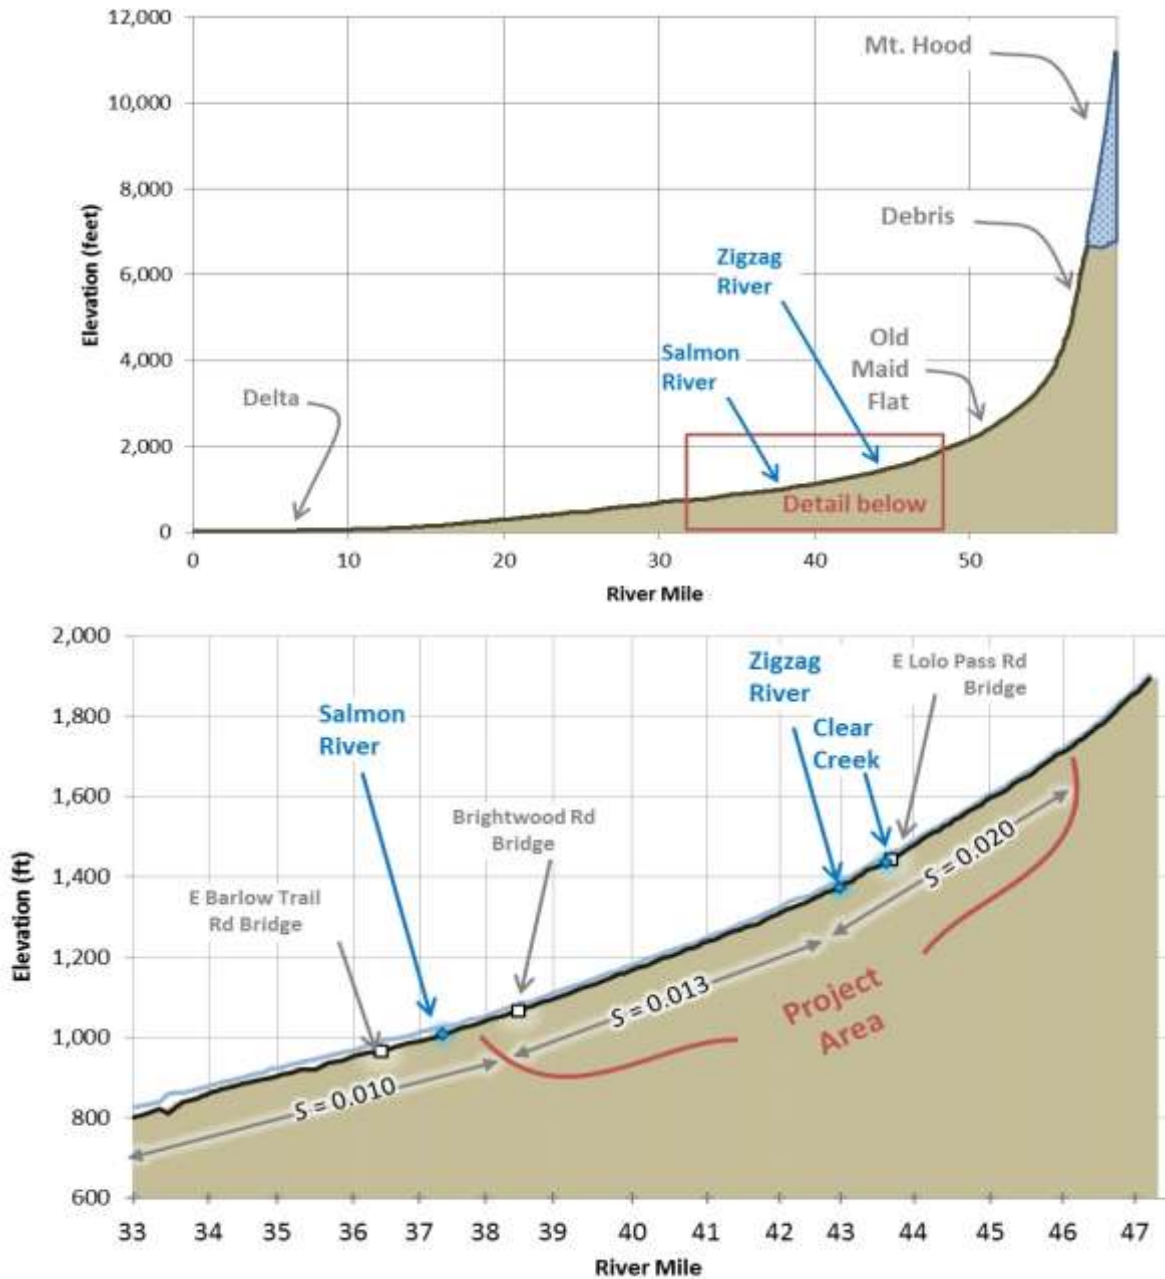
Figure 13. Valley Profile - The project area is situated roughly 10 miles from the Sandy River source area on Mt Hood. Average valley gradients through the project area range from 2 percent above the Zigzag River to 1 percent. at the Salmon River confluence.

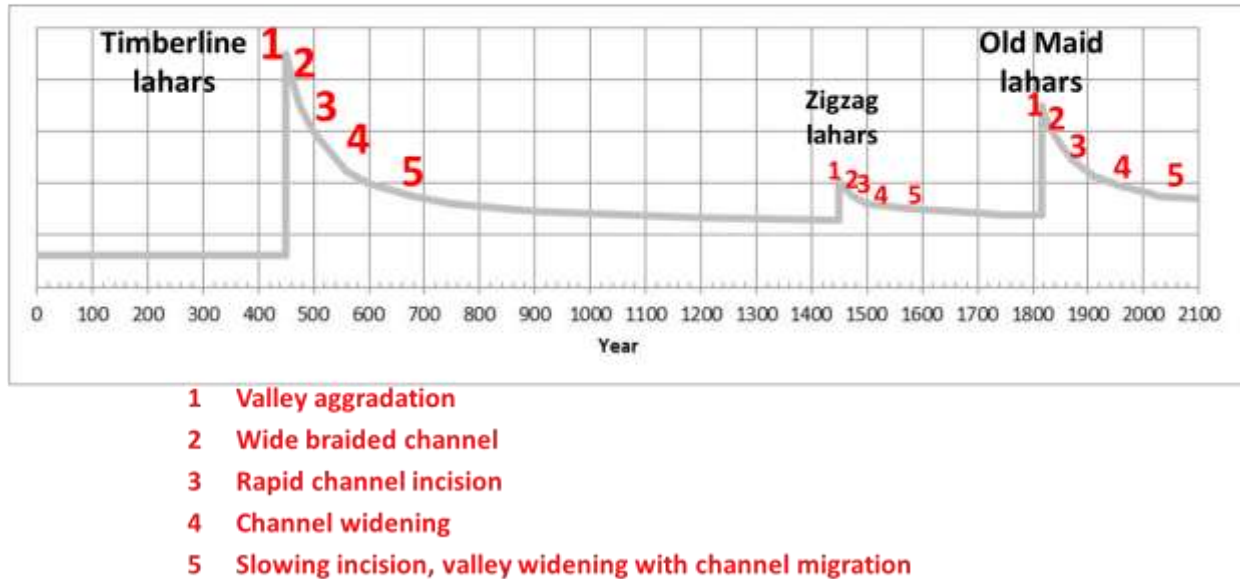
Figure 16. Sequence of elevation changes over time.

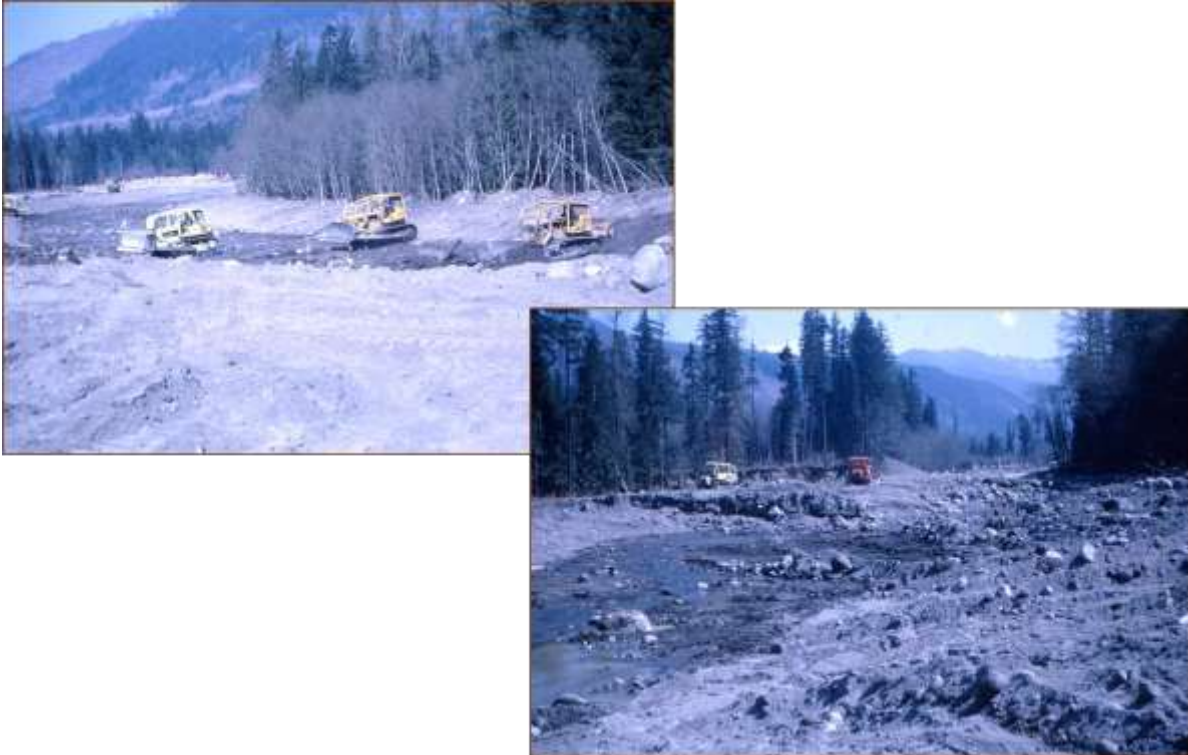
Figure 19. Army Corps of Engineers Bull Dozers Re-Grading the 1964 Channel. Following the 1964 flood the ACOE mechanically graded over the active channel to recover the pre-'64 single stem channel. The re-grading straightened and shortened the 1964 channel, increasing the channel gradient in the process. Note the large proportion of fine grained materials comprising the flood deposits. Photos courtesy of Raymond Arrigotti.

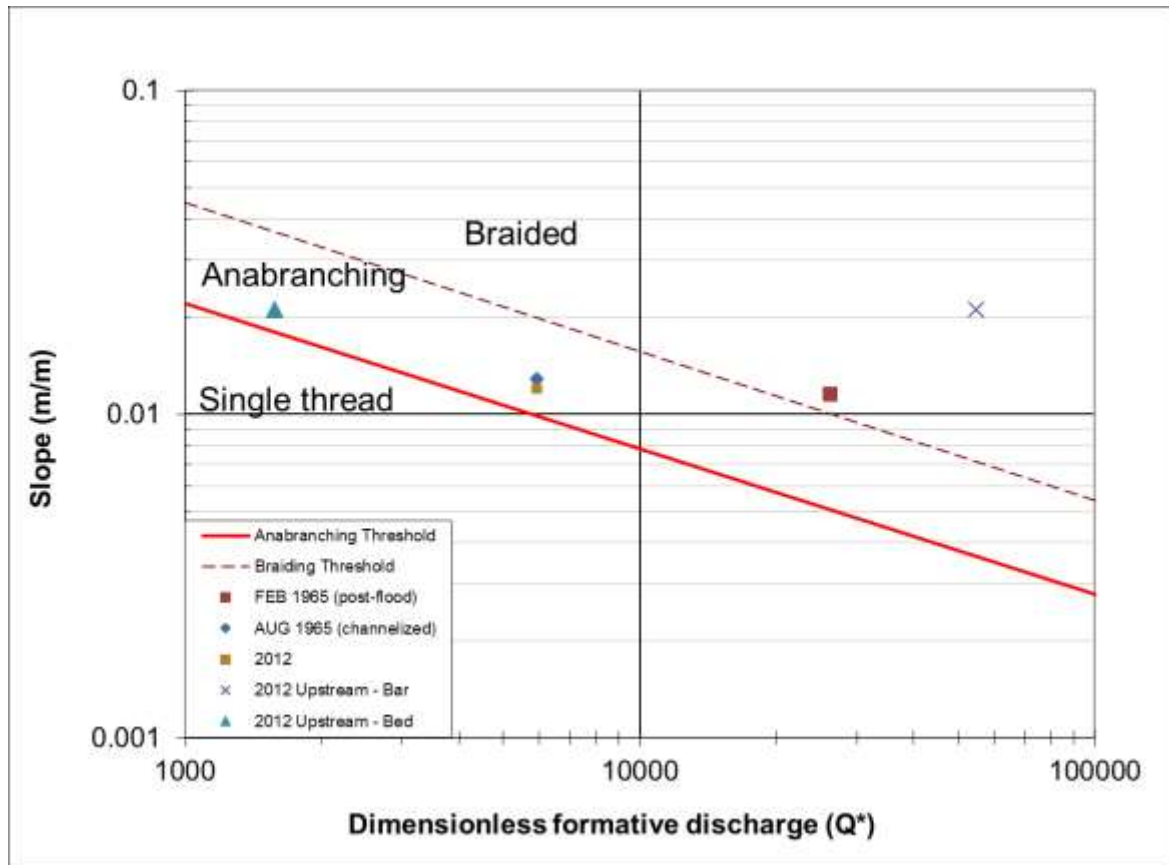
Figure 22. Anabranching Threshold for Sandy River. After Eaton et al. 2010.

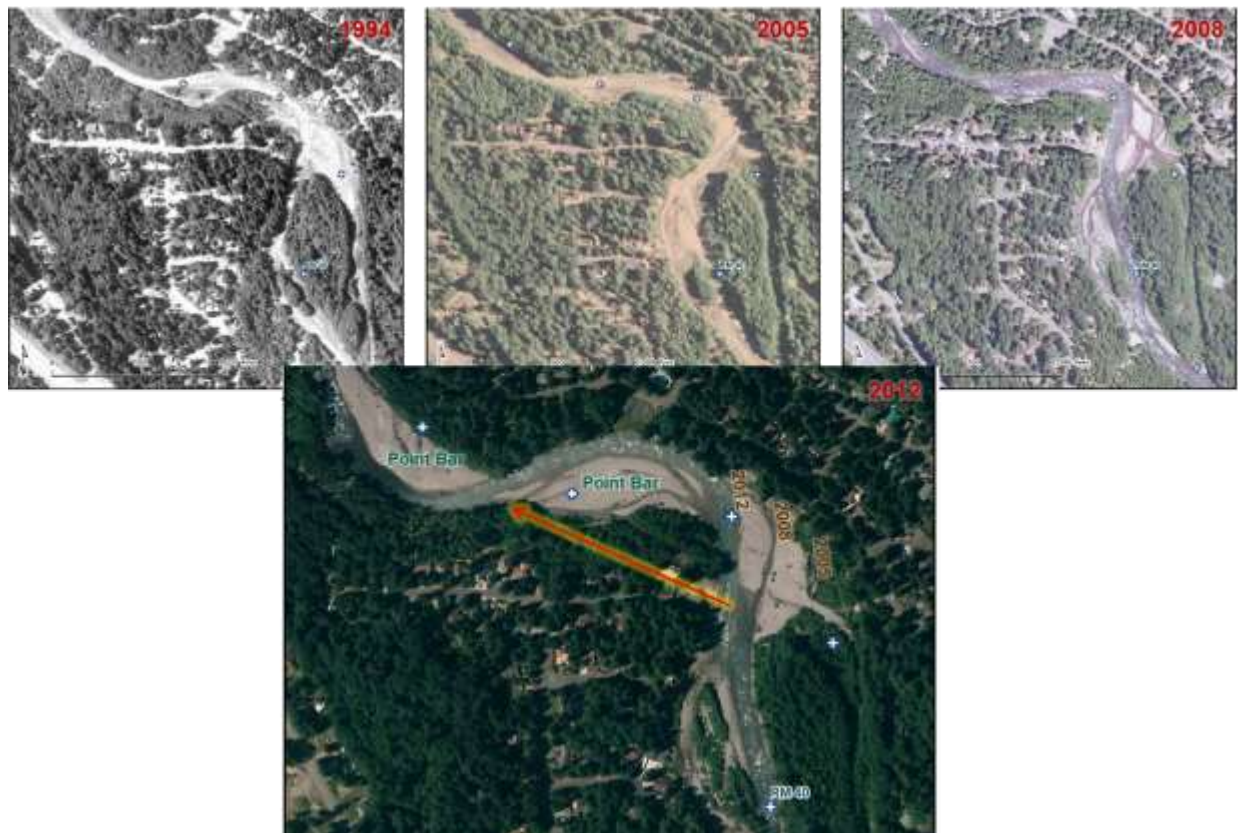
Figure 23. Timberline Rim Channel Migration. This group of air photos shows the lateral and downstream migration of the large bend adjacent to the Timberline Rim community. Note the remnant channel traces showing the distance of migration from 2005 to 2008 to 2012. Note also the size of the bend relative to property plats. Data sources: University of Oregon Libraries, USDA NAIP.

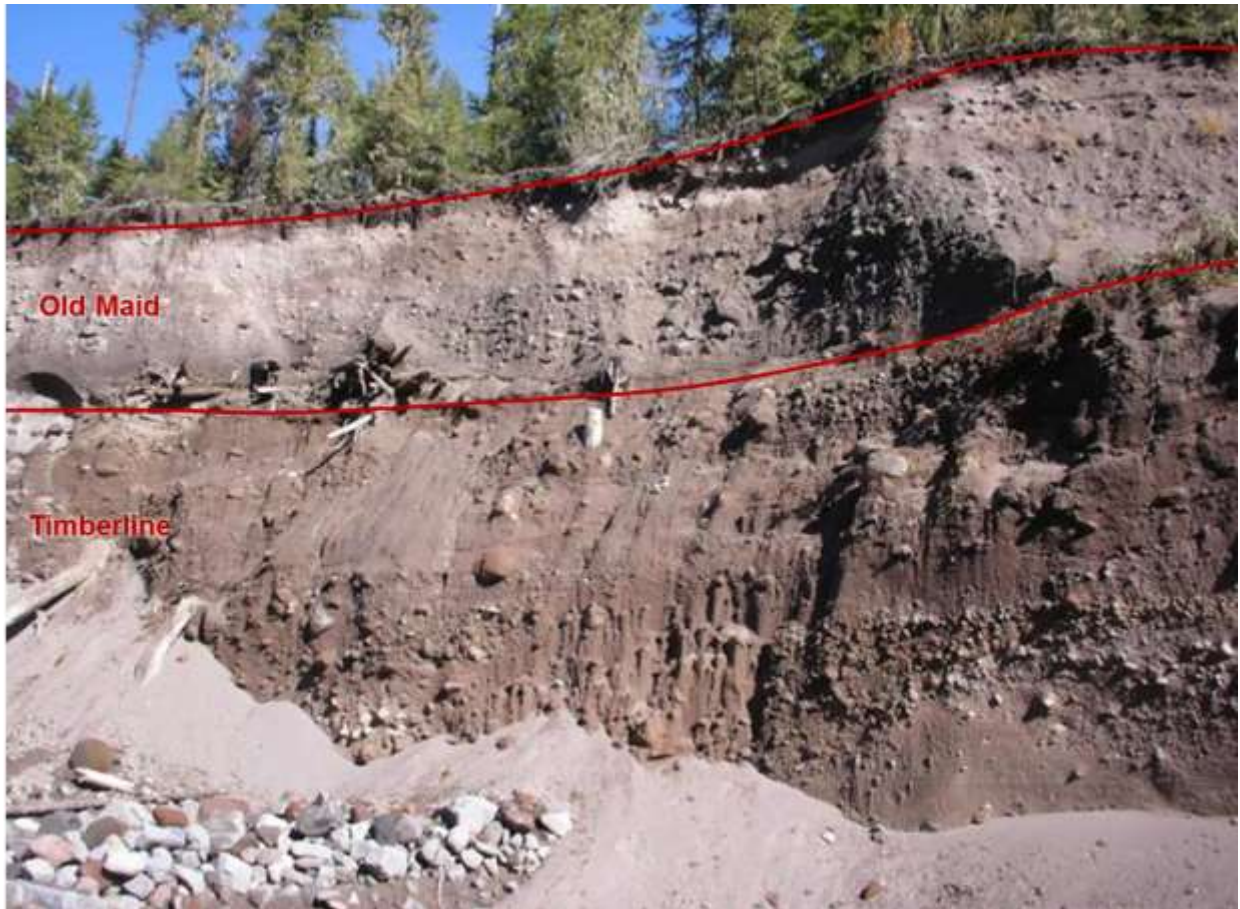
Figure 28. Old Maid and Timberline Lahar Deposits. A slope face composed of a thick Timberline lahar deposit overlain by the Old Maid lahar deposit. The slope face is set well back from the river. The lahar unit have been exposed by hillslope weathering processes. Note the collection of woody debris at the top of the Timberline lahar, buried by the Old Maid unit, suggesting the former presence of running water.

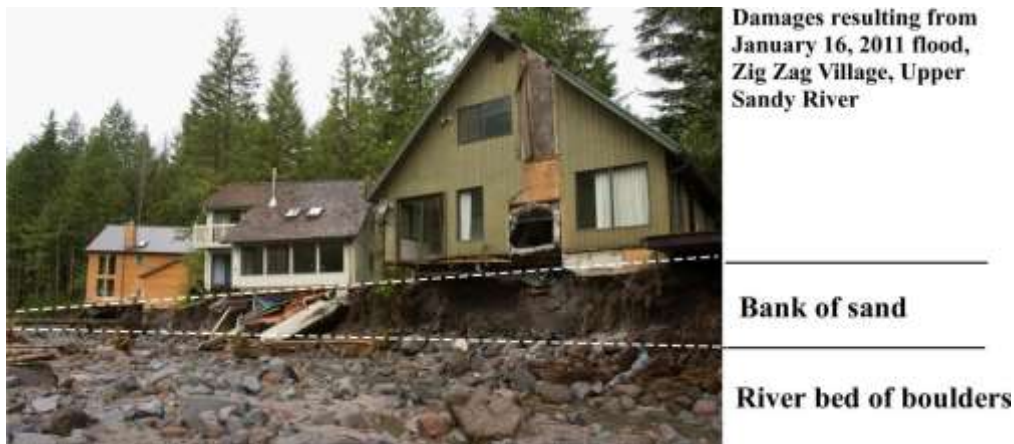
Figure 30. Home damage along the Upper Sandy River due to erosion in 2011 along right bank at Zigzag Village development, RM 45.1. Like much of Upper Sandy, the bank is composed of fine sediment that is more easily eroded than the coarse material of the river bed. Photo credit: *The Oregonian* newspaper.

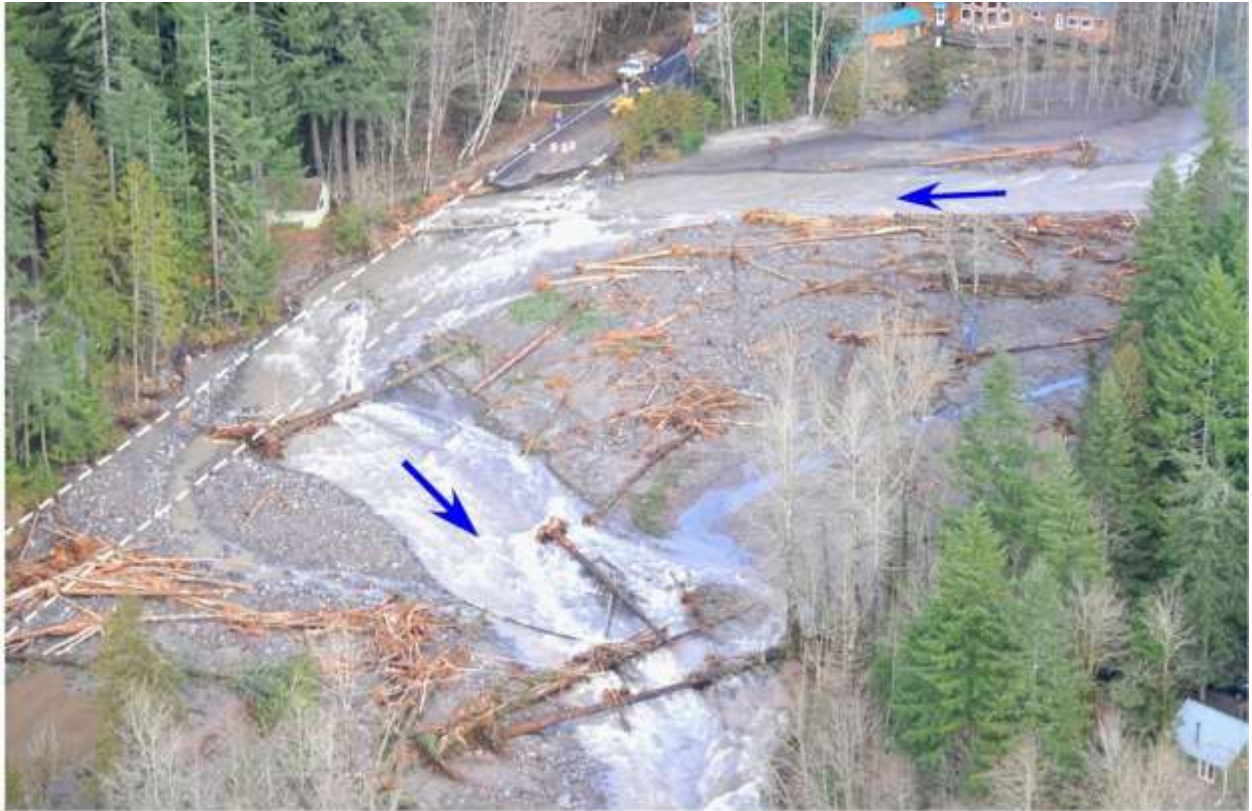
Figure 32. Upper Sandy RM 44.1 Lolo Pass Road washout in 2011. The channel moved through the road adding over 60 ft to its migration zone. The flood left a net increase in the quantity of wood in the channel which added additional flow resistance and enhanced fish habitat. Historic confinement and wood clearing has concentrated the river's energy and severely limited the formation of beneficial salmon habitat. Providing the river with more room to move and implementing flood protection measures that focus on energy dissipation will not only improve habitat but reduce long-term flood protection costs. In this case the road was rebuilt in its pre-existing location.

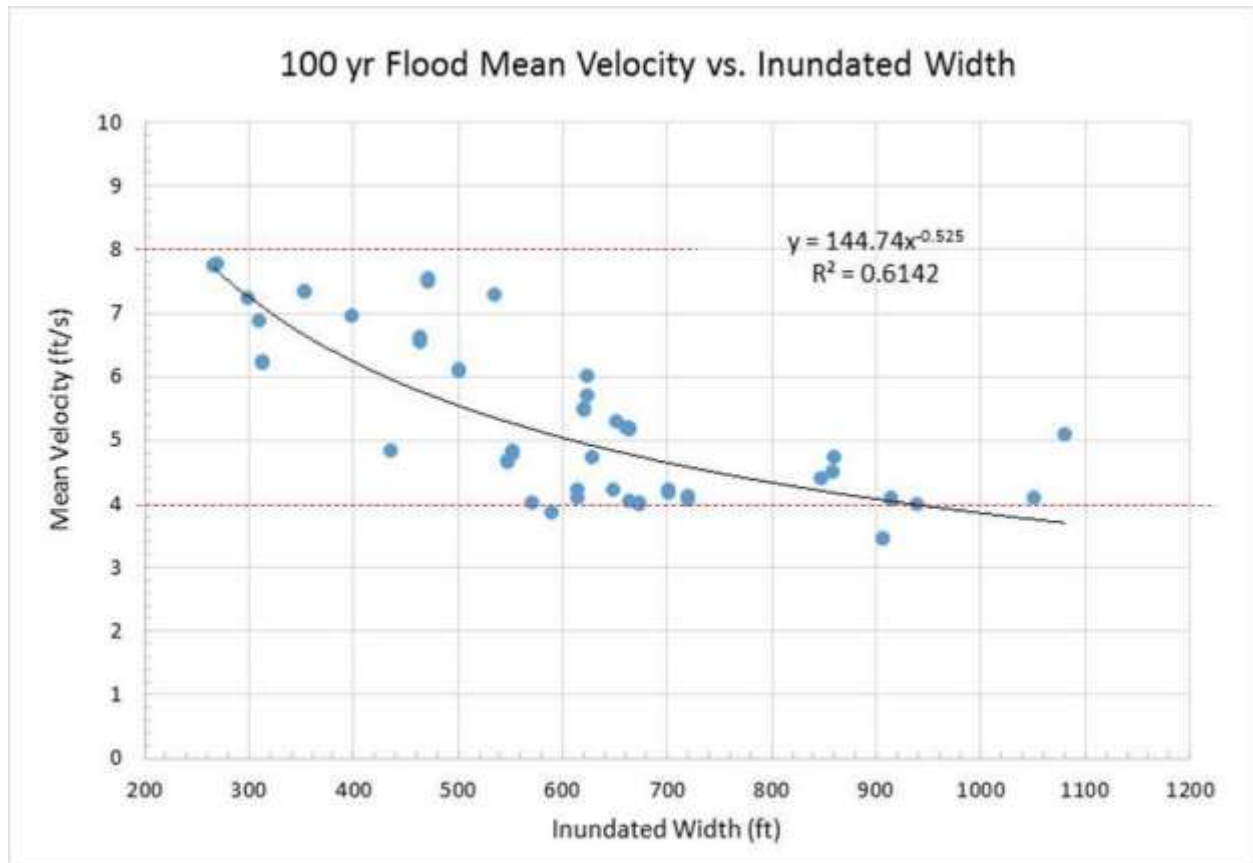
Figure 33. Output from HEC-RAS hydraulic model showing how mean velocities during the 100 yr flood decrease as a function of the inundated (floodplain) width, showing an approximately 2-fold drop when it reaches 900-1100 ft in width. This provides guidance for a minimum zone in which channel migration can be managed.

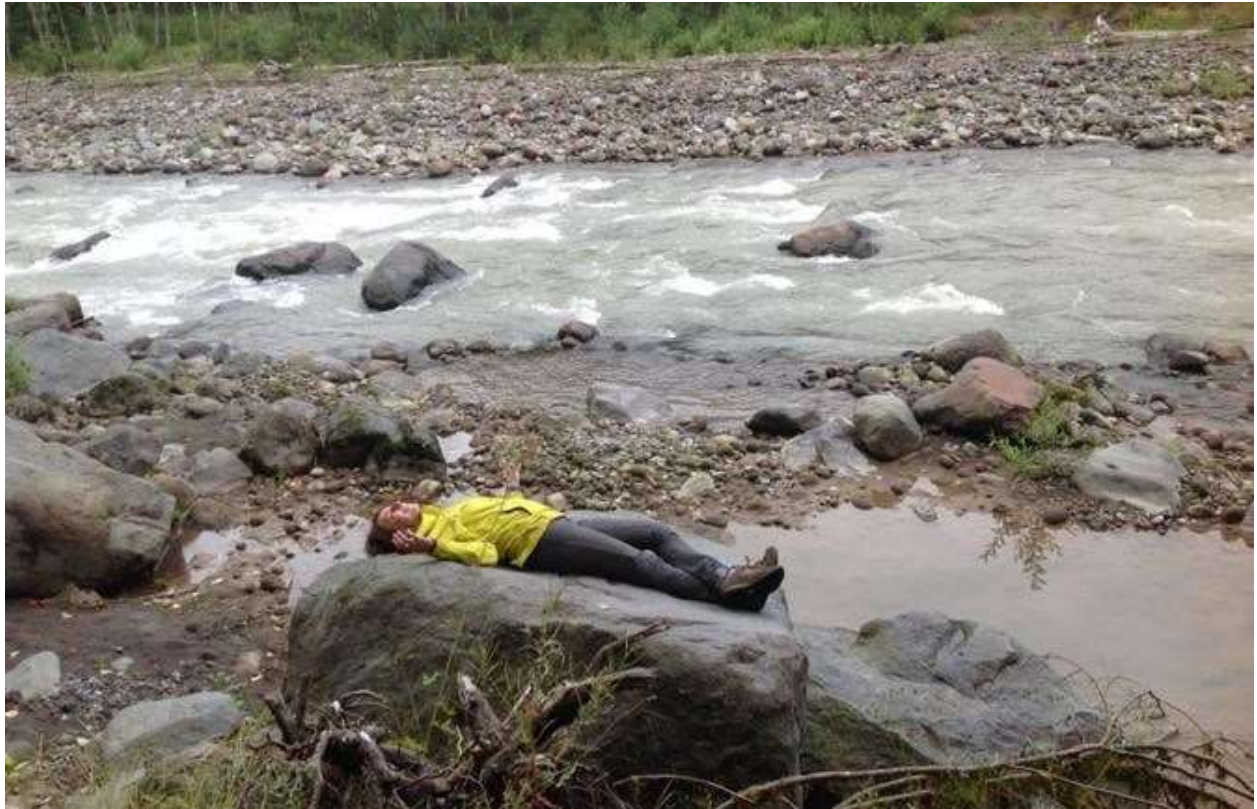
Figure 35. The Upper Sandy has a very high sediment transport capacity, leaving a coarse river bed comprised of large cobbles and boulders. The larger boulders reflect the size of rock needed to be stable. View from left bank at RM 40.65, July 2014, flow is from right to left.

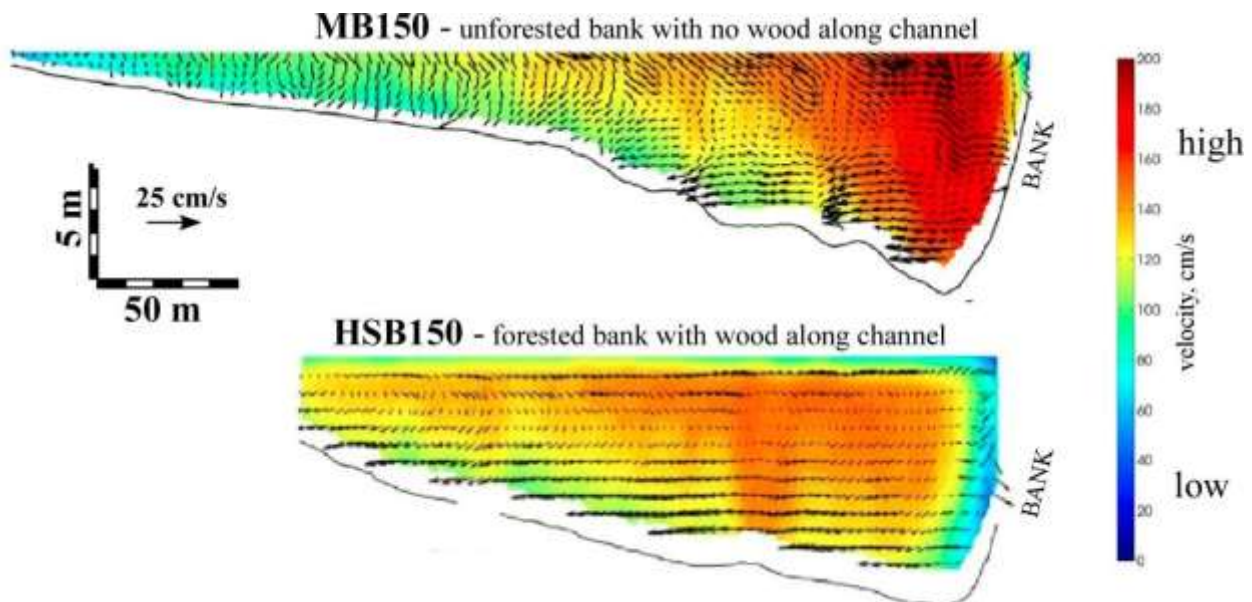
Figure 38. Flow velocity fields around two bends of Lower Wabash River, Illinois. Cross-section MB 150 is downstream of meander apex with relatively smooth bank, HSB72 is cross-section in similar location of bend where there are snags along the bank. The roughness created by the snags along HSB72 slows down velocities near the bank. Erosion rates at HSB72 are 17 times less than MB 150 (Konsoer 2014).

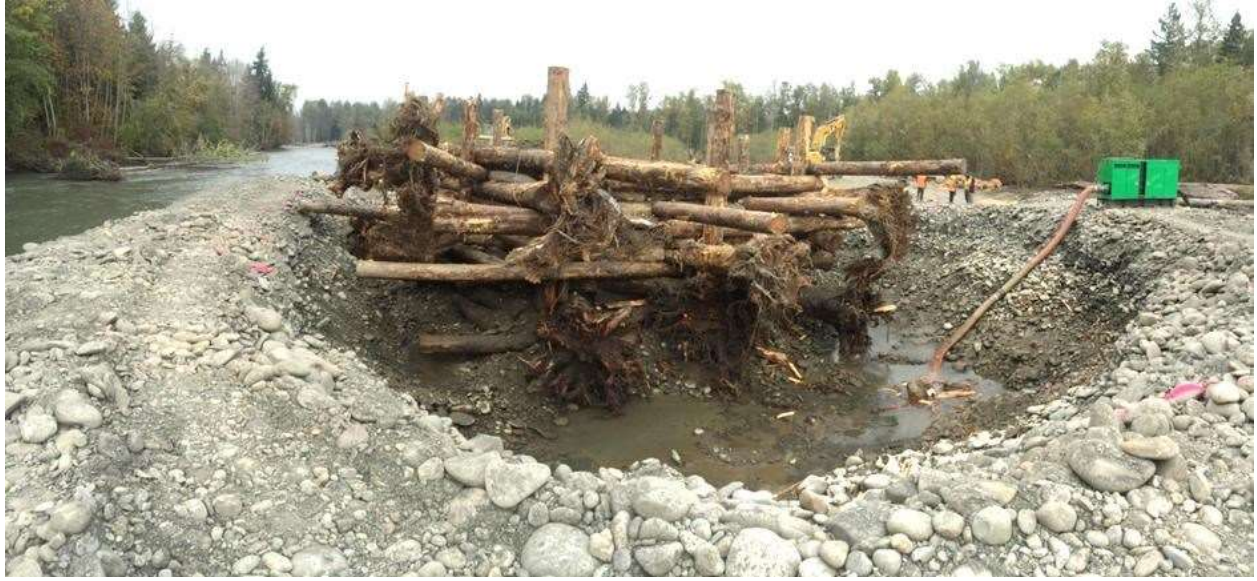
Figure 43. Example of engineered logjam that doesn't have self-settling elements of previous examples. This structure is deeply embedded into the river so that it can withstand scour without being compromised. Note people on right side of the structure. Pit is 16 feet deep and timber posts extend deeper. Elwha River 2014.

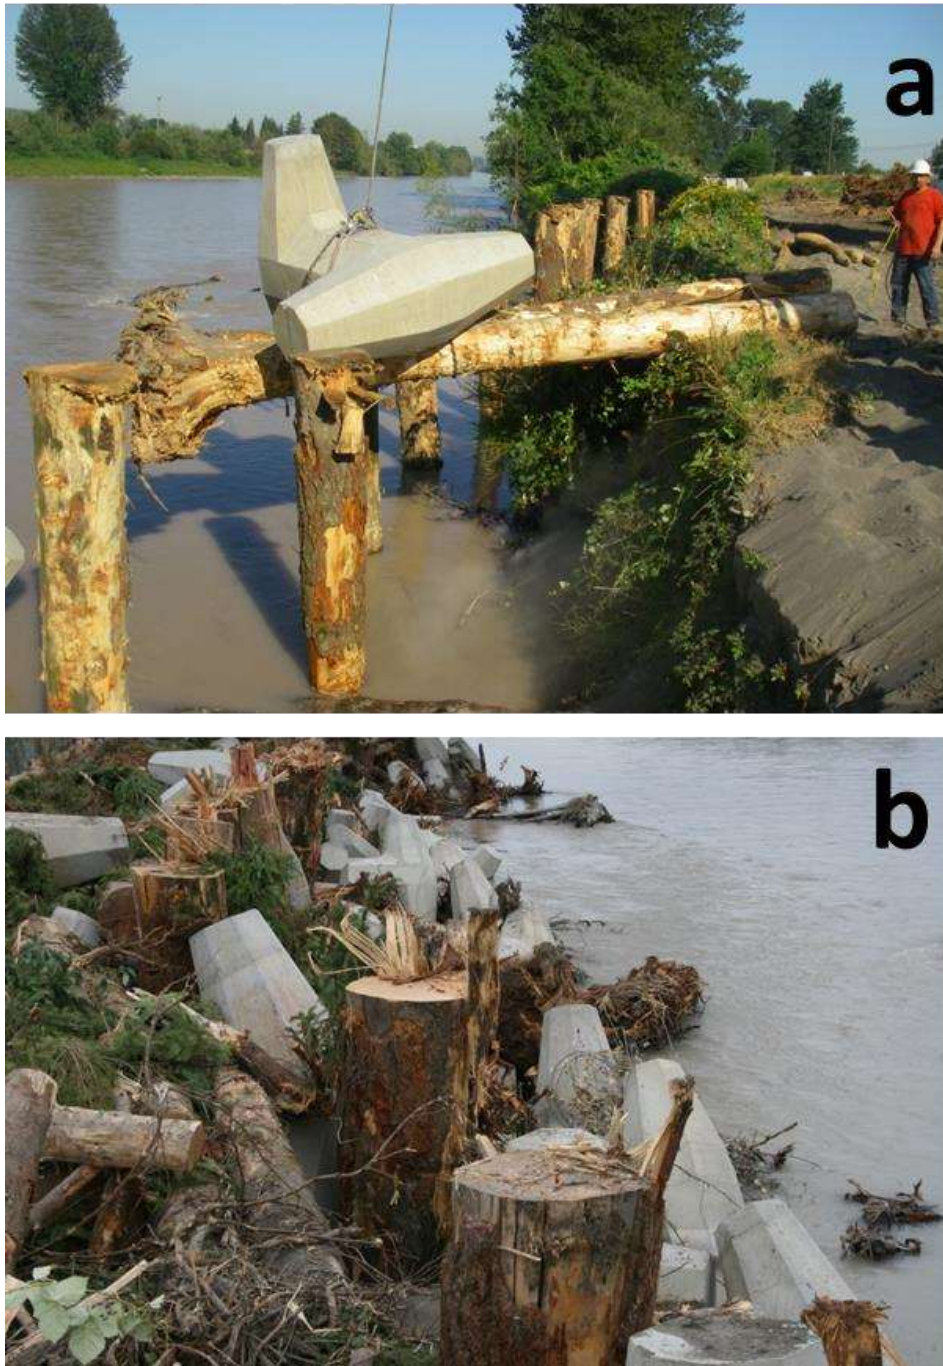
Figure 44A/B. Using a combination of timber and dolosse has been used in Washington State as a more restorative alternative to traditional measures to protect levees and roads. The dolosse are eight ton unreinforced concrete jacks that provide a complex interlocking shape emulating the function of natural snags. The top photo (a) shows how a dolo and attached log can be easily lowered into place and avoid expensive dewatering. Using the dolosse with logs creates a complex structure as shown in bottom photo (b) that can settle if undercut by scour, but without the need of rock or cable. The structures can be designed with lots of wood so the dolosse aren't even visible. Since they are self-settling, these structures don't need to be deeply

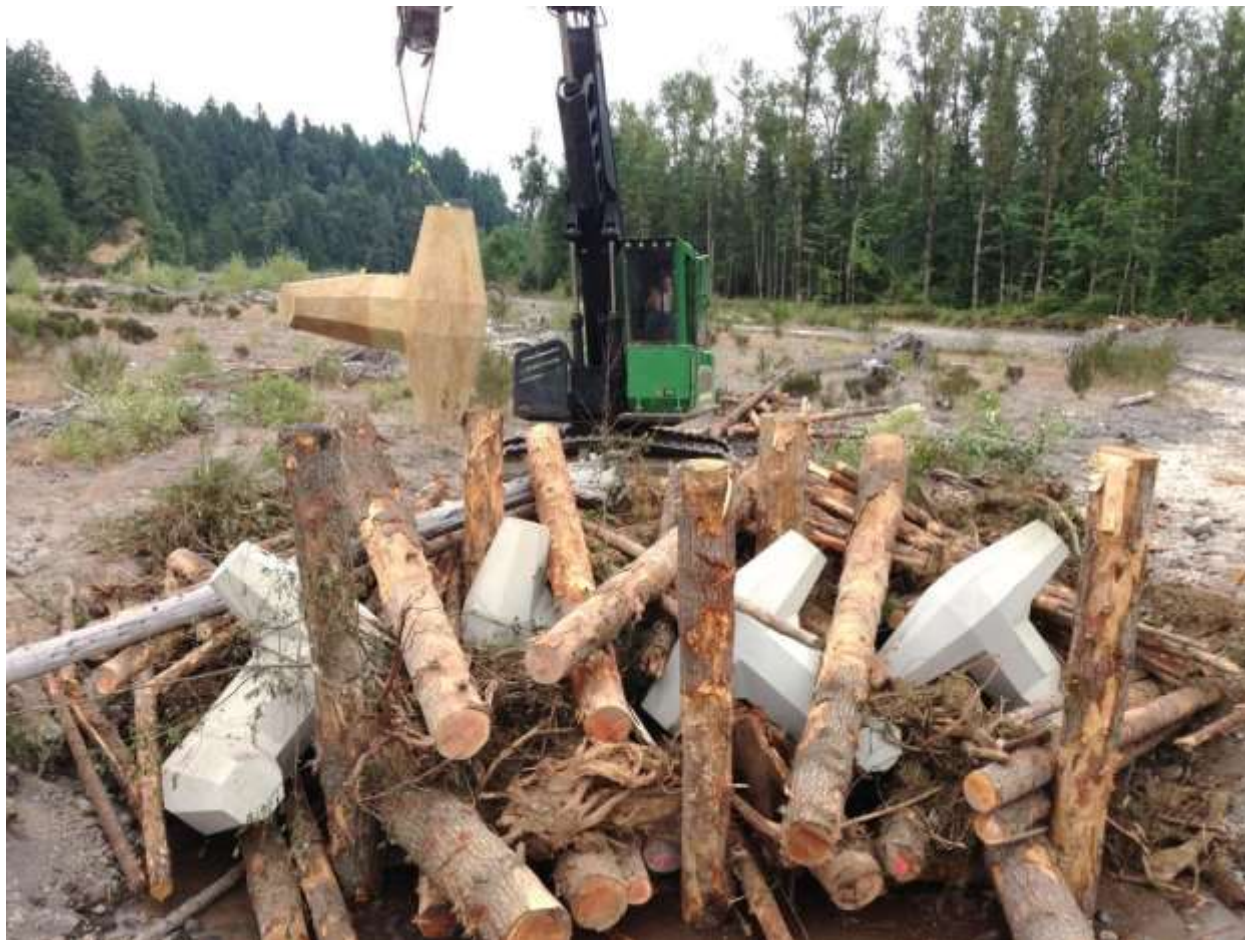
Figure 45. Construction of ELJ using 8 ton dolosse in Upper Puyallup (same structures depicted in Figure 40). The dolosse offer an interlocking ballast the structure can settle into river bed if undermined without coming apart. This means the structures don't require as much excavation, lowering construction impacts and costs. Dolosse are covered with alluvium and wood so they are barely visible in completed structure. View is looking upstream into core of the structure.

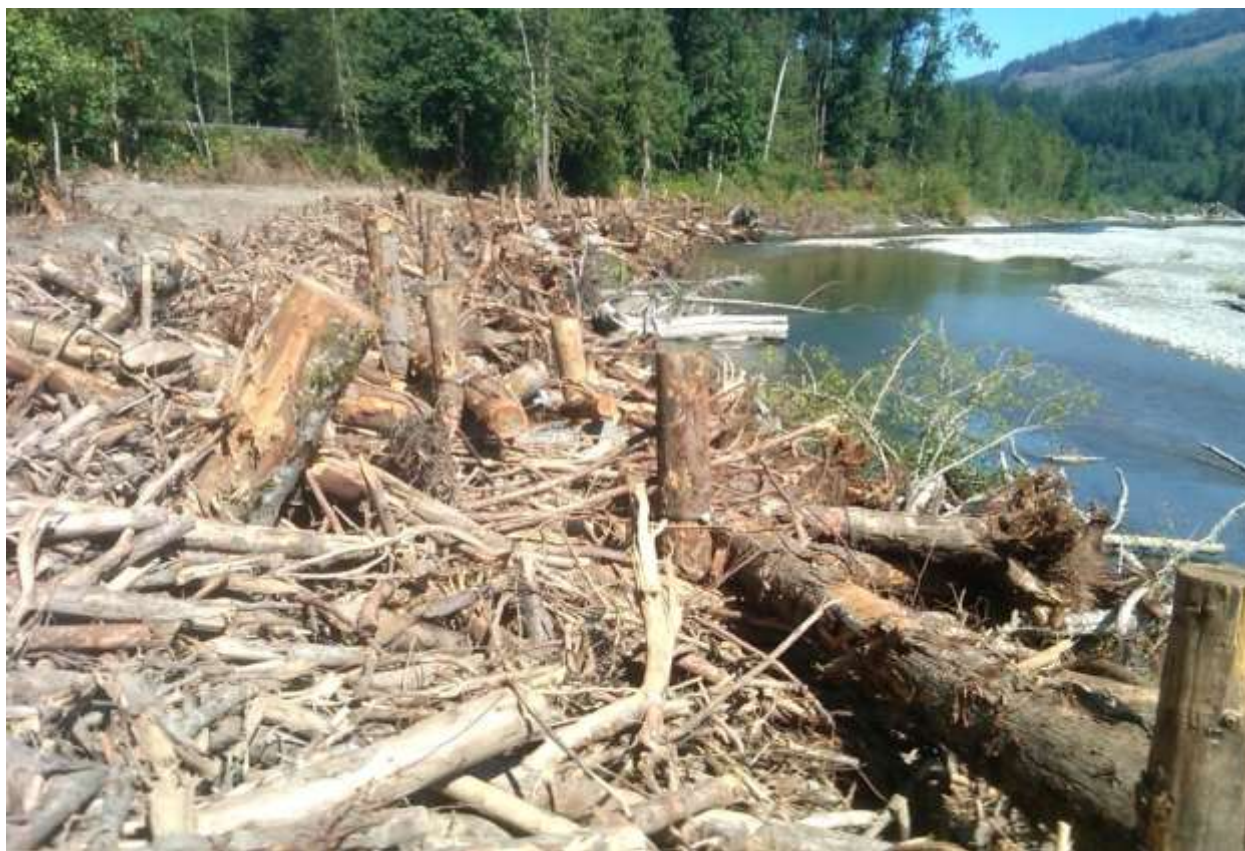
Figure 46. Example of an engineered complex timber revetment bank protection creating a rough shoreline very different than traditional rock revetments found along Sandy River. The structure along the South Fork Nooksack River in northwest Washington is stabilized with timber piles and rock collars (no dolosse). Structure was built in 2011 by Lummi Indian Nation.
