Policy Session Worksheet

Presentation Title: Upper Sandy River Area Flood Erosion Study

Flood Erosion Hazard Mitigation Evaluation

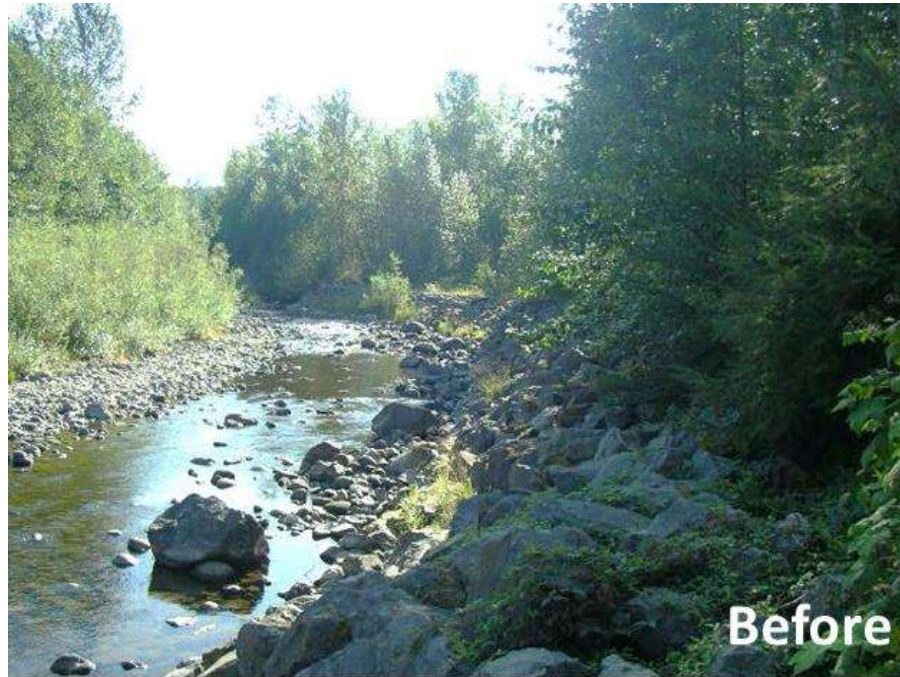
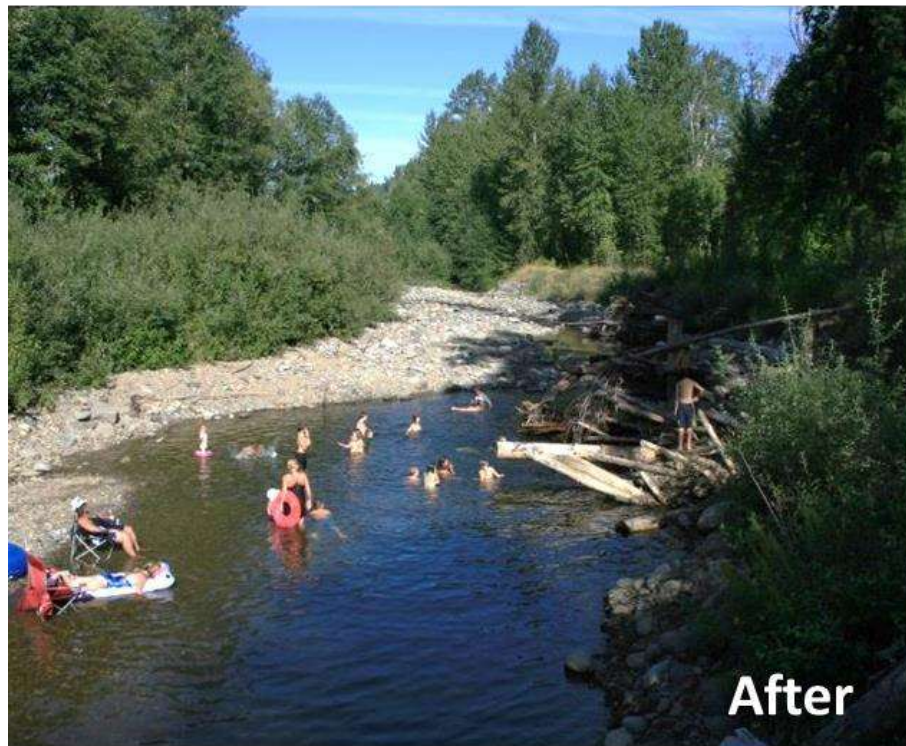
Figure 47. Illustration of how river restoration doesn't just benefit salmon, but also people. The photos above are looking upstream at same site before and after restoration of the Mashel River in Eatonville, WA. In 2006 a rock revetment was replaced by a series of engineered logjams. The logjams formed deep pools where none had previously existed and created greater textural variance in the channel. Over 400 juvenile salmon were documented in each of the ELJ pools and during the summer the pools became popular swimming holes for Eatonville residents.
