# OAK LODGE AND GLADSTONE COMMUNITY PROJECT

## TECHNICAL ANALYSIS

# **BUILDING ASSESSMENT**

## **CONCORD PROPERTY**

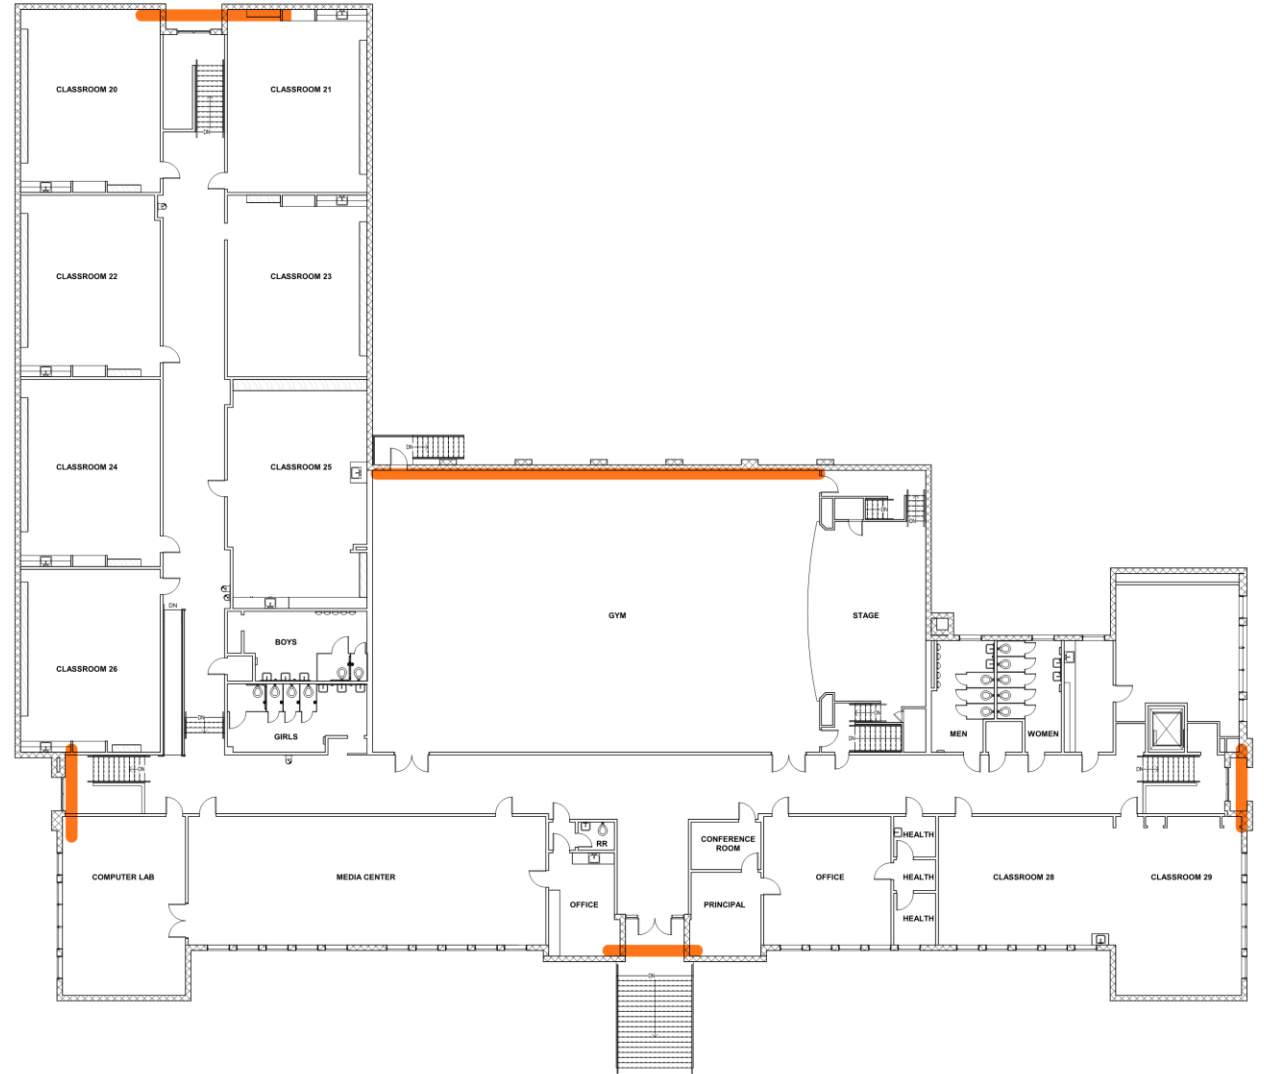
1 | UPPER LEVEL FLOOR PLAN  
A1.11 1/8" = 1'-0"

**PERFORMANCE OPTION 1:**  
**LEAVE AS IS**

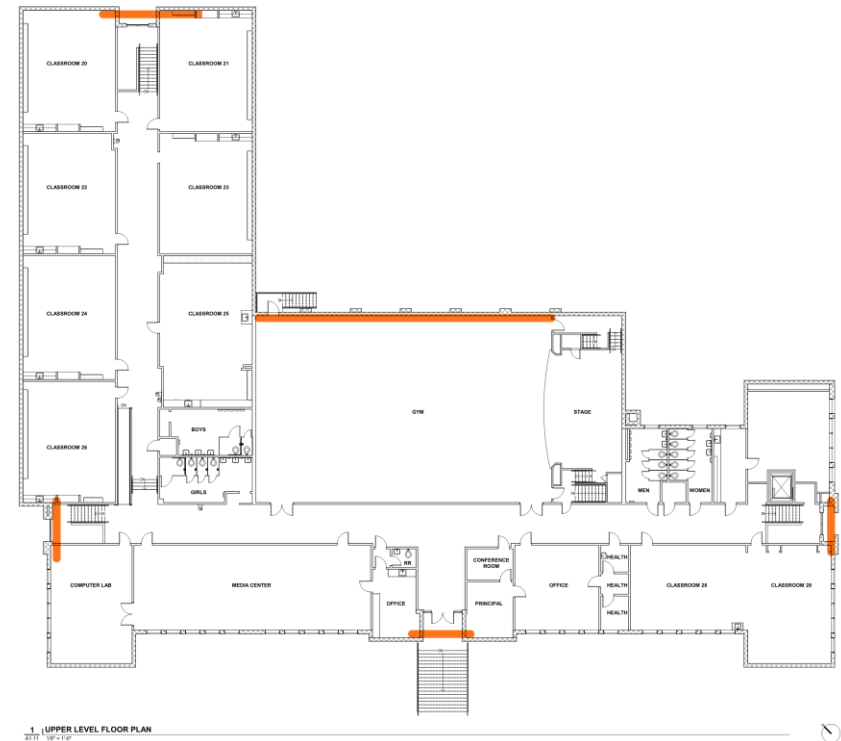
**OPTION 1:**  
**EXISTING LIMITED SEISMIC STRENGTHENING**  
**(2002)**

**CURRENT CONDITION**

Meets current code requirements = **\$ 0**

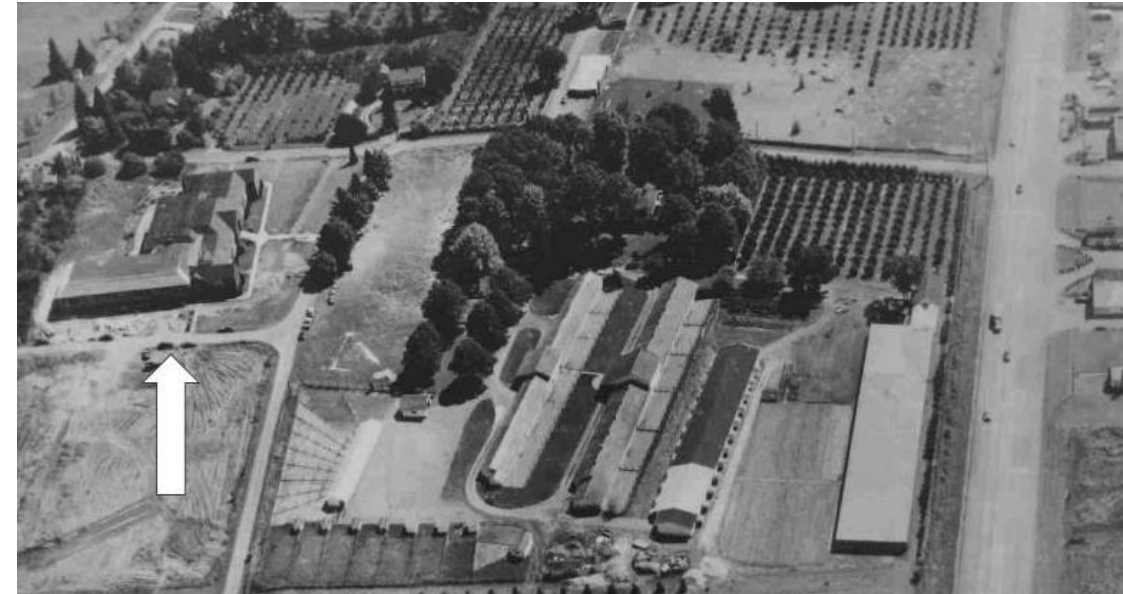
- Constructed 1936 (Architect: Francis Marion Stokes)
- Wing added 1948 (Architect: Stokes & Allyn)
- Closed 2014
- Found by SHPO to be National Register eligible
