**RENTAL ASSISTANCE DEMONSTRATION
PHYSICAL CONDITION ASSESSMENT (RPCA)
HILLSIDE MANOR
2889 SE HILLSIDE STREET
MILWAUKIE, OREGON 97222**

**D3G PROJECT NUMBER:
2018-0031**

**FINAL REPORT ISSUE DATE:
APRIL 13, 2018**

**INSPECTION DATE:
JANUARY 23, 2018**

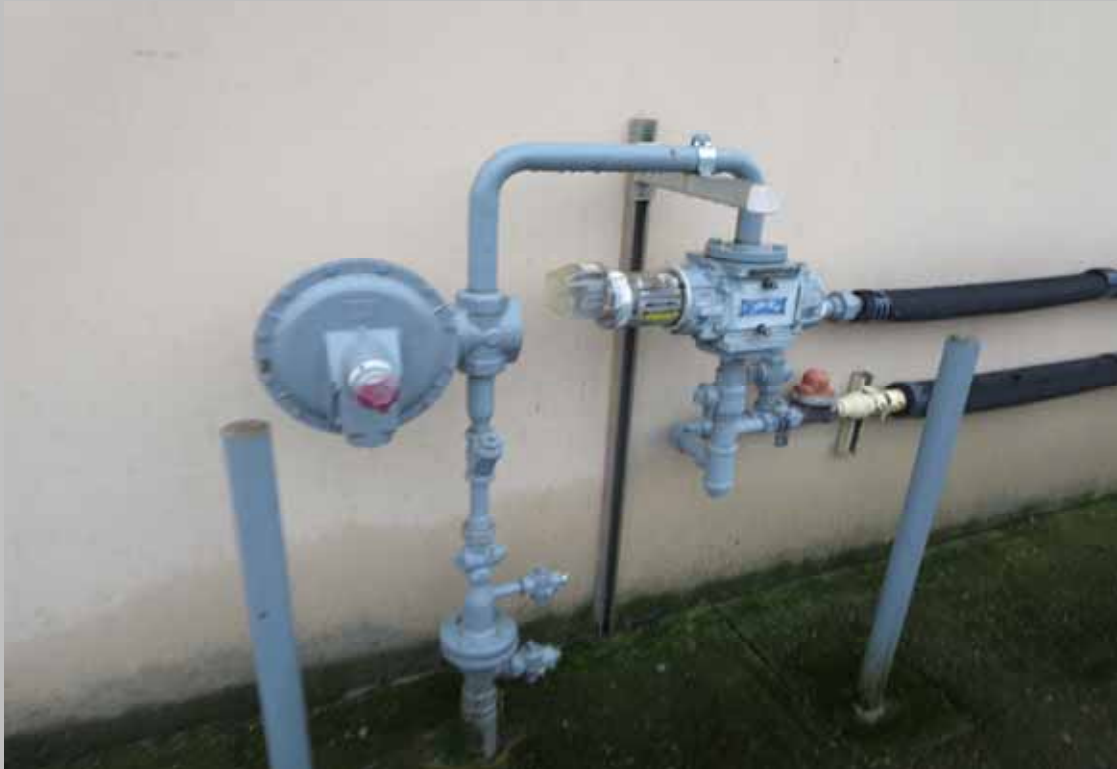
PHOTO #13

Natural gas riser

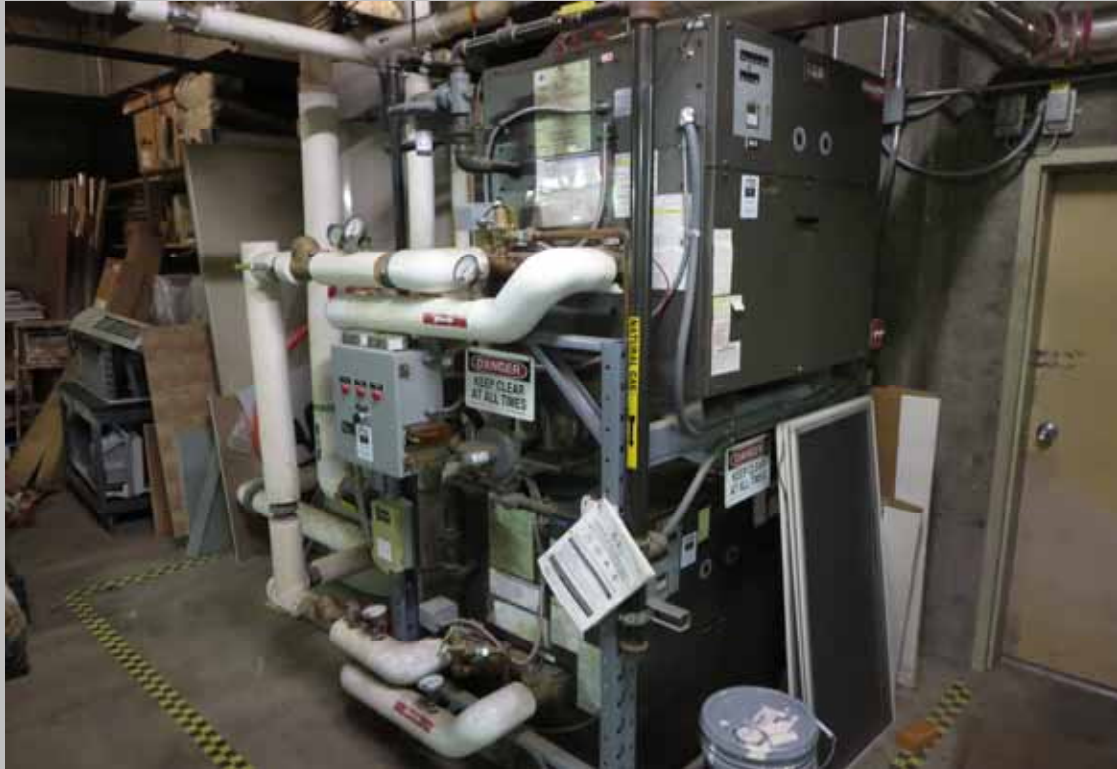
PHOTO #21

Domestic hot water boilers

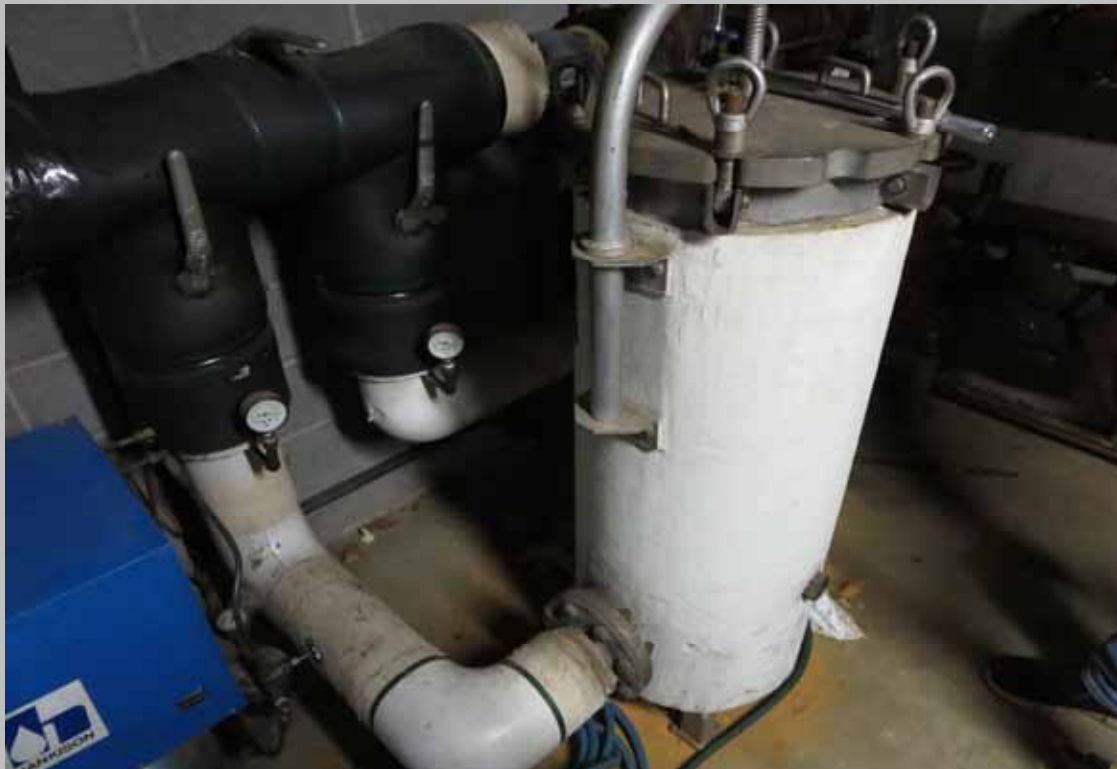
PHOTO #22

Water filtration equipment

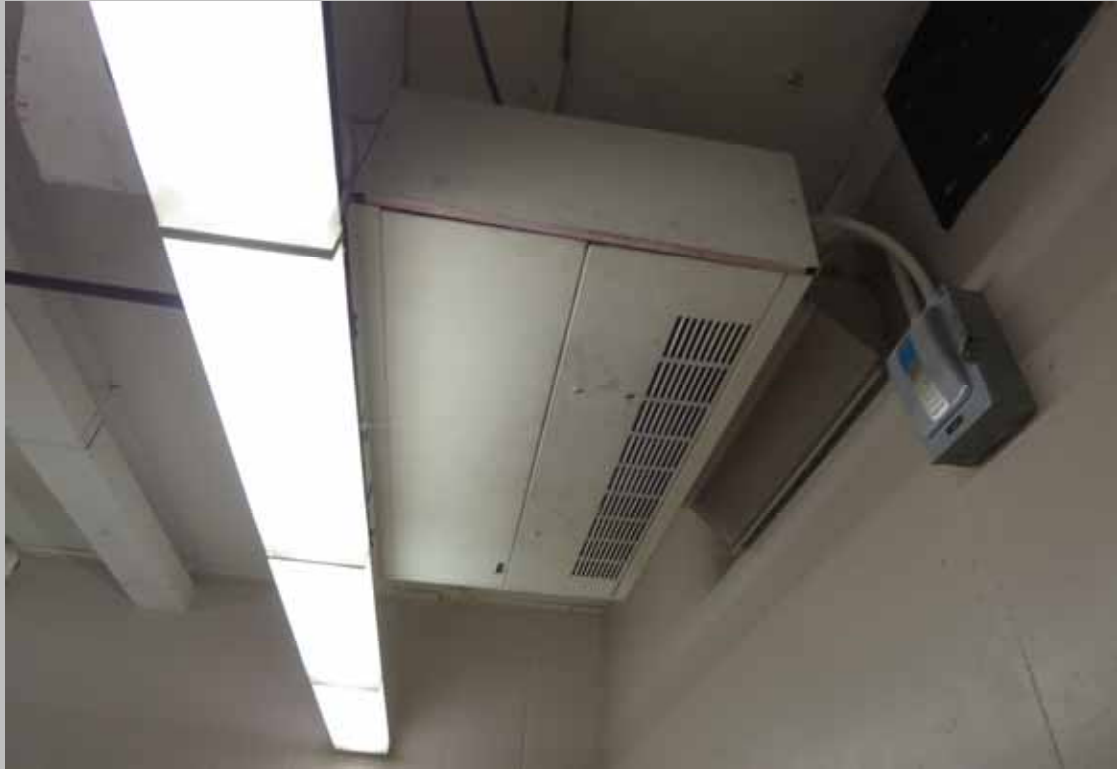
PHOTO #25

Air handler unit

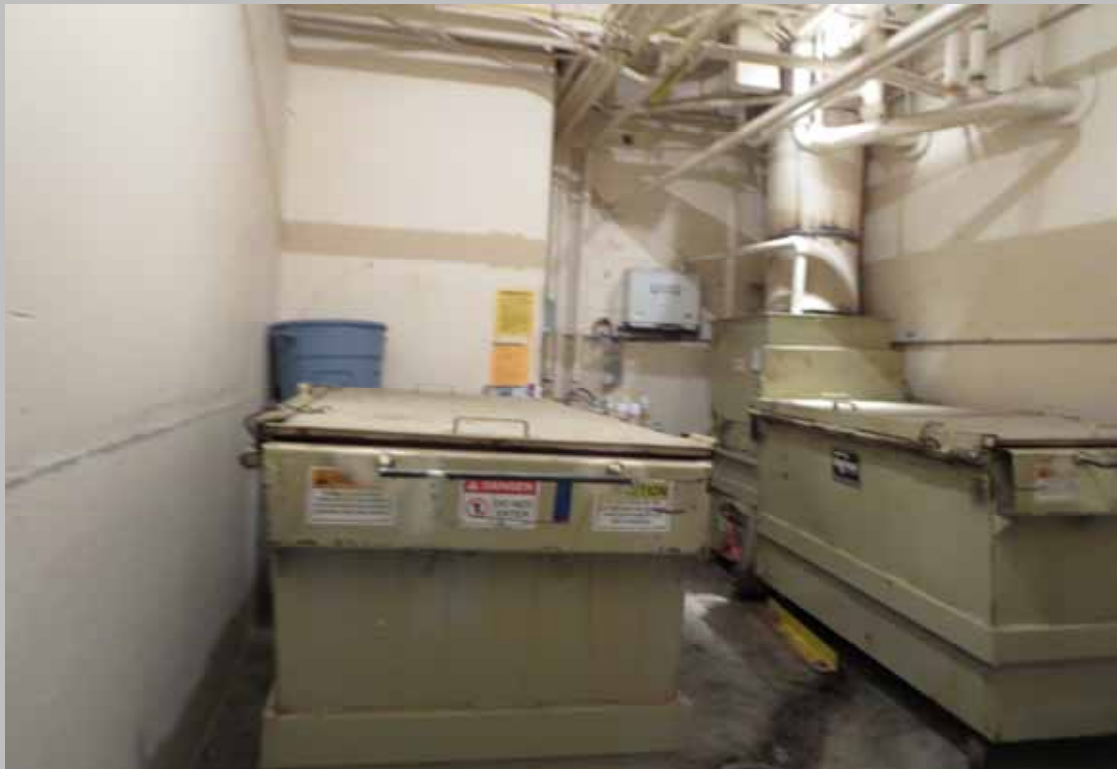
PHOTO #26

Trash compactor and dumpster

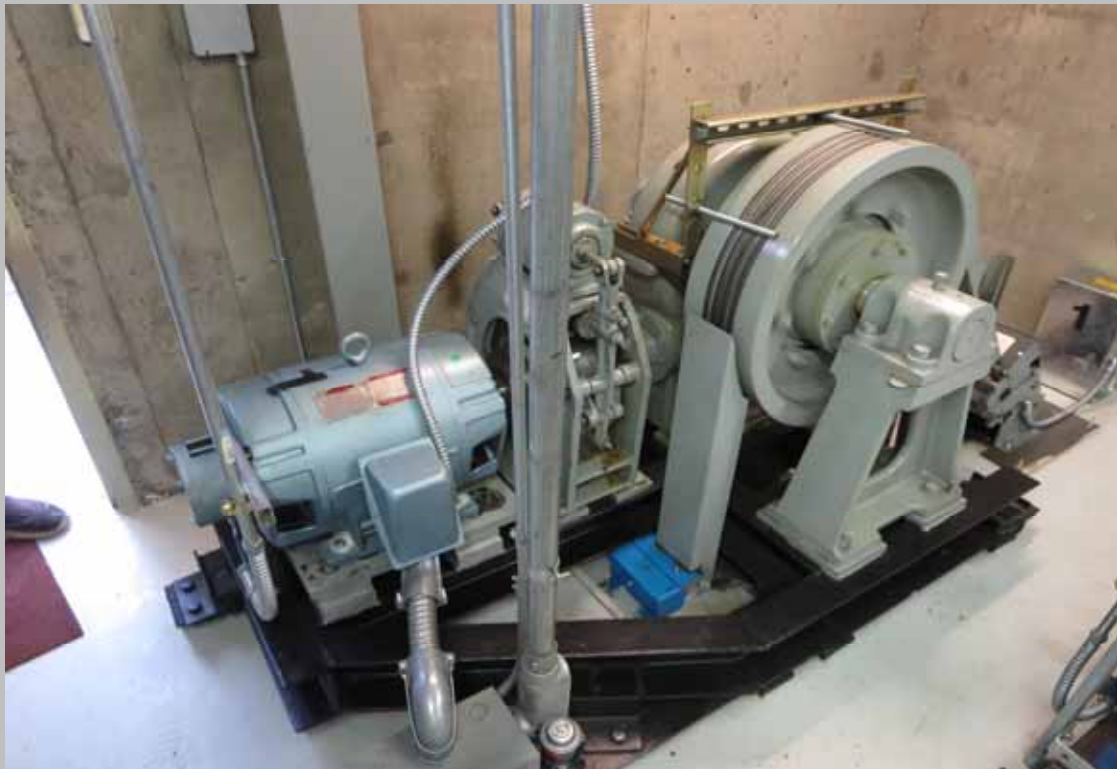
PHOTO #34

Elevator machine room

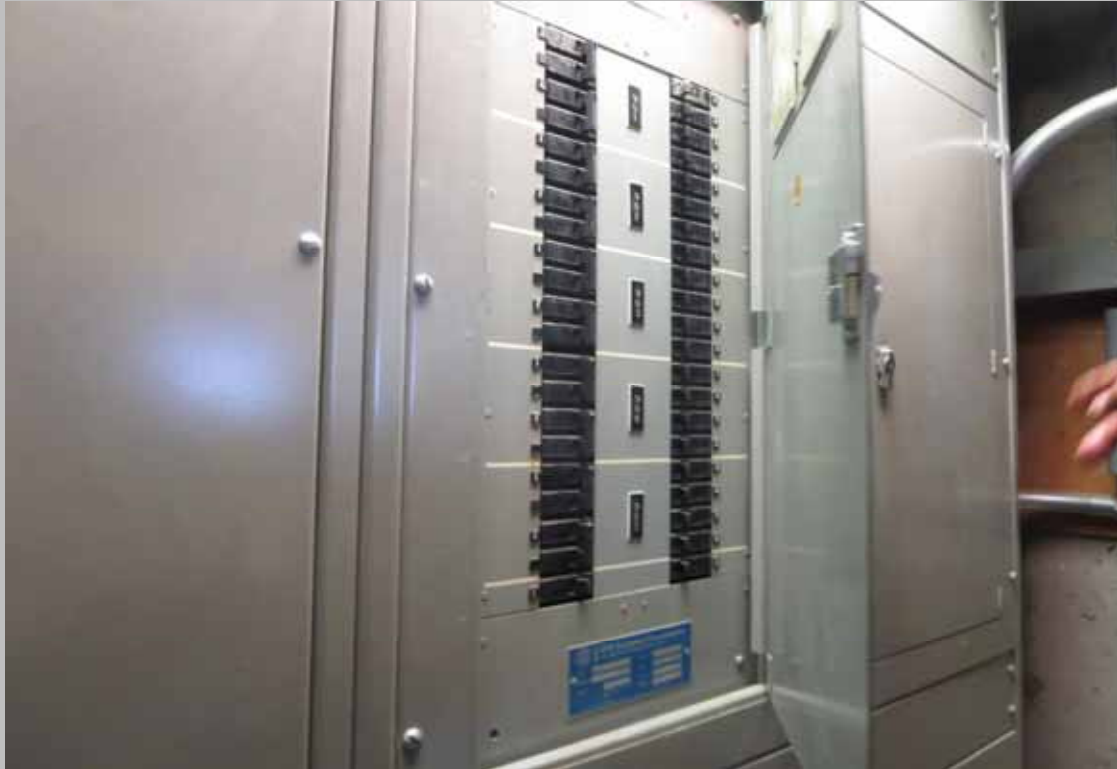
PHOTO #35

Electrical main distribution

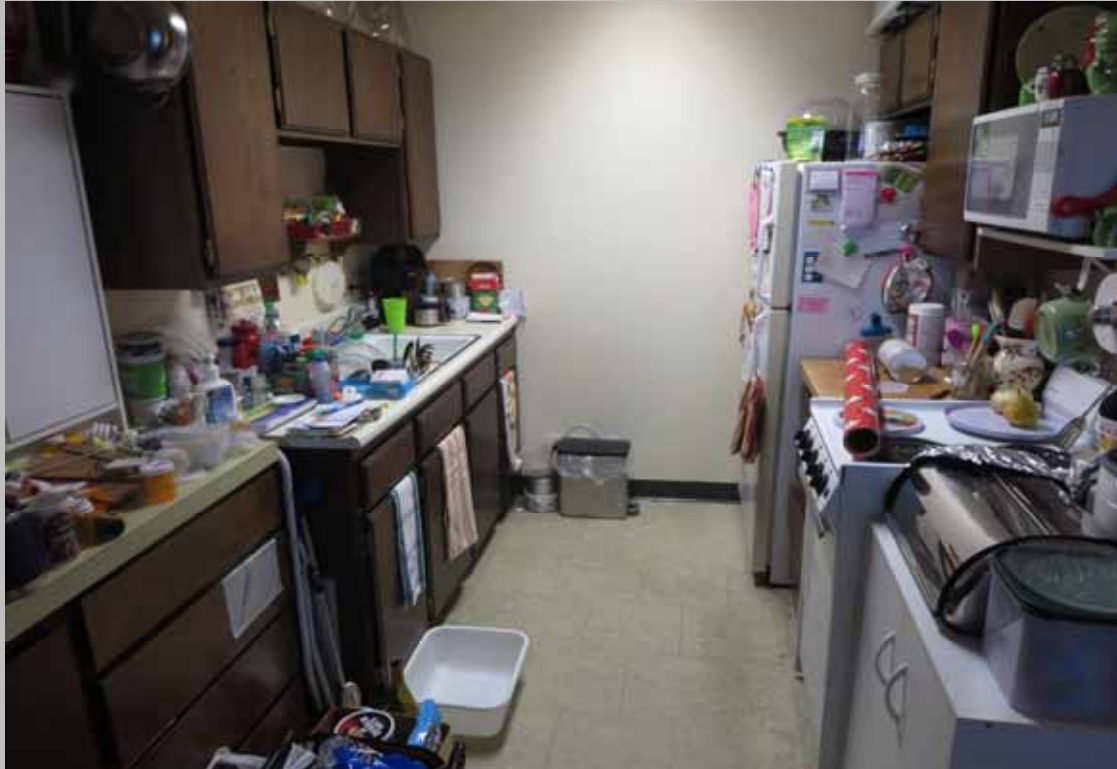
PHOTO #39

Dwelling unit kitchen

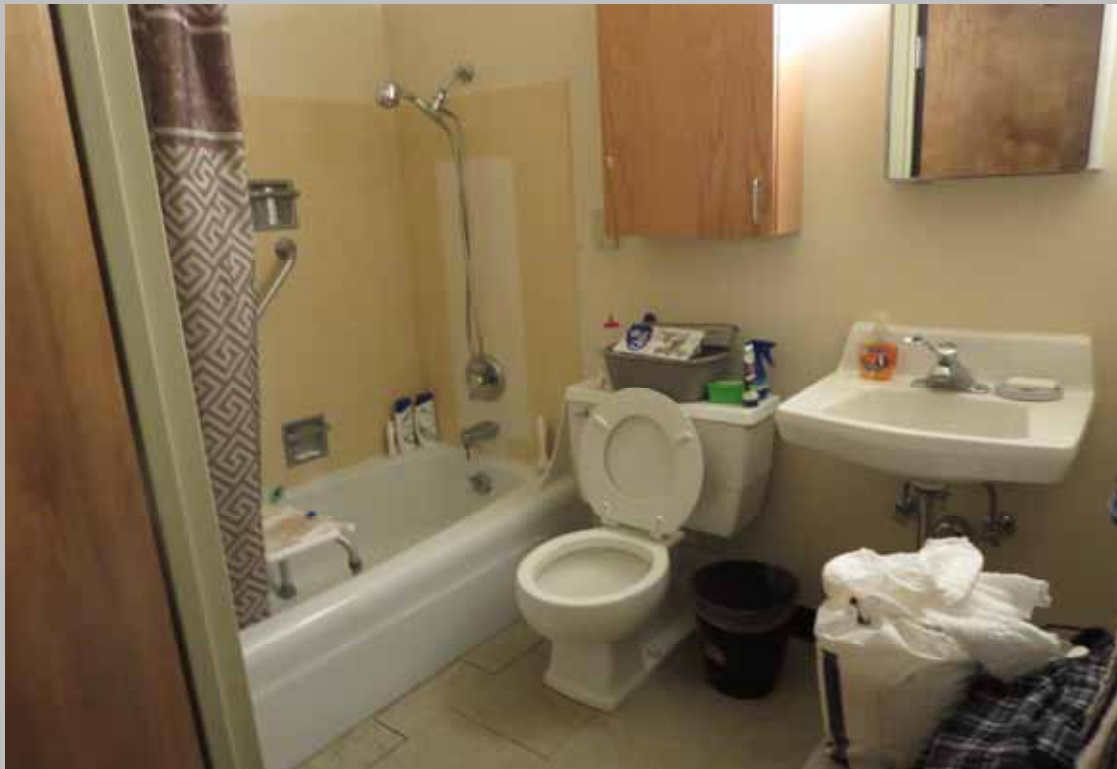
PHOTO #41

Dwelling unit bathroom with bathtub

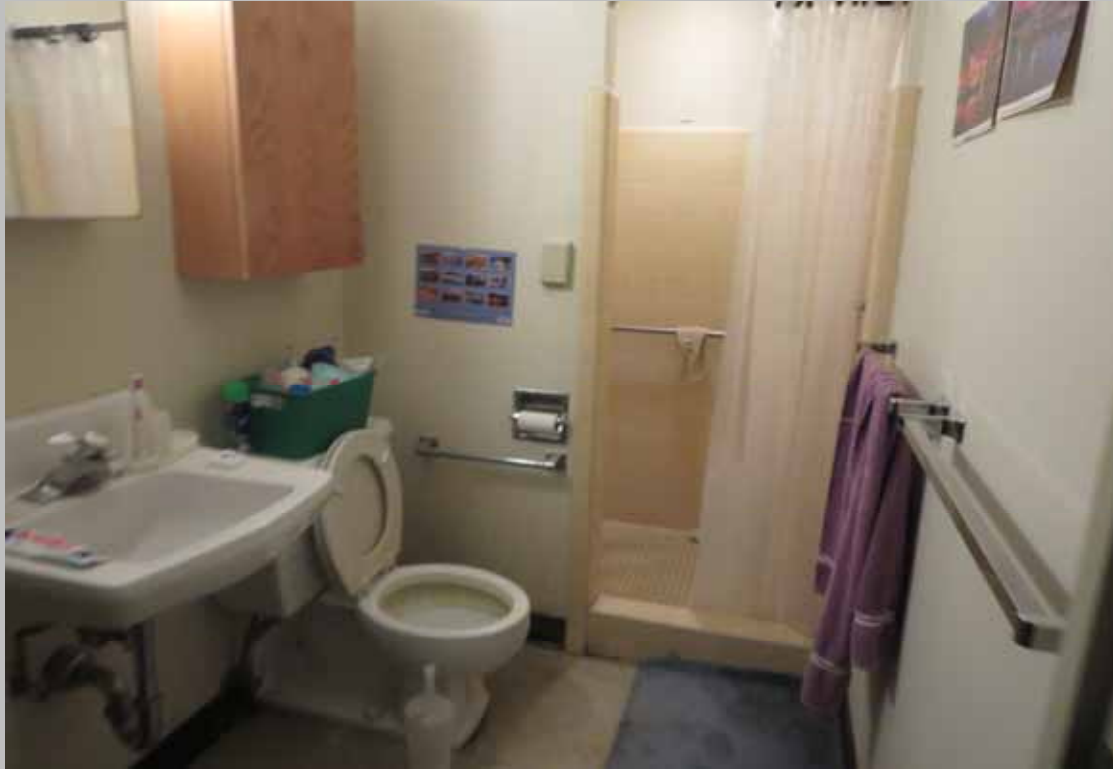
PHOTO #44

Dwelling unit bathroom with shower

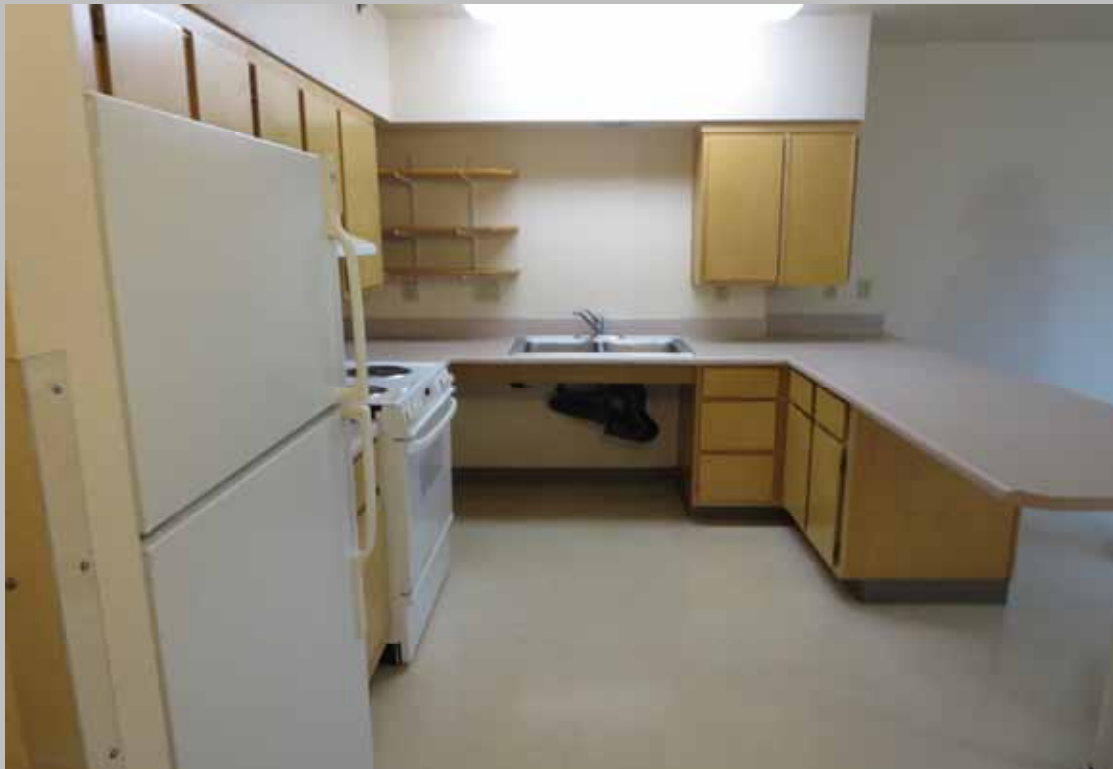
PHOTO #45

Handicapped dwelling unit kitchen

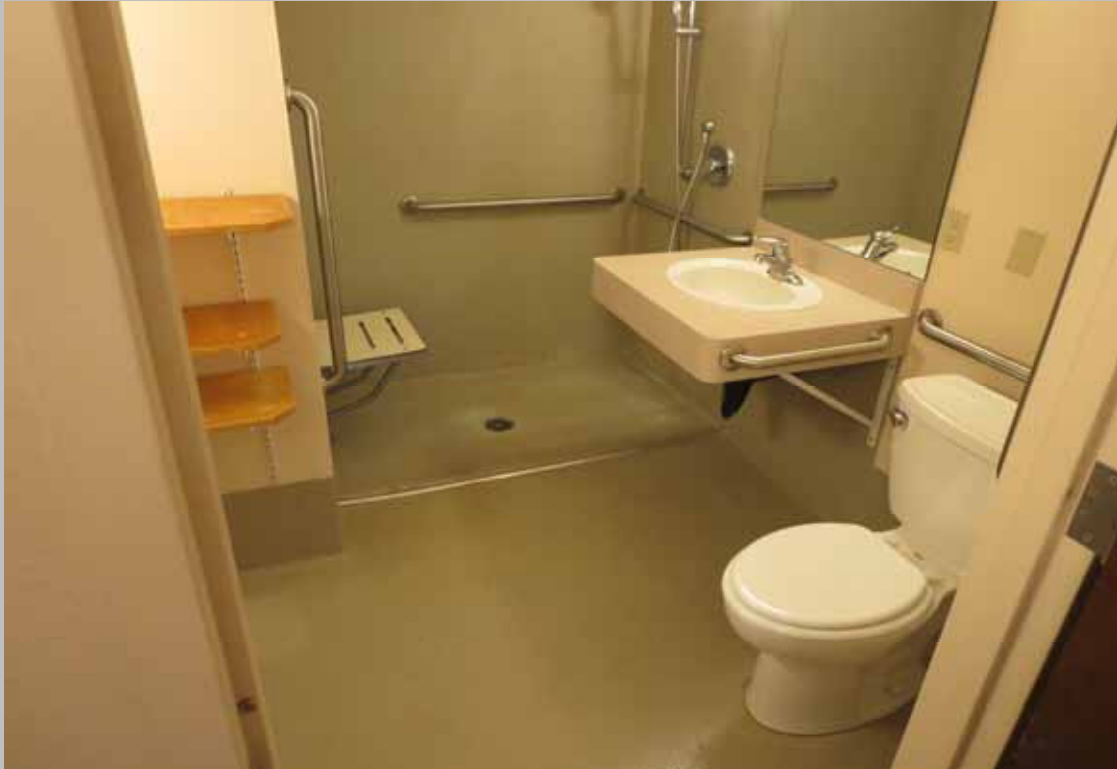
PHOTO #46

Handicapped dwelling unit bathroom

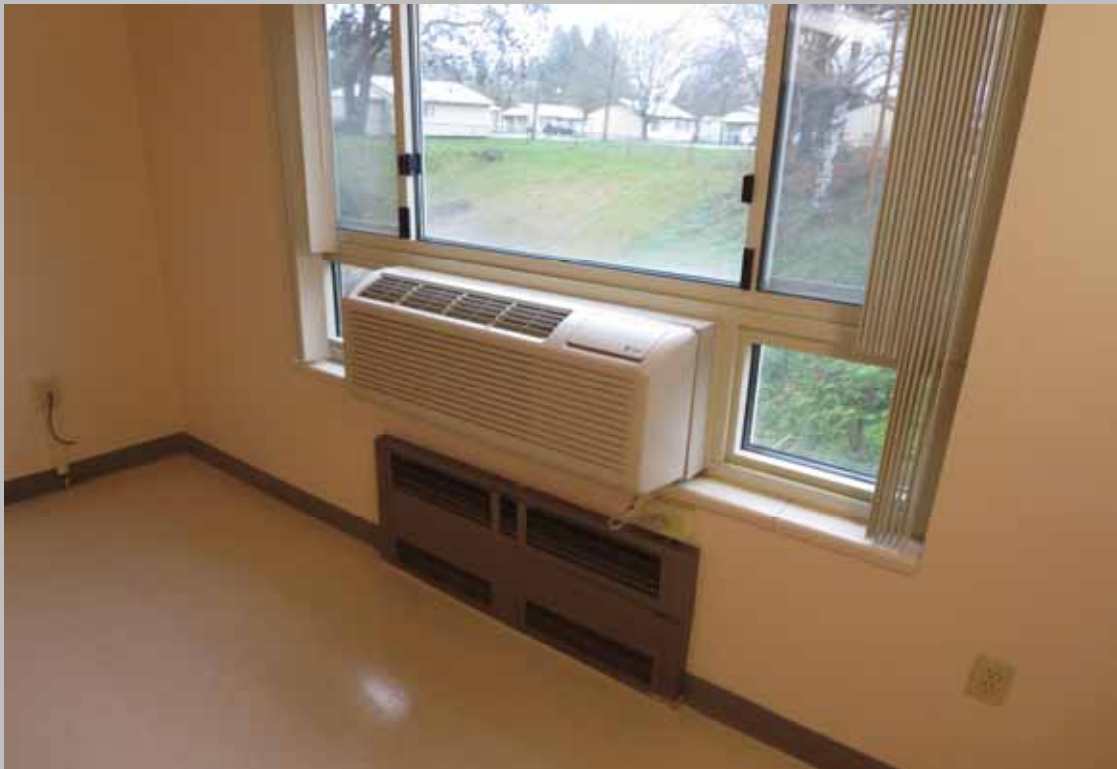
PHOTO #47

Dwelling unit PTAC

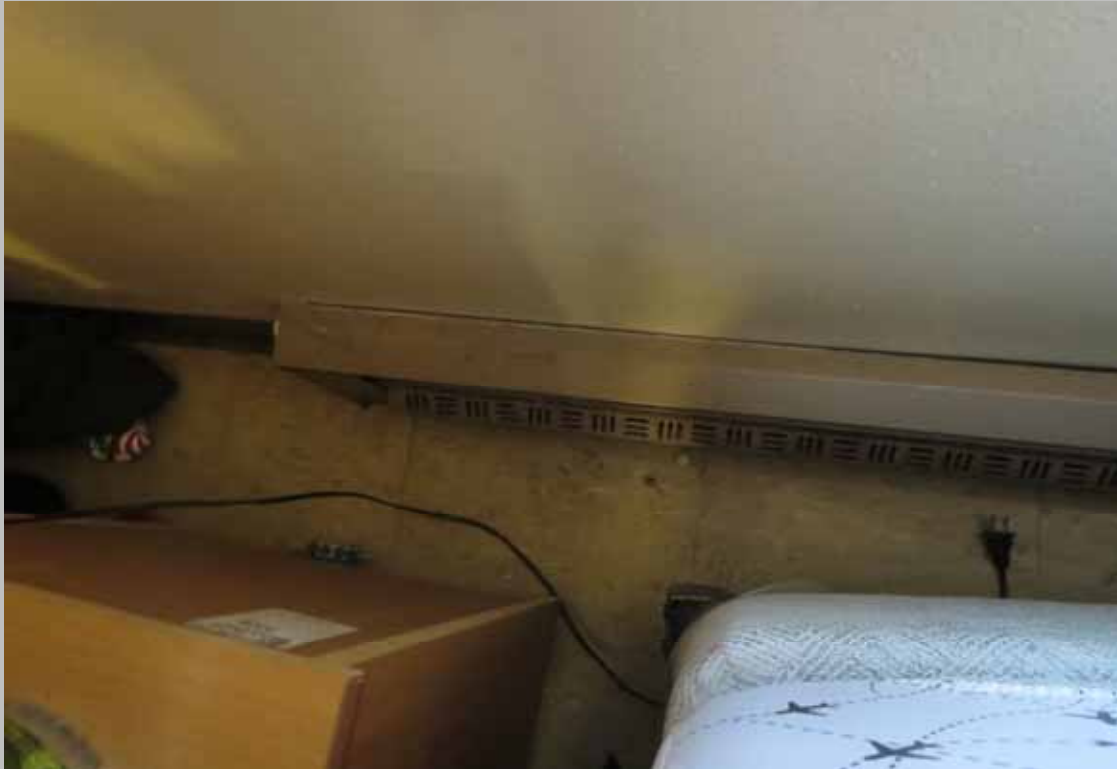
PHOTO #48

Dwelling unit baseboard heater
