Concord Property Building Assessment

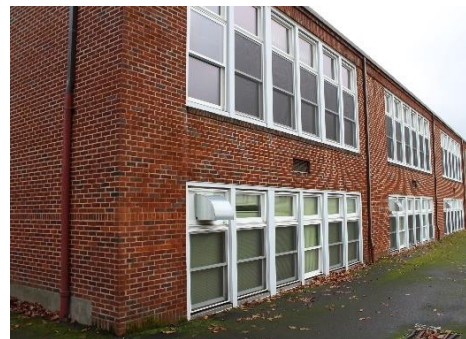
North wing, north facade

Windows are a mixture of single-pane aluminum frame and double-pane vinyl units, with a small number of original, wood divided-lite windows on the east facade and at north and south side exits. Existing wood window trim is in poor condition, needing repair/replacement. Lower level openings/vents on the east/south facades are often damaged or in poor condition, in need of repair.

- Addition of exterior wall insulation.
- Exterior window and door restoration and/or replacement, including hardware.
- Mitigation of hazardous materials as identified.

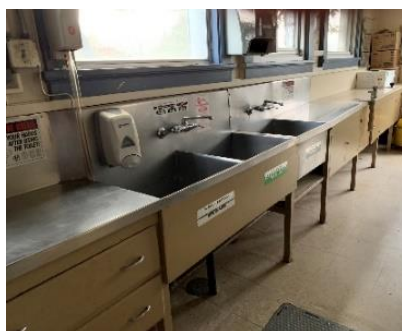
Kitchen, sink/counter, south wall

Plumbing fixtures are primarily original, with some updated in areas where previous renovations have taken place (north wing boy's and girl's restrooms and nurse office/restroom). Domestic water is supplied via existing galvanized piping, and waste/storm water piping via cast iron. A wet-pipe sprinkler system serves the entire building. A full commercial kitchen was operational until school closure in 2014, and includes sink/counter with sanitize, rinse and wash basins, dishwashing/dish sanitizing station, servery with food warmers, ovens and cooktops with commercial hood, commercial refrigerator units and commercial freezer units. Much of the equipment and cabinetry is older, if not original, in much of the kitchen area.
