6335 GEOTECHNICAL CONSULTATION

**SUBJECT: Geotechnical Consultation Services
City of Gladstone Library
525 Portland Avenue
Gladstone, Oregon**

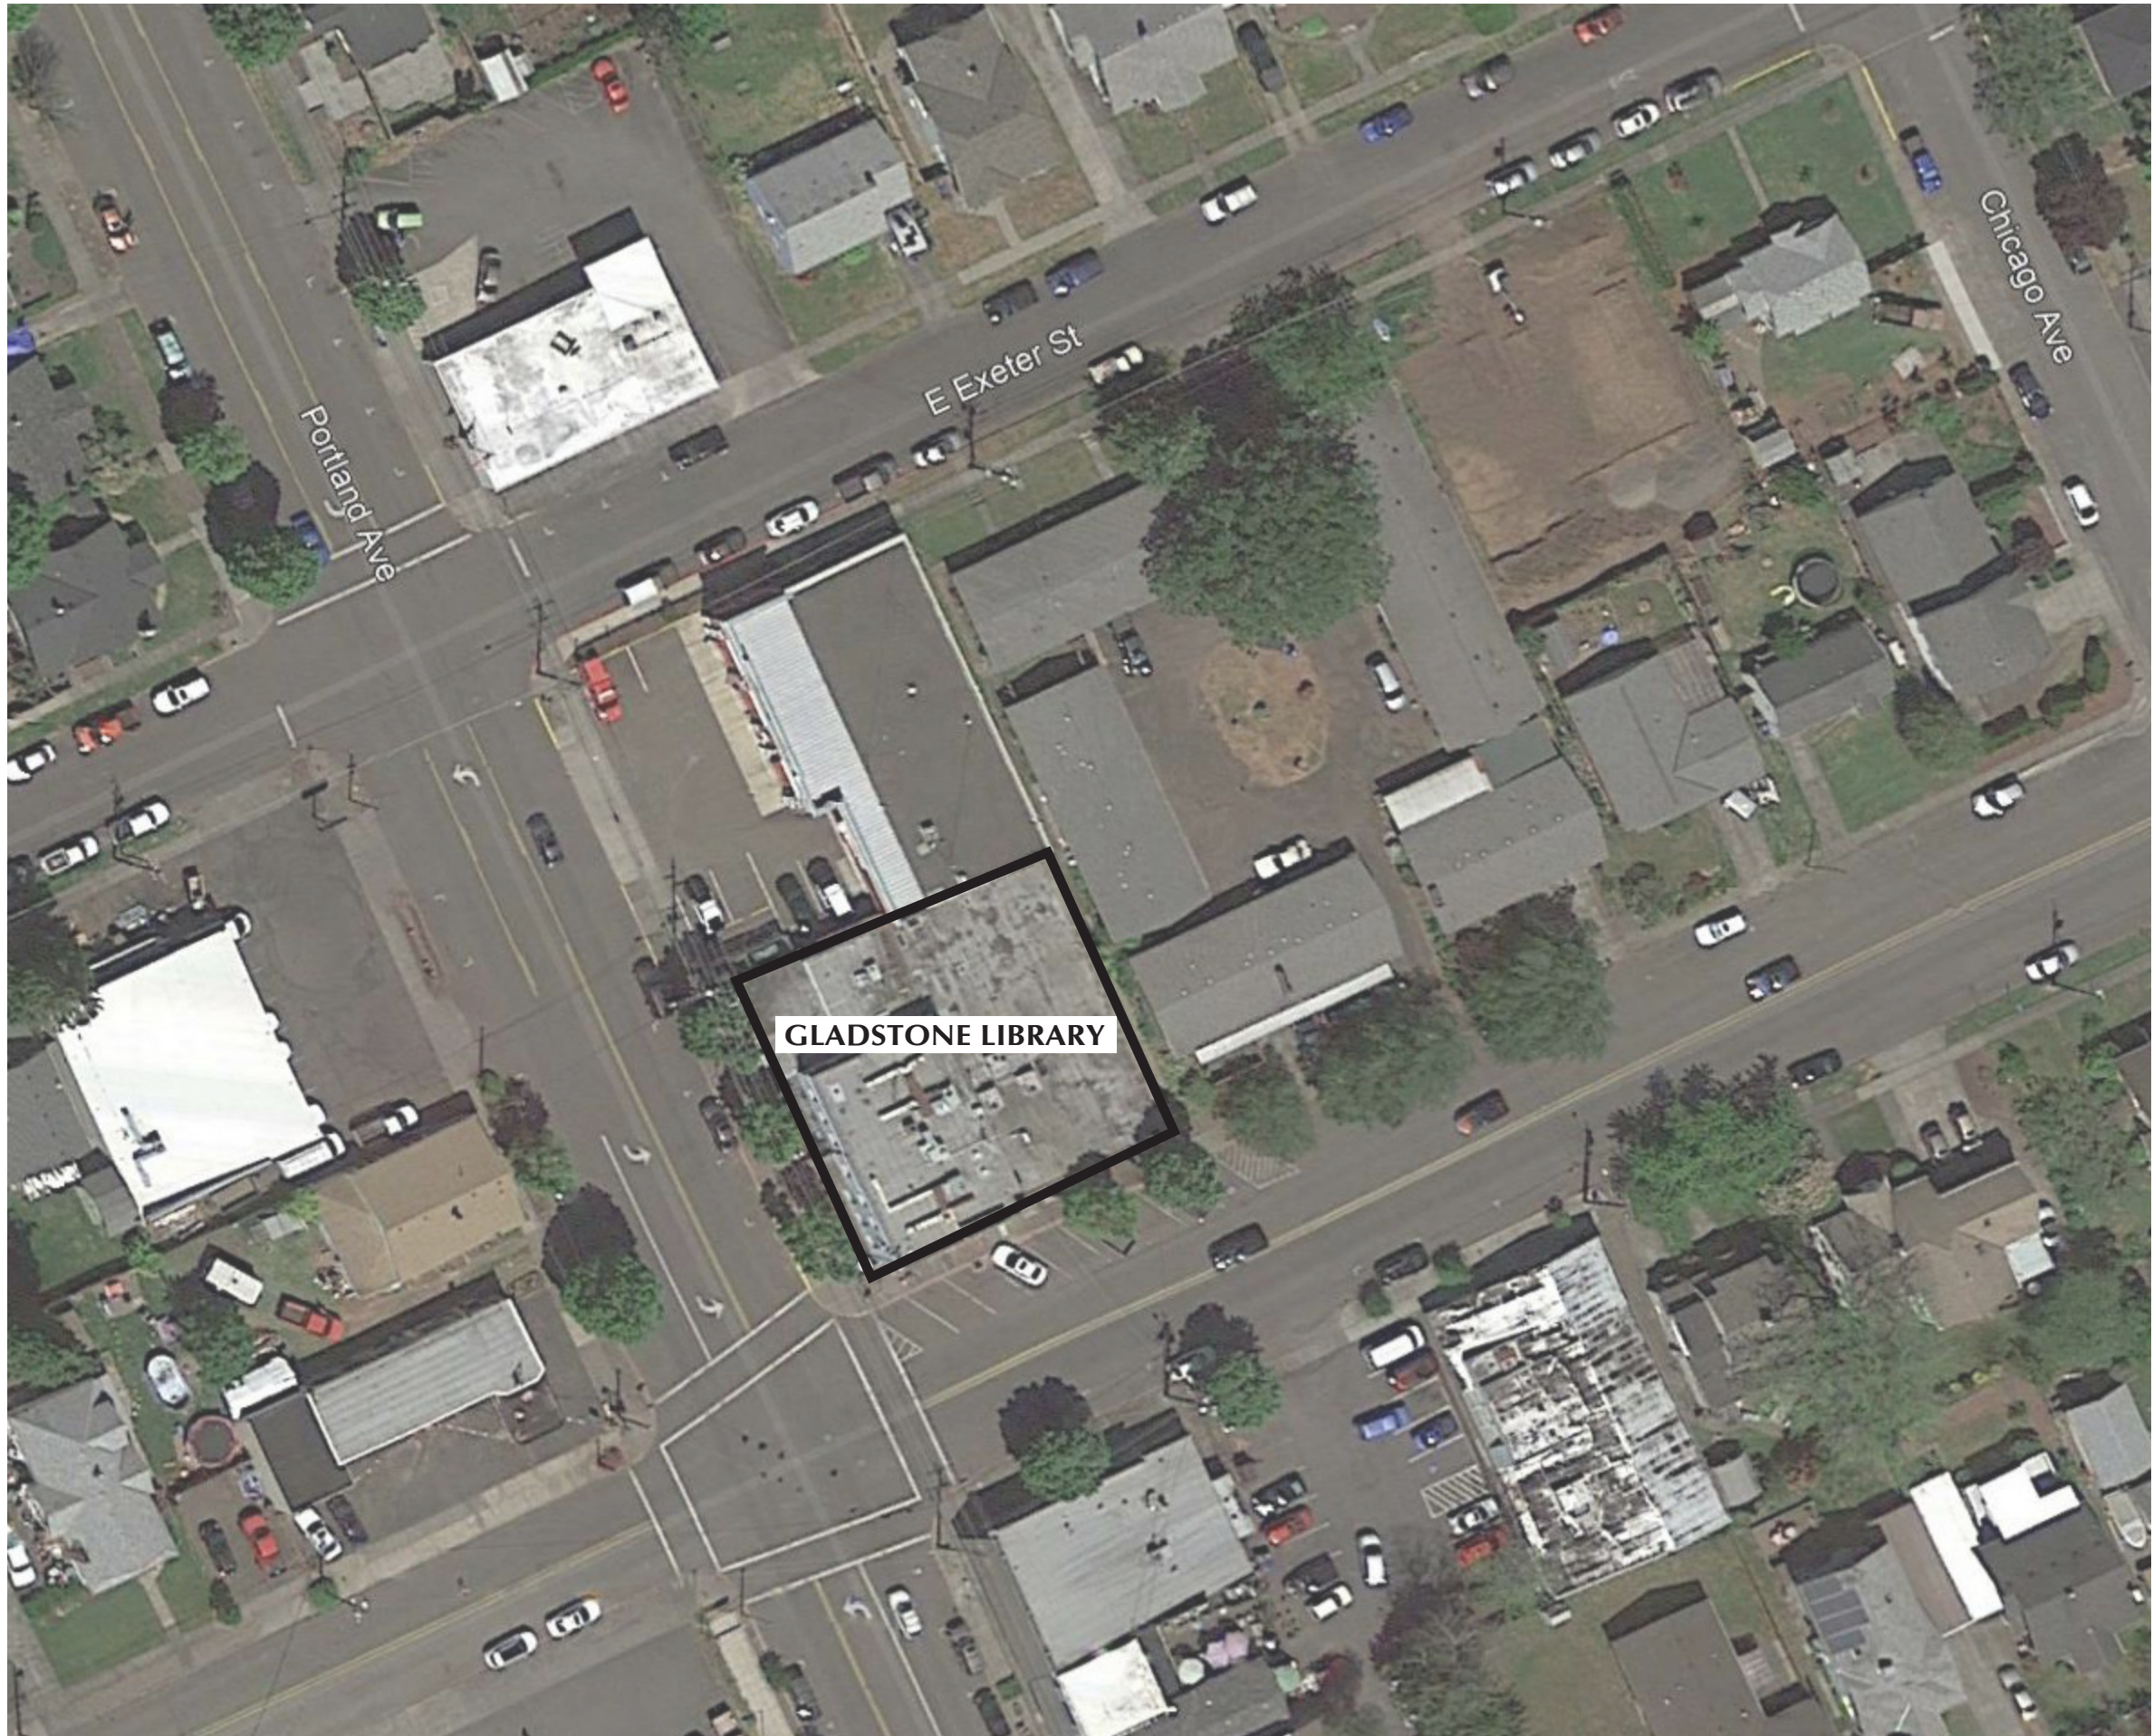
SITE PLAN FROM FILE BY GOOGLE EARTH PRO, 2019

The proposed library site is currently occupied by the City of Gladstone City Hall, located at 525 Portland Avenue in Gladstone, Oregon, and is bordered by Portland Avenue to the west; West Dartmouth Street to the south; Gladstone Volunteer Fire Department on the adjacent lot to the north; and residential housing to the east. We understand the existing City of Gladstone City Hall building is a two-story structure and occupies a footprint of approximately 9,000 square feet. Portland cement concrete sidewalks and asphalt concrete pavement roadways are located along the south and west portions of the property. Figure 2 shows the existing site.
