Clackamas County – Water Environment Services Benthic Macroinvertebrate and Geomorphic Monitoring

OVERVIEW

- Water Environment Services funds a long-term monitoring program to evaluate stream health in northern Clackamas County
- The desire to monitor stream health is based on observed impacts associated with hydromodification
- Hydromodification has been shown to have cumulative impacts on channel form and function and the ecological health of streams
- The comprehensive monitoring program began in 2009 although macroinvertebrates have been sampled since 2002

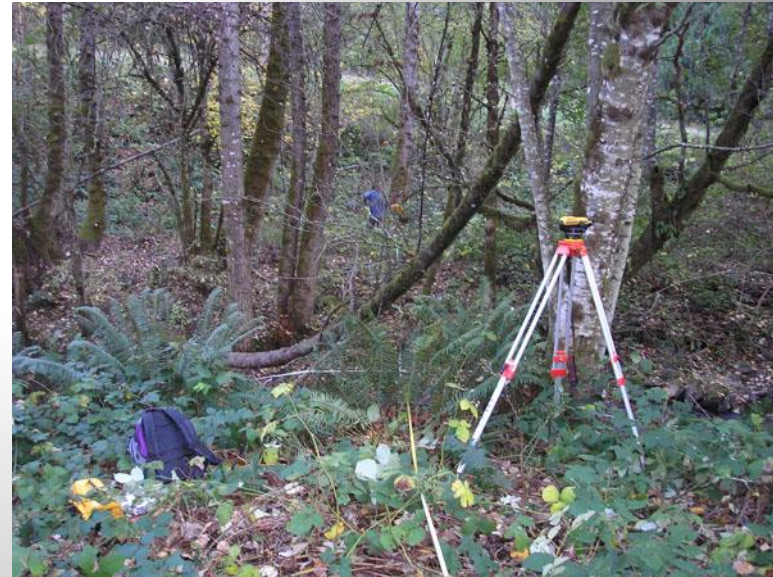
- Longitudinal and cross section profile surveys;
- Measurement of surficial substrate conditions;
- Collection of a bulk sample of bed conditions and surficial sample of bar deposits;
- Measurement of pool characteristics, and
- Assessment of bank conditions

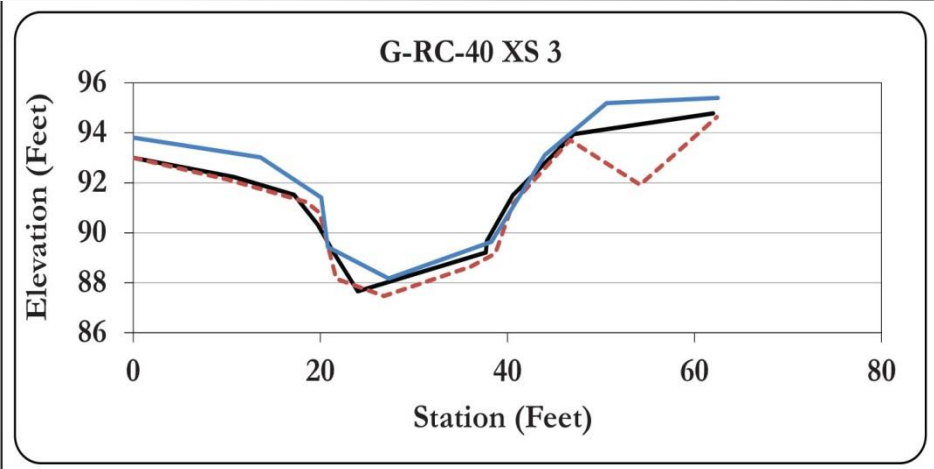
- Cross-section and longitudinal profile comparisons between monitoring years
- Comparison of substrate conditions between monitoring years
- Metrics to assess profile variability, bank erosion, pool filling
- Evaluated against antecedent conditions

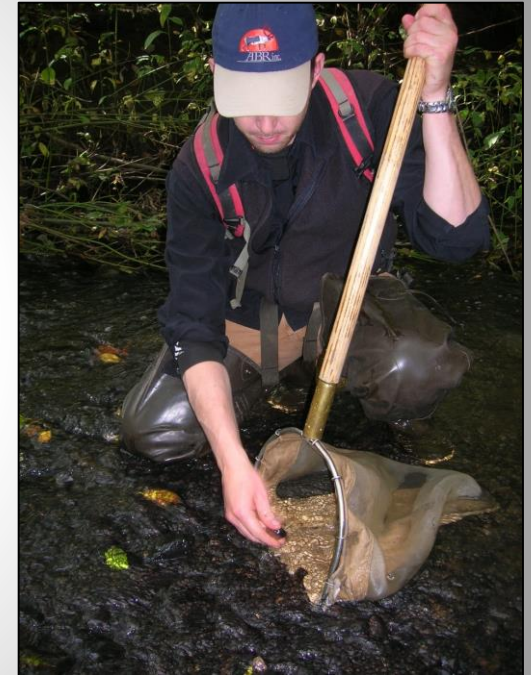
- Oregon DEQ's Benthic Macroinvertebrate Protocol for Wadeable Rivers and Streams
- An 8-kick composite sample was collected from riffles in reaches that had sufficient riffle habitat.
- Glides were sampled in low-gradient reaches that lacked riffle habitat.

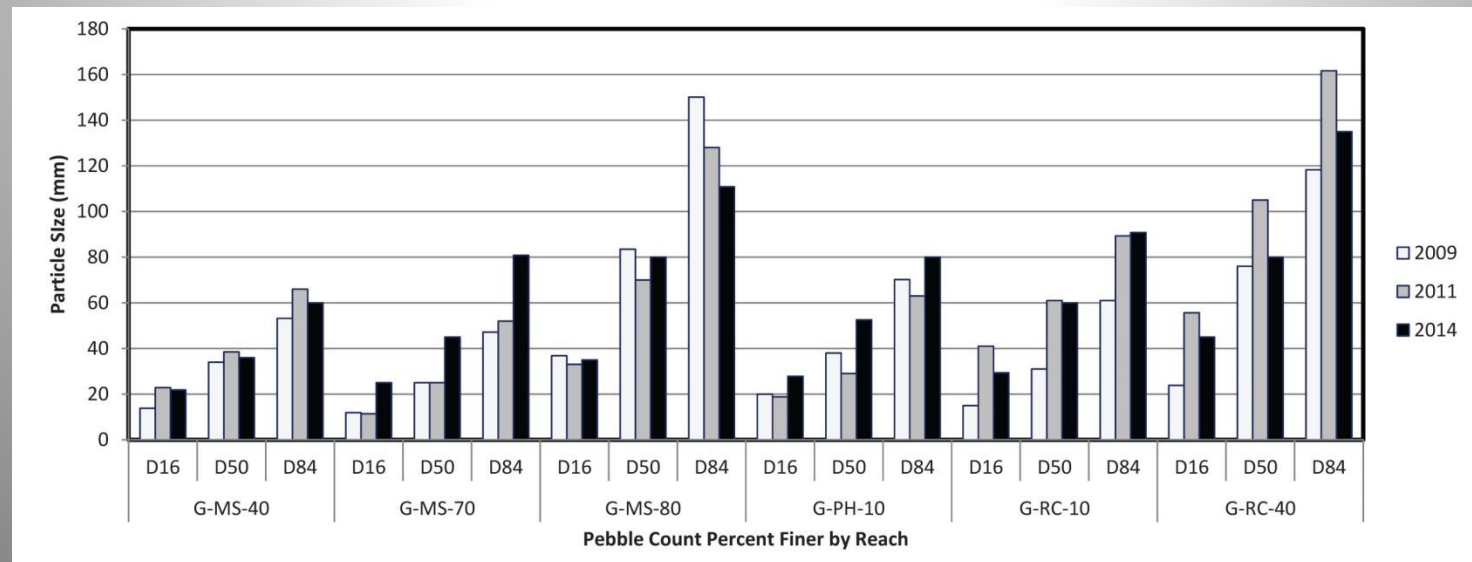
Geomorphic Results – Service District 1

- General trends suggests:
 - Increase in fine sediment in streambed from 2009-2011
 - Coarsening of streambed from 2011-2014
- Related to underlying hydrology: Last significant event was in 2008 with a moderate event in 2011
- Larger runoff events result in fine sediment delivery associated with bank erosion and poor BMP's at construction sites, etc.
- Over time, the finer material flushes from system
