6334 PRELIMINARY GEOTECHNICAL CONSULTATION

**SUBJECT: Preliminary Geotechnical Consultation Services
Oak Lodge Community Project
3811 SE Concord Road
Milwaukie, Oregon**

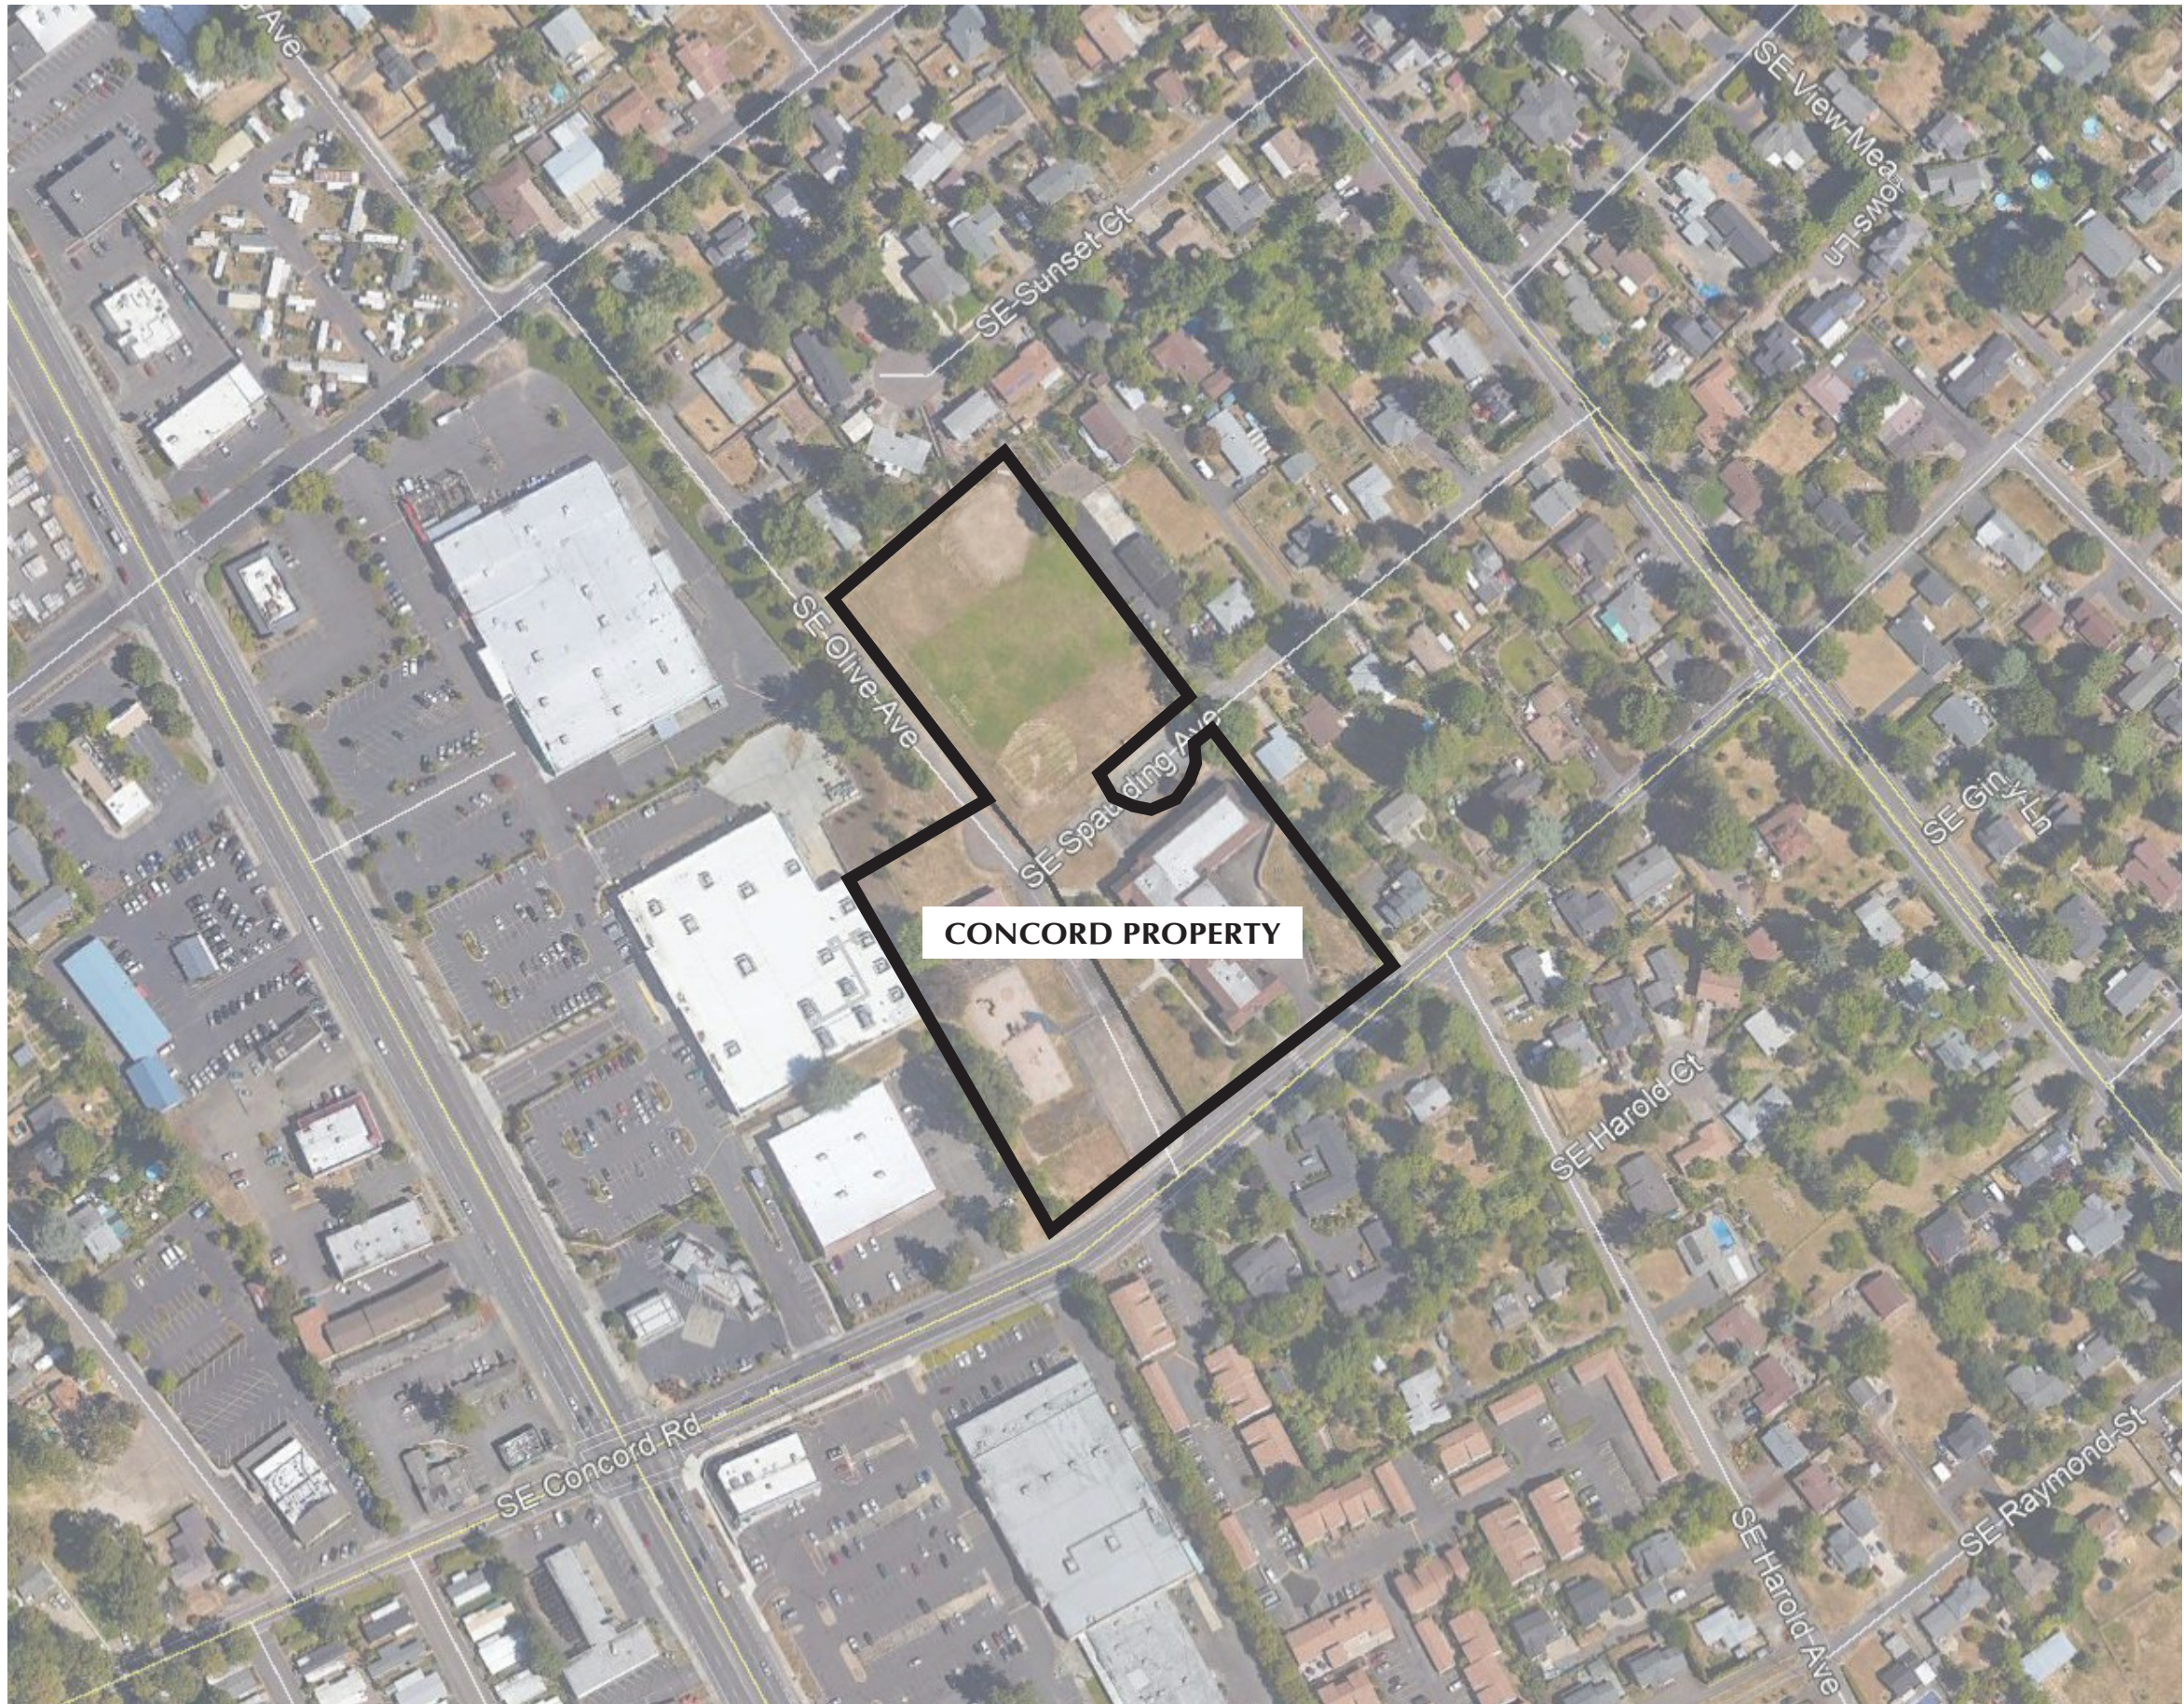
SITE PLAN FROM FILE BY GOOGLE EARTH PRO, 2019

The proposed community center site is currently occupied by North Clackamas Parks and Recreation District, located at 3811 SE Concord Road in unincorporated Oak Grove, Oregon, and is bordered commercial properties to the west; SE Concord Road to the south; and residential housing to the north and east. The site is partially bisected by SE Spaulding Avenue. Based on satellite and street view imagery, the southern portion of the site is occupied by an existing building, with grass fields on the northern portion of the property and play areas to the west. Mature trees surround the building and site perimeter, and an approximately 4 to 6 ft high retaining wall surrounds the north and east side of the existing building. Portland cement concrete (PCC) sidewalks and asphalt concrete (AC) pavement roadways are located along the south, central, and west portions of the property. Figure 2 shows the existing site.

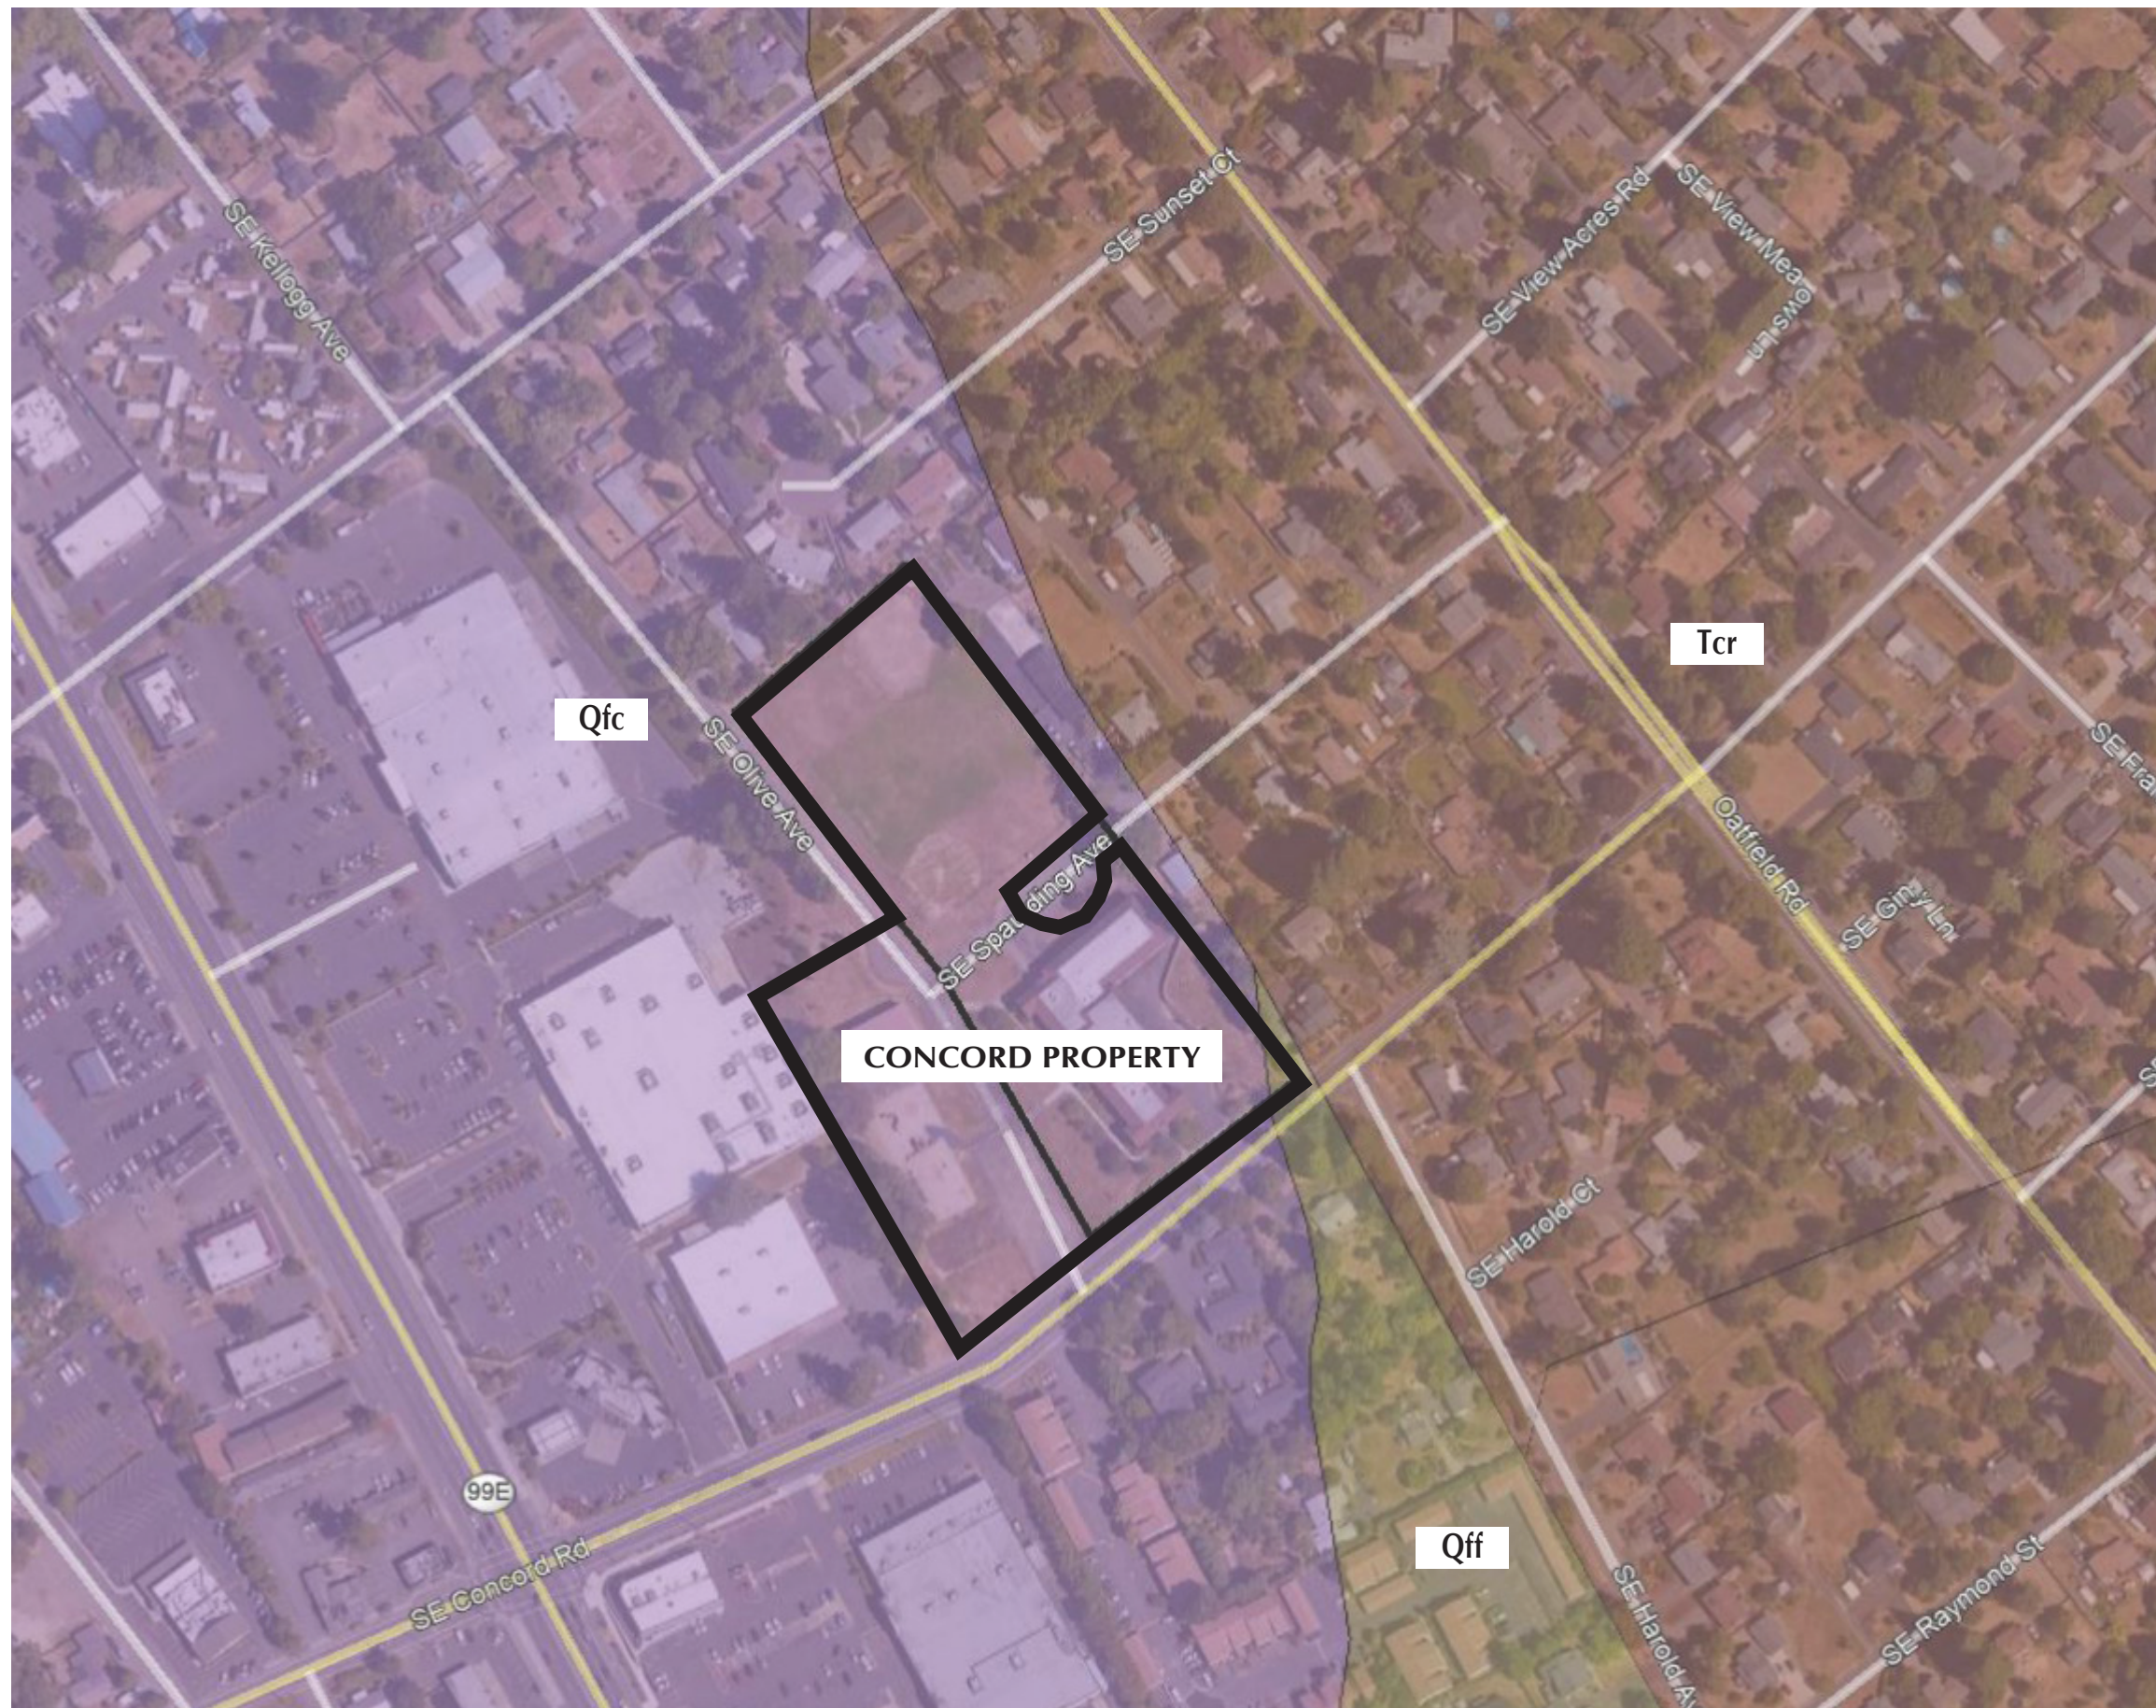
GEOLOGIC MAP

- Tcr, COLUMBIA RIVER BASALT GROUP
- Qff, CATASTROPHIC FLOOD DEPOSITS, FINE-GRAINED FACIES
- Qfc, CATASTROPHIC FLOOD DEPOSITS, COARSE-GRAINED FACIES

SITE PLAN FROM FILE BY GOOGLE EARTH PRO, 2019

Our review of available geologic and geotechnical literature indicates the site is likely mantled with variable thickness of local fill soils primarily consisting of silt, clay, sand, and gravel. The fill soils are underlain by alluvial deposits of silt, sand, and clay, often containing layers of gravels and cobbles, over the Columbia River Basalt Formation at depth. Fill soils, where present, may not be suitable for the support of on-grade structures depending on the fill composition, magnitude of foundation loads, and settlement sensitivity. The fine-grained fill and alluvial soils are extremely sensitive to moisture content and easily disturbed by

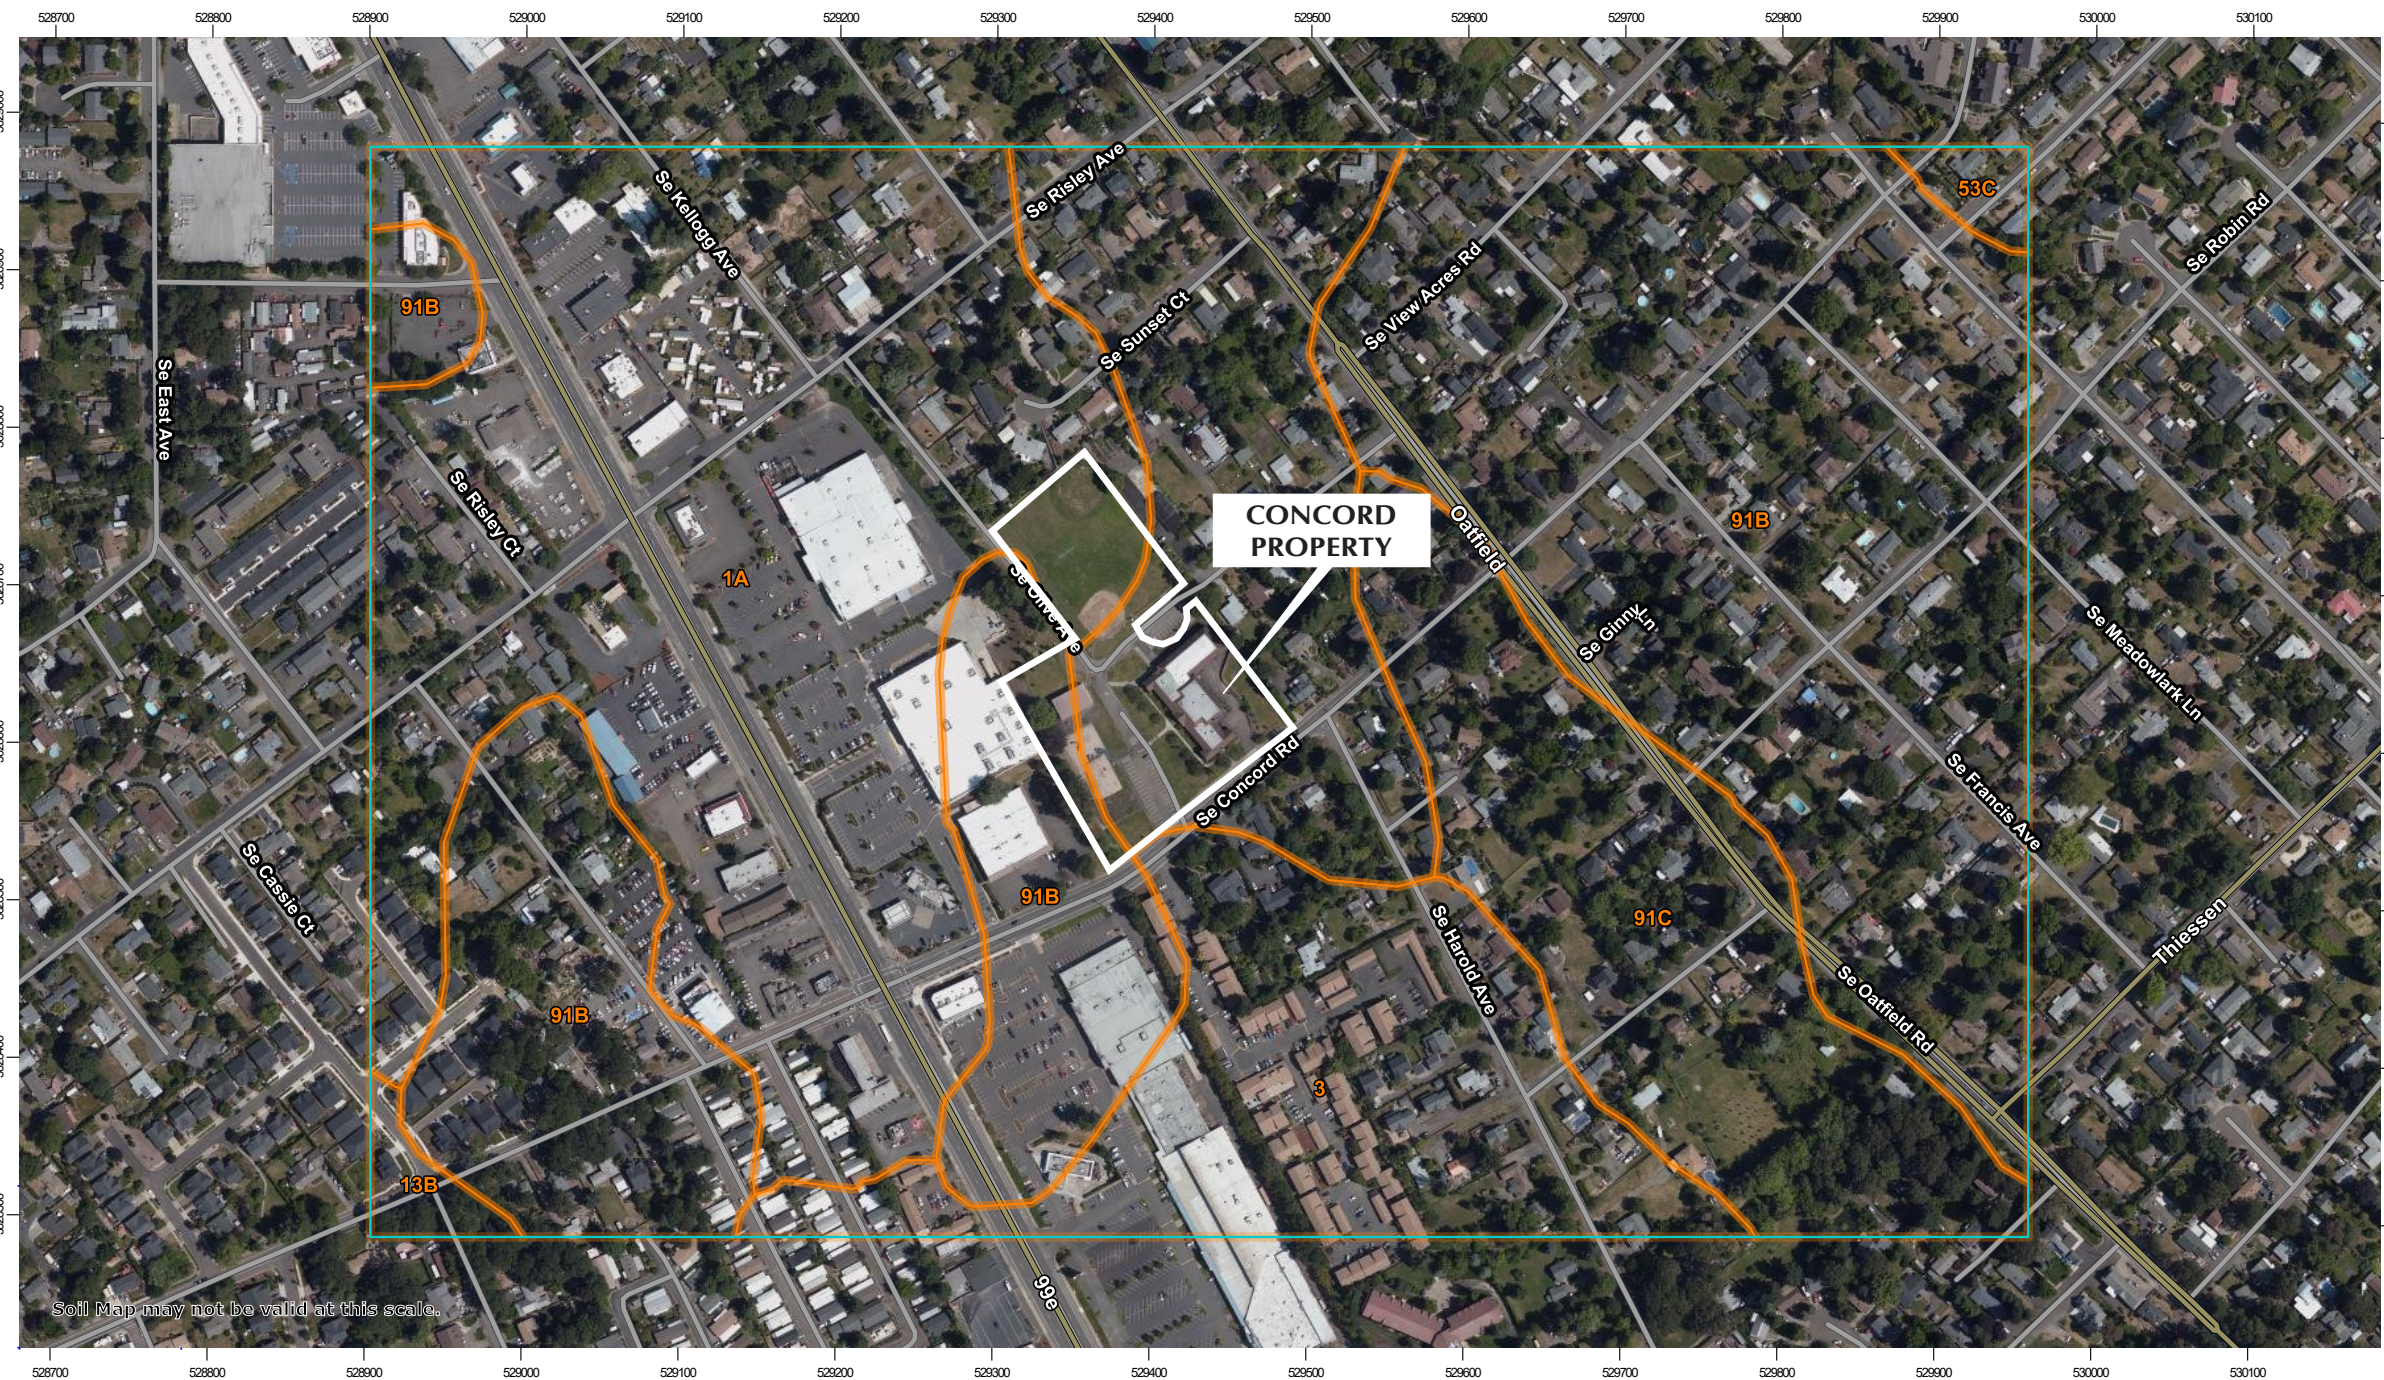
SOIL MAP
CLACKAMAS COUNTY AREA

SOIL MAP FROM FILE BY USDA, NATURAL RESOURCES CONSERVATION SERVICE, 2019
