6335 GEOTECHNICAL CONSULTATION

**SUBJECT: Geotechnical Consultation Services  
Gladstone Community Project  
525 Portland Avenue  
Gladstone, Oregon**

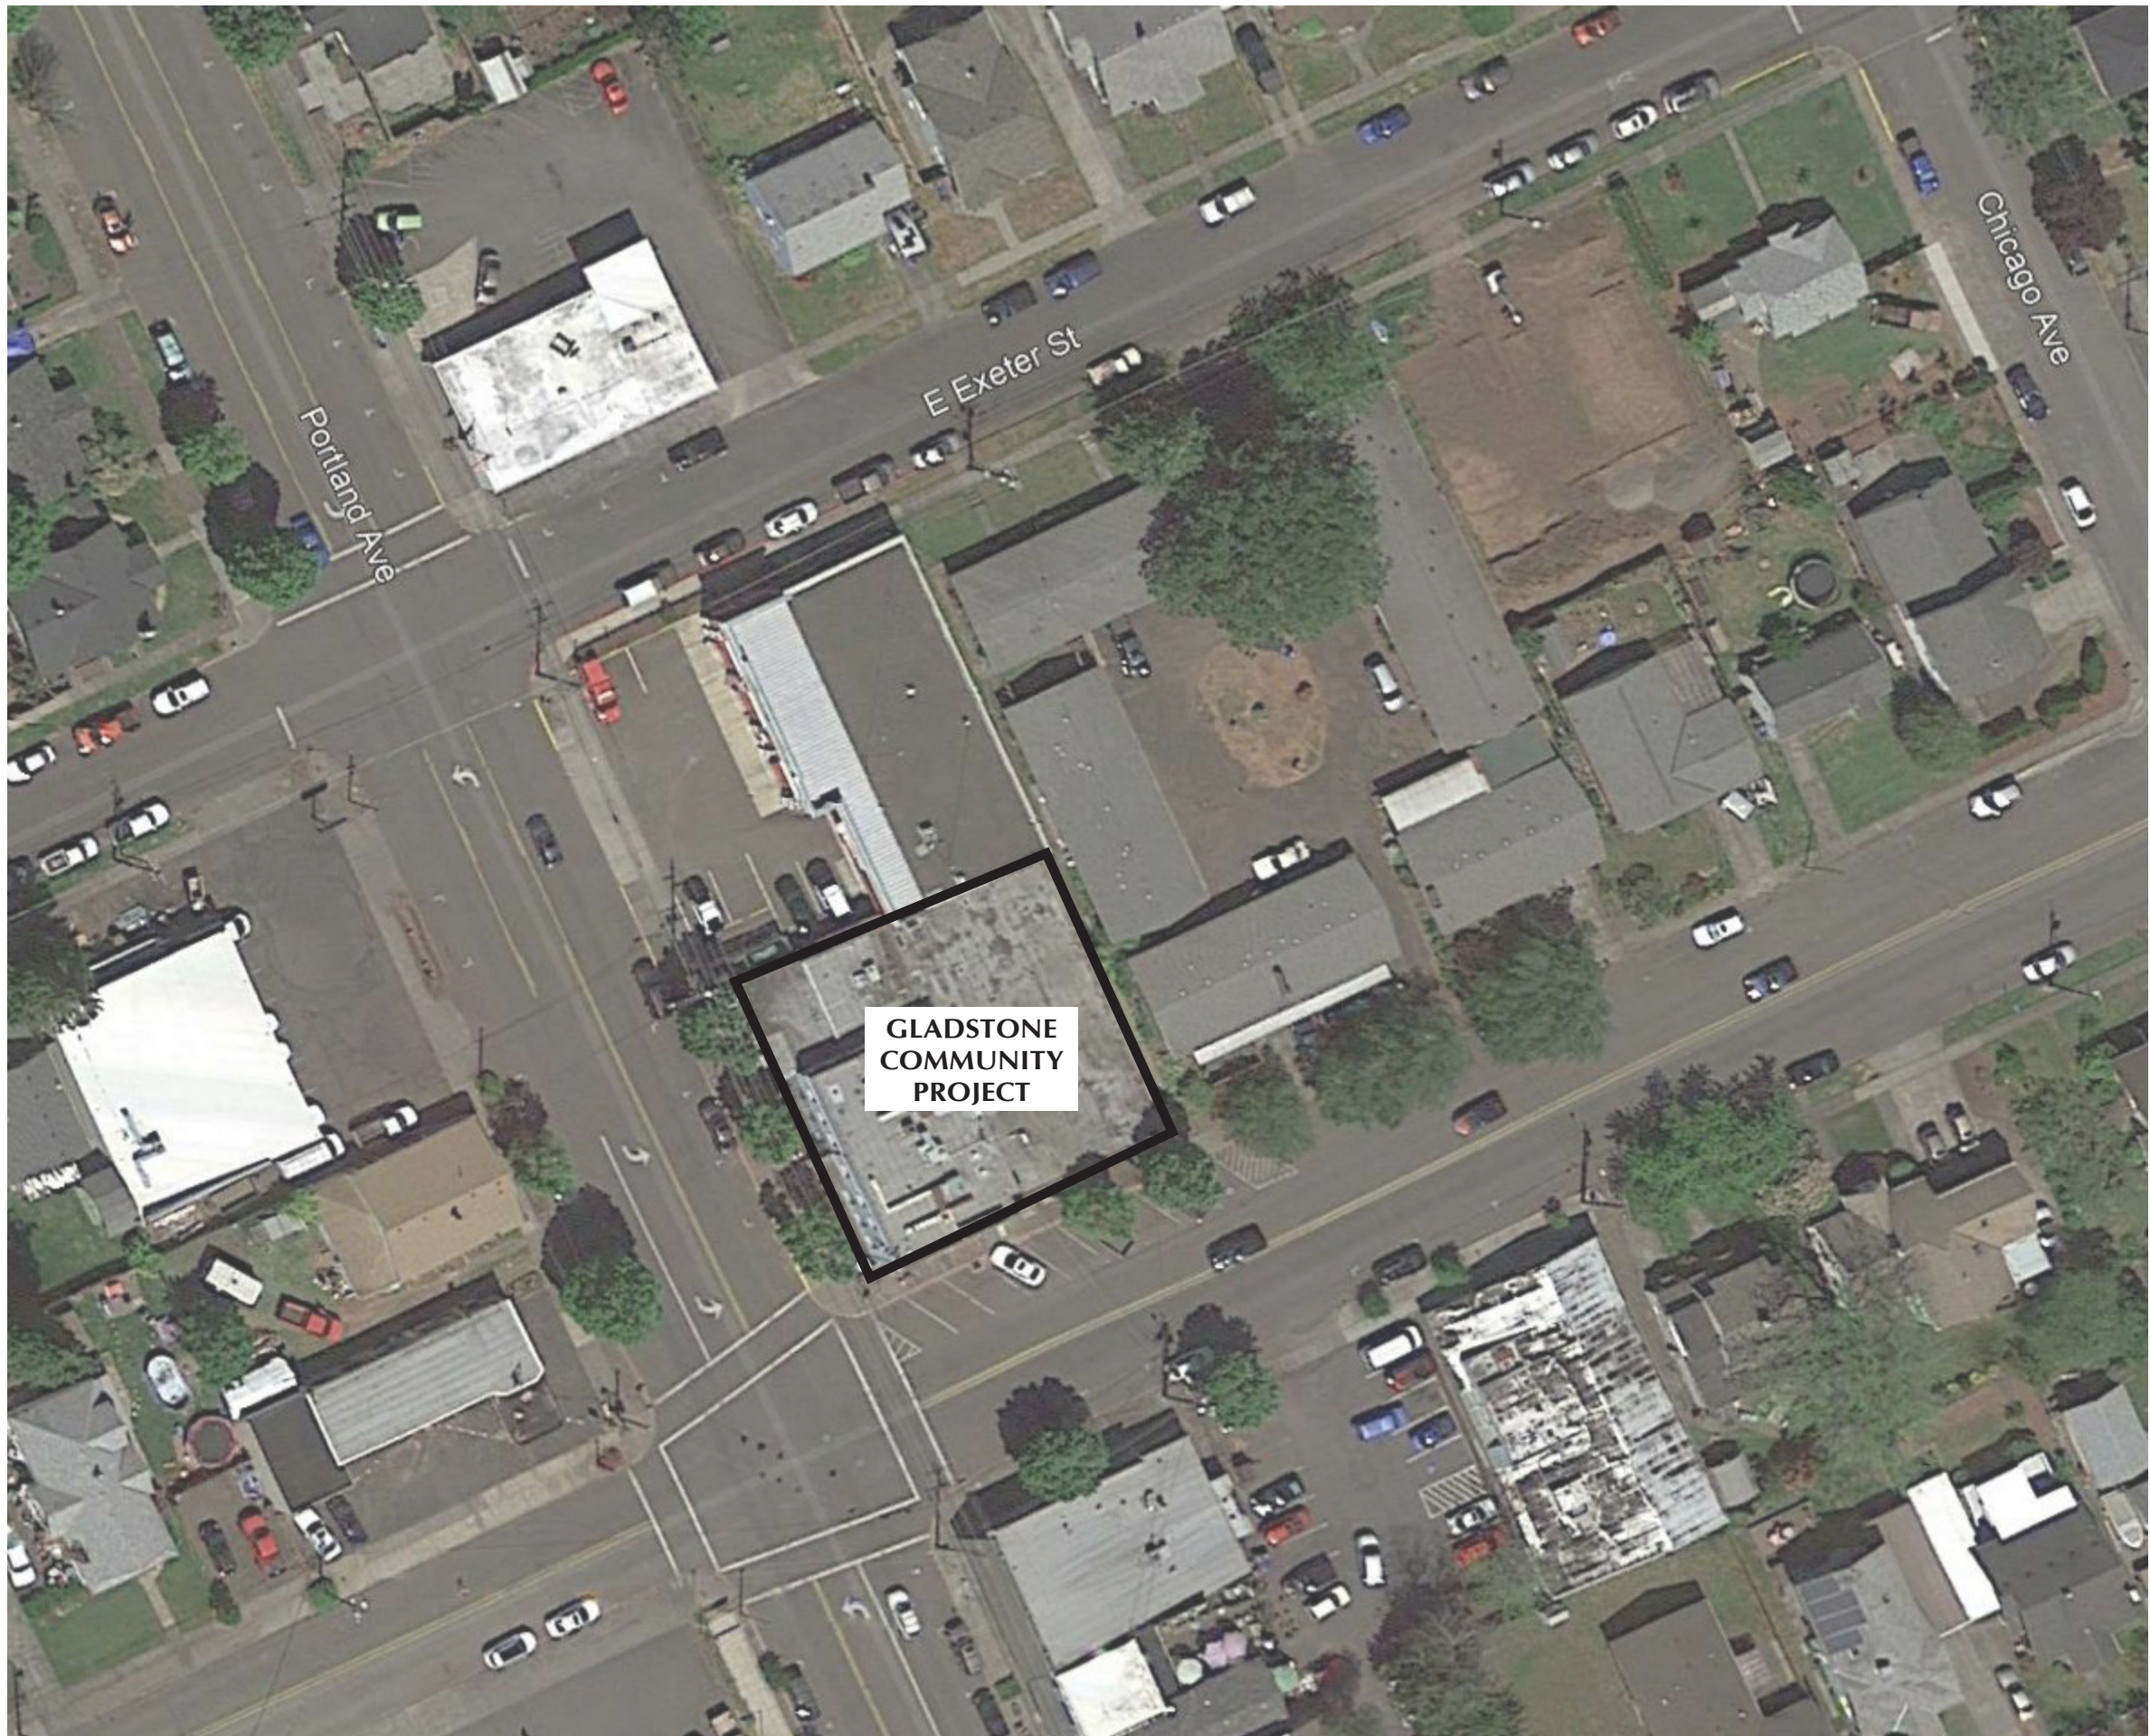
SITE PLAN FROM FILE BY GOOGLE EARTH PRO, 2019

The proposed library site is currently occupied by the City of Gladstone City Hall, located at 525 Portland Avenue in Gladstone, Oregon, and is bordered by Portland Avenue to the west; West Dartmouth Street to the south; Gladstone Volunteer Fire Department on the adjacent lot to the north; and residential housing to the east. We understand the existing City of Gladstone City Hall building is a two-story structure and occupies a footprint of approximately 9,000 square feet. Portland cement concrete sidewalks and asphalt concrete pavement roadways are located along the south and west portions of the property. Figure 2 shows the existing site.

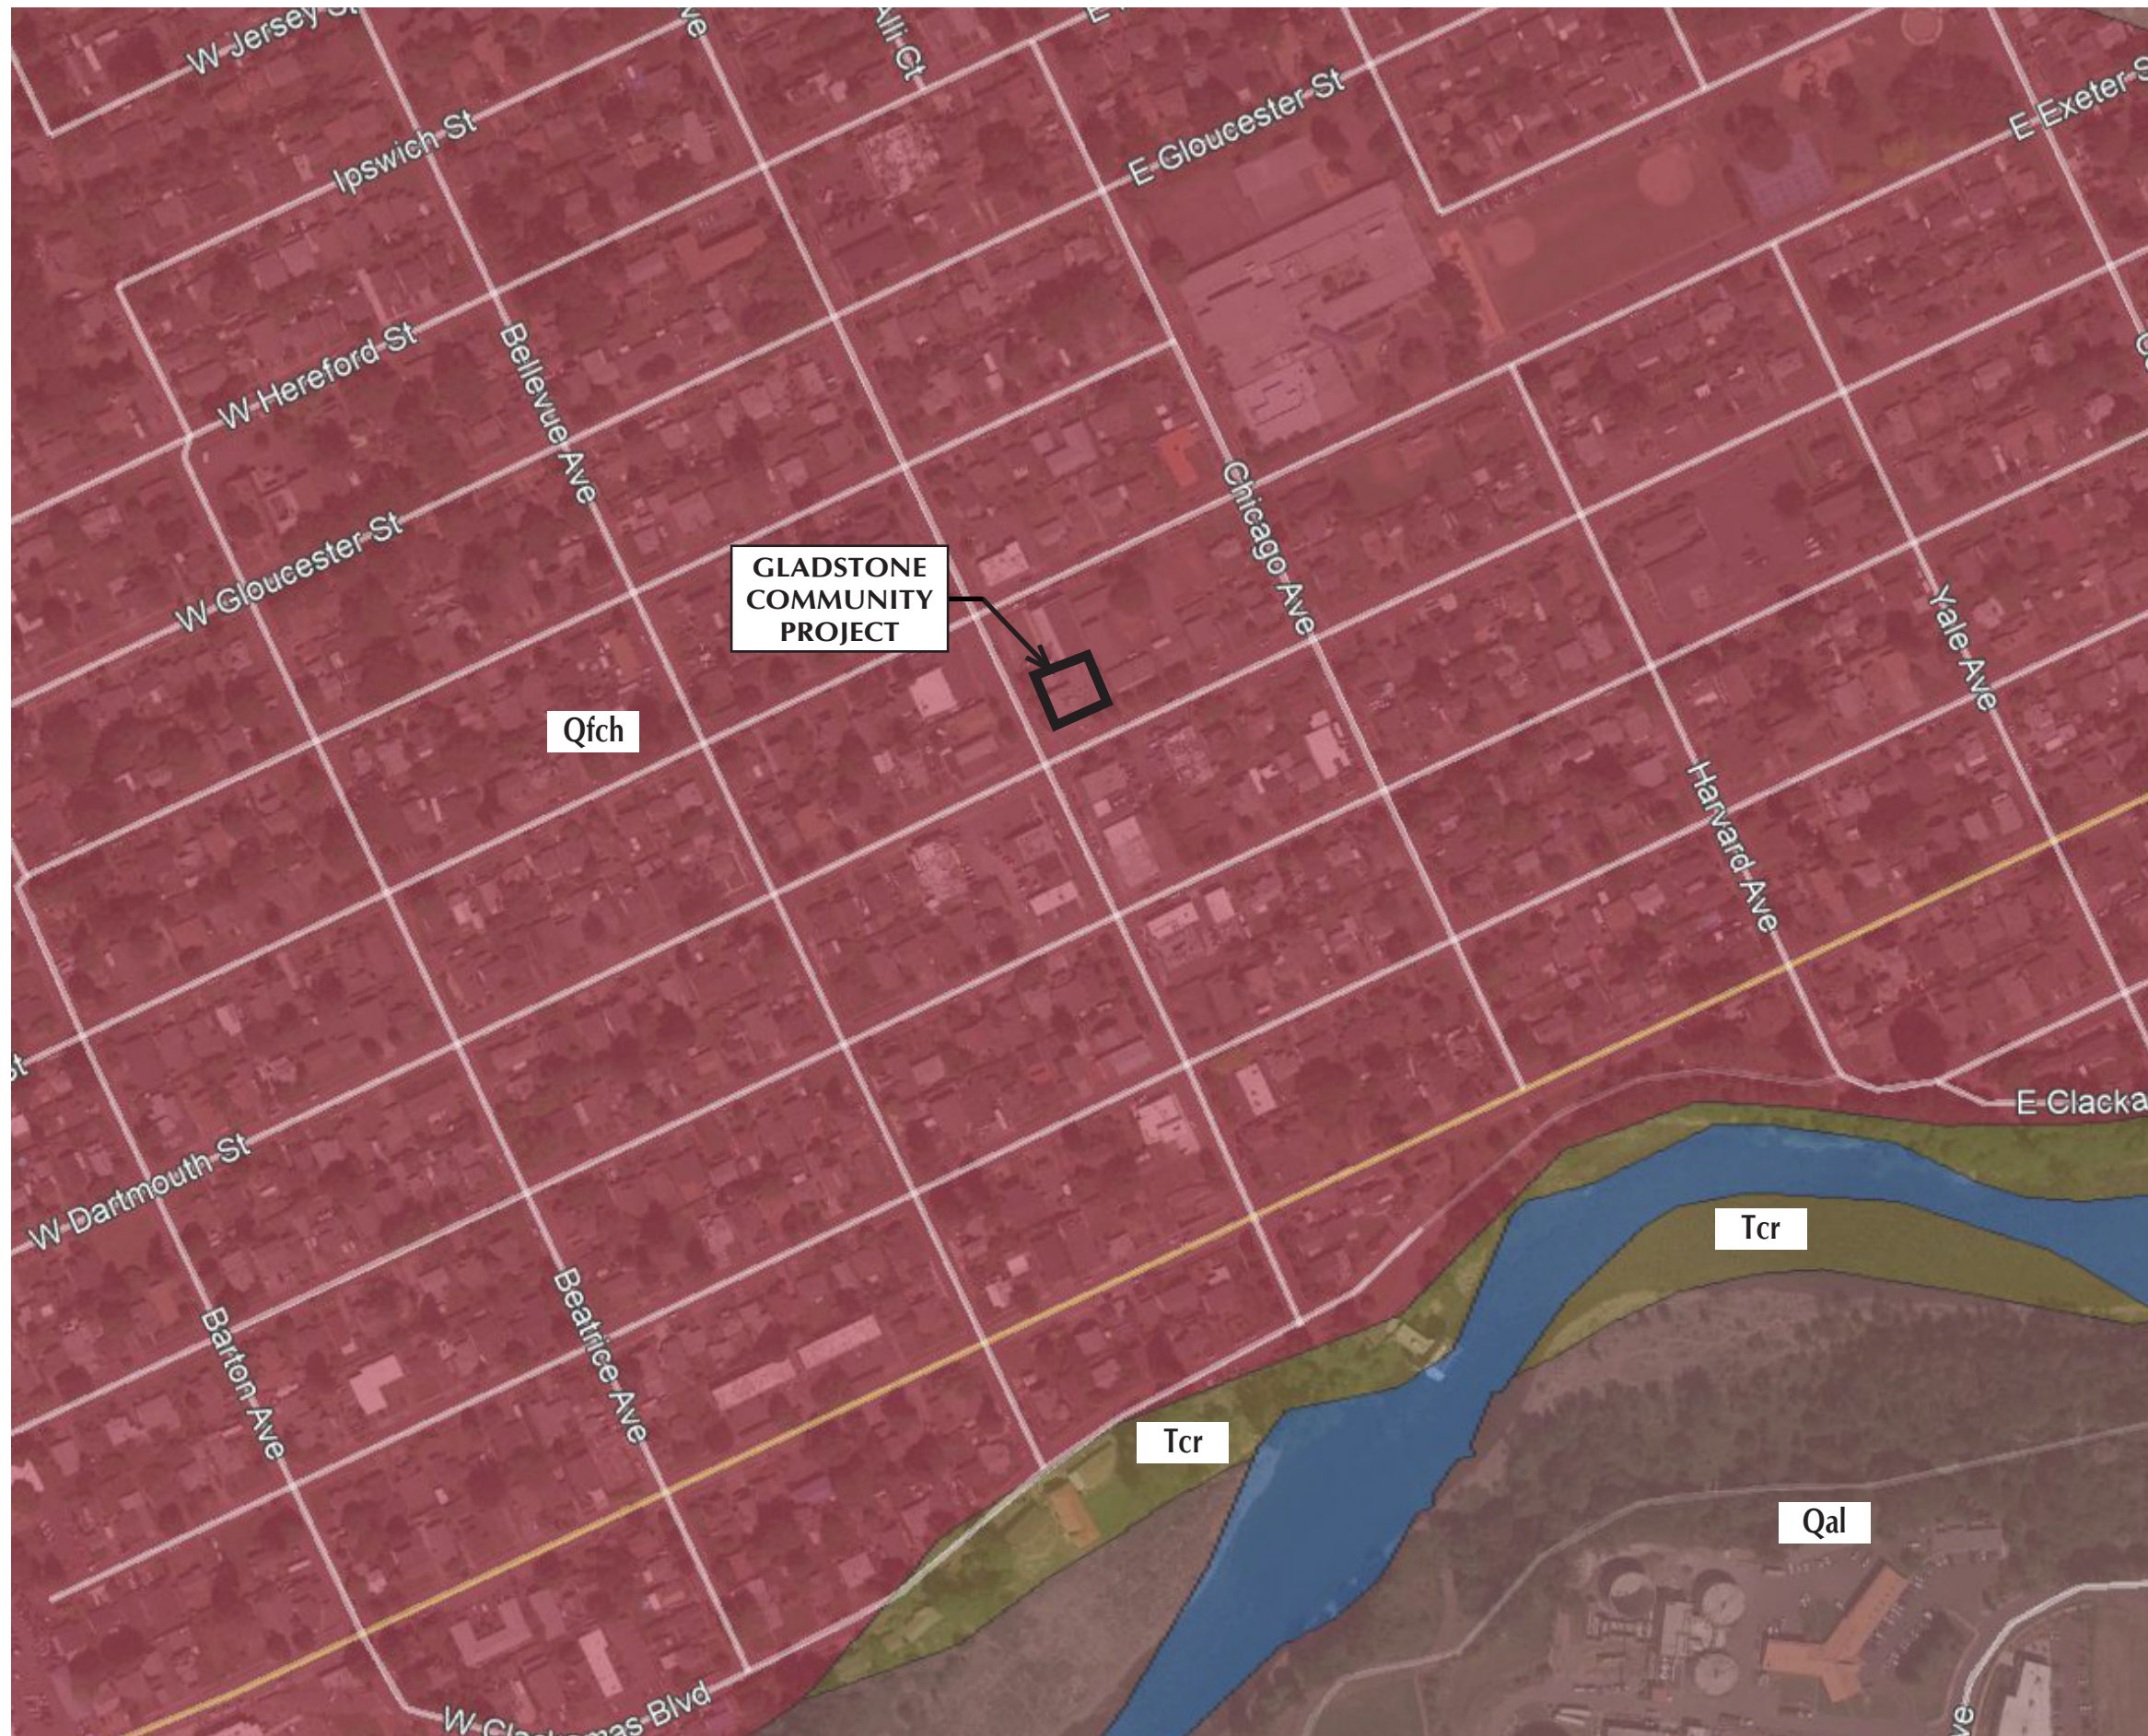
## GEOLOGIC MAP

- Qfch, CATASROPHIC FLOOD DEPOSITS, CHANNEL FACIES
- Tcr, COLUMBIA RIVER BASALT GROUP
- Qal, ALLUVIUM
- WATER

Our review of available geologic and geotechnical literature indicates the site is likely mantled with variable thickness of local fill soils primarily consisting of silt, clay, sand, and gravel. The fill soils are underlain by alluvial deposits of sand, silt, gravel, and cobbles over Columbia River Basalt Formation at depth. Fill soils, where present, may not be suitable for the support of on-grade structures depending on the fill composition, magnitude of foundation loads, and settlement sensitivity. The fine-grained fill and alluvial soils are extremely sensitive to moisture content and are easily disturbed by construction activities when wet. Careful working procedures and the use of imported granular fill material may be necessary if site preparation and grading are undertaken during wet-weather and wet-ground conditions.

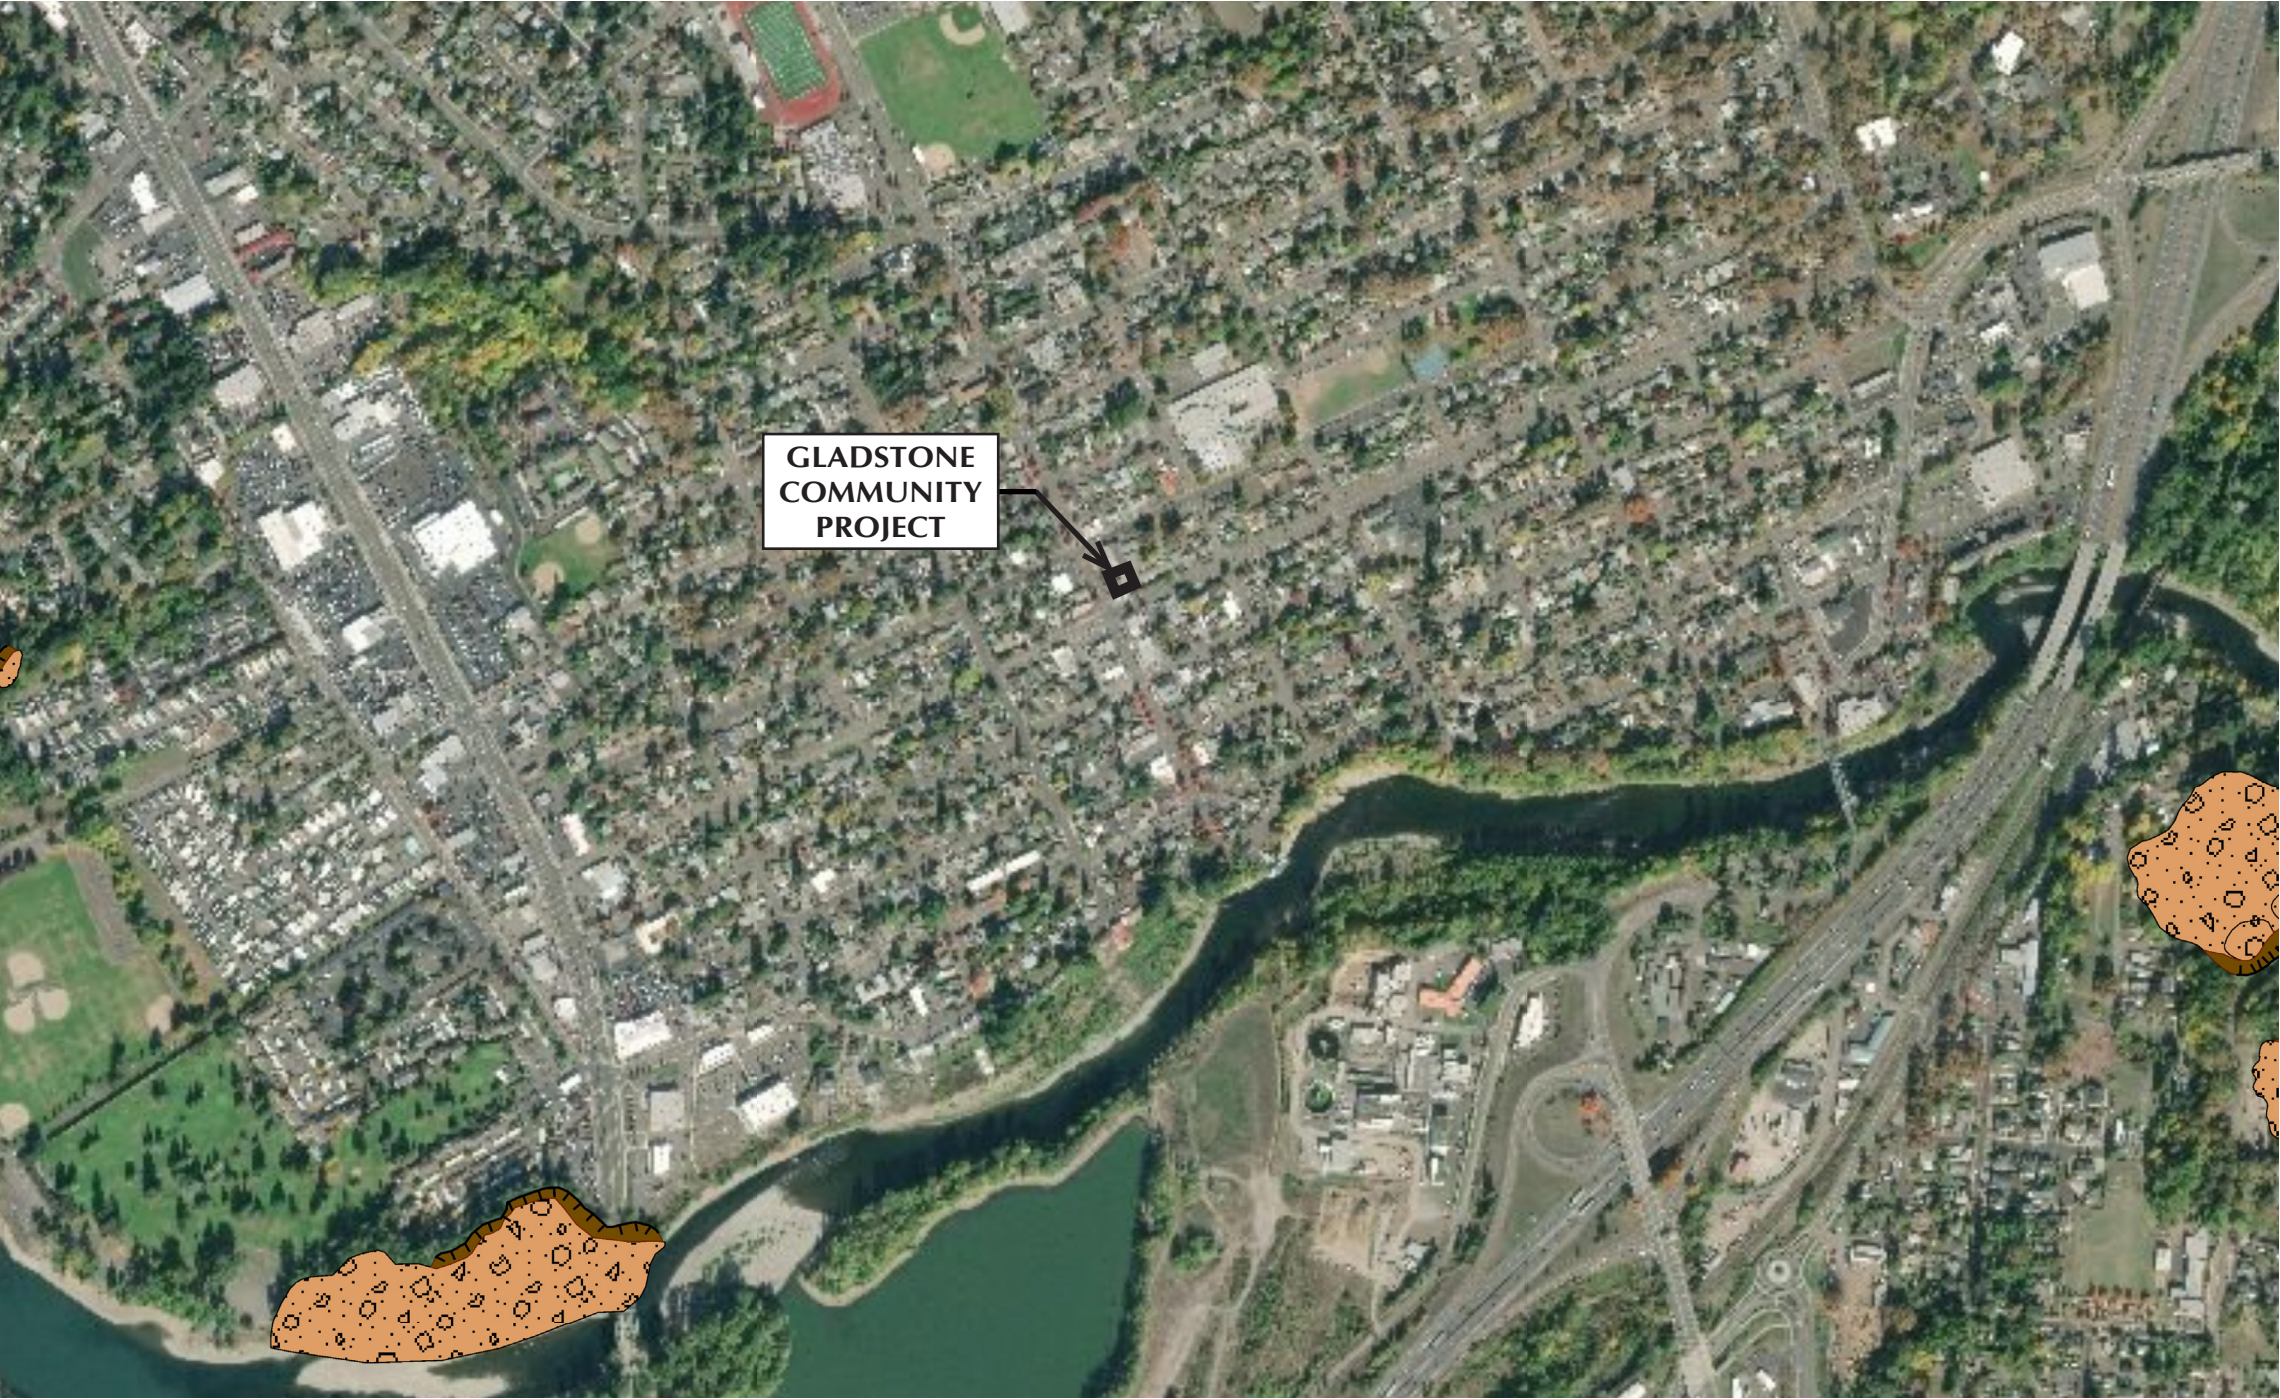
LANDSLIDE MAP FROM FILE BY ESRI, DIGITALGLOBE, GEOEYE, EARTHSTAR GEOGRAPHICS, CNES/AIRBUS
