6334 GEOTECHNICAL CONSULTATION

**SUBJECT: Geotechnical Consultation Services
Clackamas County Community Center
3811 SE Concord Road
Milwaukie, Oregon**

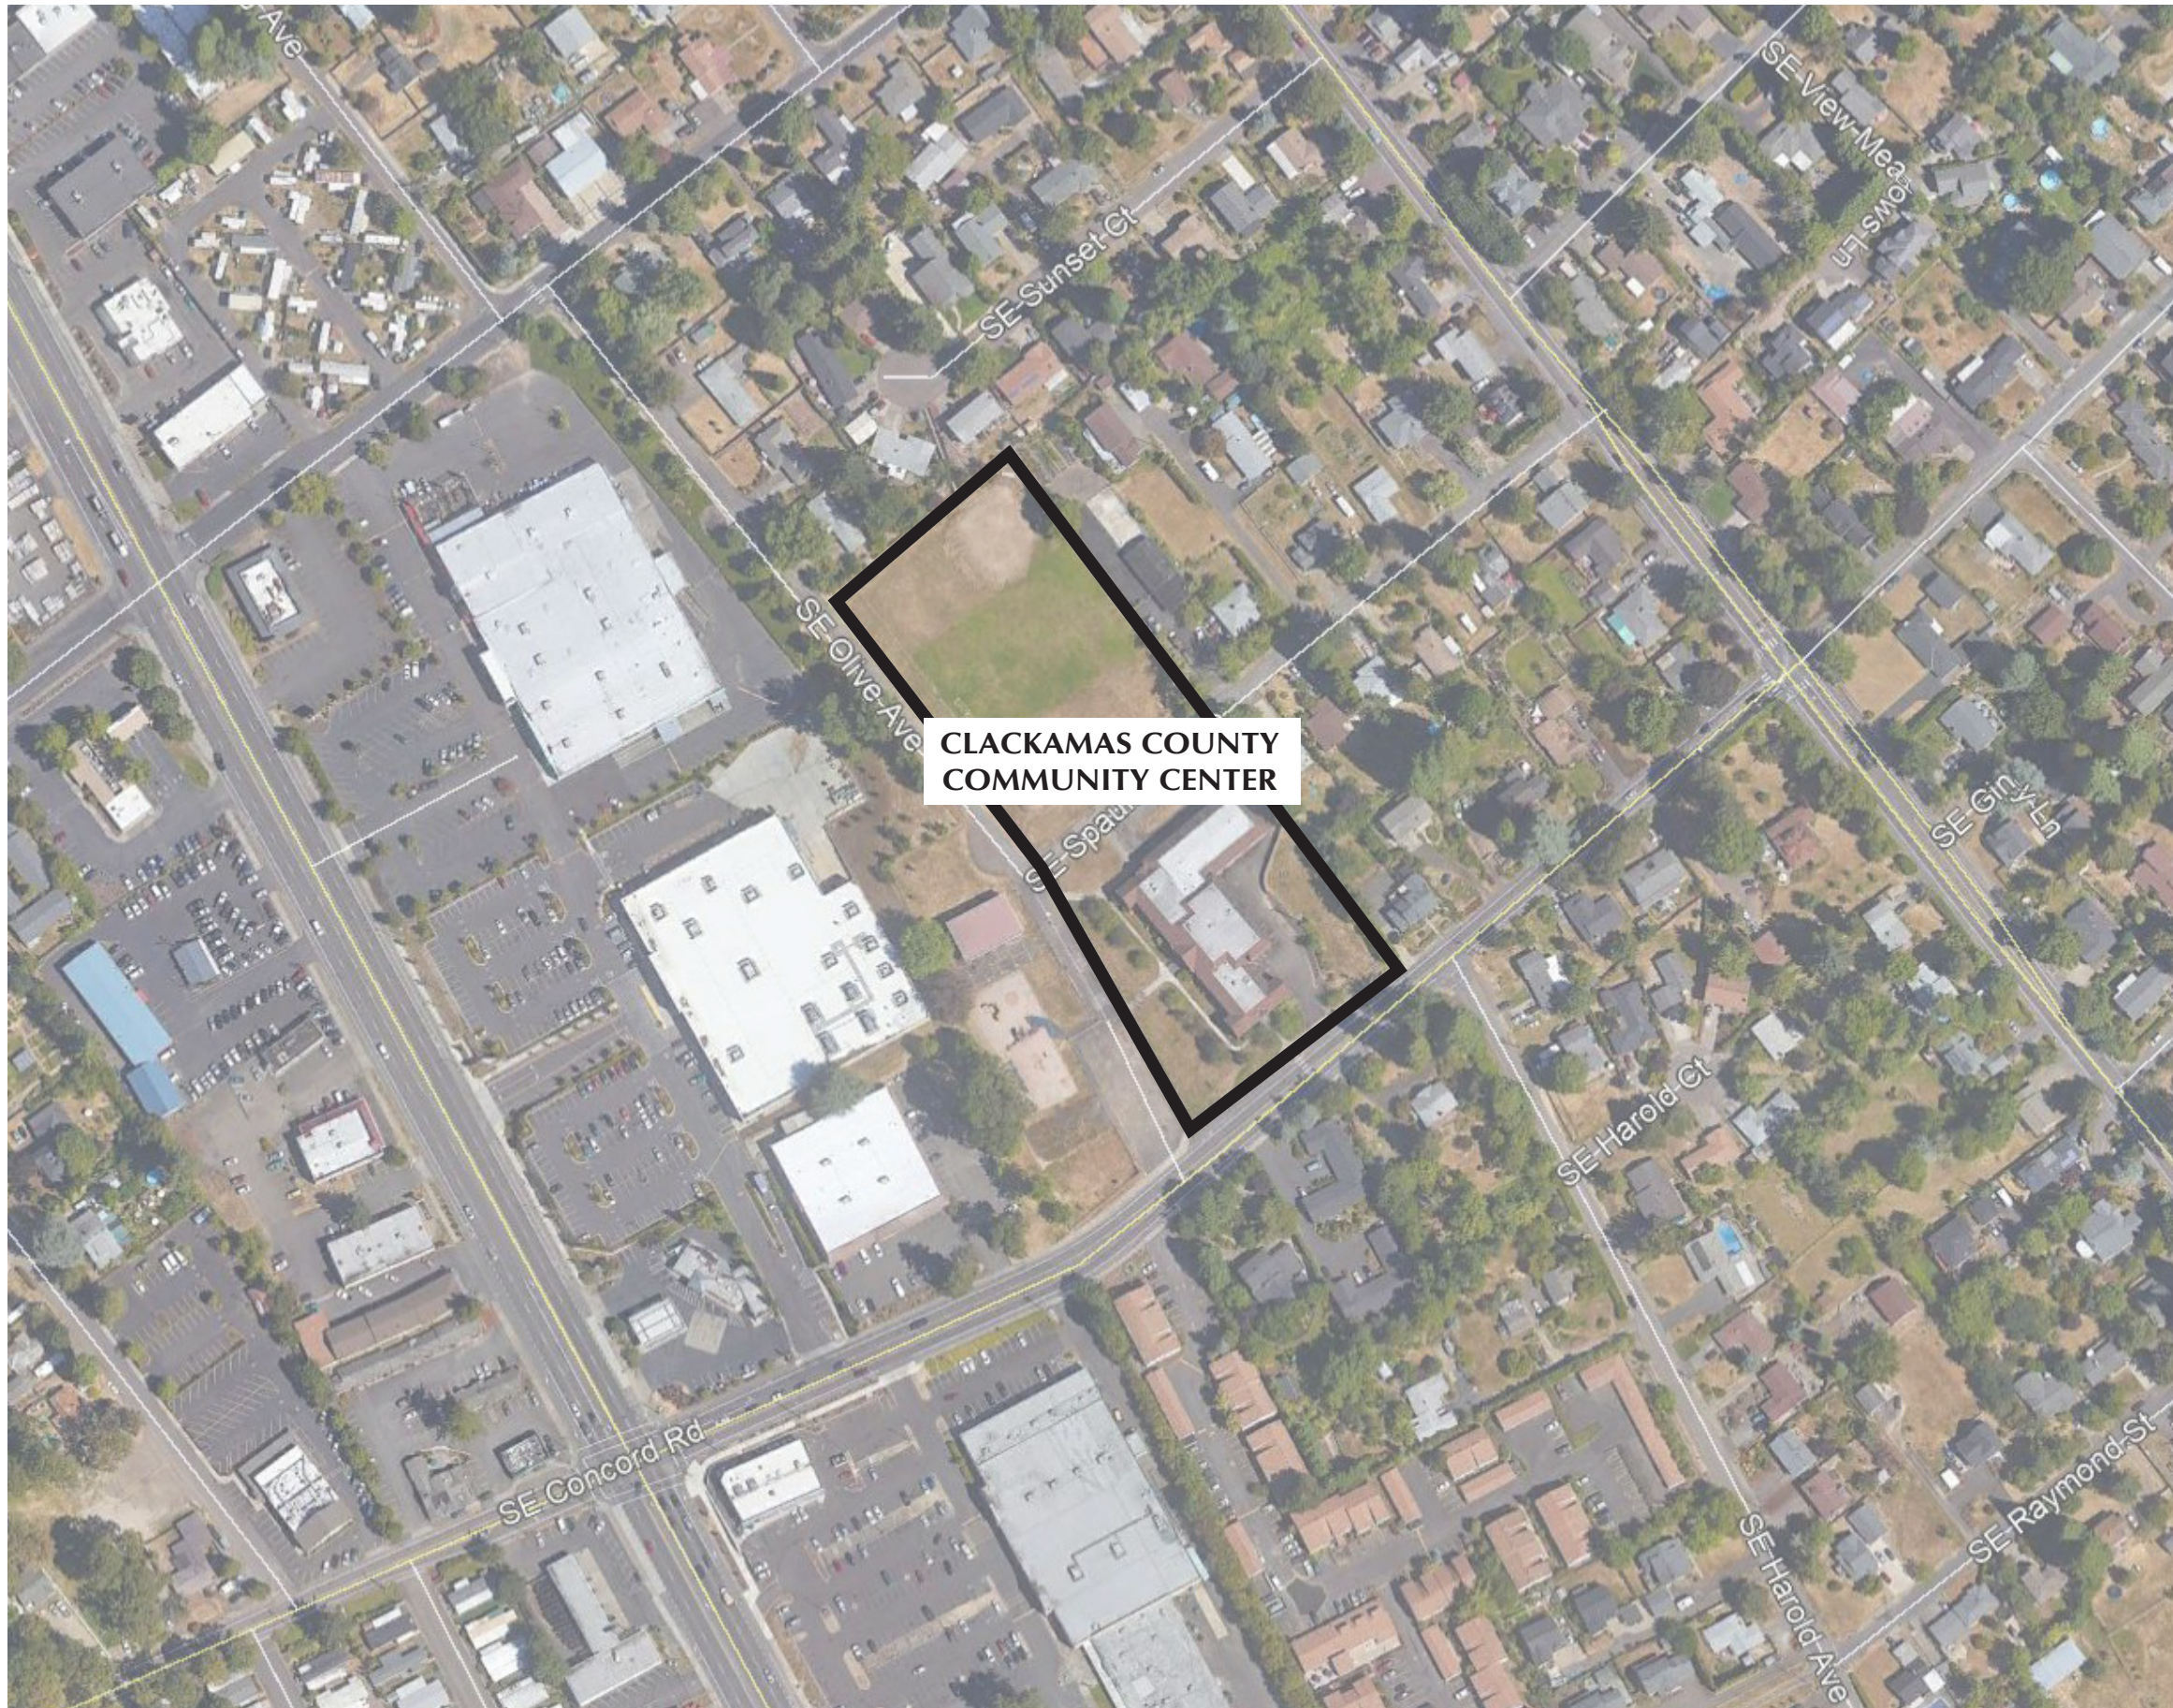
SITE PLAN FROM FILE BY GOOGLE EARTH PRO, 2019

The proposed community center site is currently occupied by North Clackamas Parks and Recreation District, located at 3811 SE Concord Road in Milwaukie, Oregon, and is bordered by SE Olive Avenue to the west; SE Concord Road to the south; and residential housing to the north and east. The site is bisected by SE Spaulding Avenue. Based on satellite and street view imagery, the southern portion of the site is occupied by an existing building, with grass fields on the northern portion of the property and play areas to the west. Mature trees surround the building and site perimeter, and an approximately 4 to 6 ft high retaining wall surrounds the north and east side of the existing building. Portland cement concrete (PCC) sidewalks and asphalt concrete (AC) pavement roadways are located along the south, central, and west portions of the property. Figure 2 shows the existing site.

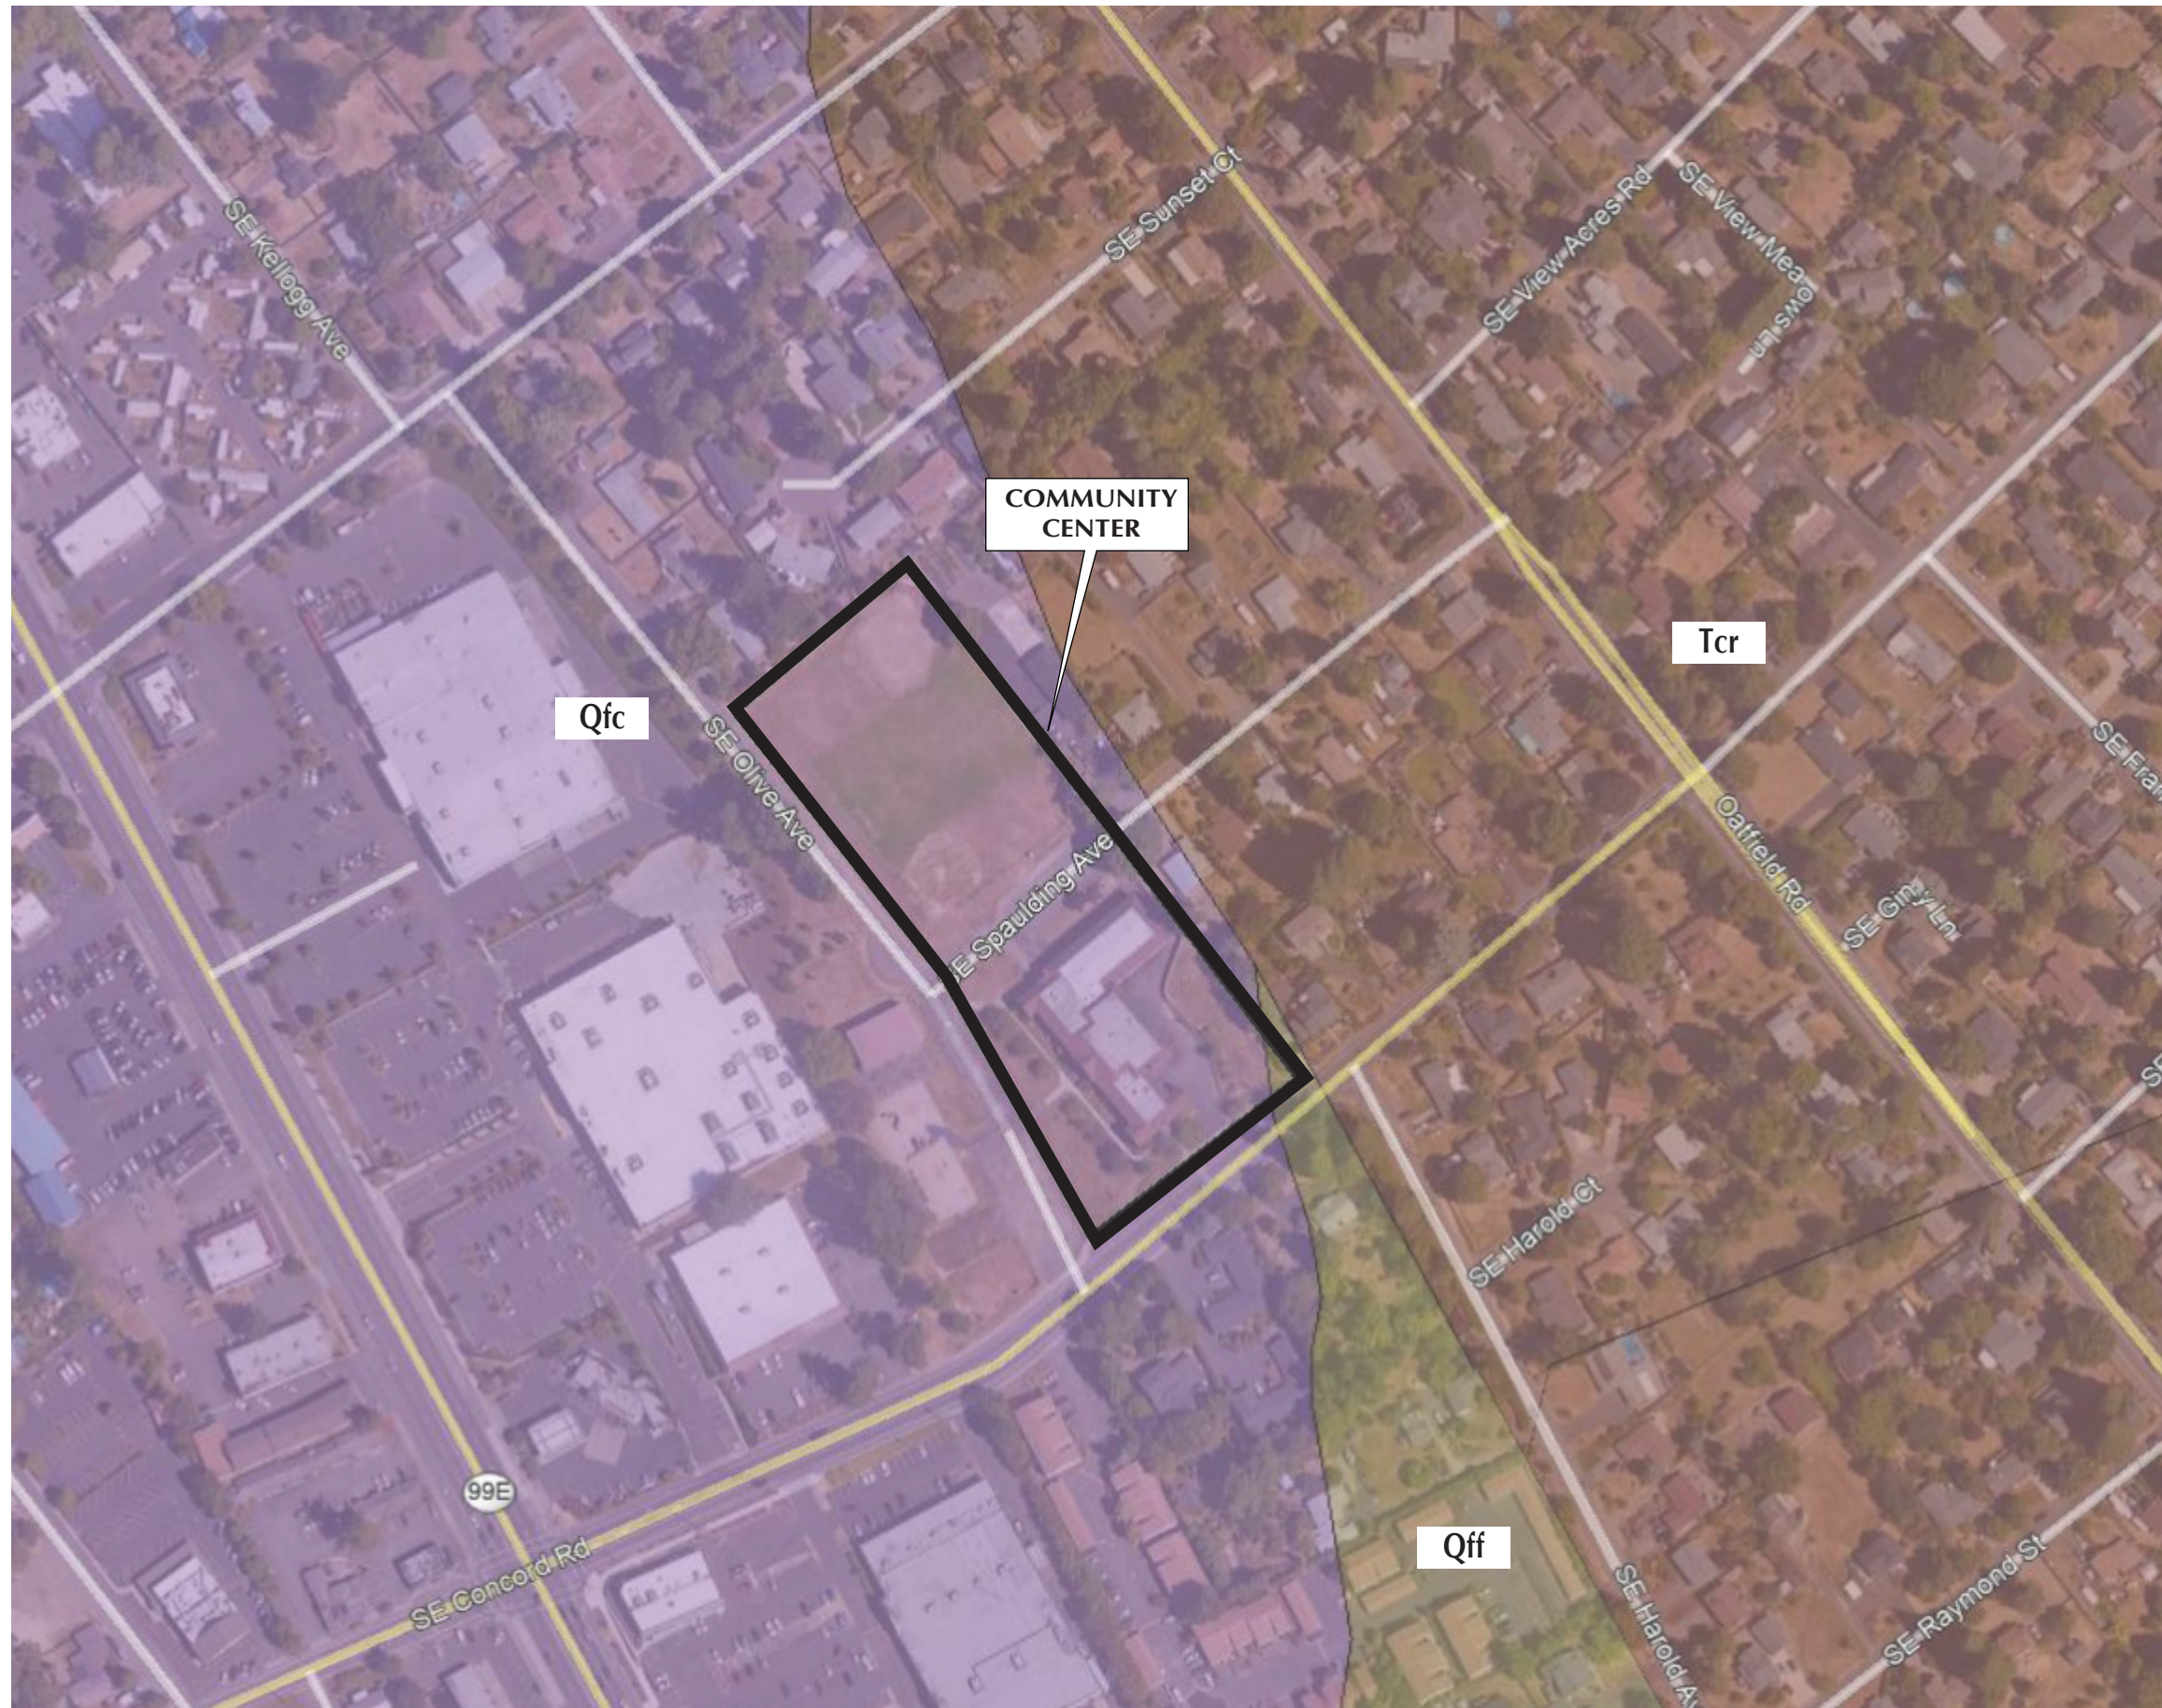
GEOLOGIC MAP

- Tcr, COLUMBIA RIVER BASALT GROUP
- Qff, CATASTROPHIC FLOOD DEPOSITS, FINE-GRAINED FACIES
- Qfc, CATASTROPHIC FLOOD DEPOSITS, COARSE-GRAINED FACIES

Our review of available geologic and geotechnical literature indicates the site is likely mantled with variable thickness of local fill soils primarily consisting of silt, clay, sand, and gravel. The fill soils are underlain by alluvial deposits of silt, sand, and clay, often containing layers of gravels and cobbles, over the Columbia River Basalt Formation at depth. Fill soils, where present, may not be suitable for the support of on-grade structures depending on the fill composition, magnitude of foundation loads, and settlement sensitivity. The fine-grained fill and alluvial soils are extremely sensitive to moisture content and easily disturbed by construction activities when wet. Careful working procedures and the use of imported granular fill material may be necessary if site preparation and grading are undertaken during wet-weather and wet-ground conditions.

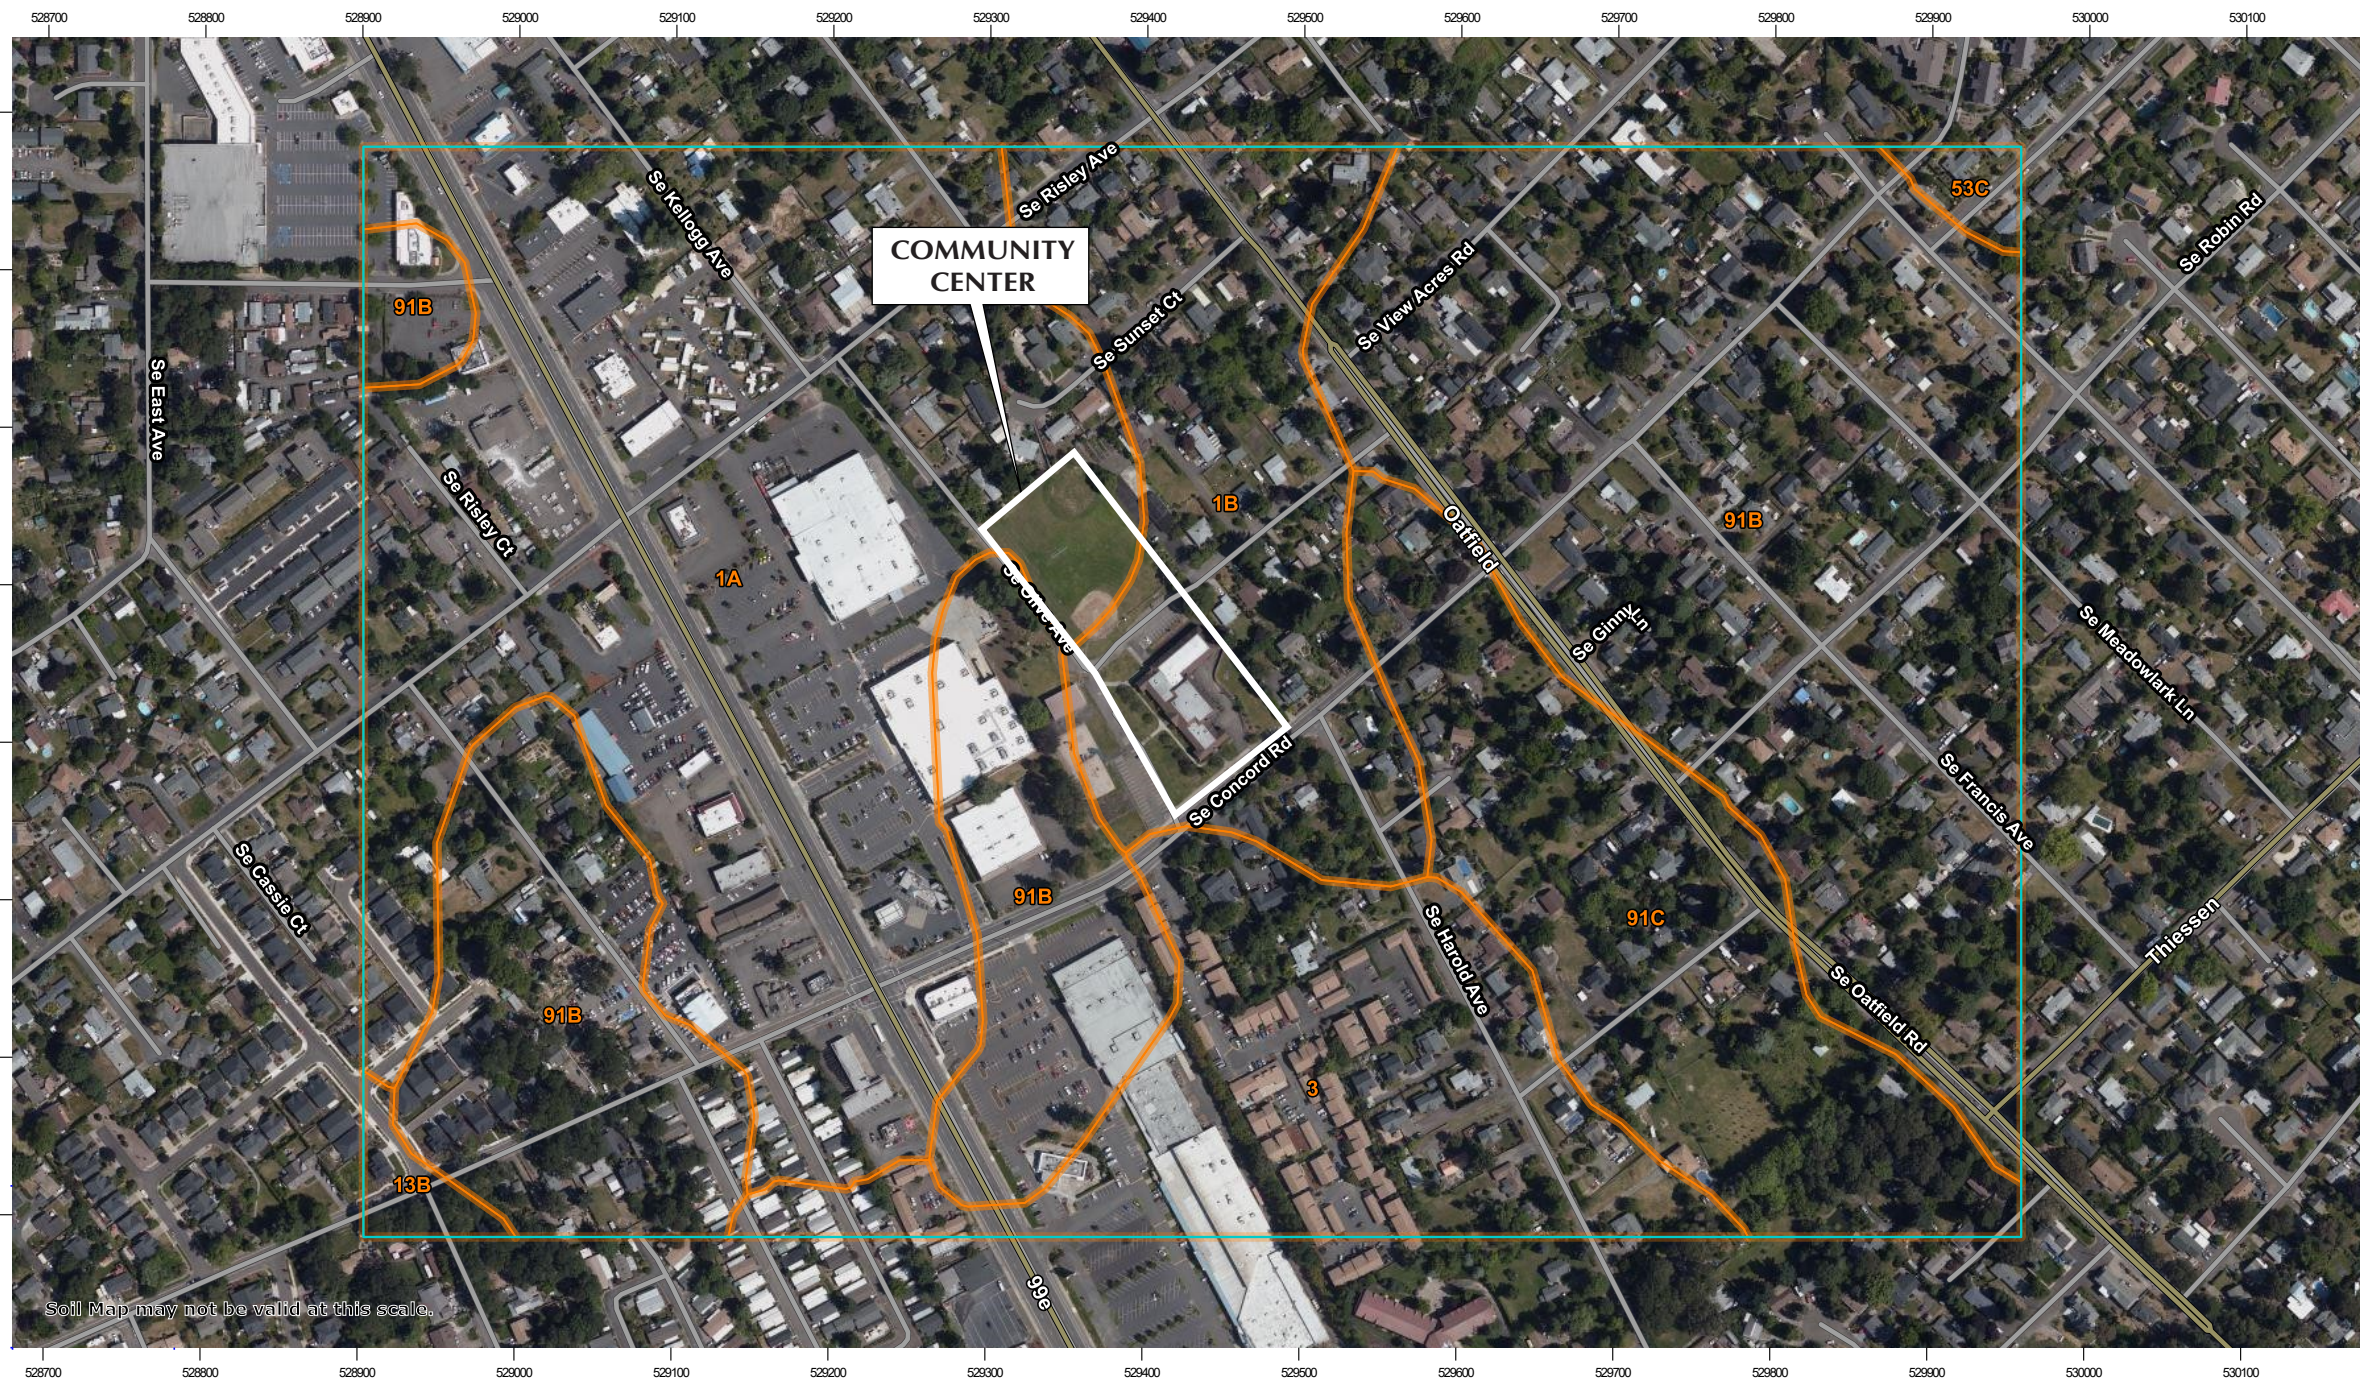
SOIL MAP CLACKAMAS COUNTY AREA

SOIL MAP FROM FILE BY USDA, NATURAL RESOURCES CONSERVATION SERVICE, 2019
