**Clackamas Water Environment Services (WES)
Storm System Master Plan (SSMP) 2022
Appendices**

Technical Memorandum:
Preliminary Soil Infiltration Characterization -
Clackamas County WES Storm System Master Plan

Preliminary Soil Infiltration Characterization – Clackamas County WES Storm System Master Plan

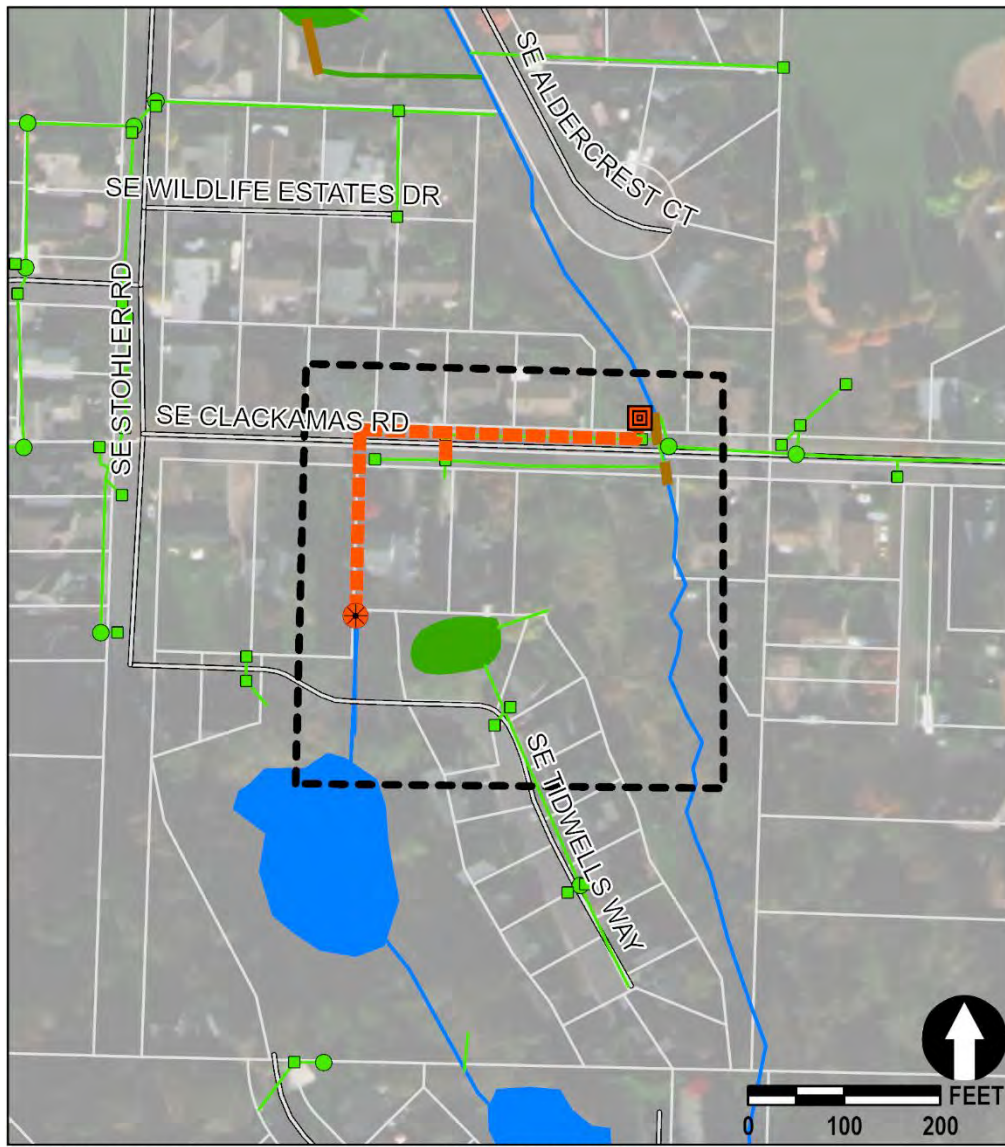
Tool Kit Elements

- 6, Modify Flow Control
- 8, Outfall Scour Protection
- 13.0, Storm Sewer Pipe

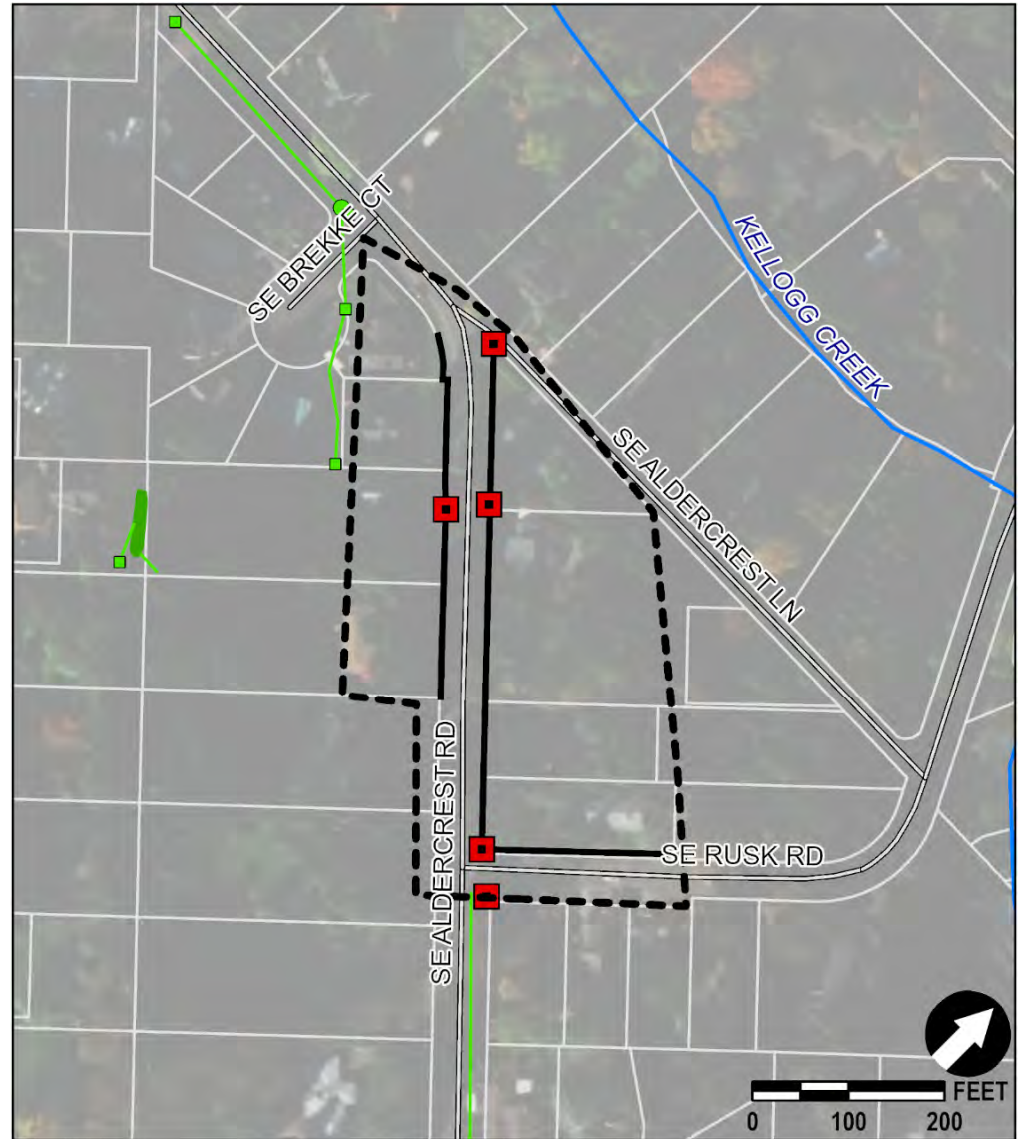
This project will construct a curb and gutter along SE Aldercrest Road to channel water south into catch basins at the intersection of SE Aldercrest Road and SE Rusk Road. The catch basins will also be replaced.

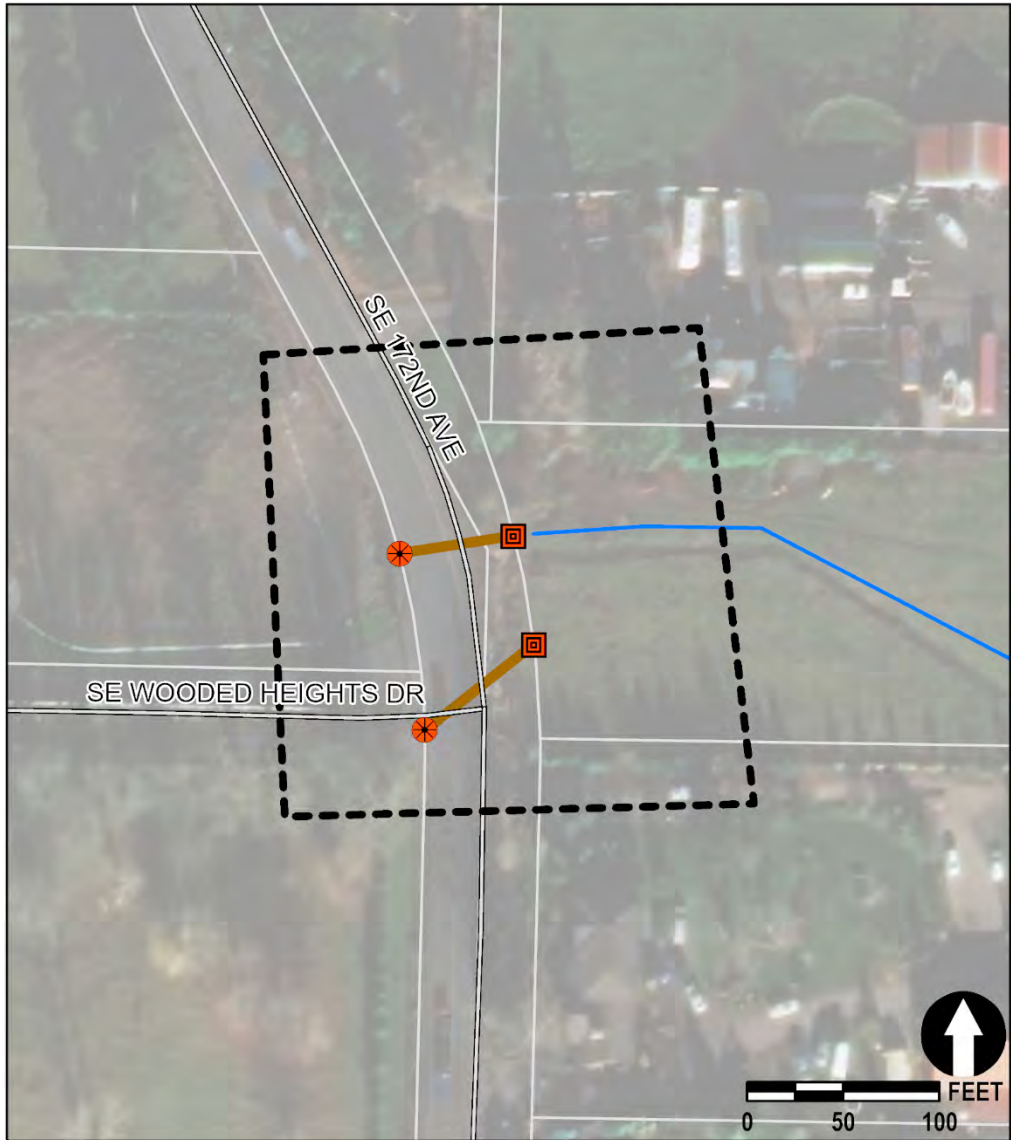
The project will replace the culvert inlets with beehive grate manholes. These larger inlet structures will be less prone to clogging from vegetation, sediment, and debris. At the outlets, rip rap scour protection or concrete splash pads will be added to keep vegetation from restricting flows and to prevent erosion.

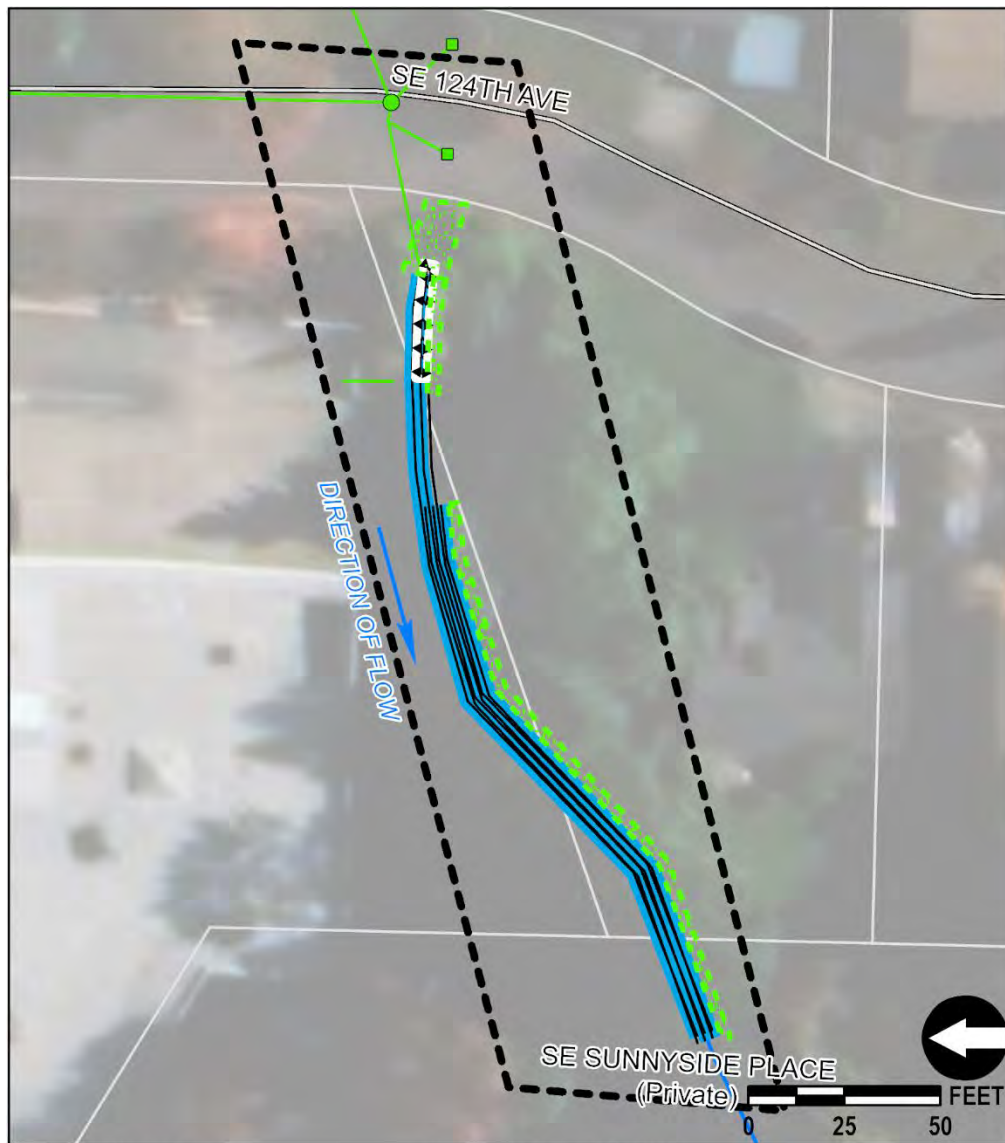
Tool Kit Elements

- 2, Bioengineered Slope
- 7, Open Channel Excavation
- 17, Revegetation

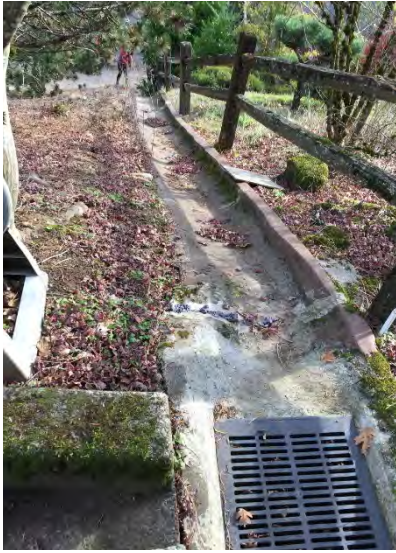
New Birdcage Inlets and Manholes

Because some inlets frequently clog with debris and cause minor flooding, this program recommends upgrading 32 inlets and manholes with a large birdcage inlet or manhole. This type of inlet will help to reduce clogging and debris accumulation at these locations that have been problematic in the past.

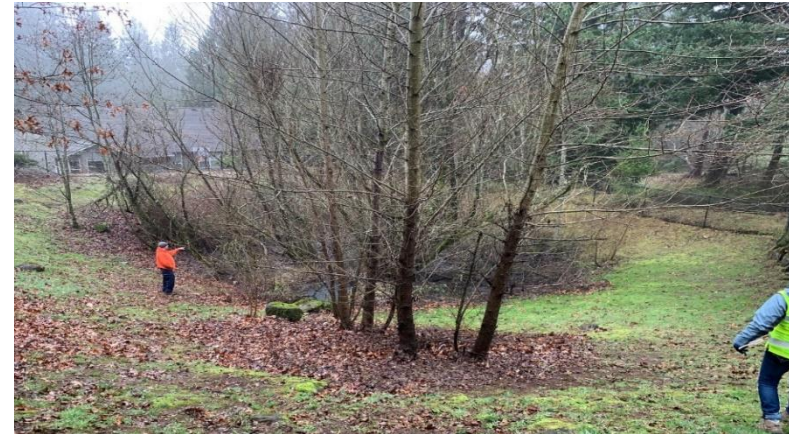
Rehabilitation a stormwater pond typically includes removal of sediment and invasive species, regrading edges, cleaning orifices and pipes and other related activities. Stormwater pond repair can include several activities or types of work. In some cases, hard features such as weirs, orifices, inlets, pipes, or other parts of the system may need to be replaced. Also, maintenance access to the ponds may need repair to allow proper equipment near the site or allow field staff to work near the site safely.

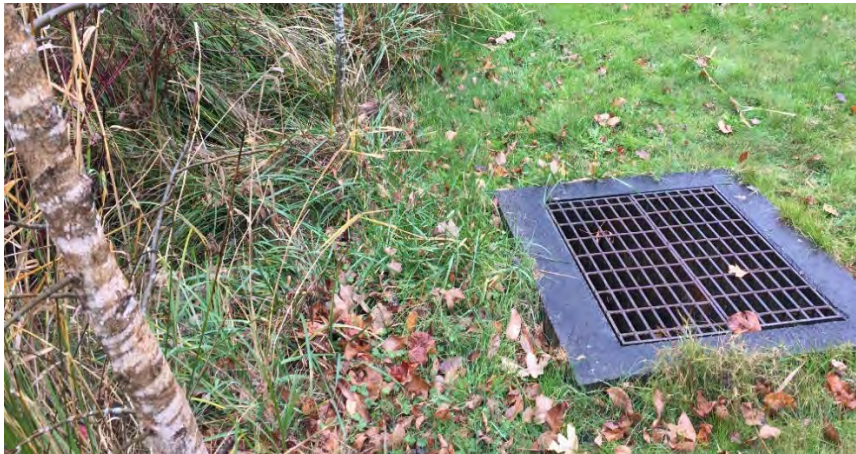
Typically, decommissioning a UIC entails filling the vault with concrete and removing the manhole cover. The area around the manhole will be restored to match the directly adjacent surfaces, either lawn or pavement.

Typically, retrofitting a UIC entails filling it with one to two feet of concrete so that the total depth is greater distance from seasonal high groundwater levels. It could also entail installing low impact development (LID) practices upstream of the UIC inlet to treat the runoff before it enters the UIC.

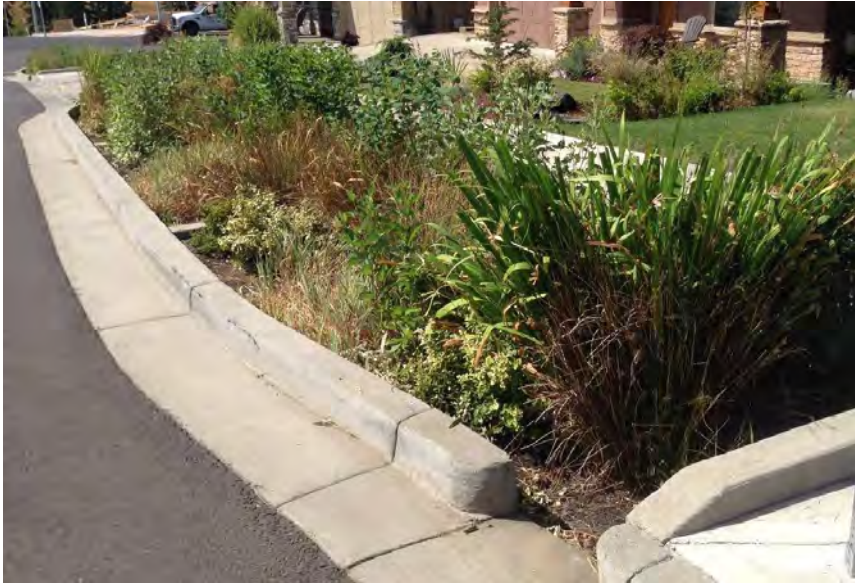
Stormwater Planter in the Right-of-Way

Stormwater planters in the right-of-way are walled basins that can be installed on existing streets where space allows, often between the curb and the sidewalk. A right-of-way planter would be installed in the parking lane near an intersection or in a portion of the sidewalk to capture stormwater runoff from an existing street. The planters either infiltrate the runoff or connect to existing conveyance in the street.

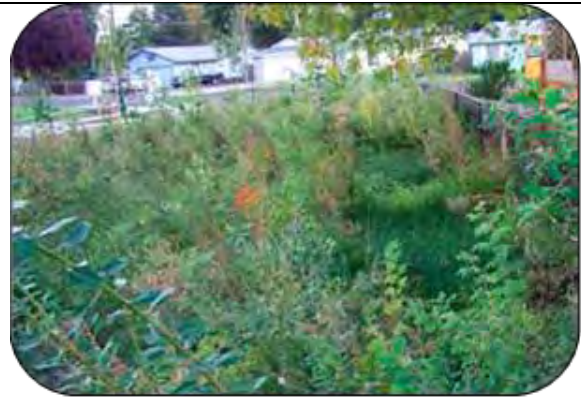
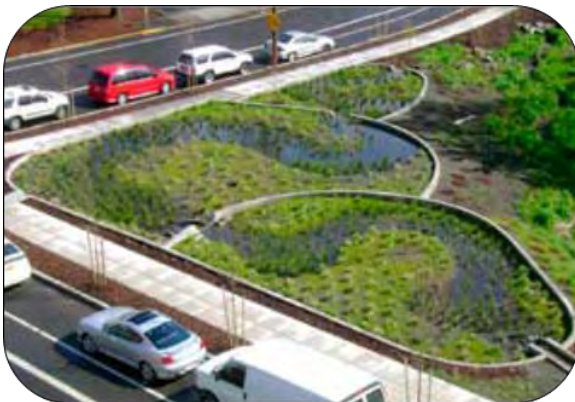
Figure 2. Key Components of Planning for Regional Stormwater Facilities

Determine Options/Understand Site Conditions

- Are regional facilities an option for this site?
- Conduct a GIS analysis to identify low points and other features such as streams, wetlands, steep slopes, and other major characteristics of the study area
- Delineate floodplains and vegetated corridors/ riparian zones
- Locate where water quality issues, erosion, or other problematic areas exist

Develop Stormwater Strategy

- Determine multiple options for siting regional facilities including specific types, locations and estimated size
- Note open space, park, or other amenity plans and goals and discuss if integrating those with regional stormwater facility would be added benefits for the community
- Estimate construction costs
- Consider future maintenance and operation access and costs

Prepare for Land Acquisition/Easements

- Identify properties not publicly owned but required for regional stormwater facility
- Begin discussion with elected officials early about land acquisition and/or easements
- Secure necessary approvals and budget before reaching out to property owners
- Prepare solid arguments about why it's in their best interest to sell or allow easements

- Begin to estimate how much stormwater needs to be detained to meet regulatory or code requirements and create conceptual designs for the facilities.
- If multiple facilities are required, create conceptual plan for the entire site including temporary facilities and conveyance infrastructure
- Show community amenities if applicable

Figure 2 (next page) describes the key components to properly assess whether a regional stormwater approach would be feasible and compatible with future development sites.

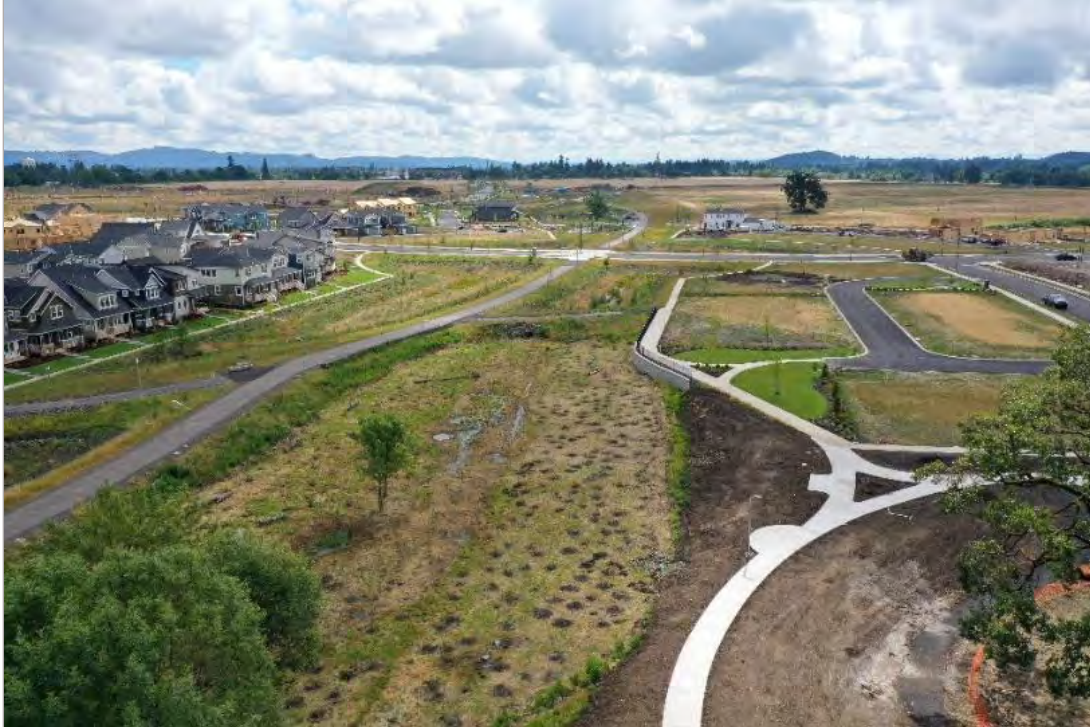
Greenway Park and Regional Stormwater Facility at Reeds Crossing, South Hillsboro
(Photo Credit: GreenWorks, PC)

Stormwater plans can also help piece together multiple services into broader vision through a regional stormwater planning approach. For instance, the greenway plan in Reeds Crossing in South Hillsboro is one example. This greenway provided active and passive recreation, wildlife habitat, natural areas to enhance views and aesthetics as well as stormwater management for the development. Creating multi-beneficial infrastructure can often enhance a development, as well as meet multiple stated community goals.

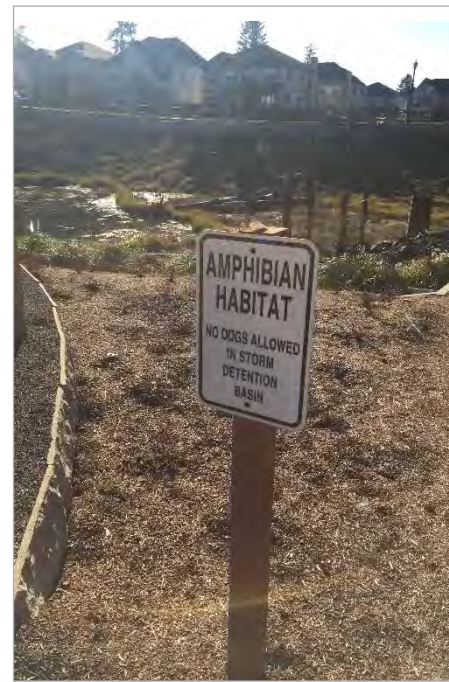
Regional Stormwater Facility, Washington County

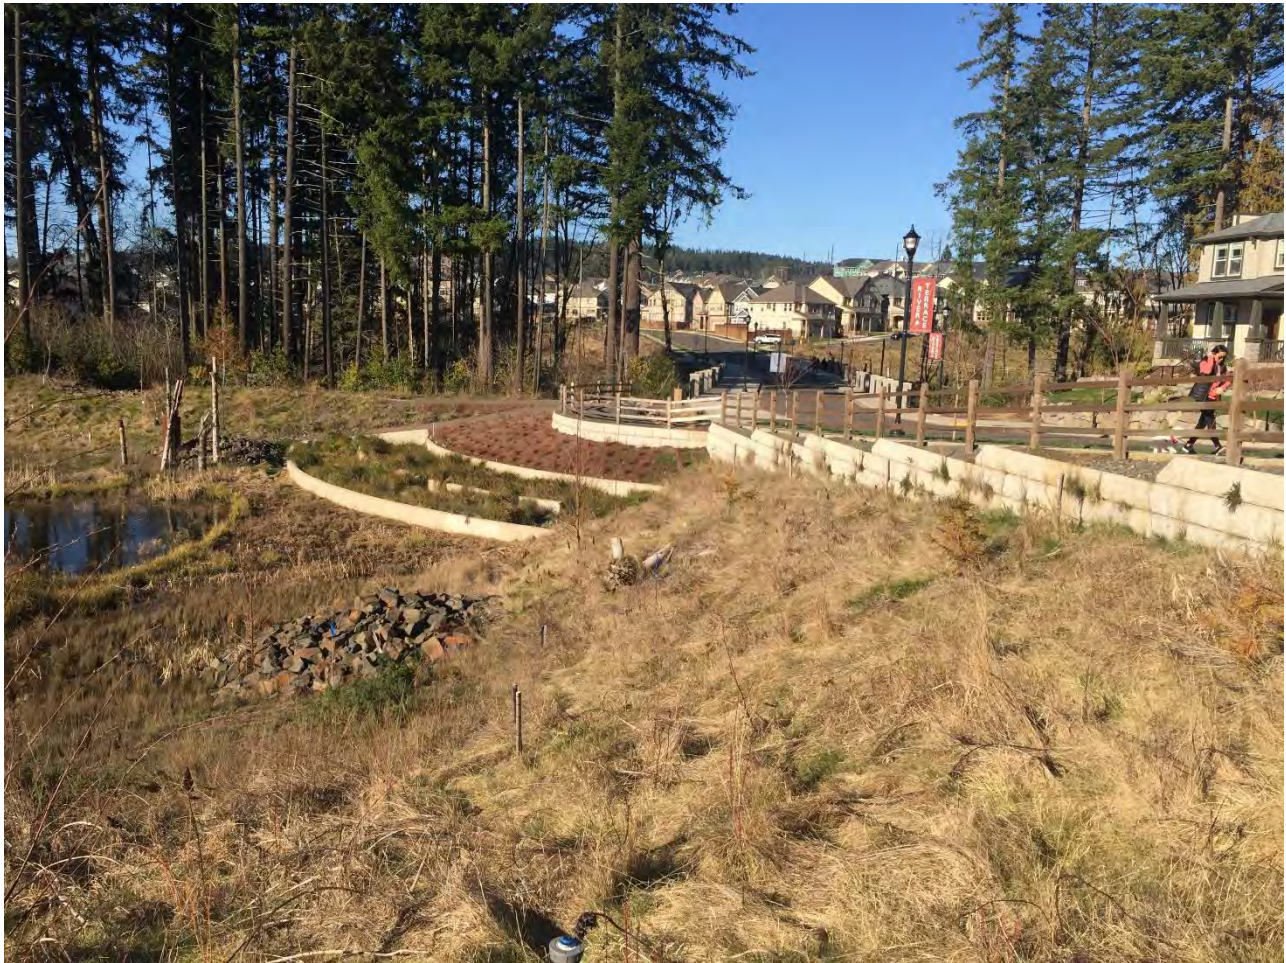
River Terrace Regional Stormwater Facility, Tigard

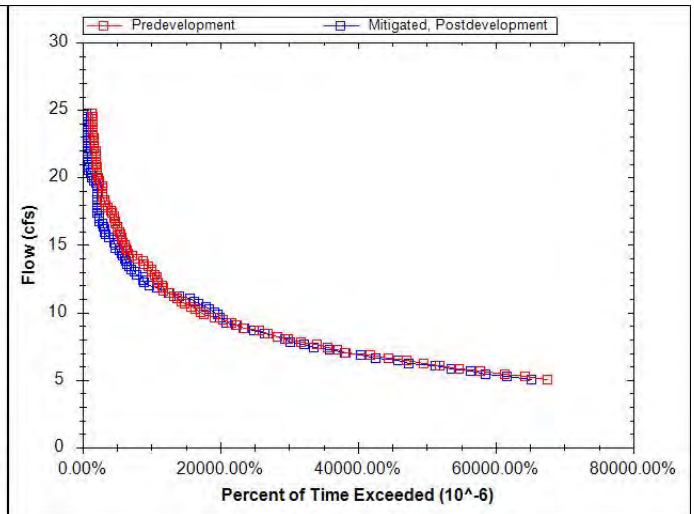
Pond ID: Pond N

Lower Orifice Invert (ft)	0.0
Lower Orifice Dia (in)	8.5
Upper Orifice Invert(ft)	4.7
Upper Orifice Dia (in)	22.3
Overflow Weir Invert(ft)	6.0
Overflow Weir Length (ft)	6.3

Flow Frequency Chart

Flow Duration Chart
