Geotechnical Investigation and Site-Specific Seismic-Hazard Evaluation

Oak Lodge Community Project

3811 SE Concord Road
Milwaukie, Oregon

October 20, 2020

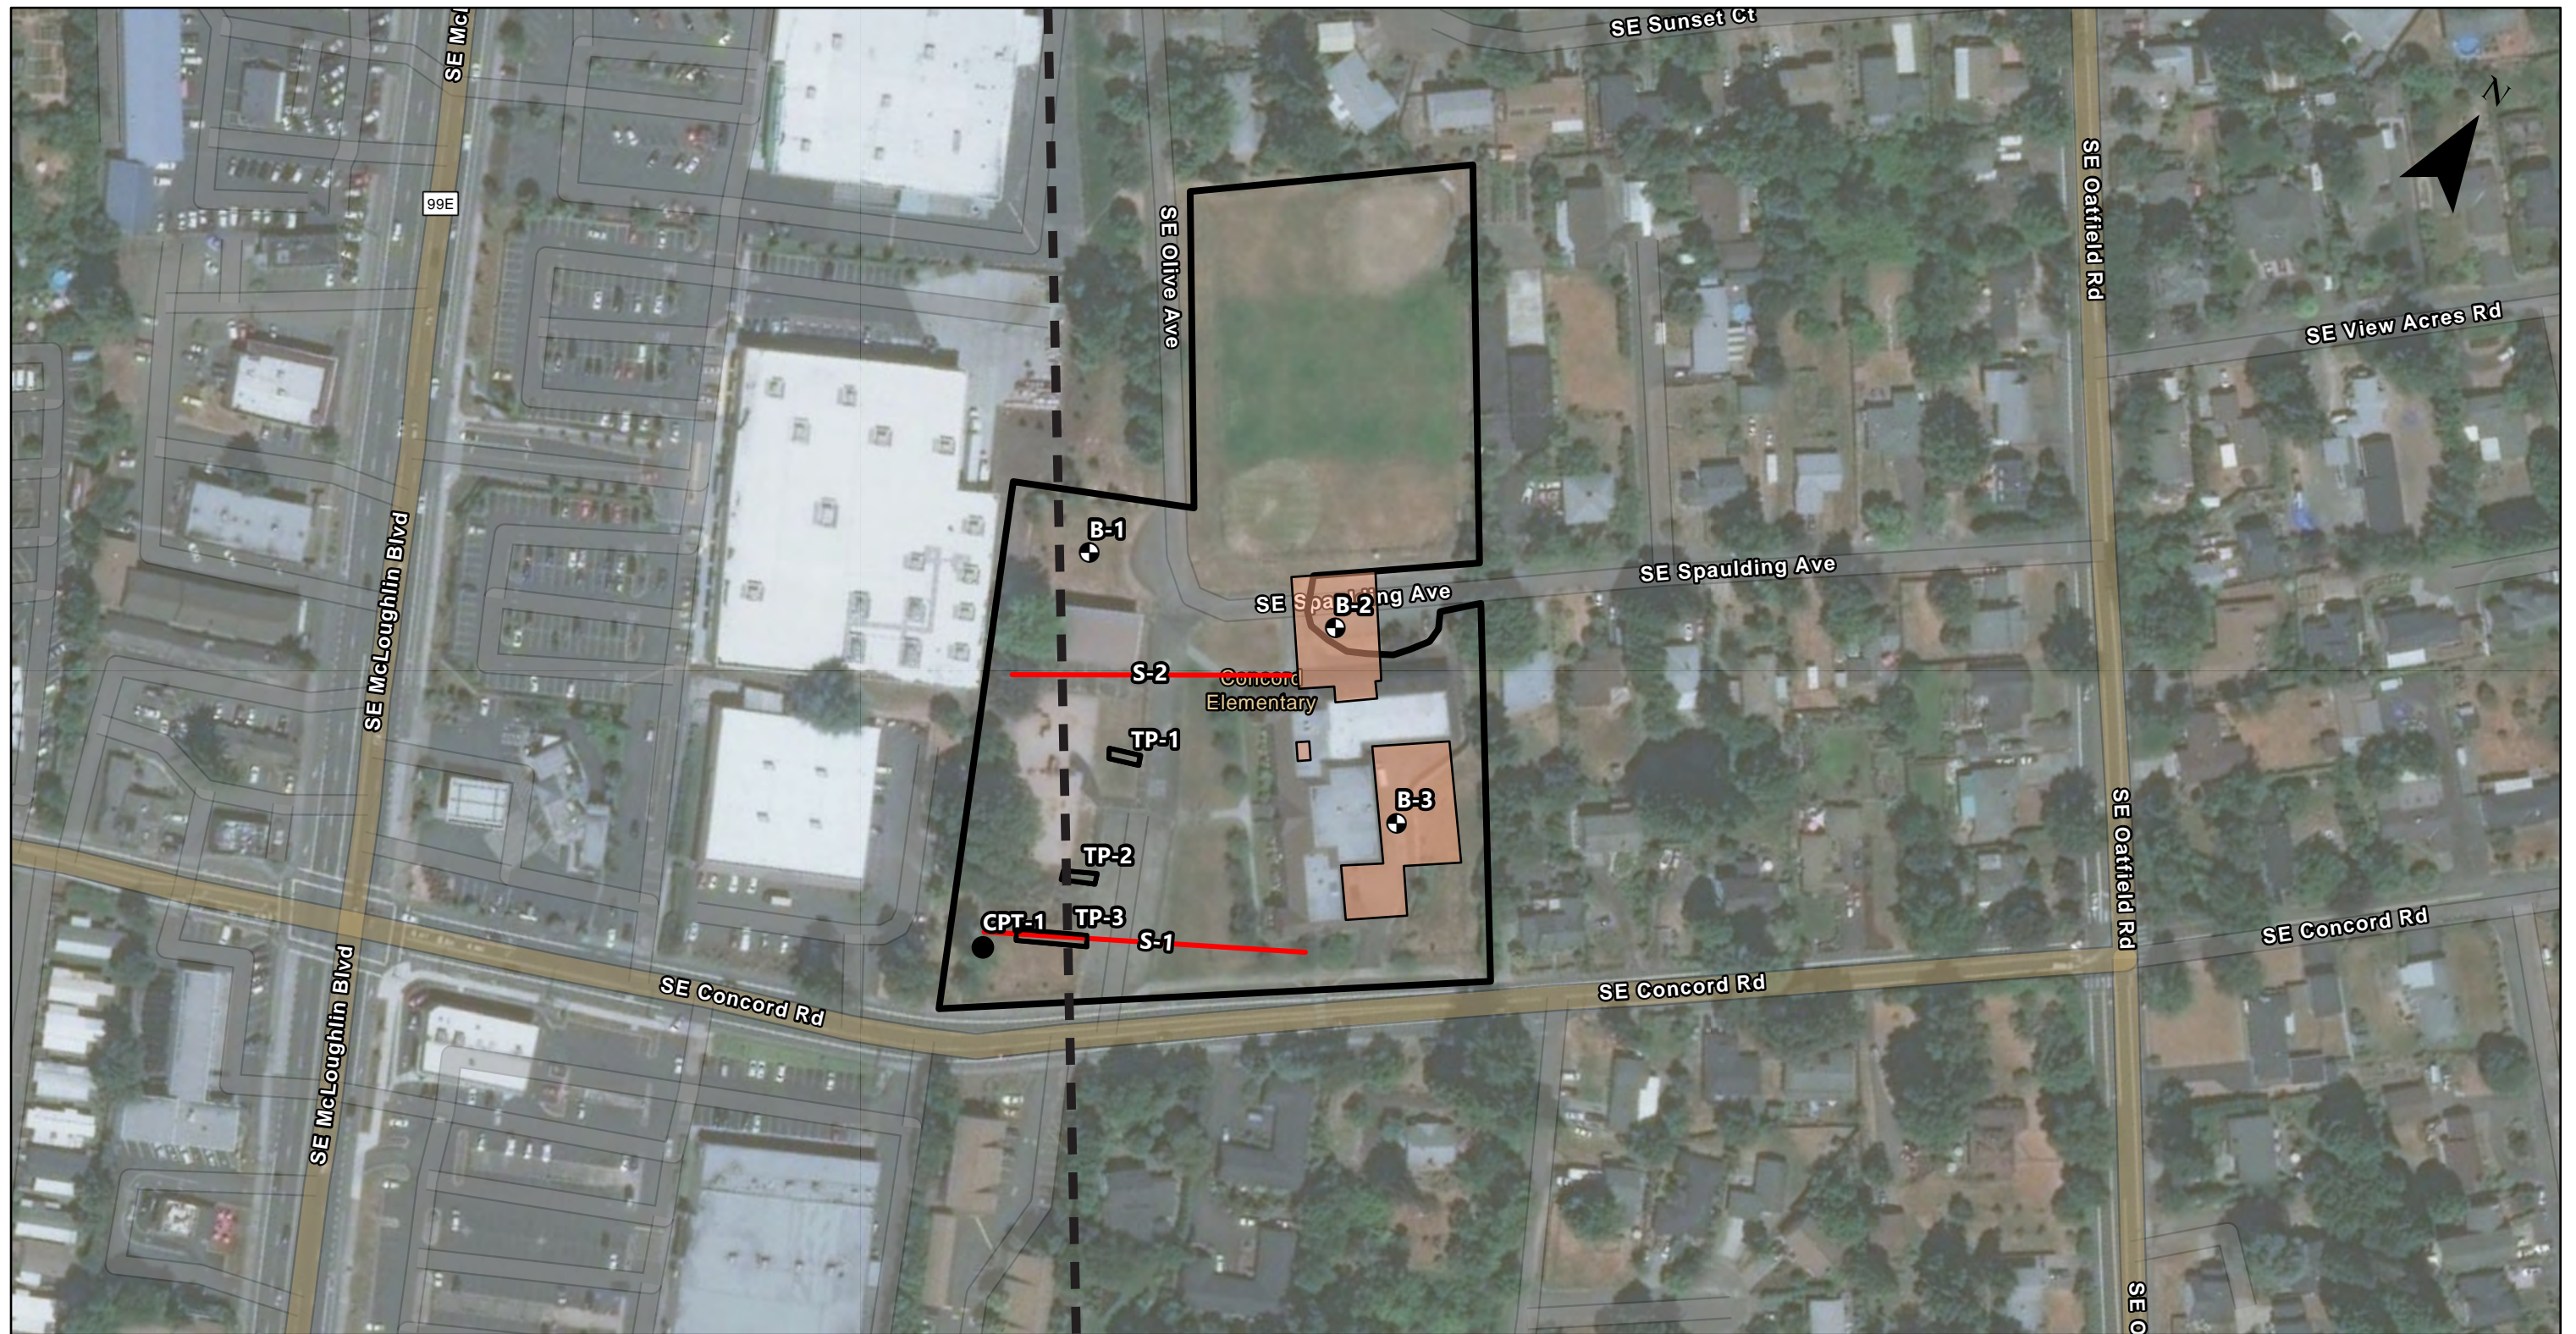
SITE PLAN

- BORING COMPLETED BY GRI (SEPTEMBER 1, 2020)
- PROPOSED IMPROVEMENT AREAS
- SEISMIC REFRACTION LINES COMPLETED BY EARTH DYNAMICS (AUGUST 5, 2020)
- CONE PENETRATION TEST COMPLETED BY GRI (AUGUST 25, 2020)
- INFERRED OATFIELD FAULT PER USGS 2020
- TEST PITS COMPLETED BY GRI (AUGUST 25, 2020)

The Site Plan, Figure 2, shows the existing site conditions and proposed improvement areas for the project in Milwaukie, Oregon. The proposed community center site is currently occupied by NCPRD located at 3811 SE Concord Road in unincorporated Oak Grove, Oregon, and is bordered by commercial properties to the west, SE Concord Road to the south, and residential housing to the north and east. The site is partially bisected by SE Spaulding Avenue. Based on our observations on site, an existing building occupies the southern portion of the site, grass fields occupy the northern portion, and play areas occupy the western portion. Mature trees surround the building and site perimeter, and an approximately 4- to 6-foot-high retaining wall surrounds the north and east sides of

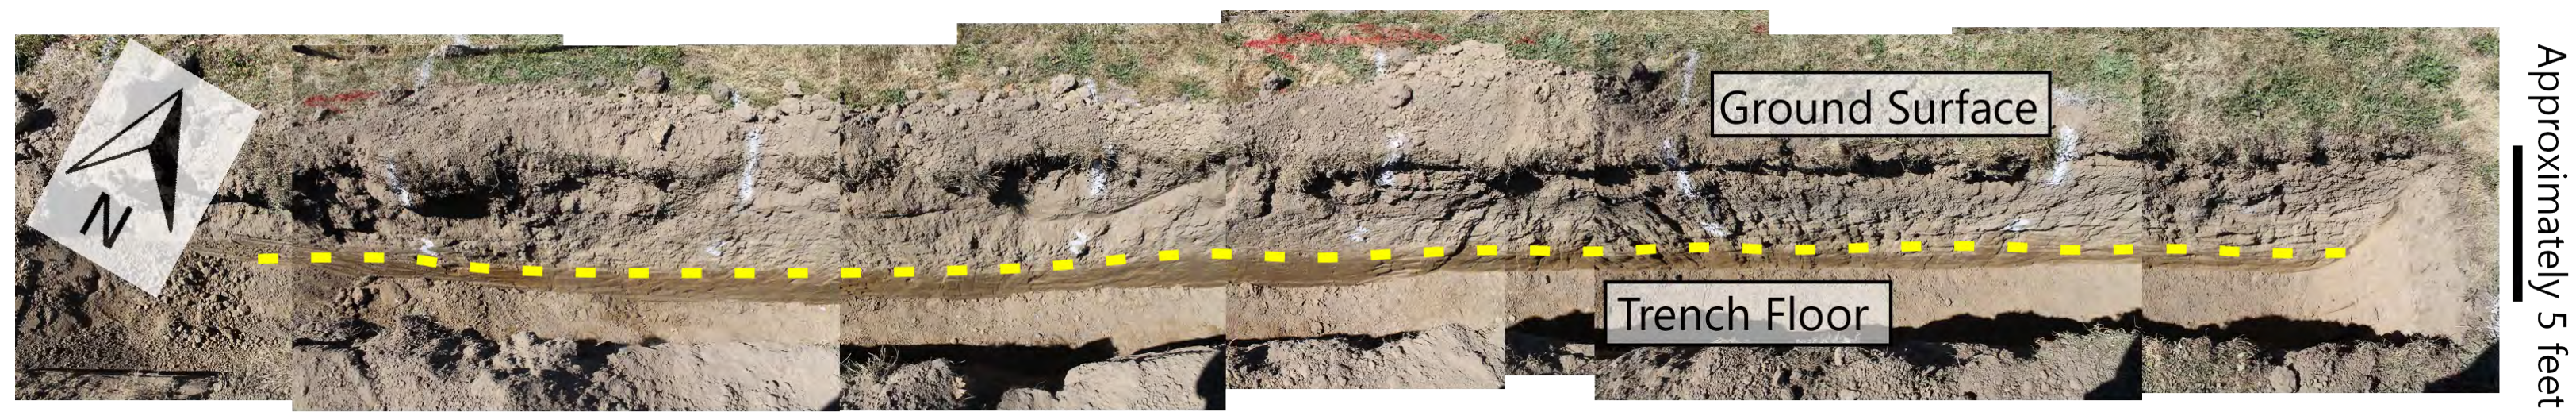
ANNOTATED TEST PIT PHOTOGRAPH

— — — — — Approximate contact within surficial sedimentary unit

— — — — — Approximately 5 feet

Test pit TP-2 was located in a strip of grass-covered level ground between a playground and paved area. This location spans an area interpreted from the results of the geophysical survey to be underlain by vertically offset basalt. An initial test pit approximately 35 feet long and up to 5 feet deep was uncovered. Representatives from GRI subsequently used hand scrapers and brushes to clean the northern pit wall of smeared or loose debris and closely examined the exposure for indications of fault-related features such as offset geologic units, contacts, or laminations (bedding); tectonically disturbed or deformed clay layers; clay gouge, soil- or clay-filled fractures or fissures; or slickensides. Stratigraphic offsets of horizontally bedded surficial sedimentary units that would be an indicator of fault rupture were not observed. Test pit TP-2 was terminated at a depth of approximately 17 feet, the limit of the excavation machinery. Basalt bedrock was not encountered. In our opinion, no evidence of faulted Pleistocene-age alluvial deposits was observed. An annotated mosaic of photographs of the northern wall of TP-2 is included as Figure 3. Test-pit details are described in Appendix A.

The Oatfield Fault is considered potentially Quaternary active and is mapped by the USGS in the southwestern portion of the project site. Results of geophysical explorations indicate basalt bedrock underlying the project site is vertically offset in the general alignment with the mapped trace of the Oatfield Fault. Clear stratigraphic offset of surficial geologic units in the upper 5 feet of a test pit excavated perpendicular to the inferred area of bedrock offset was not observed.

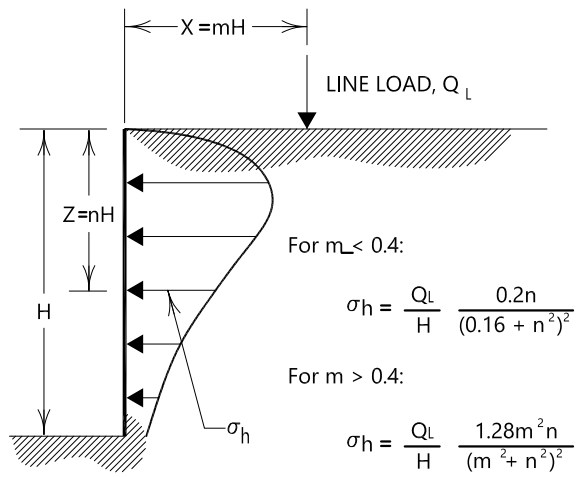
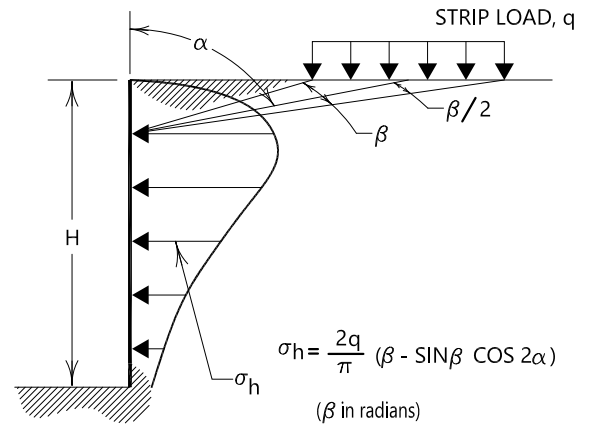
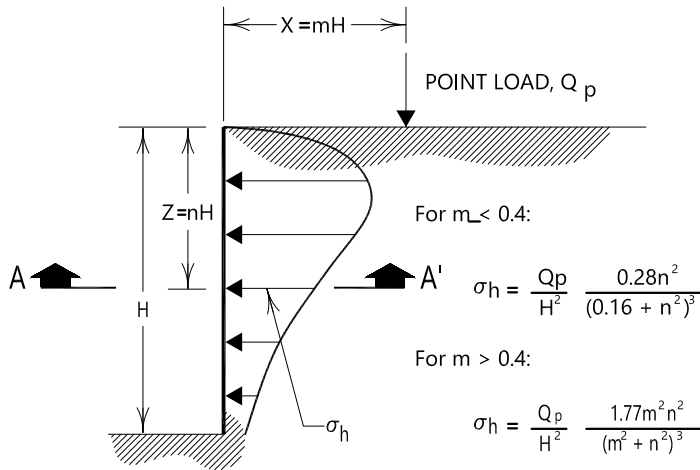
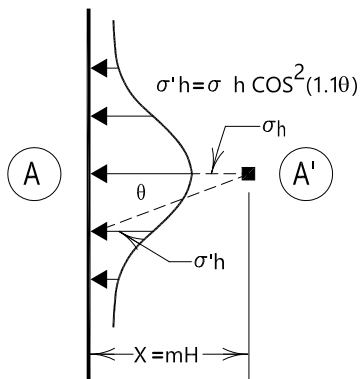
SURCHARGE-INDUCED
LATERAL PRESSURE

LINE LOAD PARALLEL TO WALL

STRIP LOAD PARALLEL TO WALL

DISTRIBUTION OF HORIZONTAL PRESSURES

VERTICAL POINT LOAD

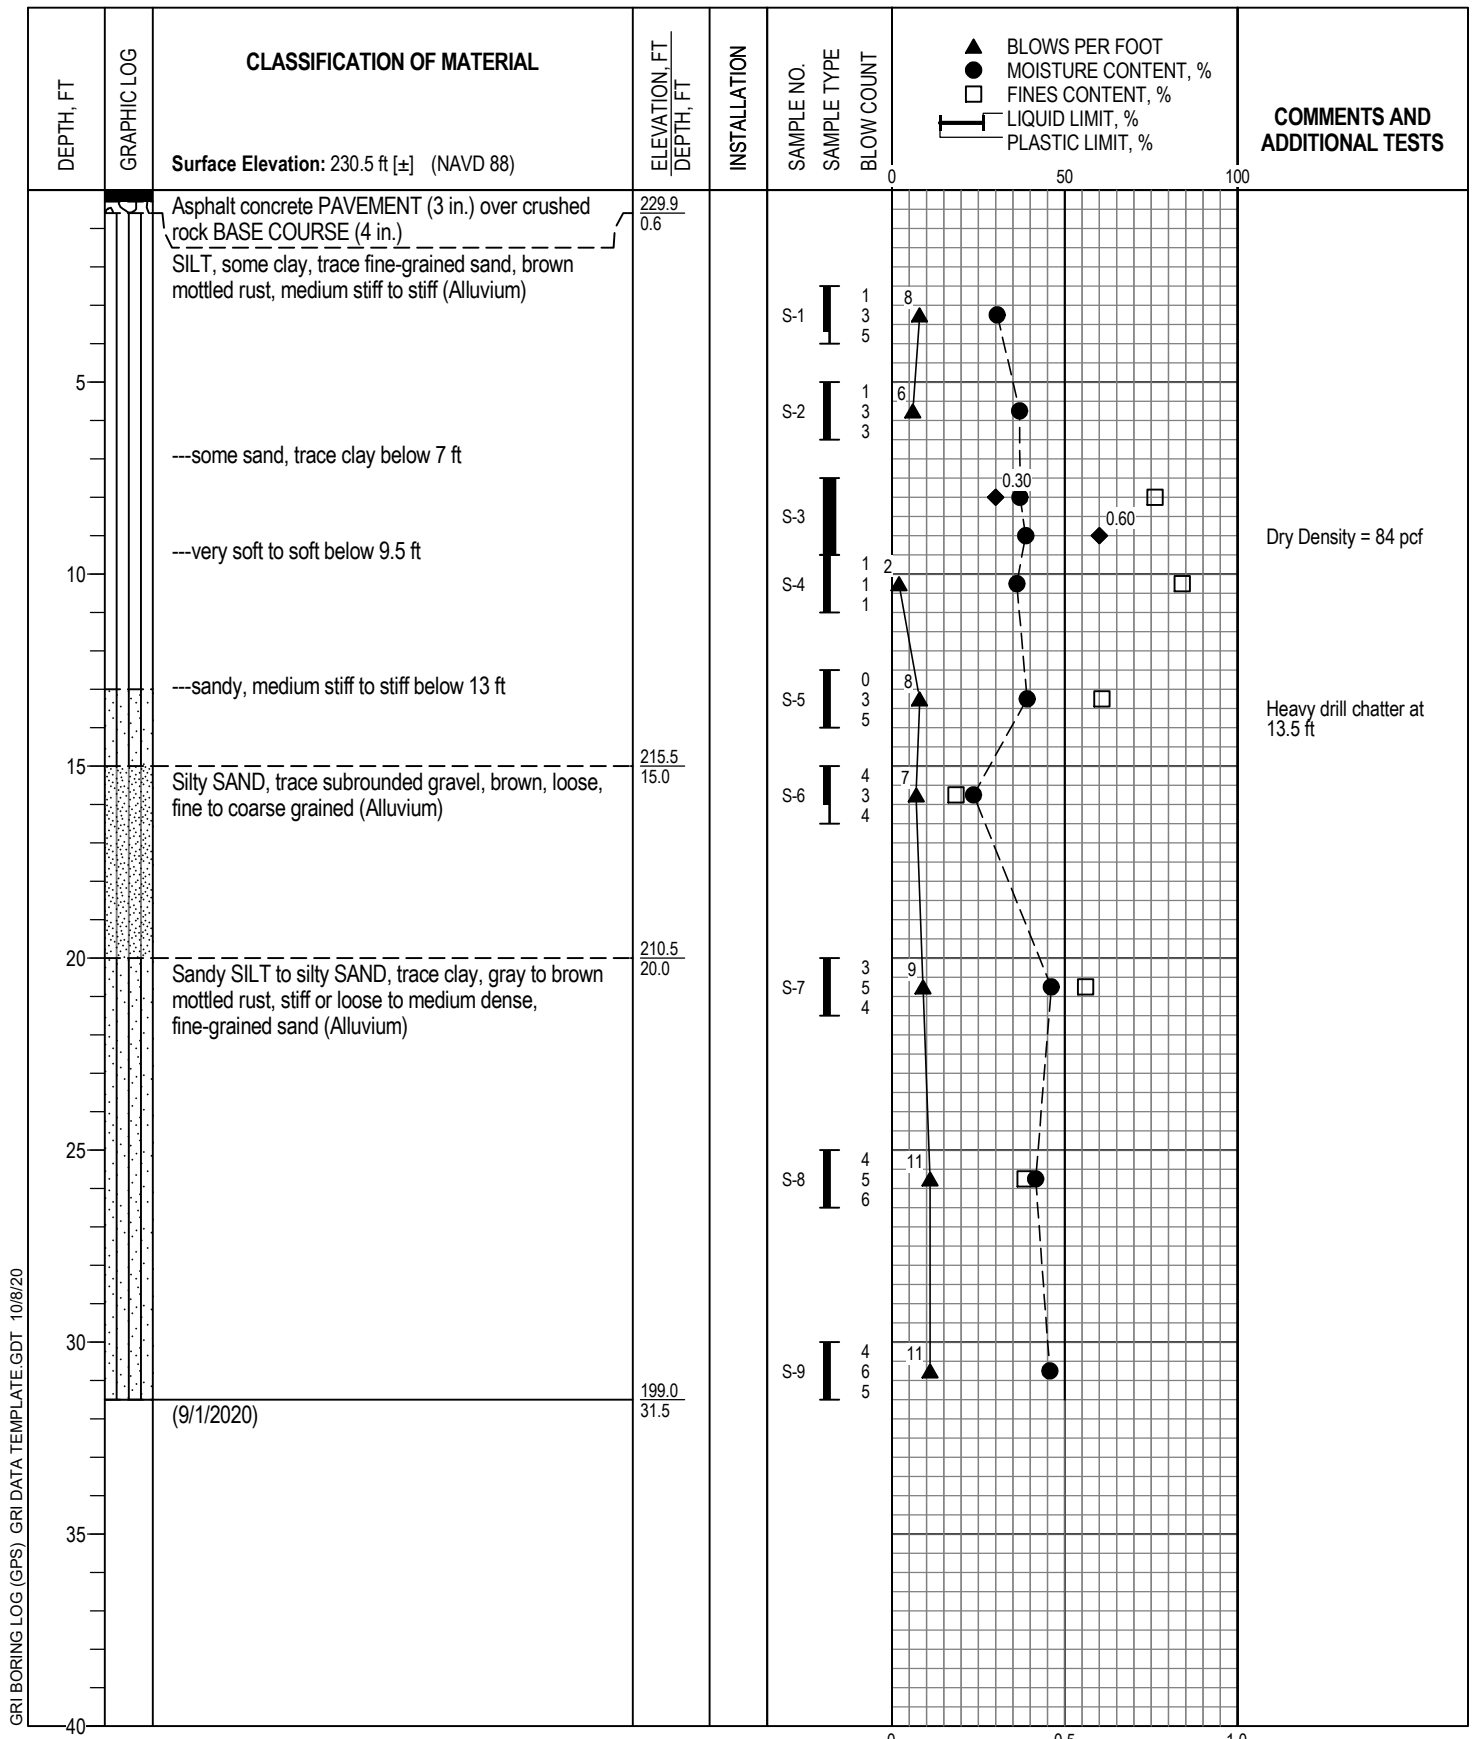
BORING B-1

Logged By: B. Cook		Drilled by: Western States Soil Conservation, Inc.	
Date Started: 9/1/20		GPS Coordinates: 45.4109° N -122.6243° W (WGS 84)	
Drilling Method: Mud Rotary		Hammer Type: Auto Hammer	
Equipment: Geoprobe 7720 DT		Weight: 140 lb	
Hole Diameter: 5 in.		Drop: 30 in.	
Note: See Legend for Explanation of Symbols		Energy Ratio: 0.8

The drilled borings were completed using mud-rotary, open-hole drilling techniques using a truck-mounted Geoprobe 7720 DT drill rig provided and operated by Western States Soil Conservation, Inc., of Hubbard, Oregon. The drilled borings were advanced to depths of about 31.5 feet to 71.5 feet below existing site grades. The field-exploration work was coordinated and documented by an experienced member of GRI's geotechnical engineering team, who maintained a log of the materials and conditions disclosed during the course of work.

to the right, SPT N-values are shown graphically, along with the natural moisture contents, dry unit weights, Torvane shear-strength values, Atterberg limits, and percentages passing the No. 200 sieve where applicable. The terms and symbols used to describe the materials encountered in the borings are defined in Table 1A, 2A, and the attached legend.

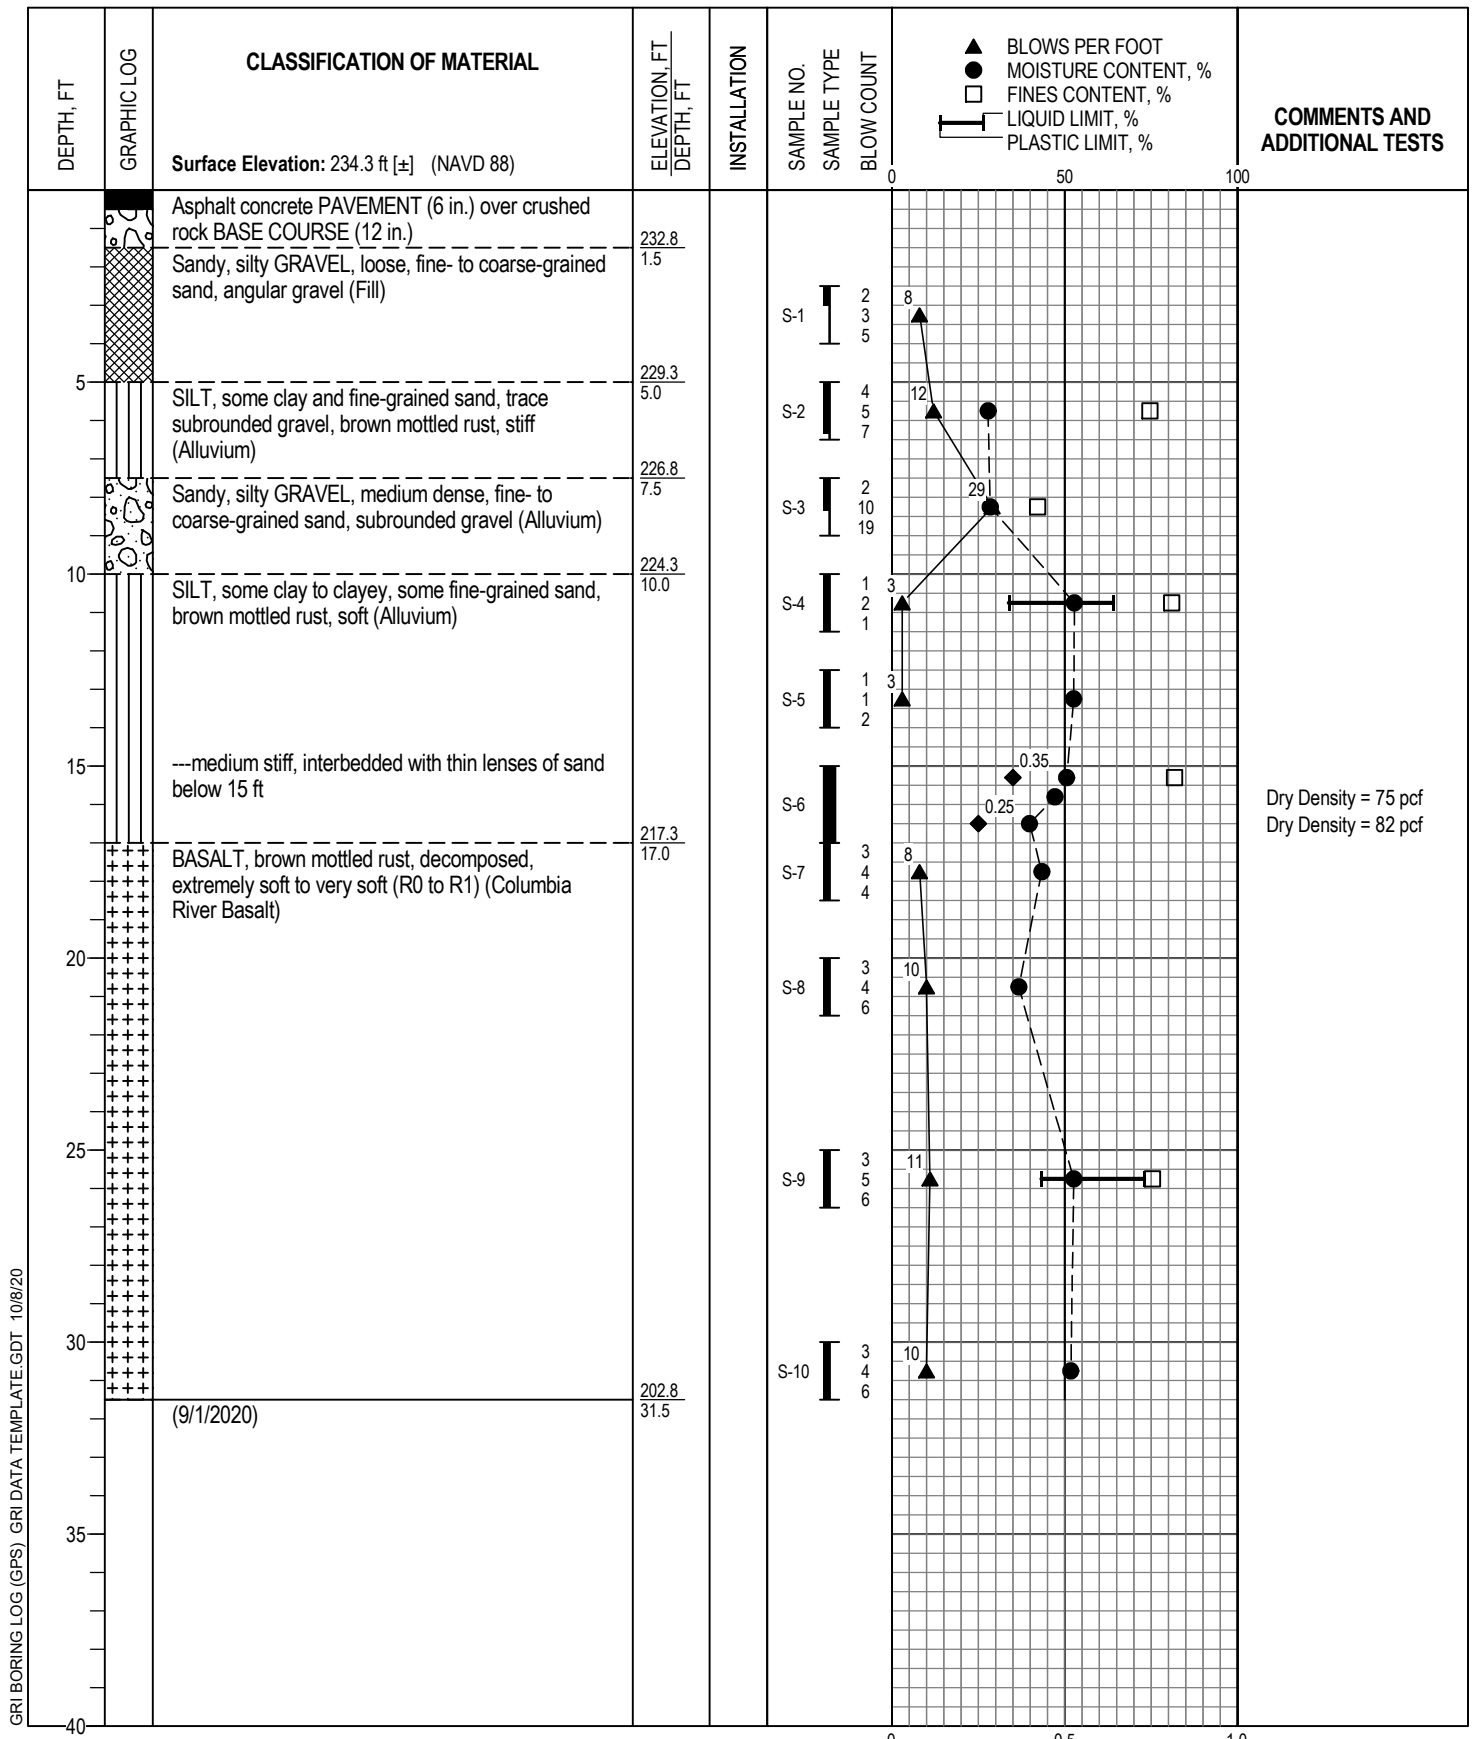
BORING B-2

Logged By: B. Cook		Drilled by: Western States Soil Conservation, Inc.	
Date Started: 9/1/20	GPS Coordinates: 45.4106° N -122.6237° W (WGS 84)		
Drilling Method: Mud Rotary	Hammer Type: Auto Hammer		
Equipment: Geoprobe 7720 DT	Weight: 140 lb		
Hole Diameter: 5 in.	Drop: 30 in.		
Note: See Legend for Explanation of Symbols	Energy Ratio: 0.8

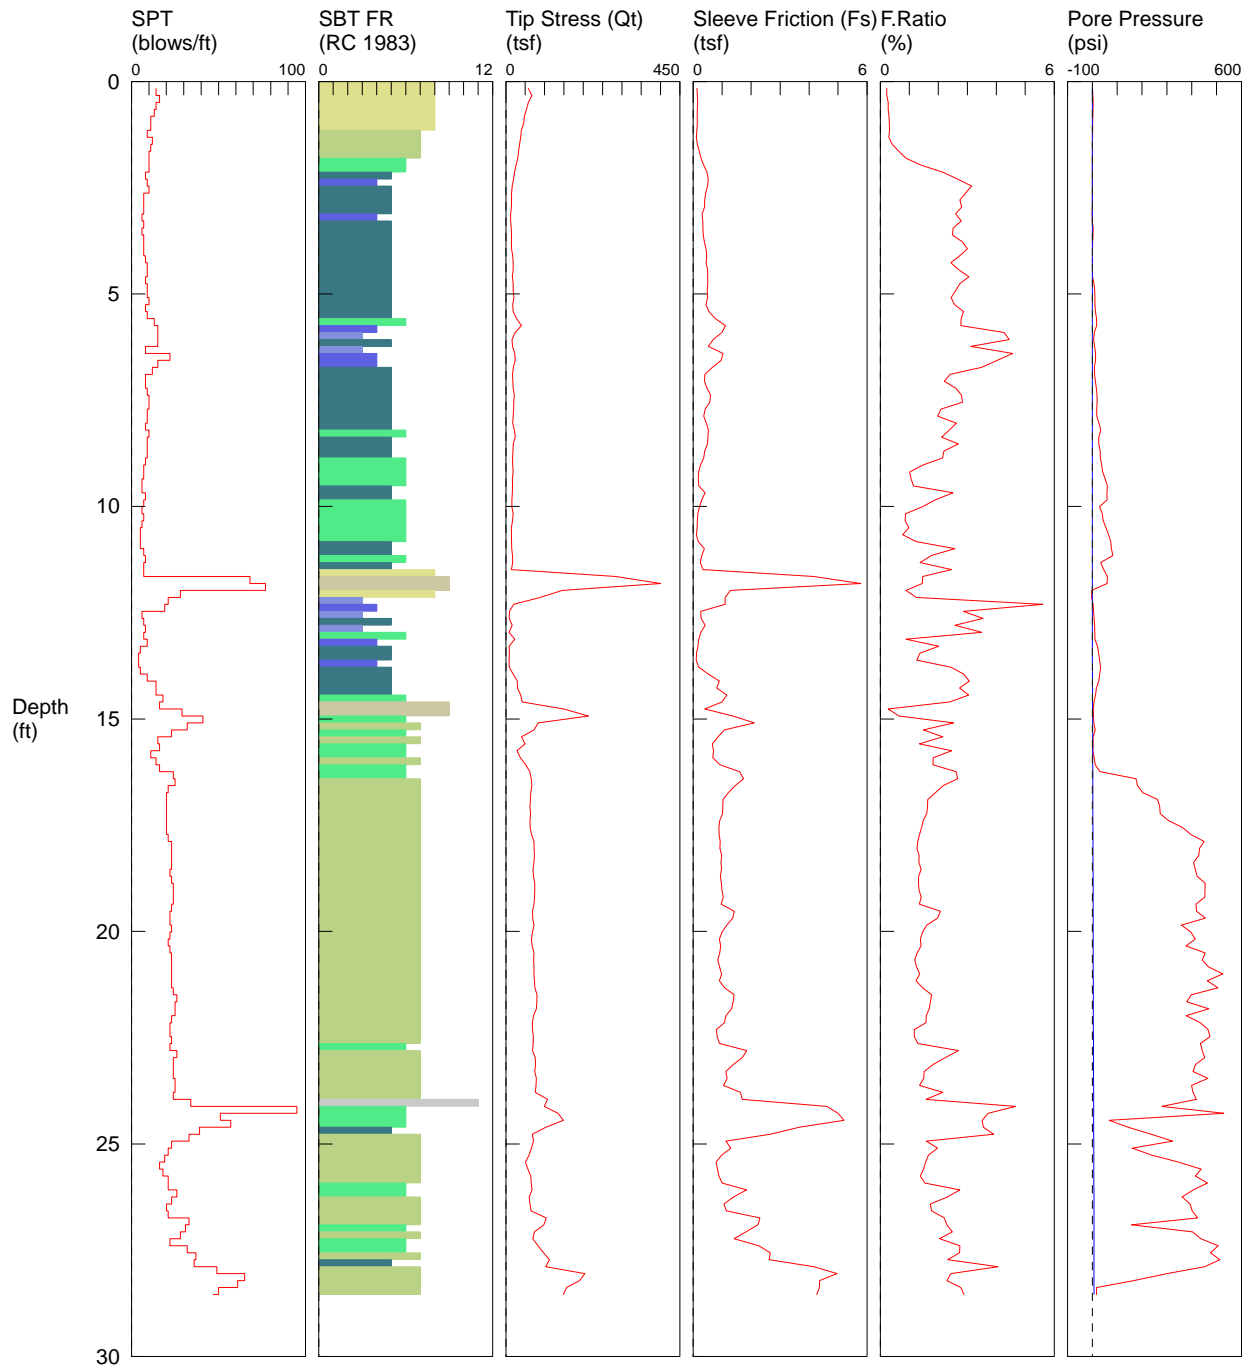
CONE PENETRATION TEST CPT-1

- 1 sensitive fine grained
 - 2 organic material
 - 3 clay
 - 4 silty clay to clay
 - 5 clayey silt to silty clay
 - 6 sandy silt to clayey silt
 - 7 silty sand to sandy silt
 - 8 sand to silty sand
 - 9 sand
 - 10 gravelly sand to sand
 - 11 very stiff fine grained (*)
 - 12 sand to clayey sand (*)
- *SBT/SPT CORRELATION: UBC-1983

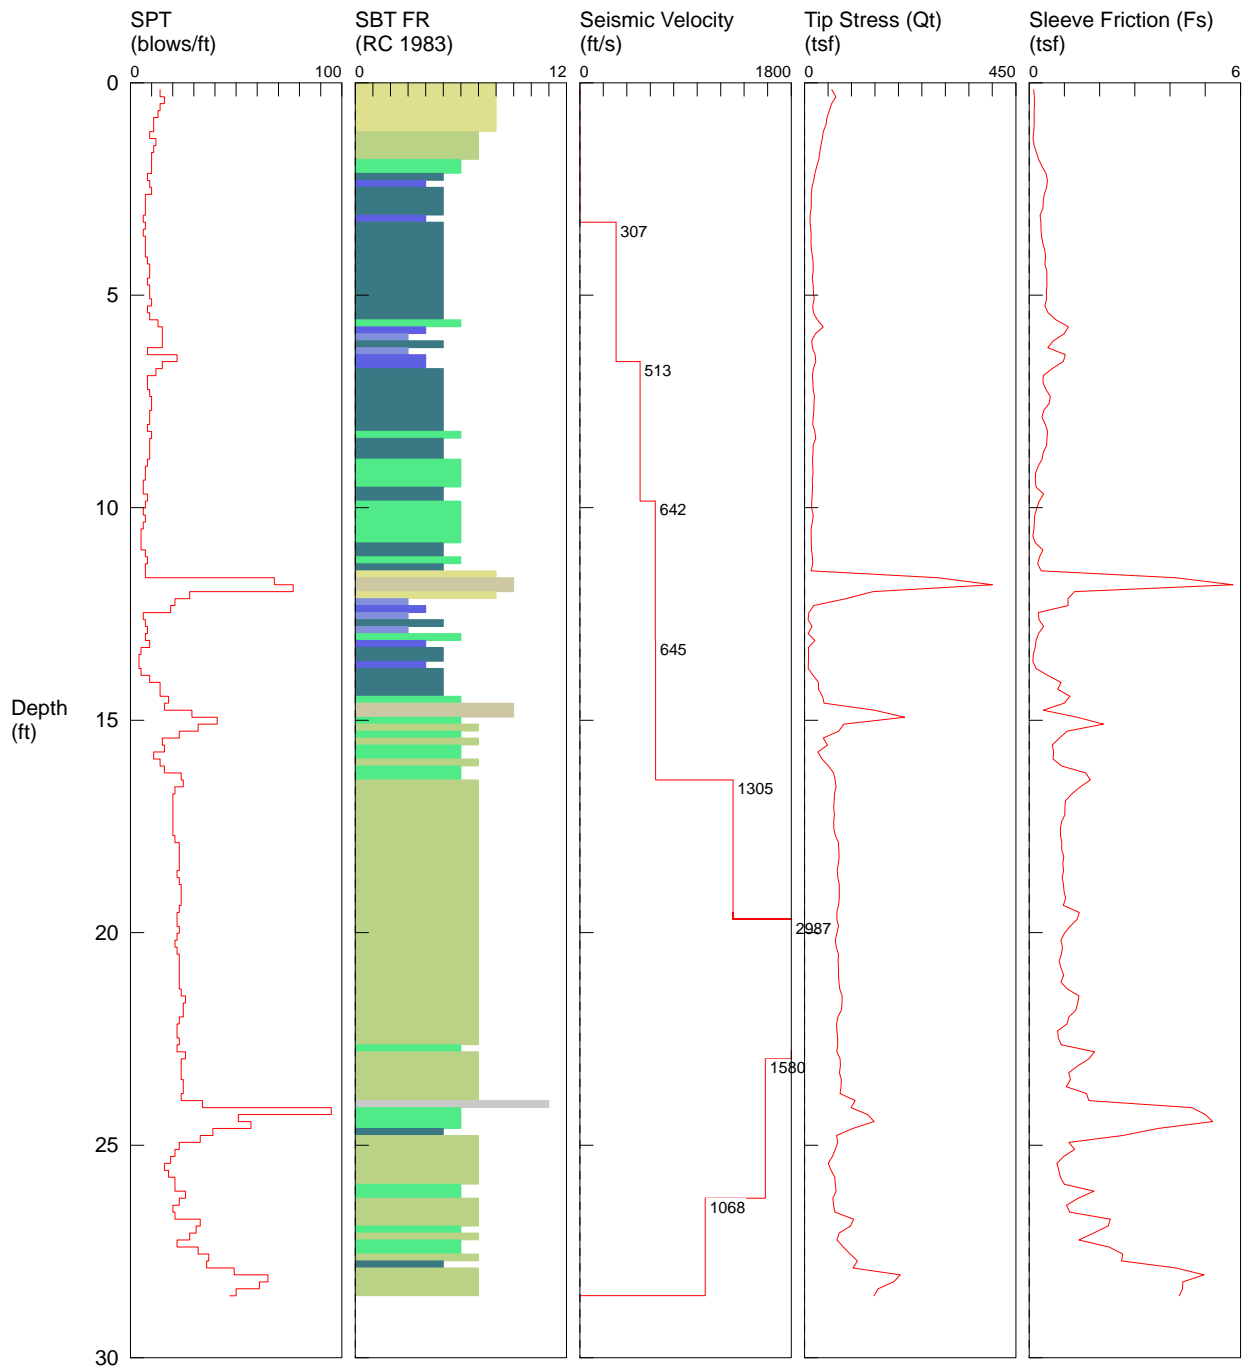
Observed By: B. Cook	Advanced By: Oregon Geotechnical Explorations, Inc.
Date Started: 08/25/20	Ground Surface Elevation: Not Available
Coordinates: Not Available

| 1 sensitive fine grained | 4 silty clay to clay | 7 silty sand to sandy silt | 10 gravelly sand to sand |

One CPT probe, designated CPT-1, was advanced to a depth of about 28.5 feet using a track-mounted rig provided and operated by Oregon Geotechnical Explorations, Inc., of Keizer, Oregon. During a CPT, a steel cone is forced vertically into the soil at a constant rate of penetration. The force required to cause penetration at a constant rate can be related to the bearing capacity of the soil immediately surrounding the point of the penetrometer cone. This force is measured and recorded every 2 inches. In addition to the cone measurements, measurements are obtained of the magnitude of force required to force a friction sleeve attached above the cone through the soil. The force required to move the friction sleeve can be related to the undrained shear strength of fine-grained soils. The dimensionless ratio of sleeve friction to point-bearing capacity provides an indicator of the type of soil penetrated. The cone penetration resistance and sleeve friction can be used to evaluate the relative consistency of cohesionless and cohesive soils, respectively. In addition, a piezometer fitted between the cone and the sleeve measures changes in water pressure as the probe is advanced and can also be used to measure the groundwater depth. The probe is also operated using an accelerometer fitted to the probe, which allows measurement of the arrival time of shear waves from impulses generated at the ground surface and calculation of shear-wave velocities for the surrounding soil profile.

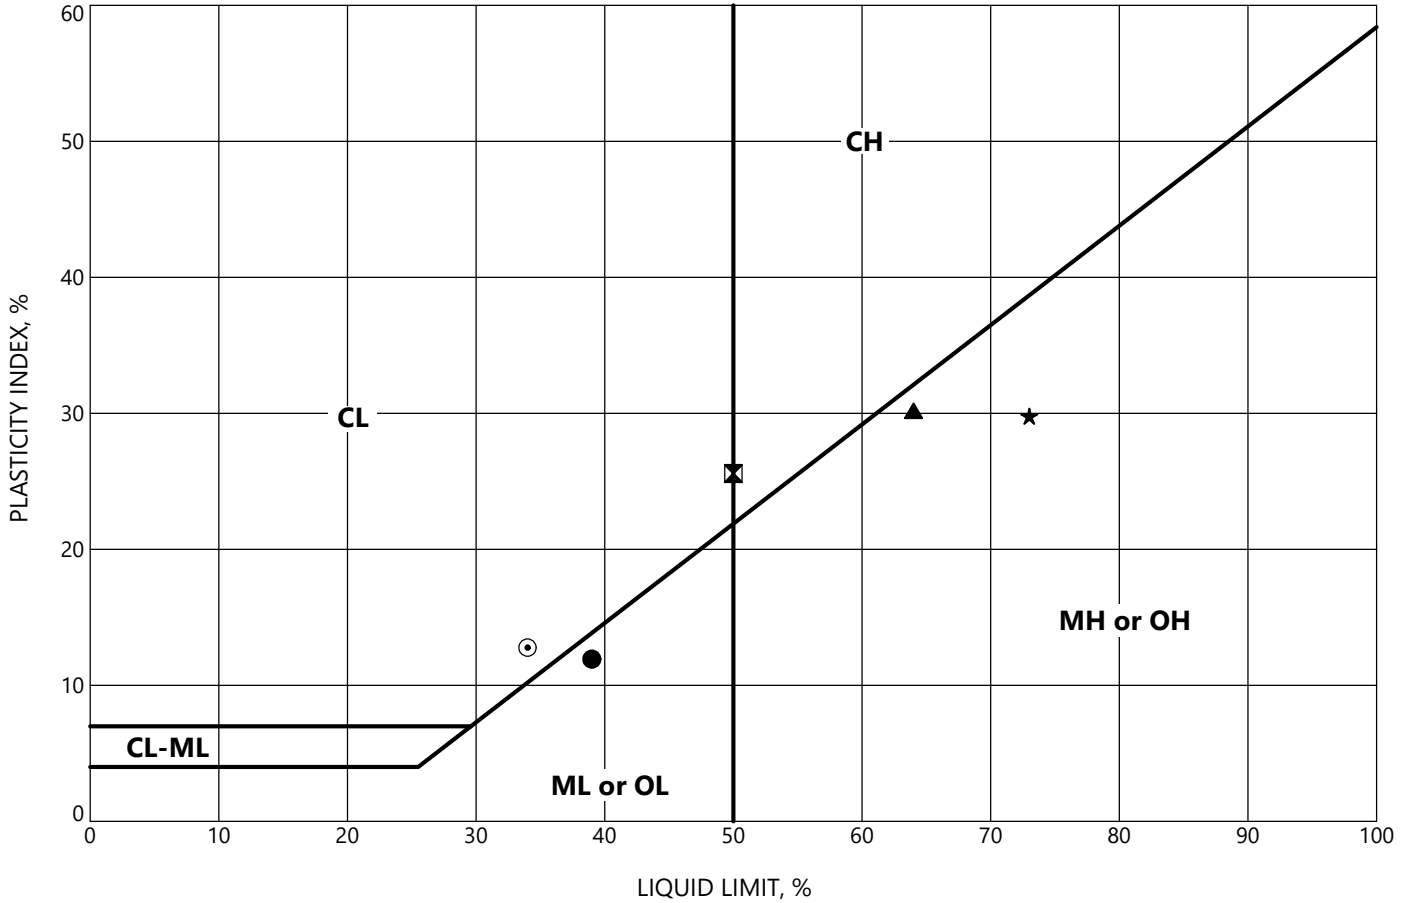
PLASTICITY CHART

Location	Sample	Depth, ft	Classification	LL	PL	PI	MC, %
●	B-1	S-2	4.0	SILT, some clay, trace to some fine-grained sand, brown mottled rust (Alluvium)	39	27	12	35
⊠	B-1	S-12	55.0	CLAY, some silt and fine- to medium-grained sand, blue-gray (Alluvium)	50	24	26	39
▲	B-3	S-4	10.0	SILT, some clay to clayey, some fine-grained sand, brown mottled rust (Alluvium)	64	34	30	53
★	B-3	S-9	25.0	BASALT, brown mottled rust, decomposed, extremely soft to very soft (R0 to R1) (Columbia River Basalt)	73	43	30	53
⊙	TP-1	S-2	3.5	Silty CLAY, trace to some fine-grained sand, dark brown to gray (Alluvium)	34	21	13	19

The clay ranges in color from light brown to orange-brown or dark brown, blue-gray or gray and may contain light gray to dark gray mottling. The clay contains a trace of silt to silty and a trace of sand to sandy. The clay may contain gravel or cobbles. We estimate the relative consistency of the clay is stiff. The natural moisture content of the clay ranges from 29% to 47%. Atterberg-limits testing completed on a sample of the clay are provided on Figure 9A and indicate the clay has medium plasticity.

Basalt interpreted to be Columbia River Basalt was encountered at depths of about 63 feet in boring B-1, 17 feet in boring B-3, and 16 feet in test pit TP-3. Borings B-1 and B-3 were terminated in the basalt at depths of about 71.5 feet and 31.5 feet, respectively. Test pit TP-3 was terminated in the basalt at the maximum depth of the excavation equipment at a depth of about 19 feet. The basalt is typically brown to gray and may be mottled brown and black or rust, contains some vesicles, and is predominantly decomposed to decomposed. The weathering of the basalt may decrease with depth. The relative hardness of the basalt ranges from extremely soft (R0) to soft (R2). Atterberg-limits testing completed on a decomposed sample of basalt is provided on Figure 9A and indicate the decomposed basalt has a medium to high plasticity.

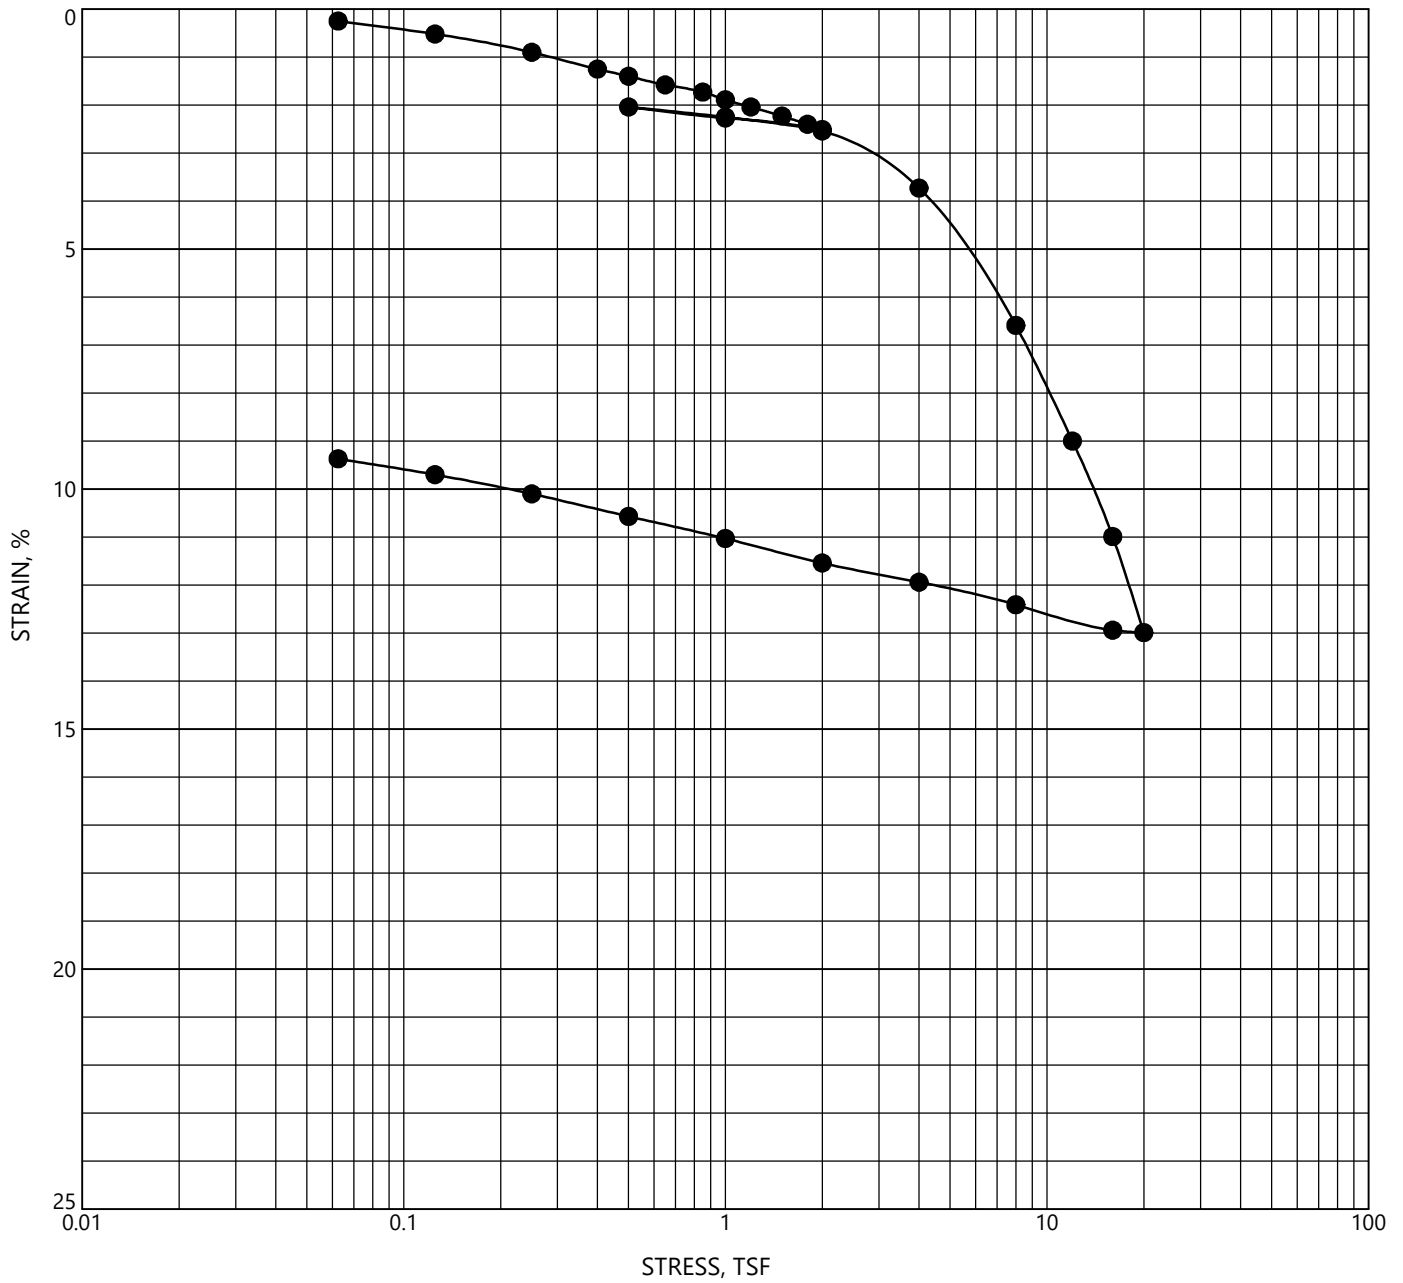
CONSOLIDATION TEST

Location	Sample	Depth, ft	Classification	Initial	
				γ_d , pcf	MC, %
● B-1	S-1	2.8	SILT, some clay, trace to some fine-grained sand, brown mottled rust, stiff (Alluvium)	86	33

The silt ranges in color from light brown to orange-brown or dark brown, rust, or gray and may contain rust, dark brown, light gray, or gray mottling. The silt contains a trace of clay to clayey and a trace of sand to sandy. A 3- to 4-inch-thick heavily rooted zone was observed at the ground surface in boring B-1 and test pits TP-1 through TP-3. Based on SPT N-values and Torvane shear-strength values, the relative consistency of the silt ranges from very soft to stiff. The natural moisture content of the silt ranges from 6% to 59%. Atterberg-limits testing completed on samples of the silt are provided on Figure 9A and indicate the silt has a low to high plasticity. One-dimensional consolidation testing was completed on select samples of silt obtained from boring B-1 at depths of about 2.8 feet and 8 feet. Test results indicate the silt soil is heavily overconsolidated and has a relatively low compressibility in the preconsolidated range of pressures and a moderate to high compressibility in the normally consolidated ranges of pressures, see Figures 10A and 11A.

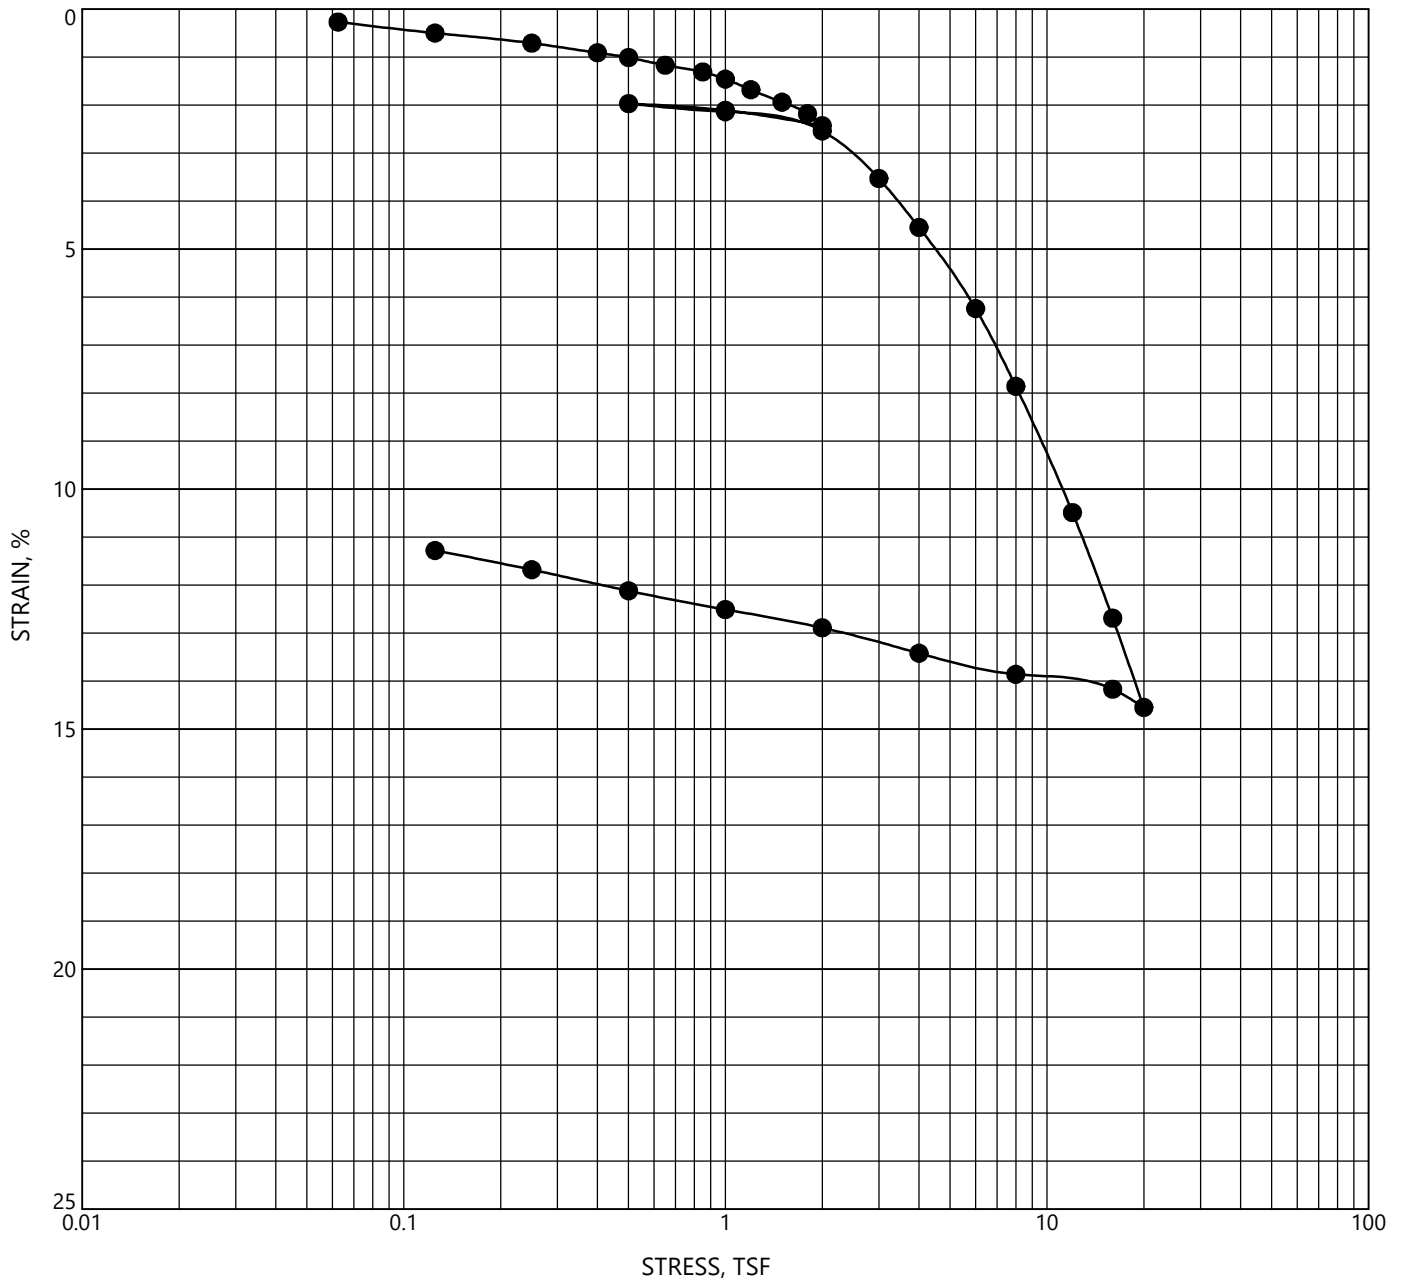
●	Location	Sample	Depth, ft	Classification	Initial	
					γ_d , pcf	MC, %
●	B-2	S-3	8.0	SILT, some fine-grained sand, trace clay, brown mottled rust, medium stiff to stiff (Alluvium)	84	37
