Geotechnical Investigation and Site-Specific Seismic-Hazard Evaluation

Oak Lodge Community Project

3811 SE Concord Road
Milwaukie, Oregon

October 20, 2020

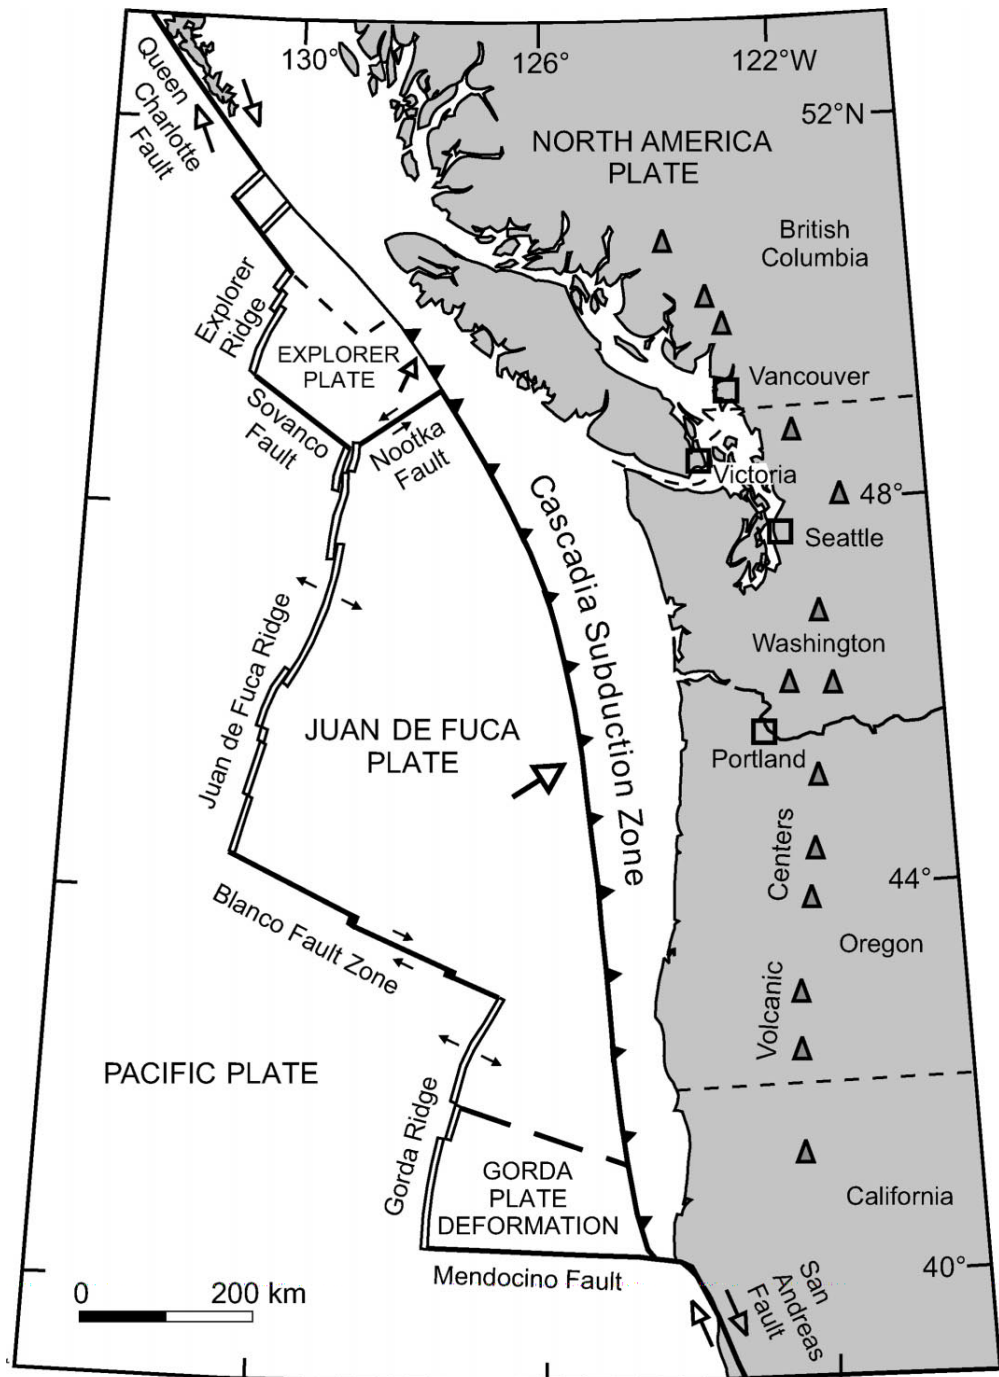
A) TECTONIC MAP OF PACIFIC NORTHWEST, SHOWING ORIENTATION AND EXTENT OF CASCADIA SUBDUCTION ZONE (MODIFIED FROM DRAGERT AND OTHERS, 1994)

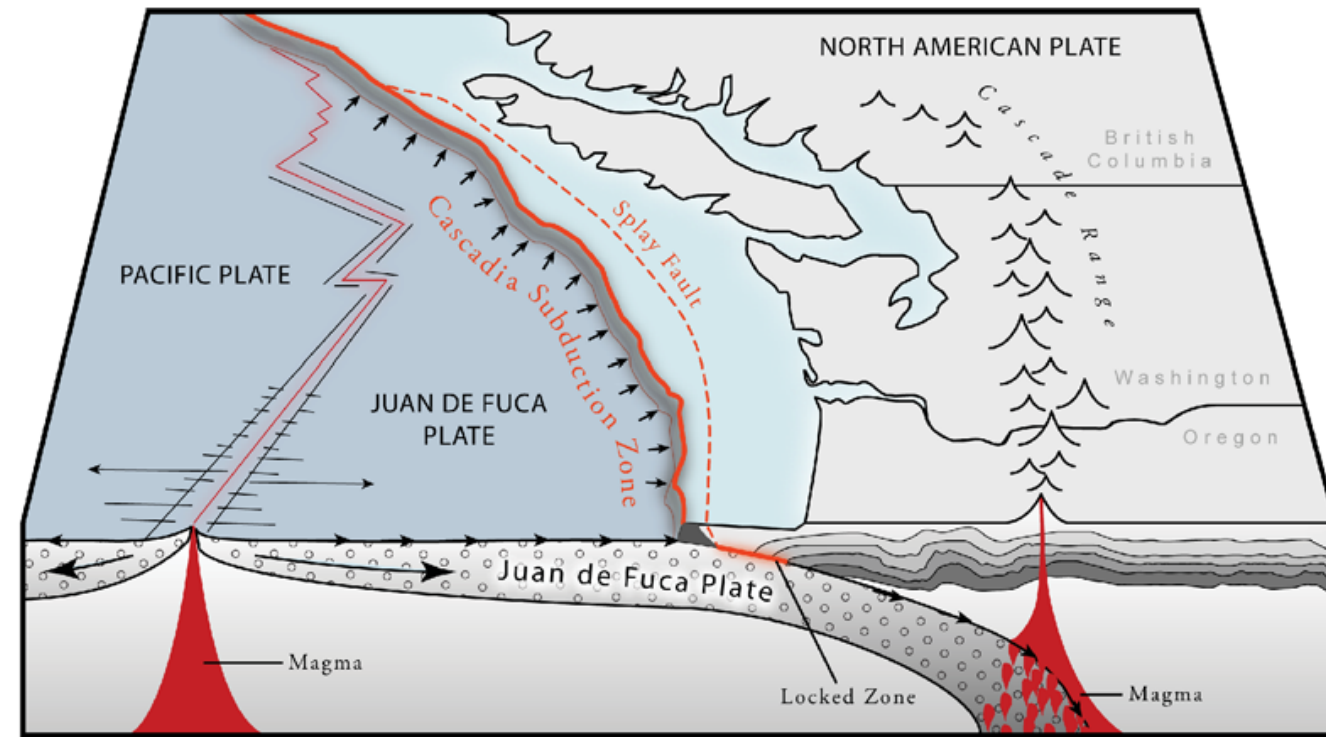
Cascadia Subduction Zone Setting

CASCADIA SUBDUCTION ZONE SETTING, TSUNAMI INUNDATION MAPS, OREGON DEPARTMENT OF GEOLOGY AND MINERAL INDUSTRY, 2013

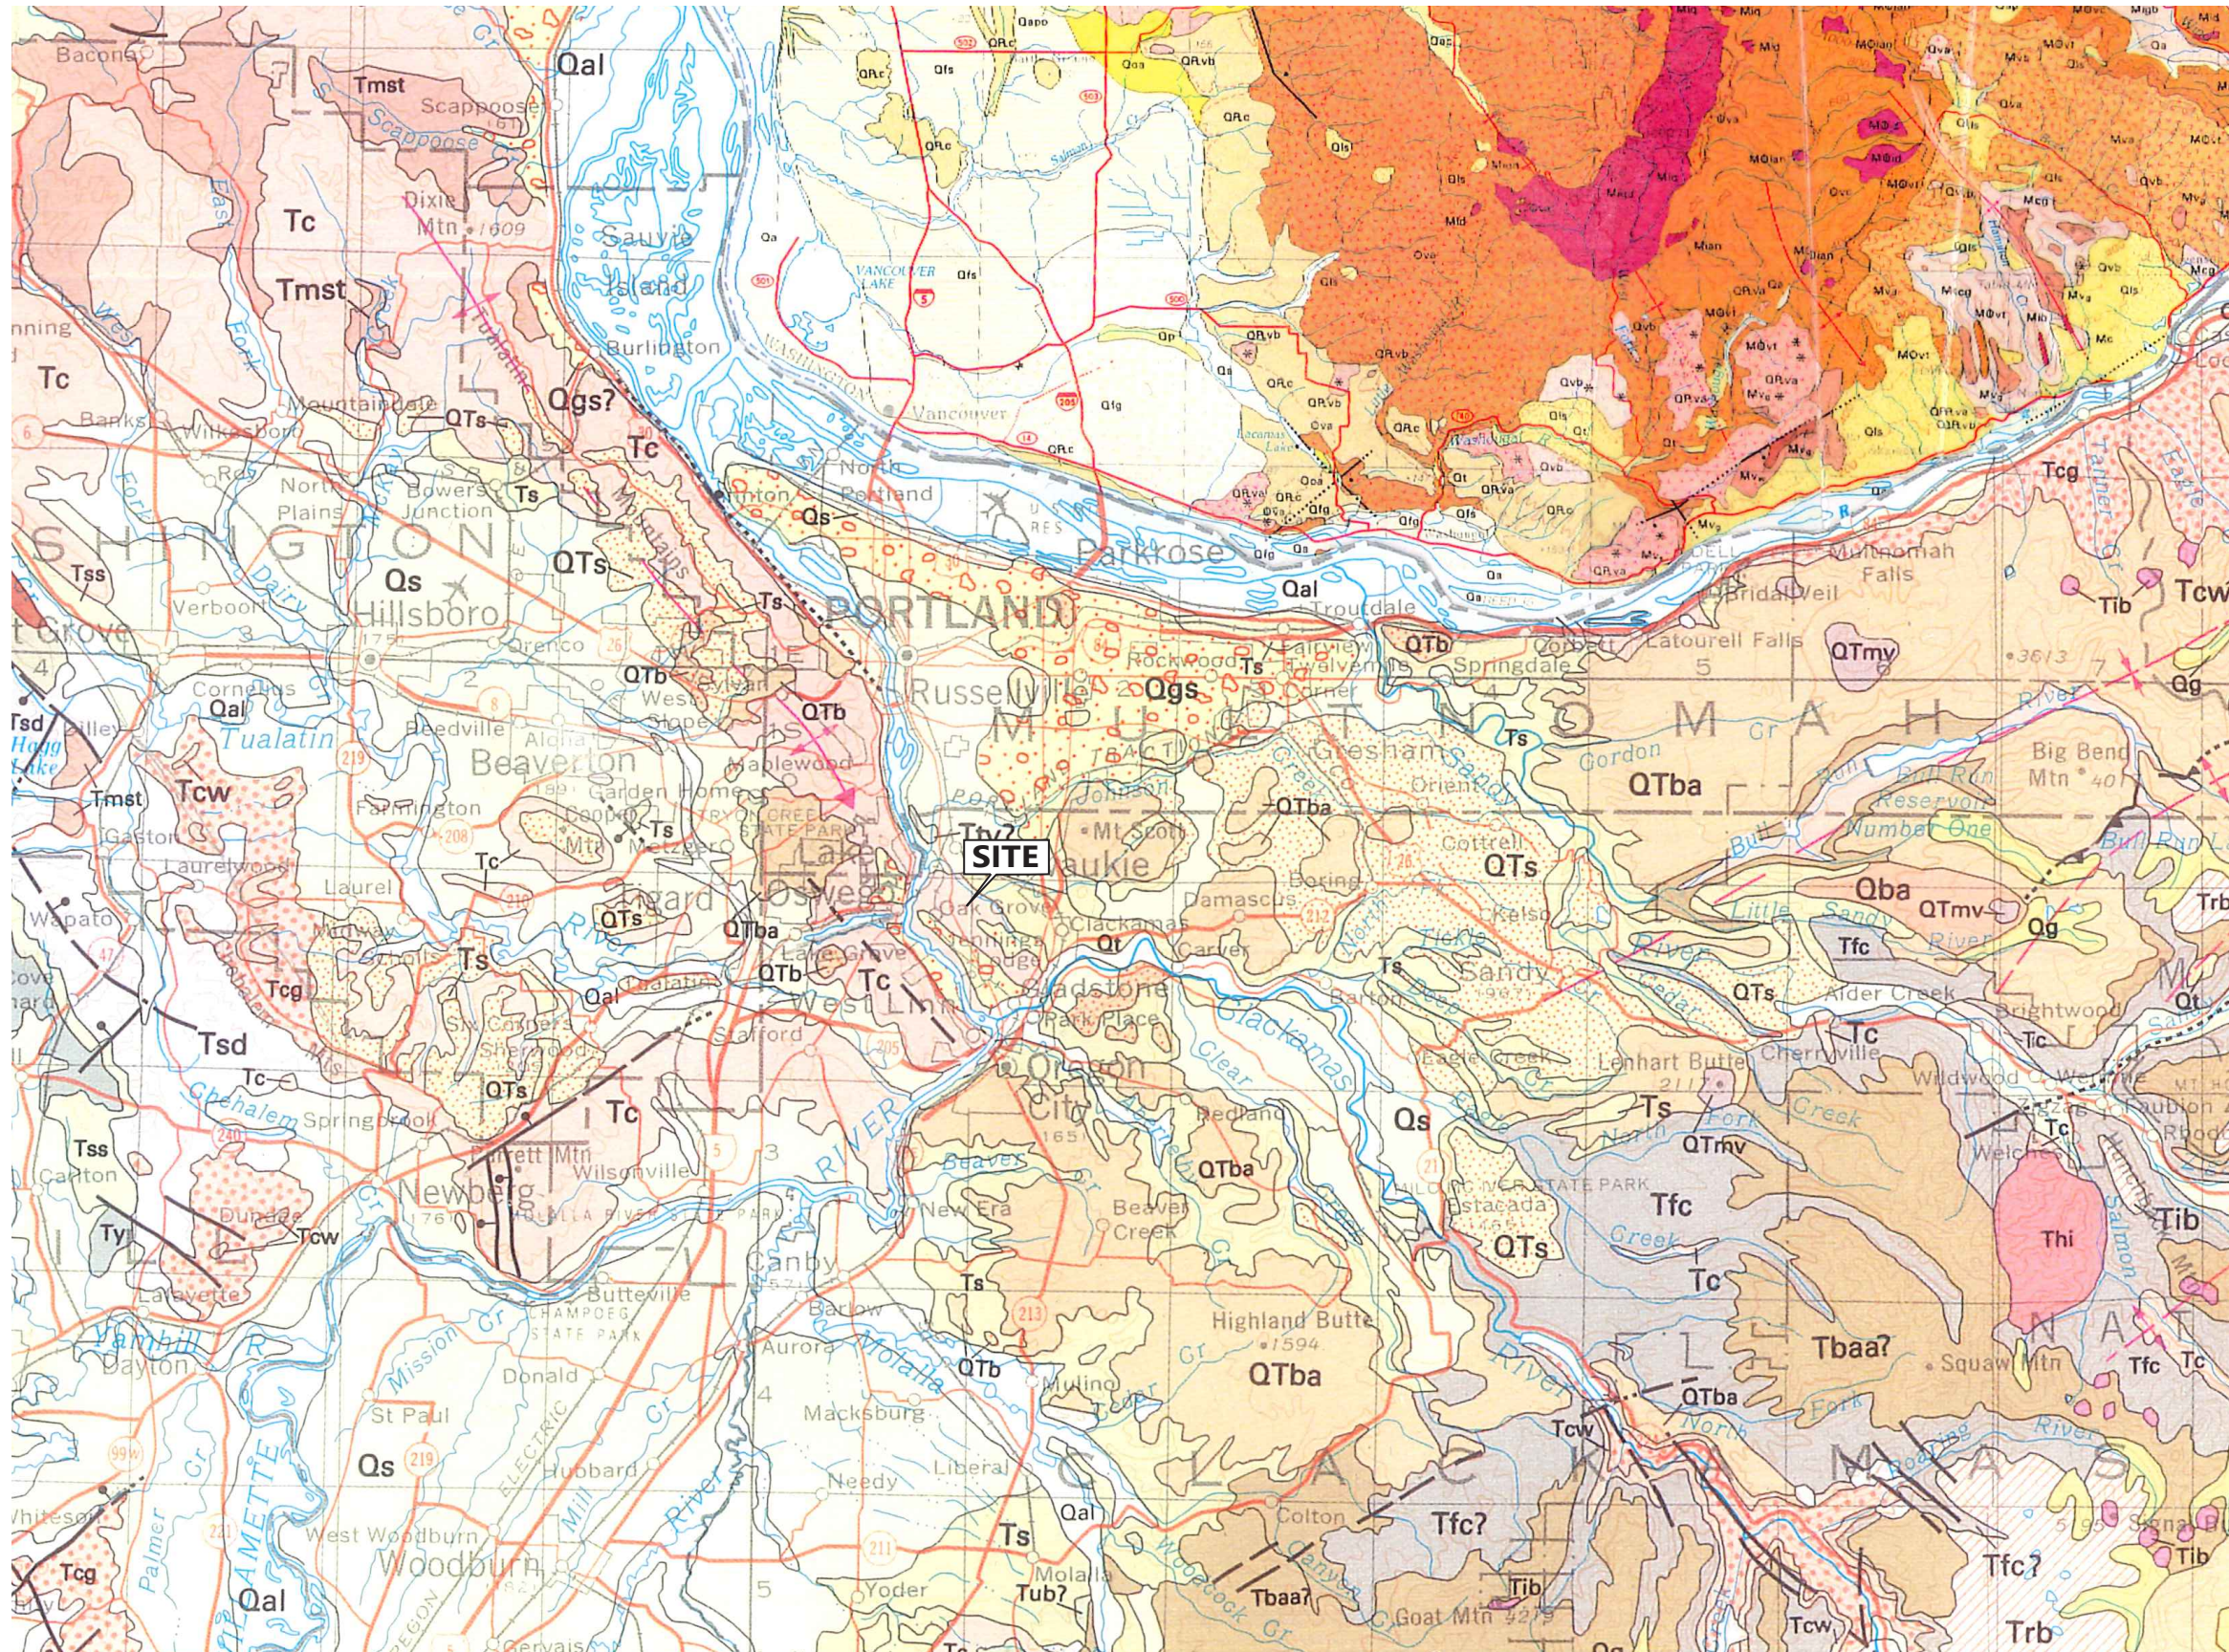
REGIONAL GEOLOGIC MAP

- **Contact** — Approximately located
- - - **Fault** — Dashed where inferred; dotted where concealed; queried where doubtful; ball and bar on downthrown side
- ▲?▲▲ **Thrust fault** — Dashed where inferred; dotted where concealed; queried where doubtful; sawteeth on upper plate
- ⊥ ⁷ **Strike and dip of bed**

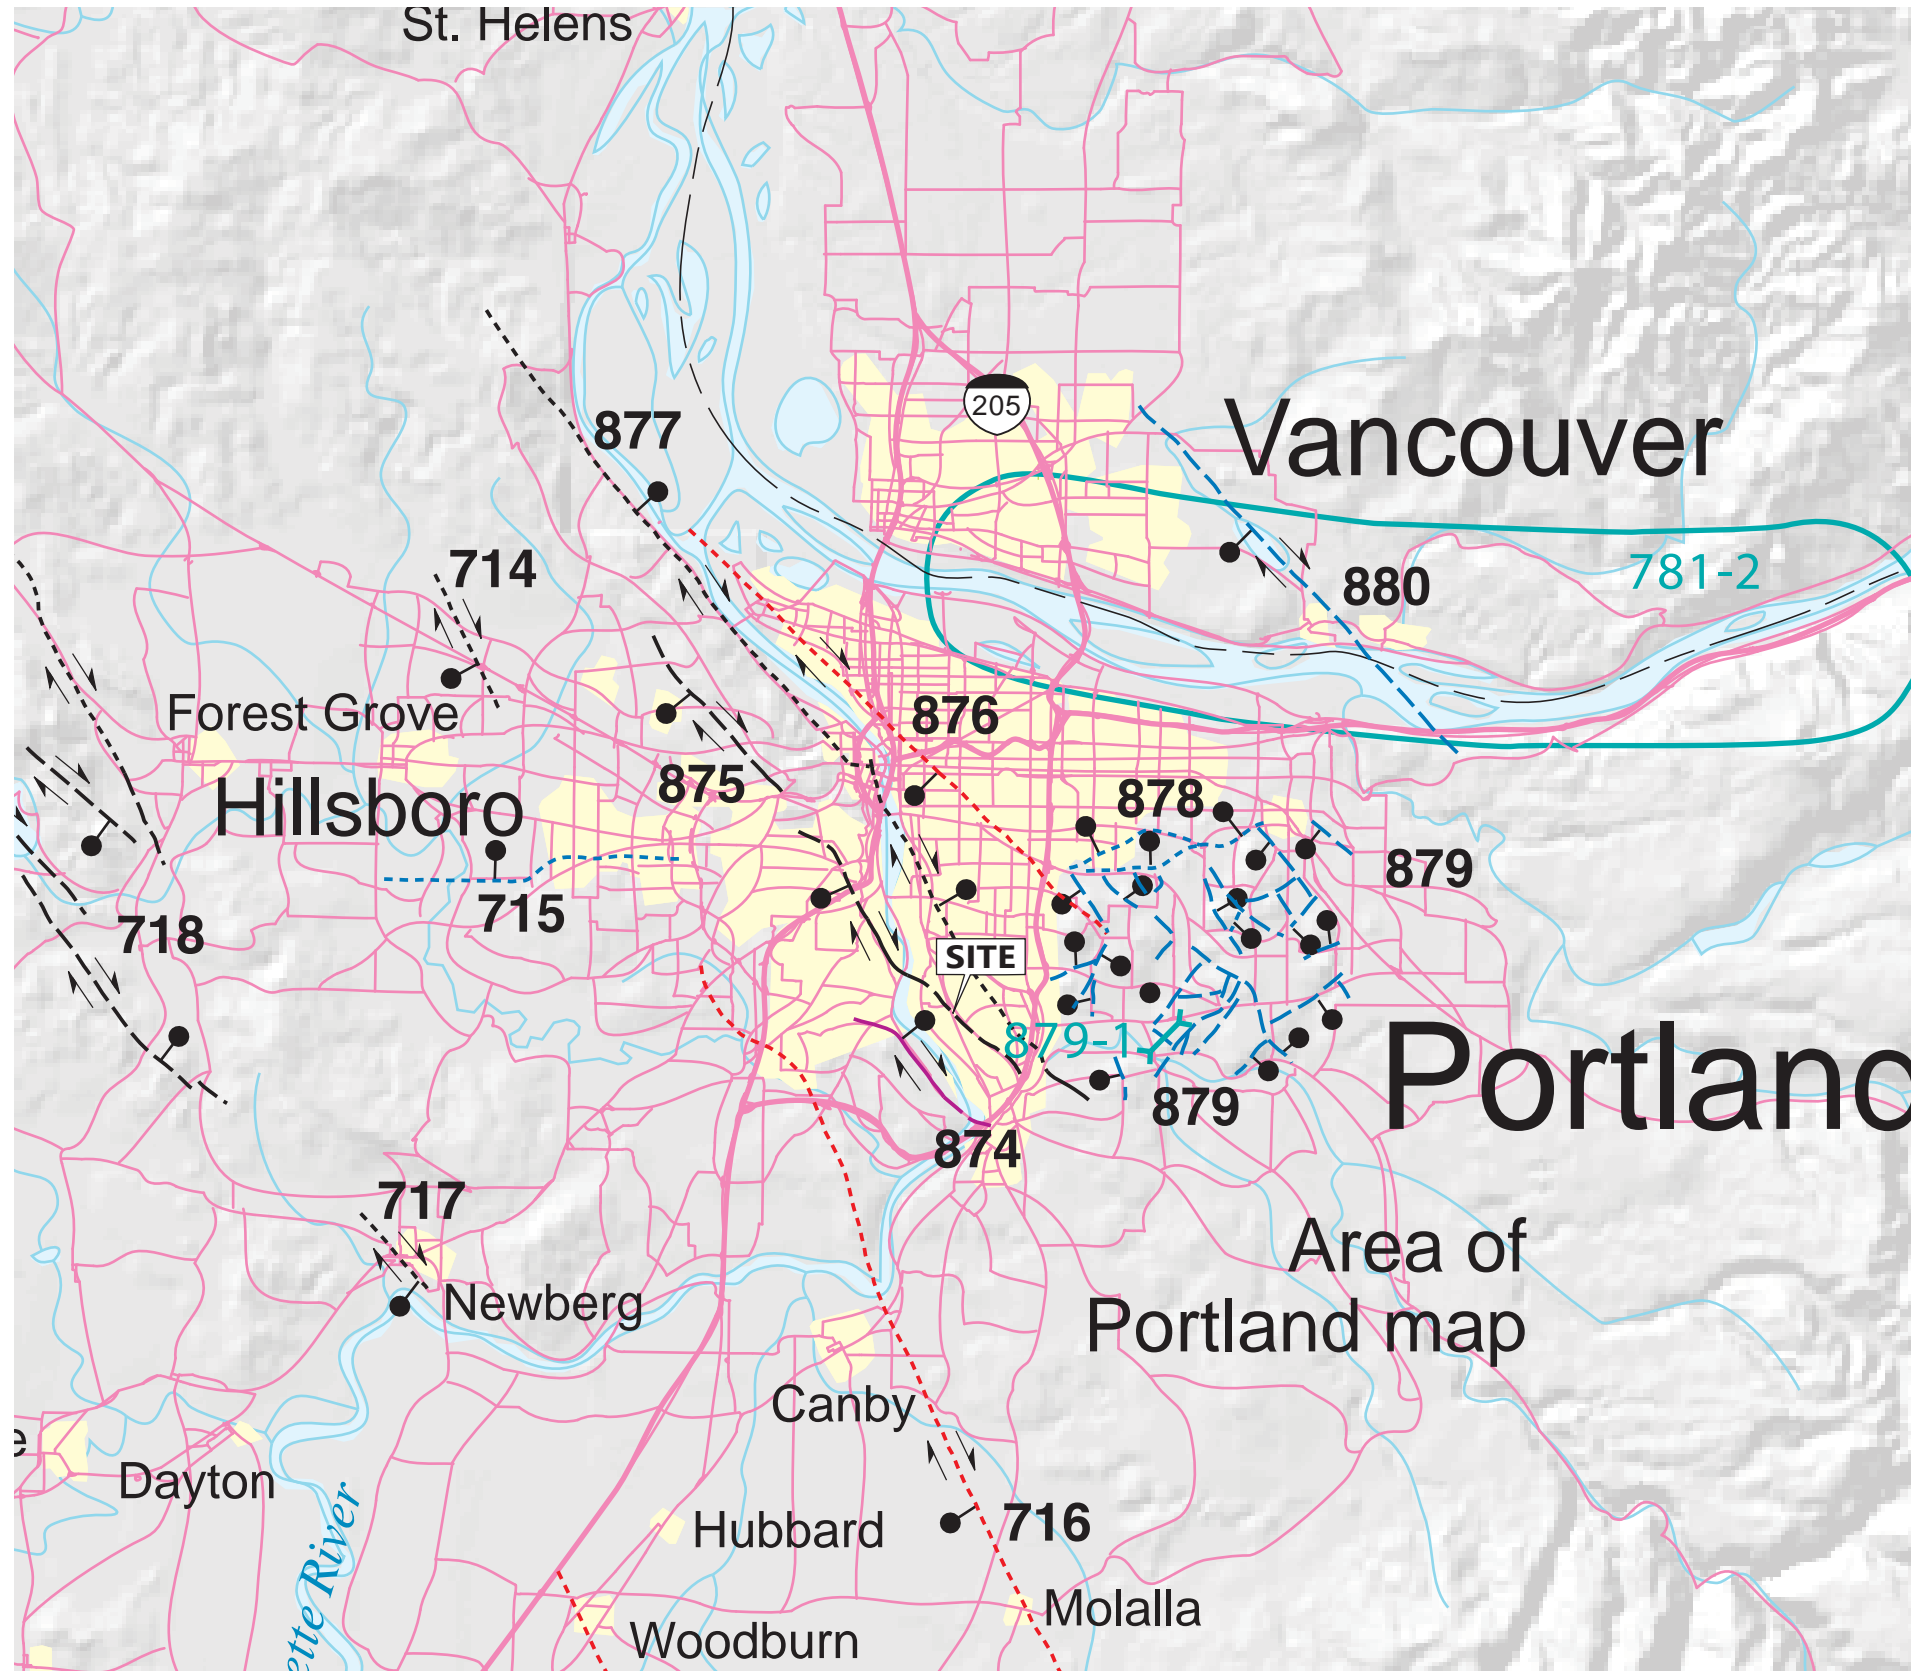
LOCAL FAULT MAP

TIME OF MOST RECENT SURFACE RUPTURE

- Holocene (<10,000 years) or post last glaciation (<15,000 years; 15 ka); no historic ruptures in Oregon to date
- Late Quaternary (<130,000; post penultimate glaciation)
- Late and middle Quaternary (<750,000 years; 750 ka)
- Quaternary, undifferentiated (<1,600,000 years; <1.6 Ma)
- Class B structure (age or origin uncertain)

FAULT NUMBER	NAME OF STRUCTURE
714	HELVETIA FAULT
715	BEAVERTON FAULT
716	CANBY-MOLALLA FAULT
717	NEWBERG FAULT
718	GALES CREEK FAULT ZONE
719	SALEM-EOLA HILLS HOMOCLINE
864	CLACKAMAS RIVER FAULT ZONE
867	EAGLE CREEK THRUST FAULT
868	BULL RUN THRUST FAULT
872	WALDO HILLS FAULT
873	MOUNT ANGEL FAULT
874	BOLTON FAULT
875	OATFIELD FAULT
876	EAST BANK FAULT
877	PORTLAND HILLS FAULT
878	GRANT BUTTE FAULT
879	DAMASCUS-TICKLE CREEK FAULT ZONE
880	LACAMAS LAKE FAULT
881	TILLAMOOK BAY FAULT ZONE

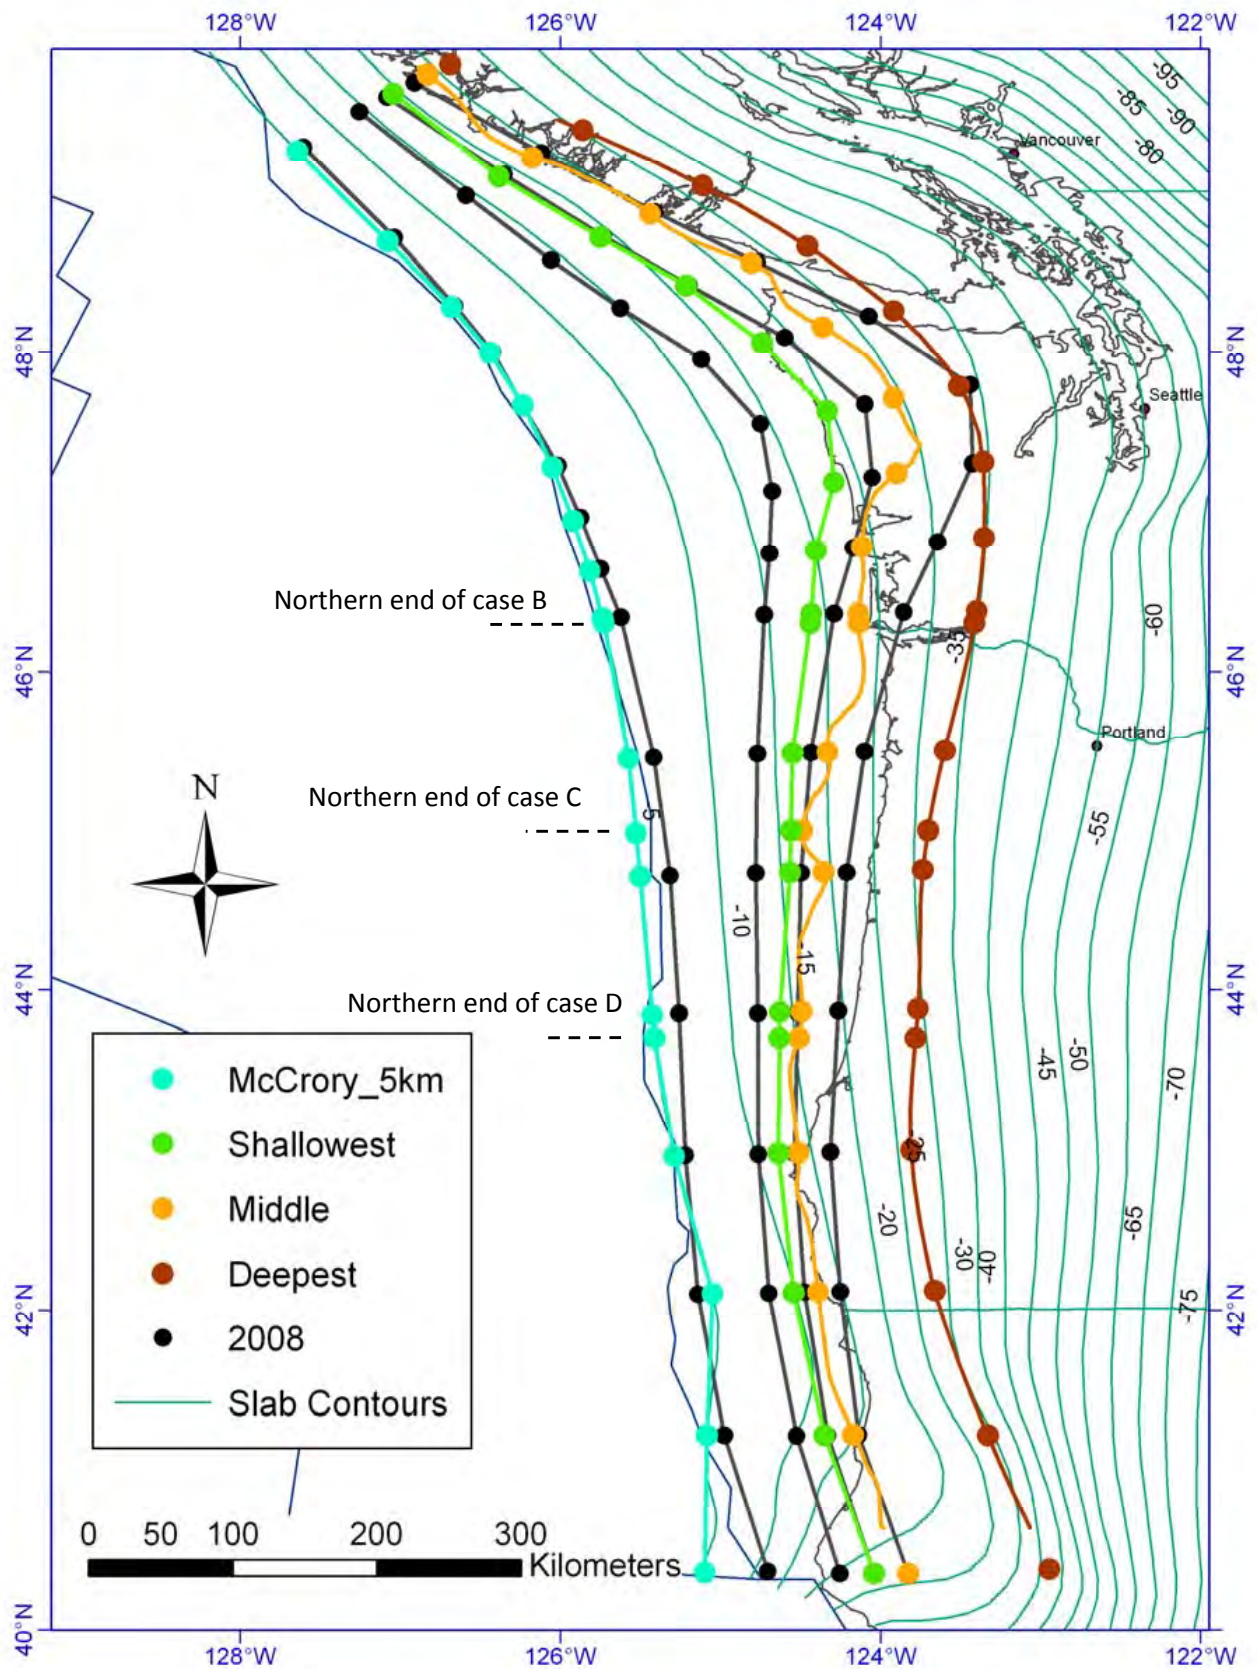
ASSUMED RUPTURE LOCATIONS
(CASCADIA SUBDUCTION ZONE)

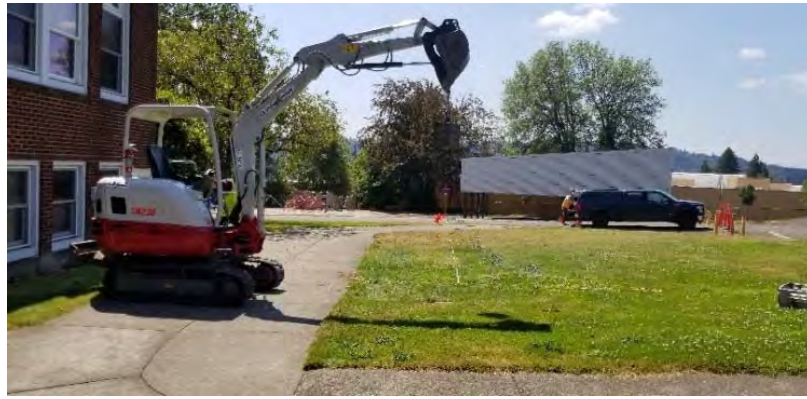
Photo 1. Seismic Refraction using 300 # weight drop.

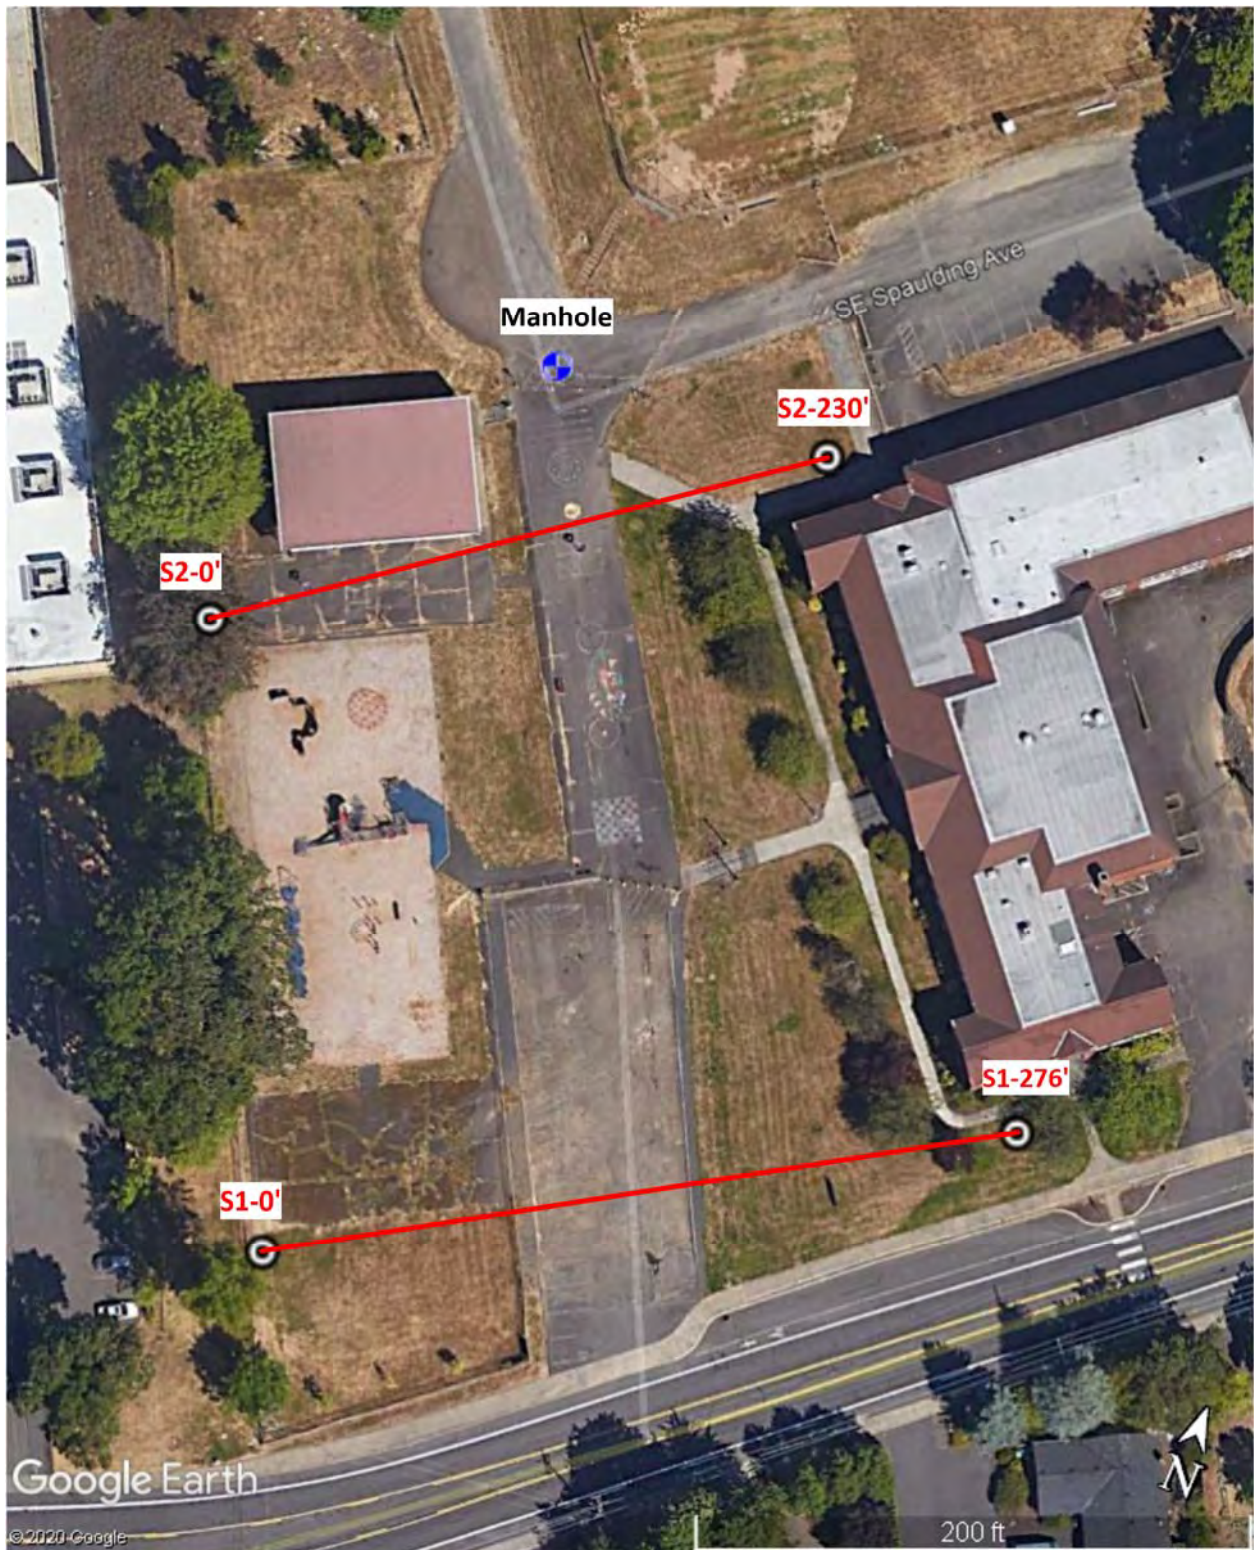
Figure 1. Site image showing locations of geophysical profiles and mapped Oatfield Fault. (USGS)

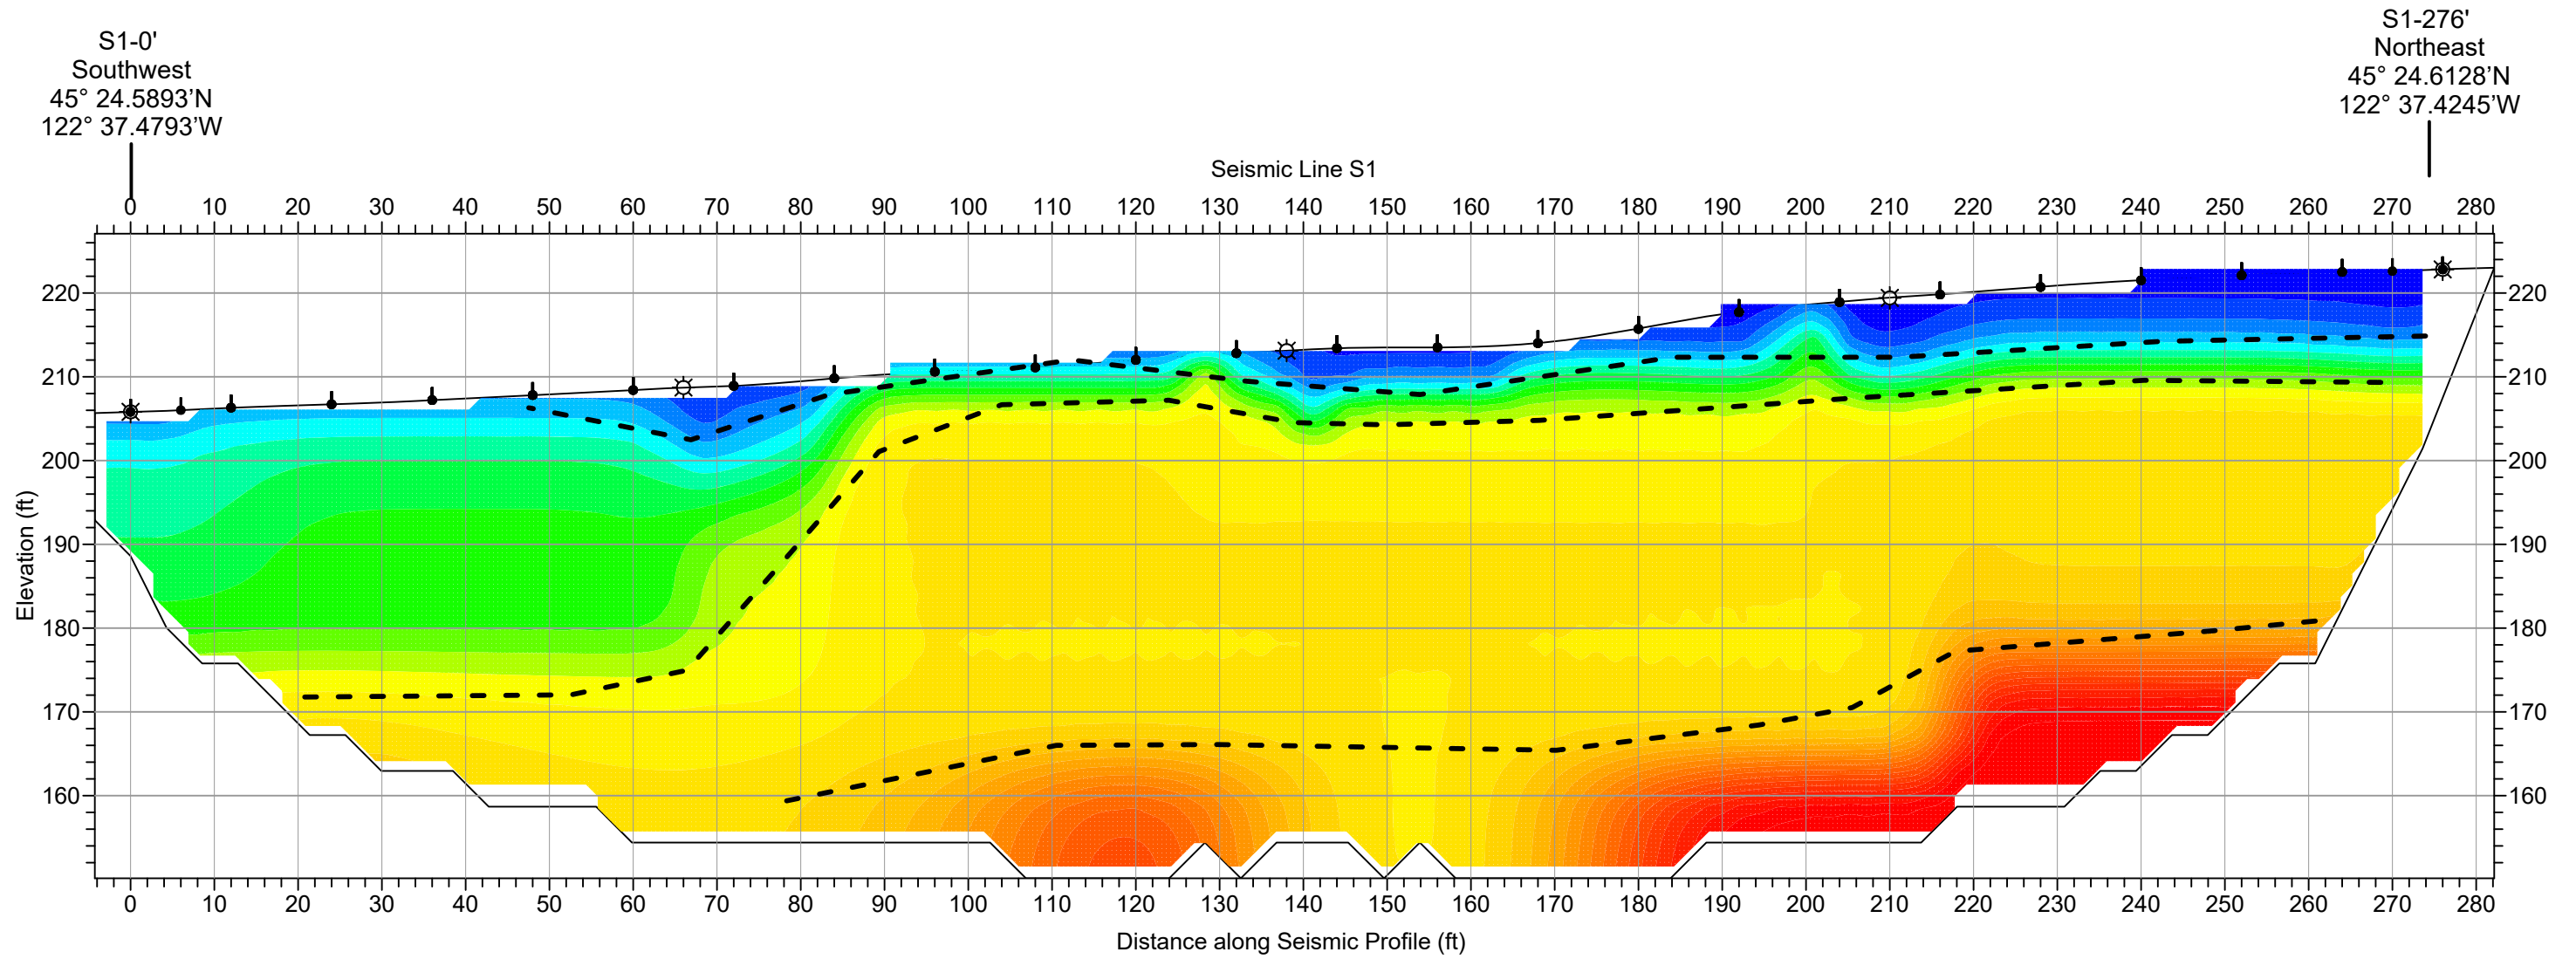
EARTH DYNAMICS LLC 2284 NW Thurman St. Portland, OR 97210 (503) 227-7659 Email: DLauer@earthdyn.com	Concord Elementary School Milwaukie, Oregon Seismic Profile S1 - SeisOpt2D Model
	Job #: 20212 Date: 8/17/2020 Figure: A-1

Dashed lines are interpreted seismic velocity interfaces

Horizontal Scale: 1" = 20'
Vertical Scale: 1" = 20'

Horizontal Latitude and Longitude (WGS 1984) surveyed with Trimble GeoXH 6000 GPS Receiver (Post-processed estimated horizontal accuracy < 1 foot)
Geophone elevations surveyed with level and rod tied to reported GPS elevation.

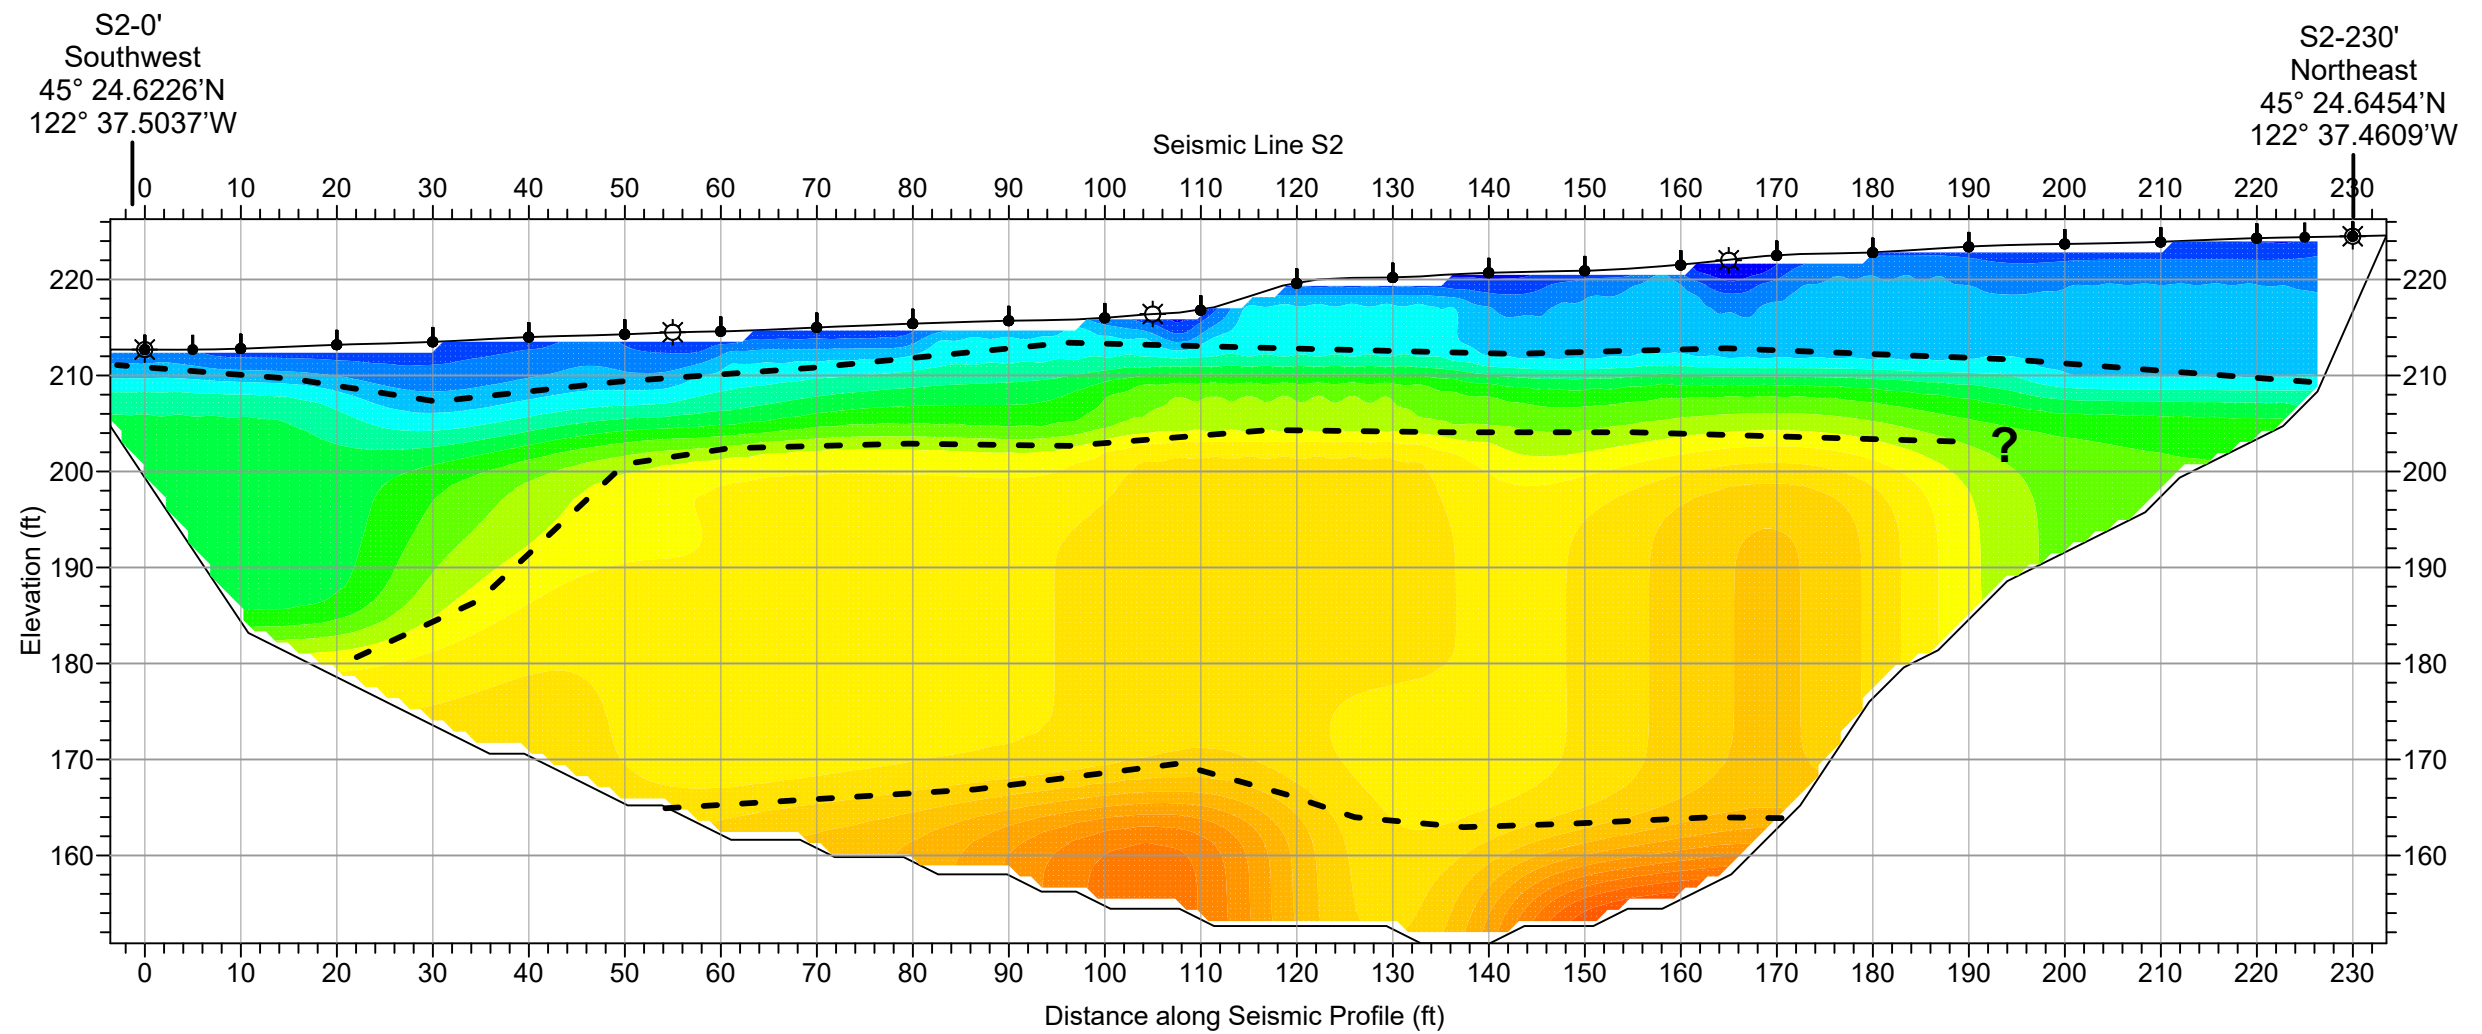
EARTH DYNAMICS LLC 2284 NW Thurman St. Portland, OR 97210 (503) 227-7659 Email: DLauer@earthdyn.com	Concord Elementary School Milwaukie, Oregon Seismic Profile S2 - SeisOpt2D Model	
	Job #: 20212 Date: 8/17/2020 Figure: A-2

Dashed lines are interpreted seismic velocity interfaces

Horizontal Scale: 1" = 20'
Vertical Scale: 1" = 20'

Horizontal Latitude and Longitude (WGS 1984) surveyed with Trimble GeoXH 6000 GPS Receiver (Post-processed estimated horizontal accuracy < 1 foot)
Geophone elevations surveyed with level and rod tied to reported GPS elevation.

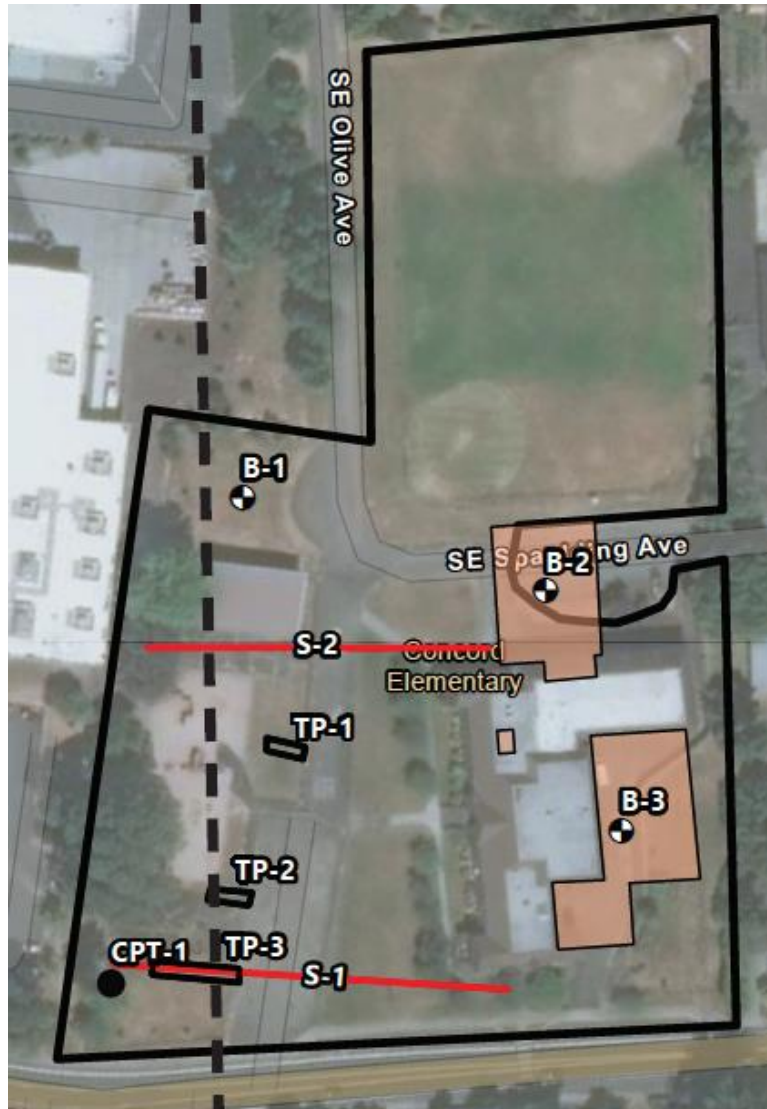
Site Explorations

- Fault Structure Evaluation
 - 2 Seismic-Refraction Arrays
 - 3 Test Pit Trench Excavations
- Foundation & Seismic Design
 - 1 Cone Penetration Test (CPT)
 - 3 Geotechnical Borings

- ⊕ BORING COMPLETED BY GRI (SEPTEMBER 1, 2020)
- PROPOSED IMPROVEMENT AREAS
- SEISMIC REFRACTION LINES COMPLETED BY EARTH DYNAMICS (AUGUST 5, 2020)
- CONE PENETRATION TEST COMPLETED BY GRI (AUGUST 25, 2020)
- TEST PITS COMPLETED BY GRI (AUGUST 25, 2020)
- INFERRED OATFIELD FAULT PER USGS 2020

Subsurface materials and conditions at the site were investigated on August 5 through September 1, 2020, with two seismic-refraction arrays designated S-1 and S-2, one cone penetration test (CPT) probe designated CPT-1, three test-pit excavations designated TP-1 through TP-3, and three drilled borings designated B-1 through B-3. The approximate locations of the explorations completed for this investigation are shown on Figure 2.

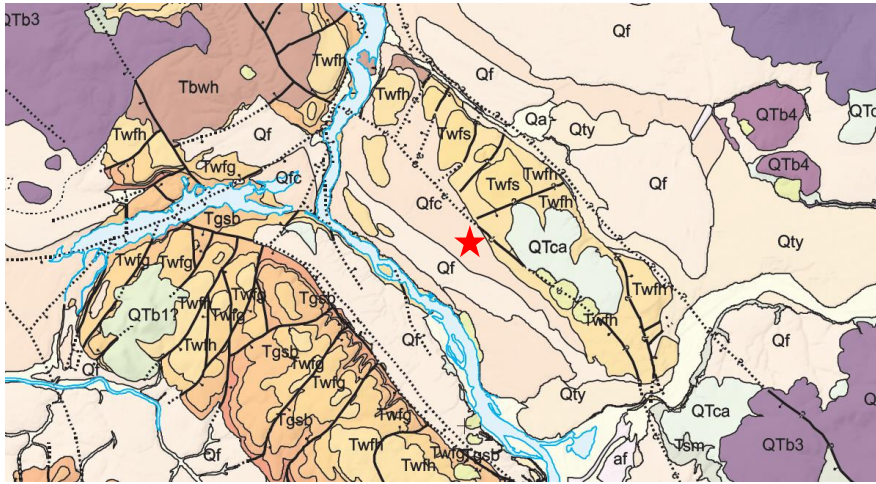
Background/Geologic Setting

Source: Wells et al. 2018

- Project Area – Red Star
 - Site- Missoula Flood Deposits (~15 thousand years old)
 - Adjacent/At Depth – Basalt (~15 million years old)
 - Faults – Numerous; Most considered inactive
- **USGS Quaternary Fold and Fault Database:** Inventory of active and recently active faults
 - **Oatfield Fault:** “Class A” – Geologic evidence exists for the presence of a fault; not considered active

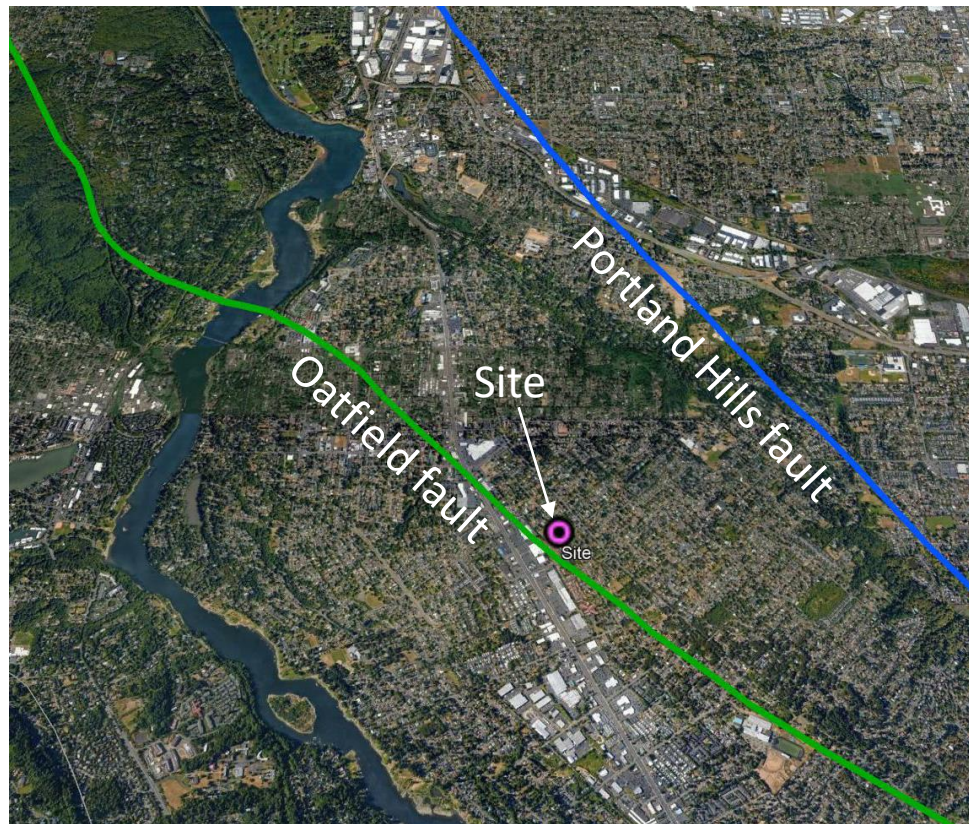
Seismic Sources: Earthquake Return Period & Probability

Portland Hills Fault:

- Estimated Return Period M7:
~ 14,000 years
- Estimated Probability of Occurrence:
 - Less than 1% in 50 years

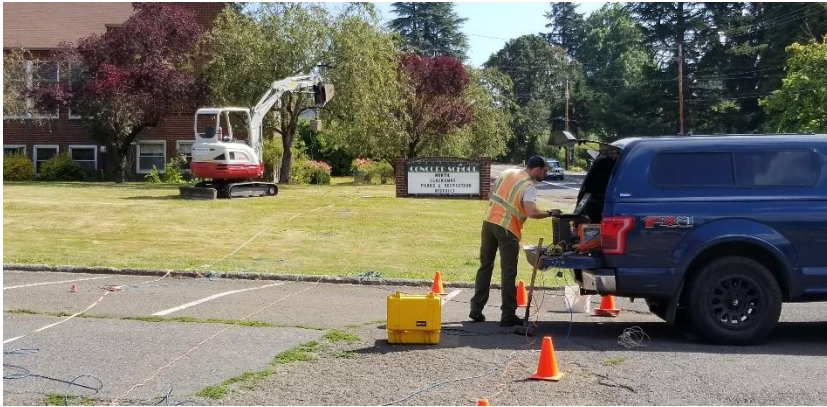
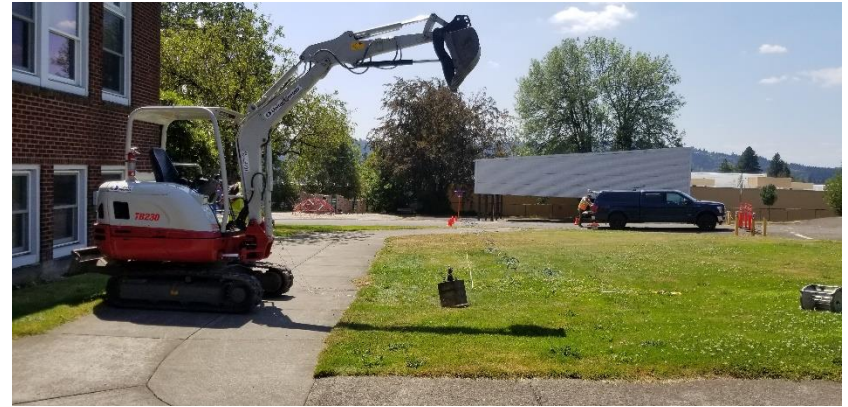
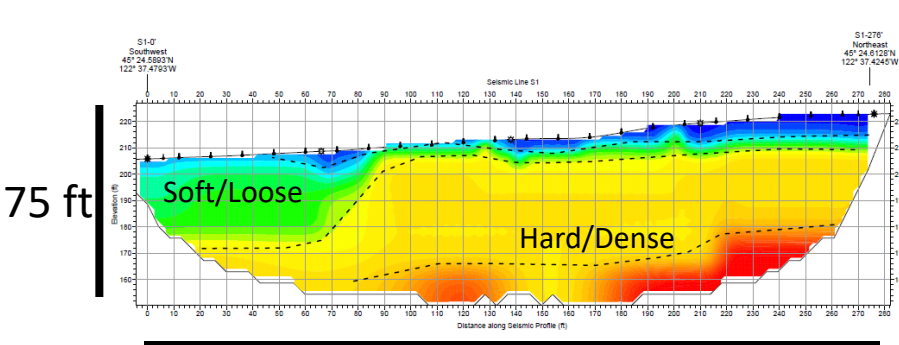
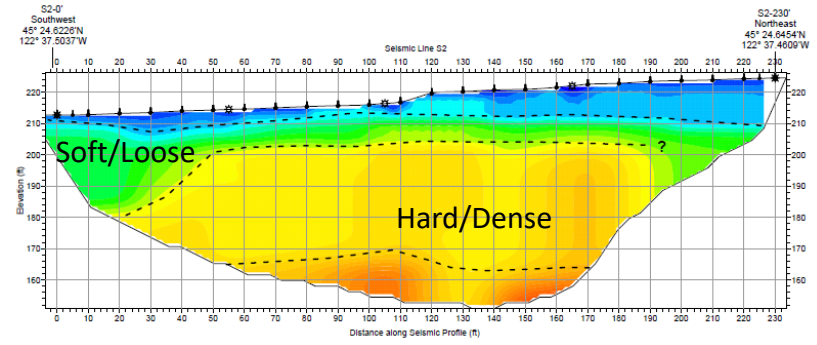
Seismic-Refraction Geophysical Survey

Soft/Loose

Compressional wave Velocity (ft/s)

Hard/Dense
