Geotechnical Investigation and Site-Specific Seismic-Hazard Evaluation

Oak Lodge Community Project

3811 SE Concord Road
Milwaukie, Oregon

October 20, 2020

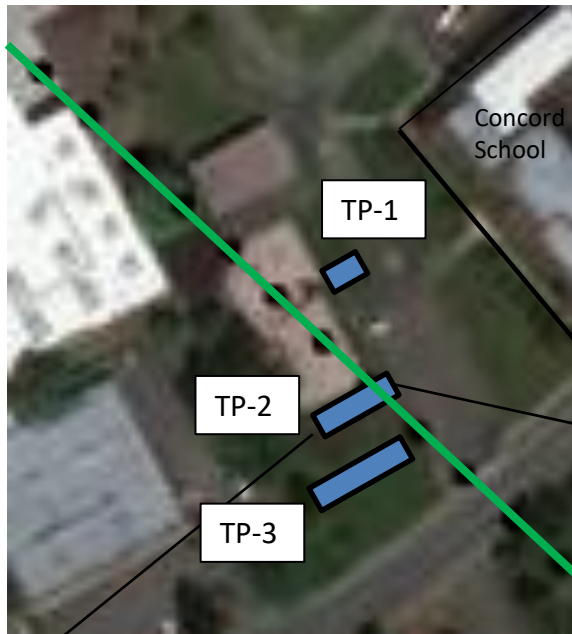
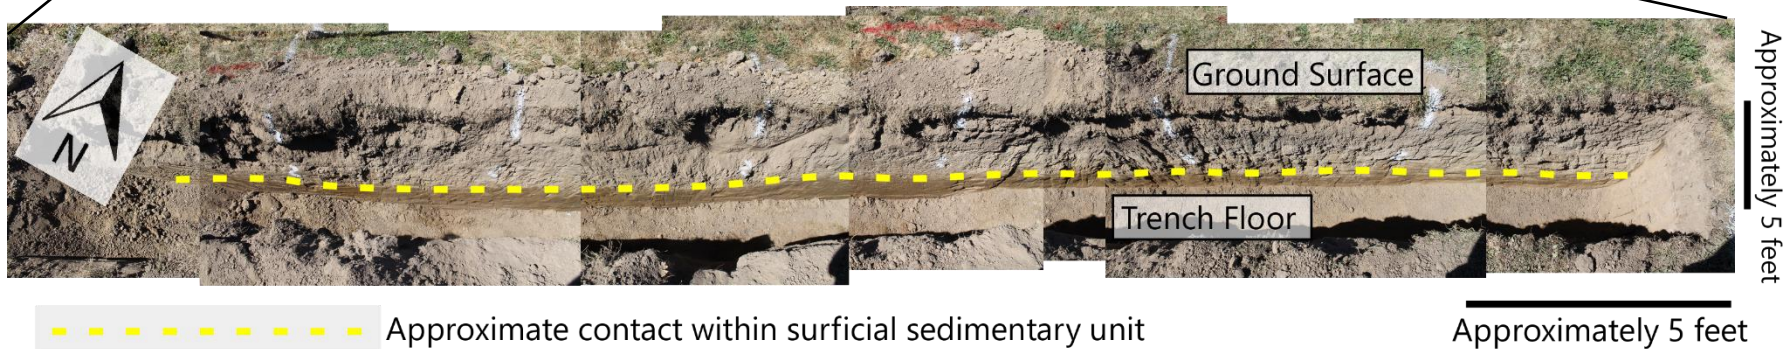
Test Pit Trench Excavations

- Test pits: geotechnical data and fault assessment
- Site constraints – playground, asphalt
- TP-2 crosses mapped Oatfield fault-green
- Soil units not broken = fault is older than 15,000 years (photo below)

--- Approximate contact within surficial sedimentary unit

Approximately 5 feet
