Architectural
Resources Group

Concord School Historic Resource Assessment

January 2020

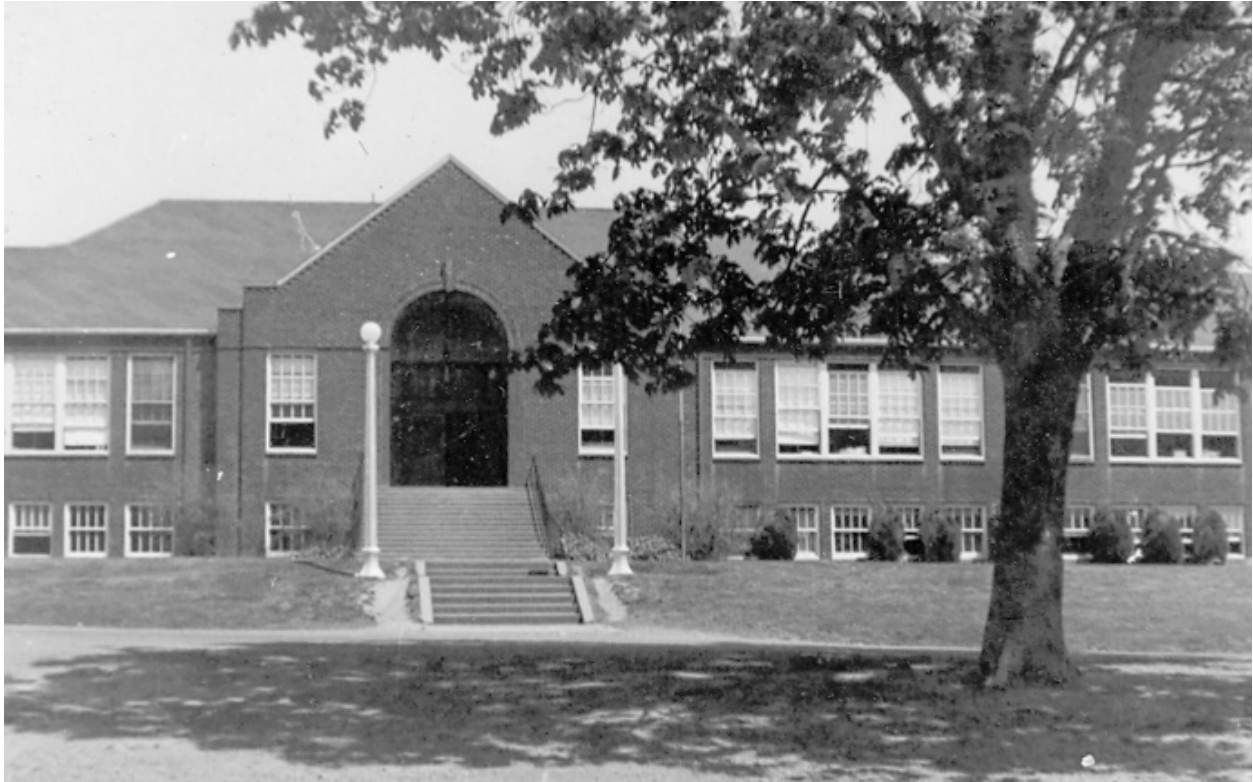
Figure 3. Photograph showing western façade of Concord School building, 1955. Note multilight wood windows and lampposts (Oak Lodge History Detectives).

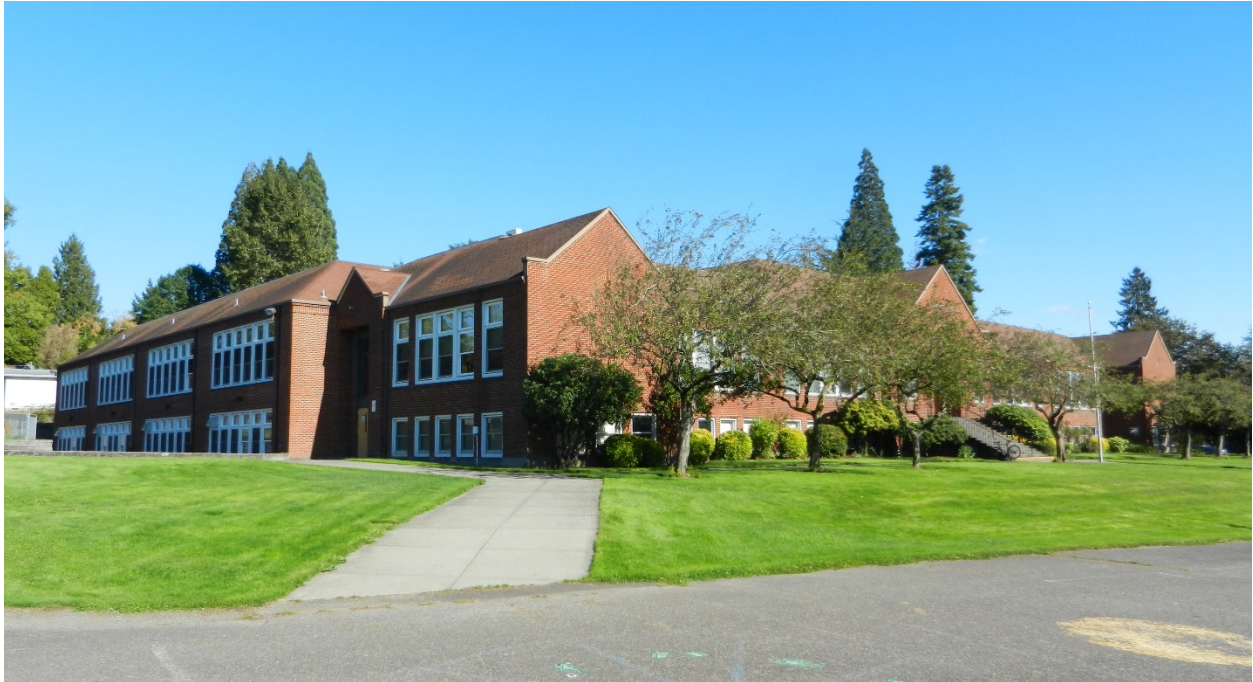
Lateral view of the Concord School showing the primary (western) façade of the 1936 building (right) and the 1948 addition (left), camera facing southeast (ARG, October 2019).

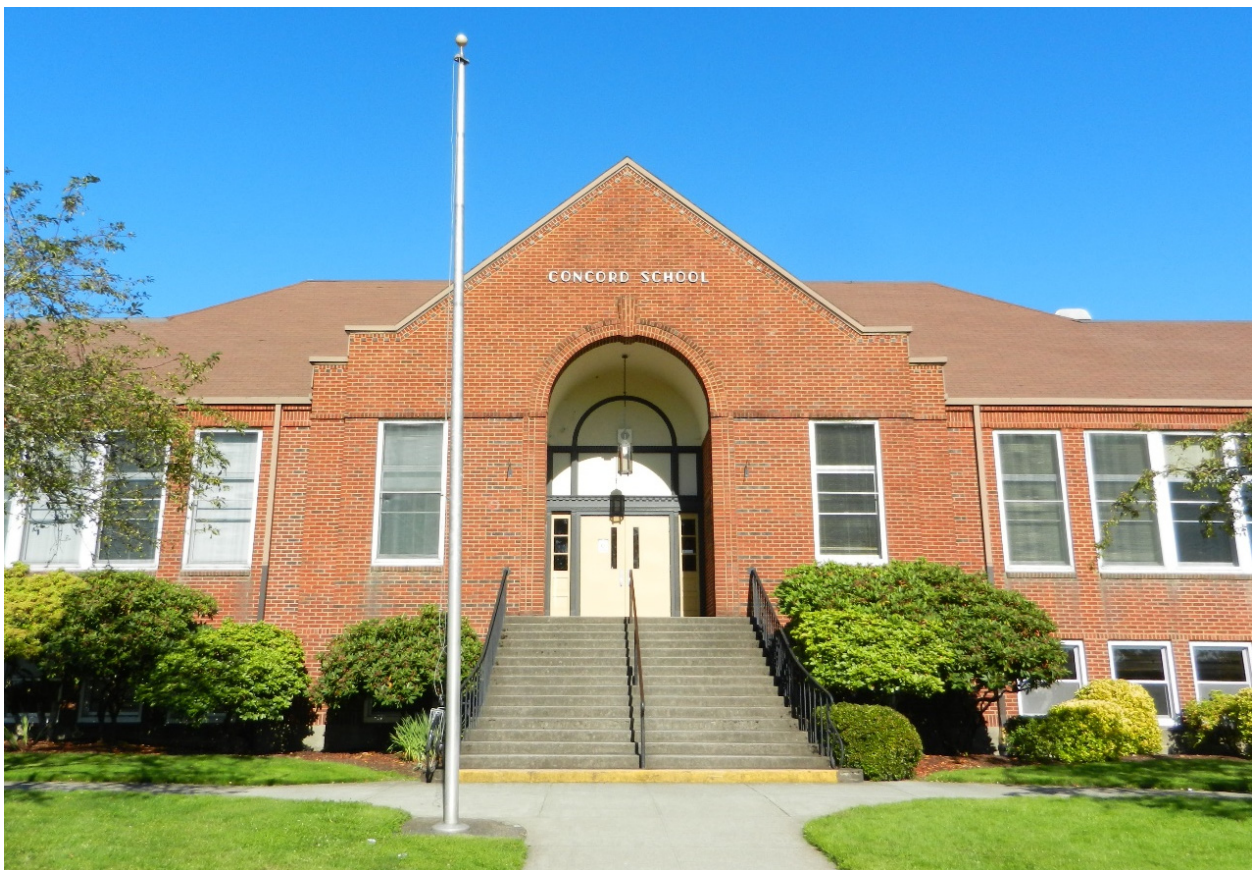
Primary entrance, western façade, camera facing east (ARG, October 2019) .

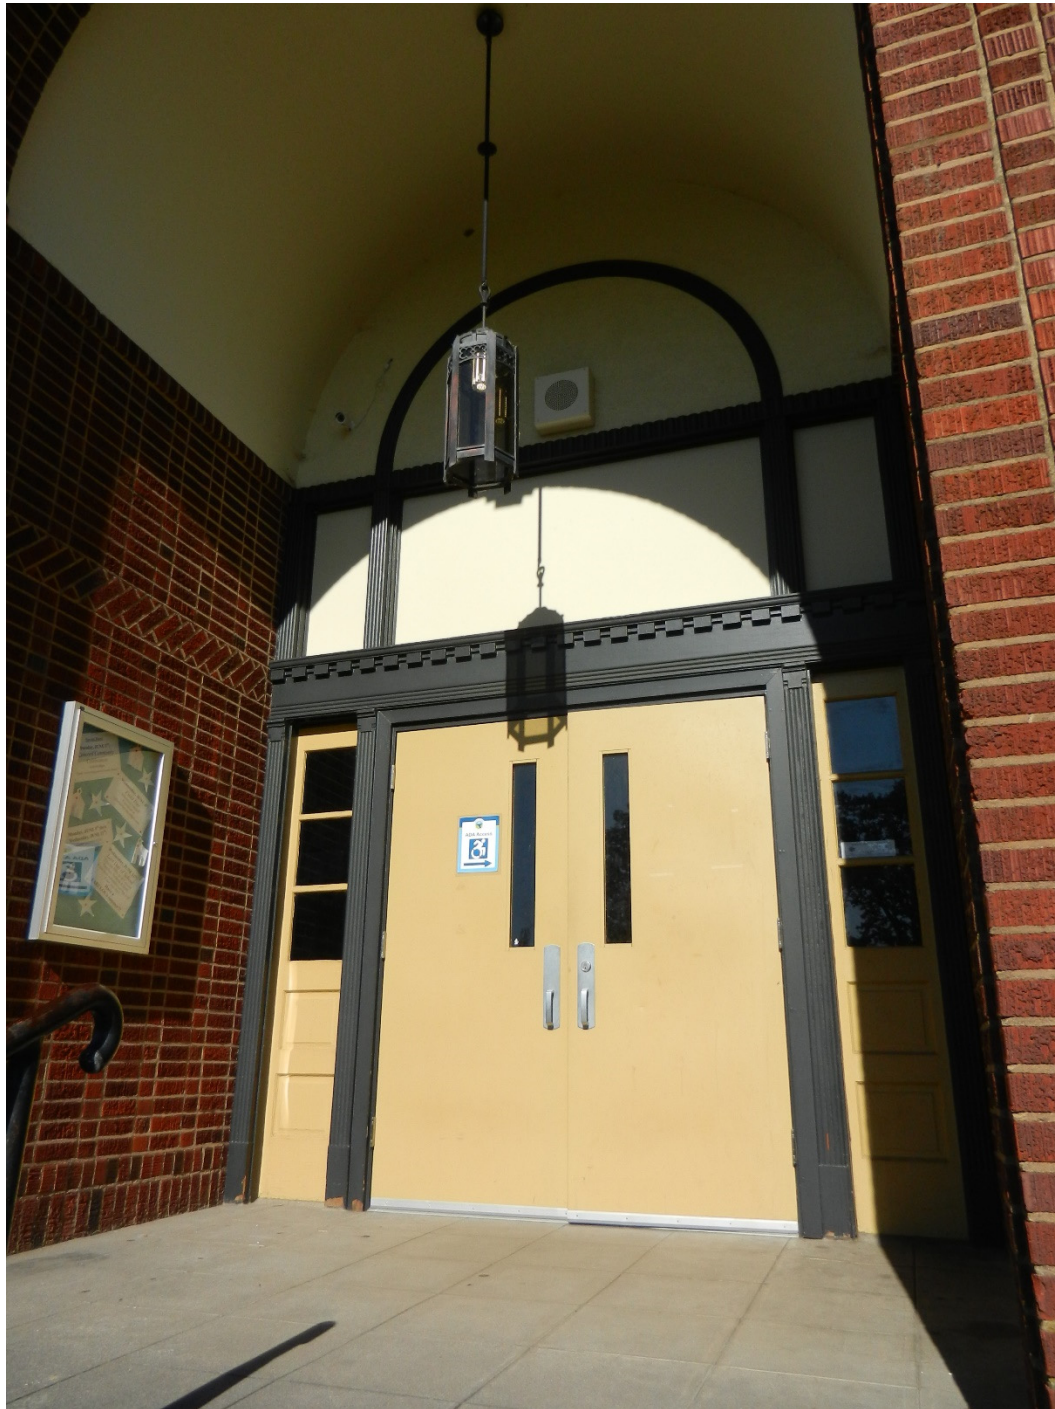
Primary entrance, western façade, camera facing east-northeast (ARG, October 2019).

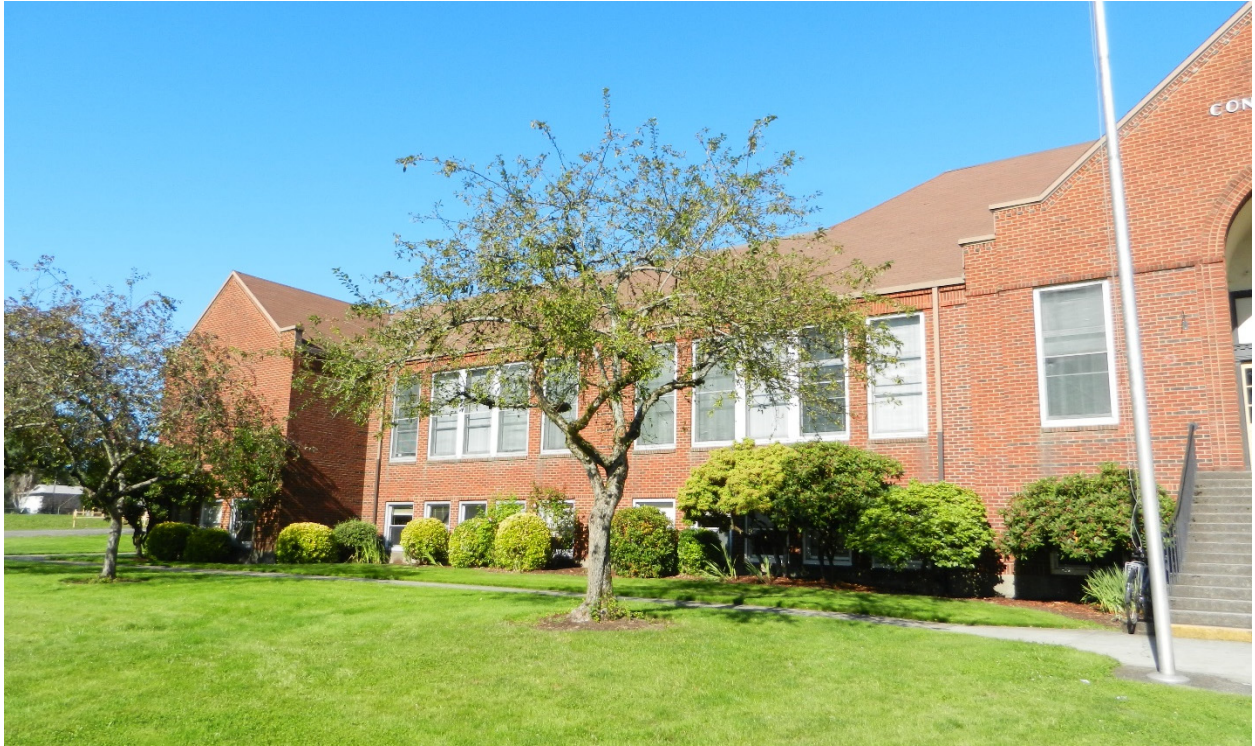
Northern portion of the primary (western) façade, camera facing east-northeast (ARG, October 2019).

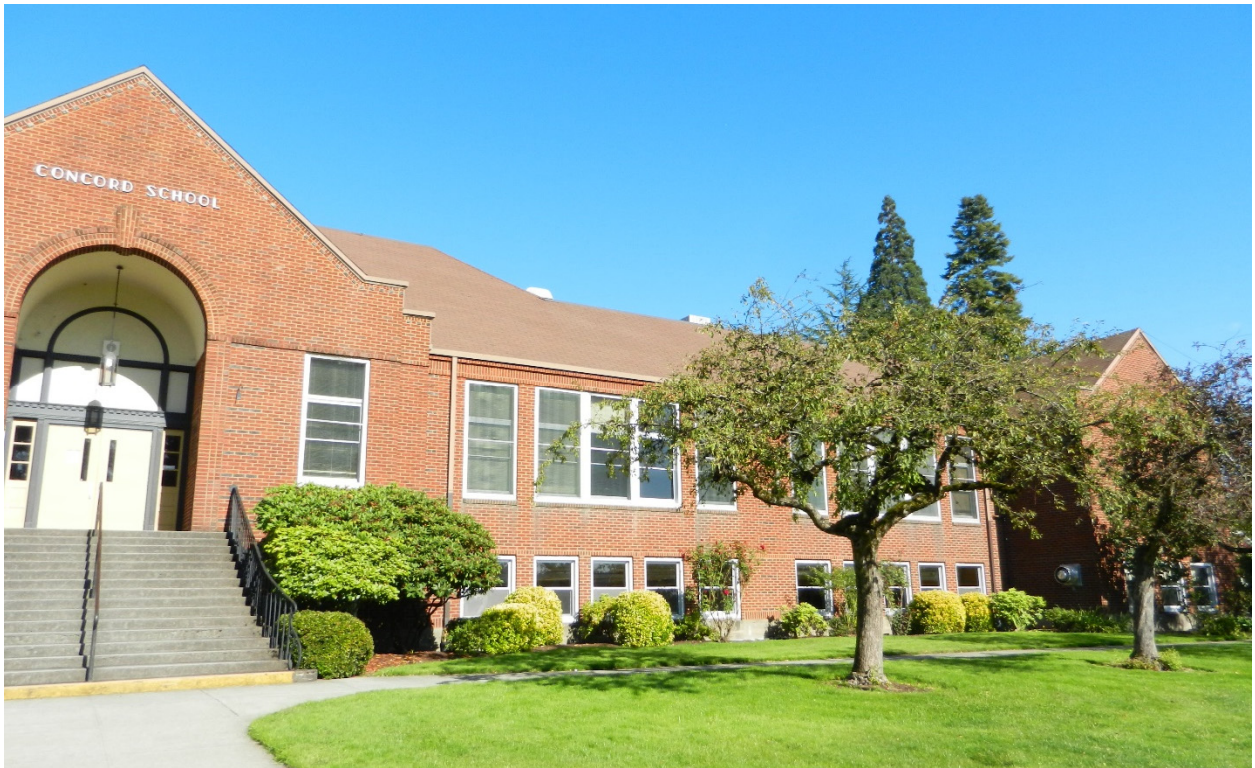
Southern portion of primary (western) façade, camera facing east-southeast (ARG, October 2019).

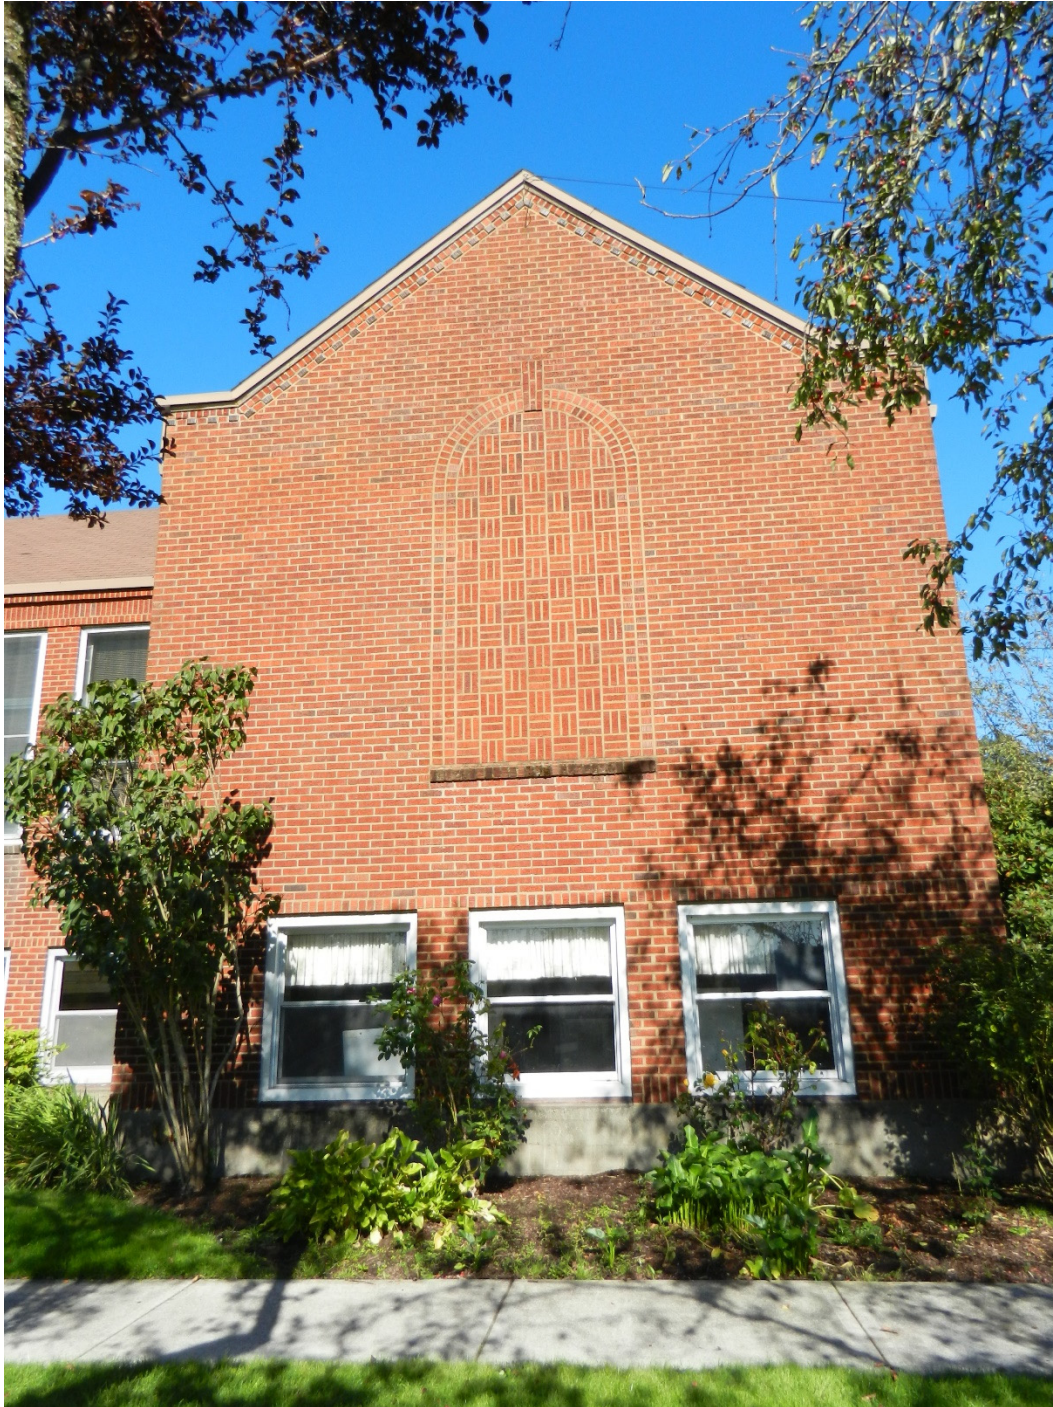
Projecting end bay at the southern end of the primary (western) façade, camera facing east (ARG, October 2019).

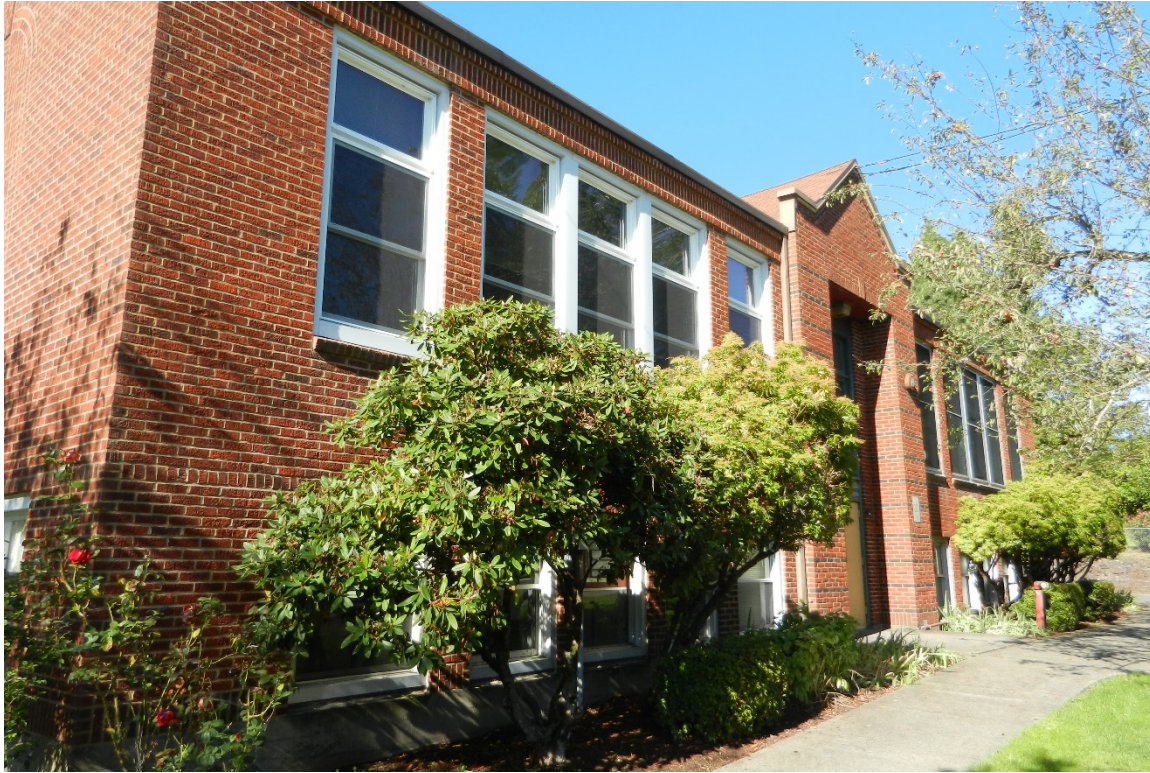
Southern façade, camera facing northeast (ARG, October 2019).

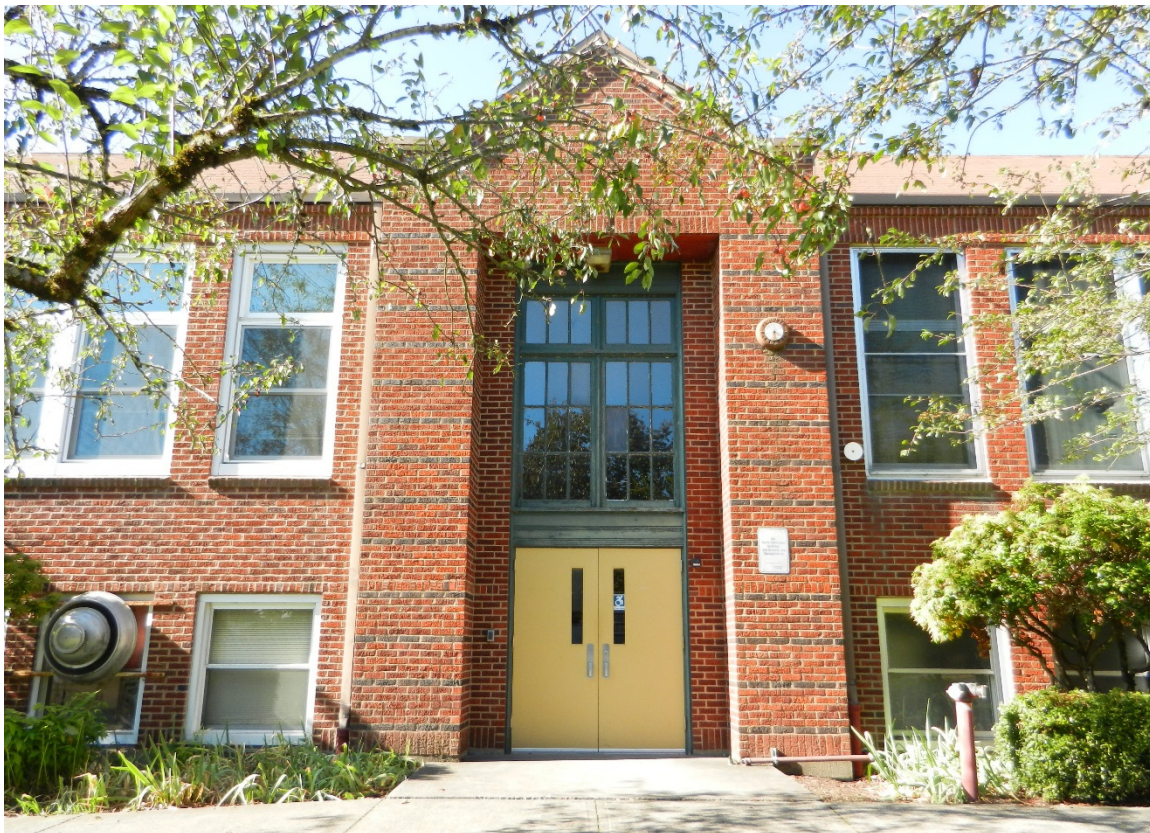
Southern façade, camera facing north (ARG, October 2019).

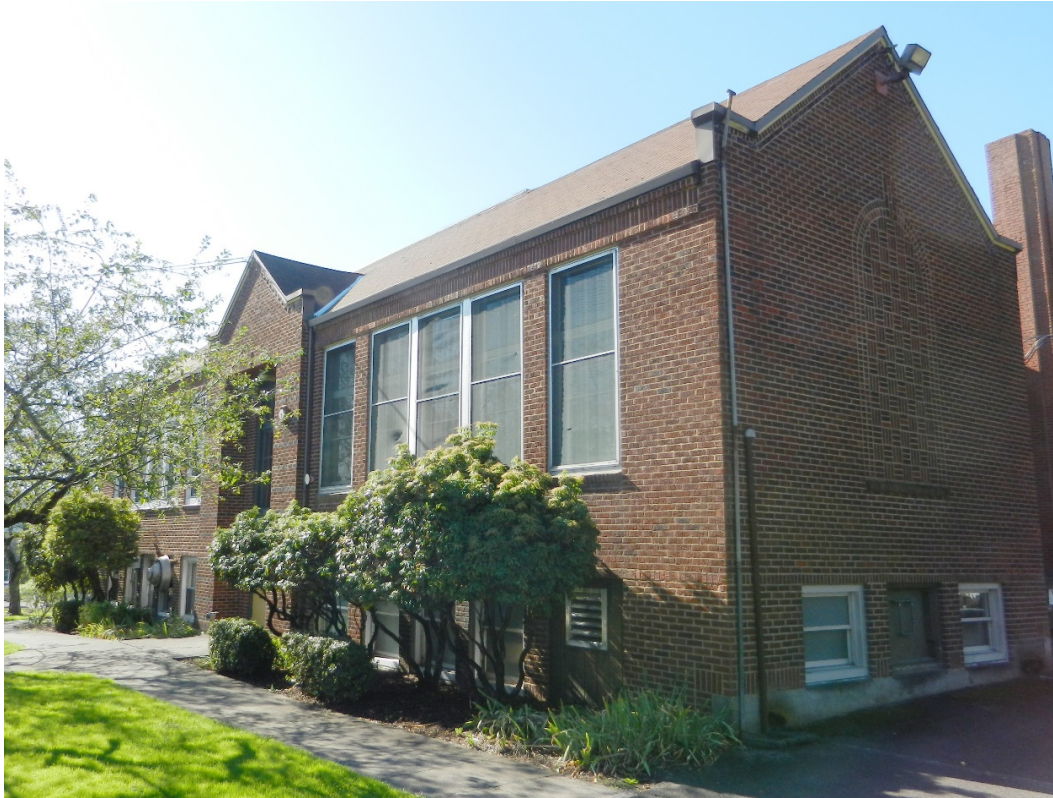
Southern façade, camera facing northwest (ARG, October 2019).

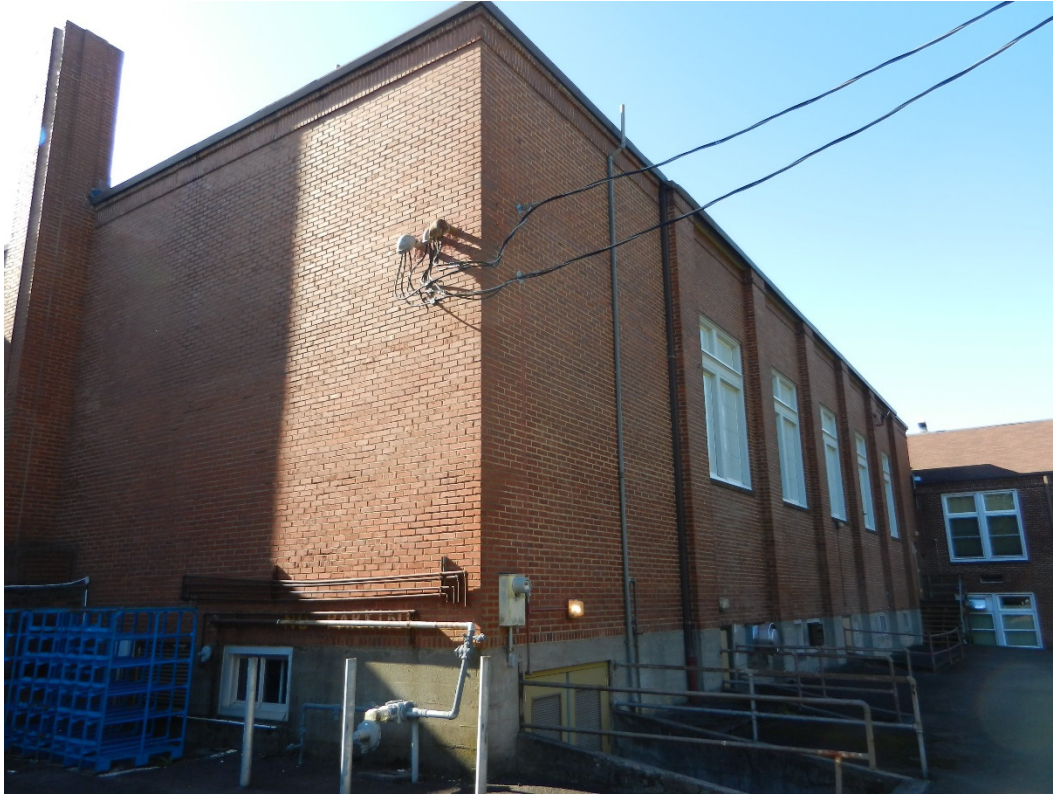
Rear (eastern) façade, camera facing northwest (ARG, October 2019).

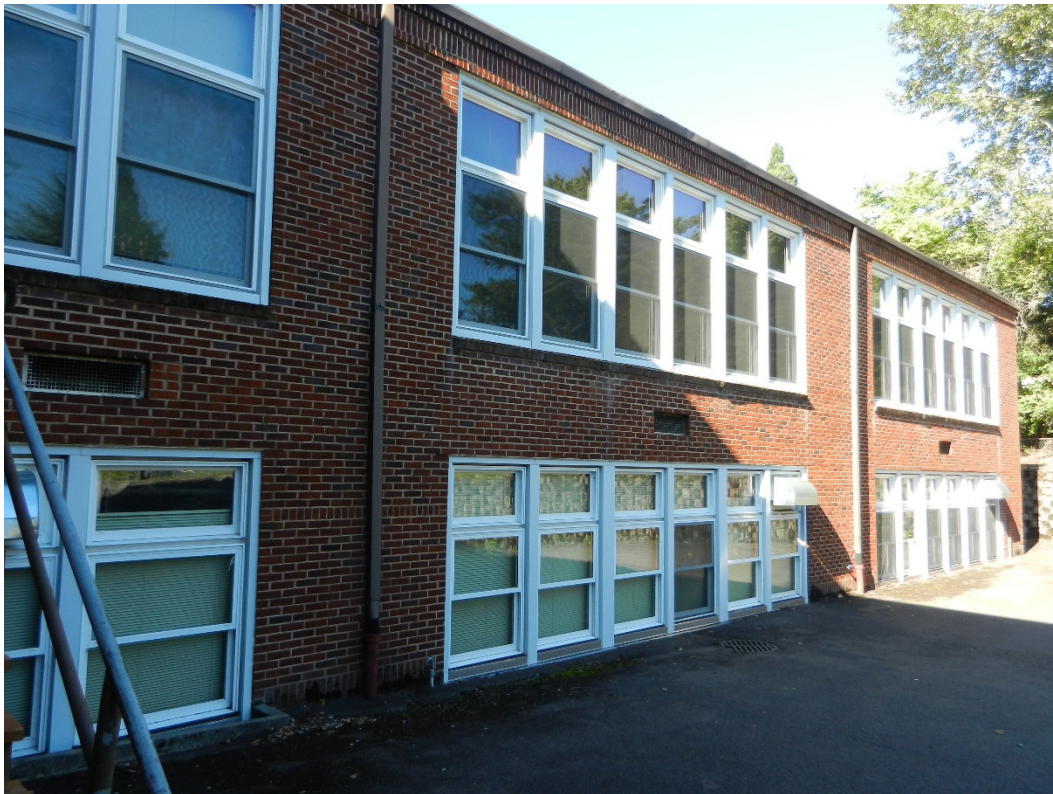
Southern façade of rear wing addition, camera facing northeast (ARG, October 2019).

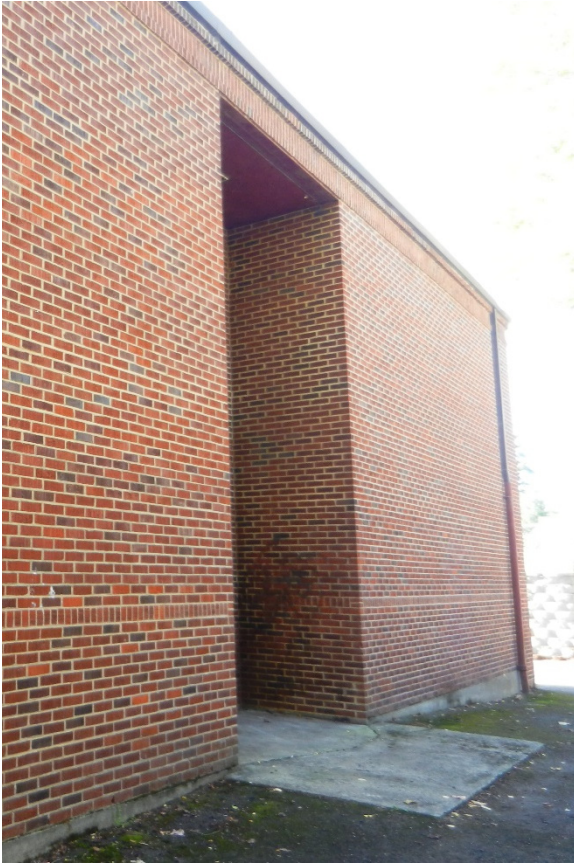
Eastern façade of rear wing addition, camera facing northwest (ARG, October 2019).

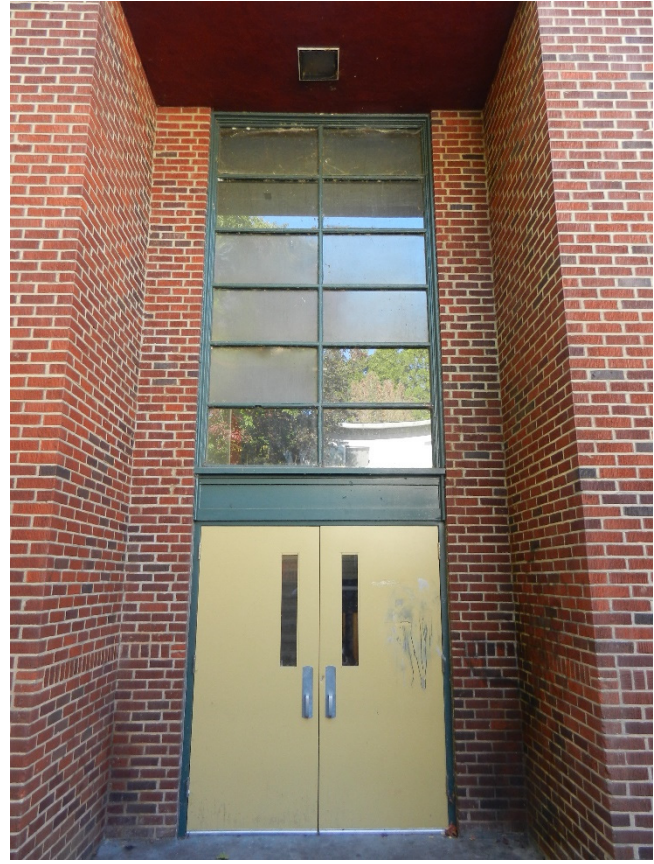
Eastern façade of rear wing addition, camera facing west (ARG, October 2019).

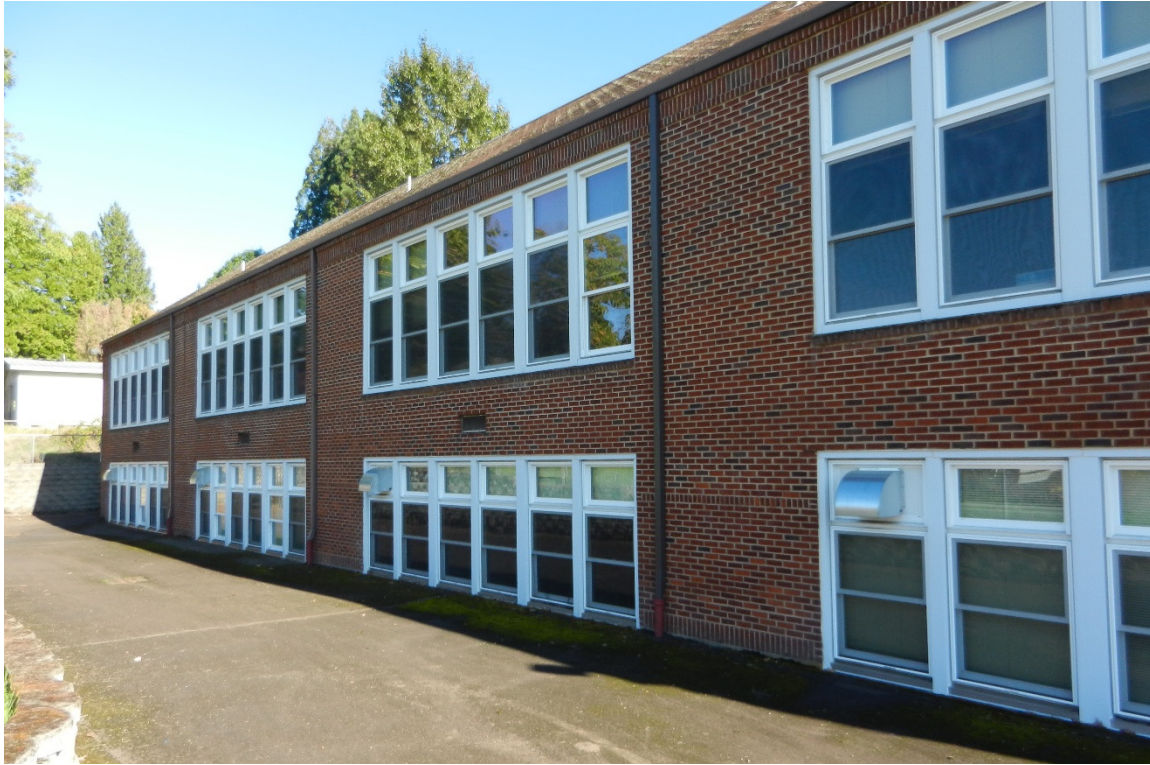
Northern façade of rear wing addition, camera facing southeast (ARG, October 2019).

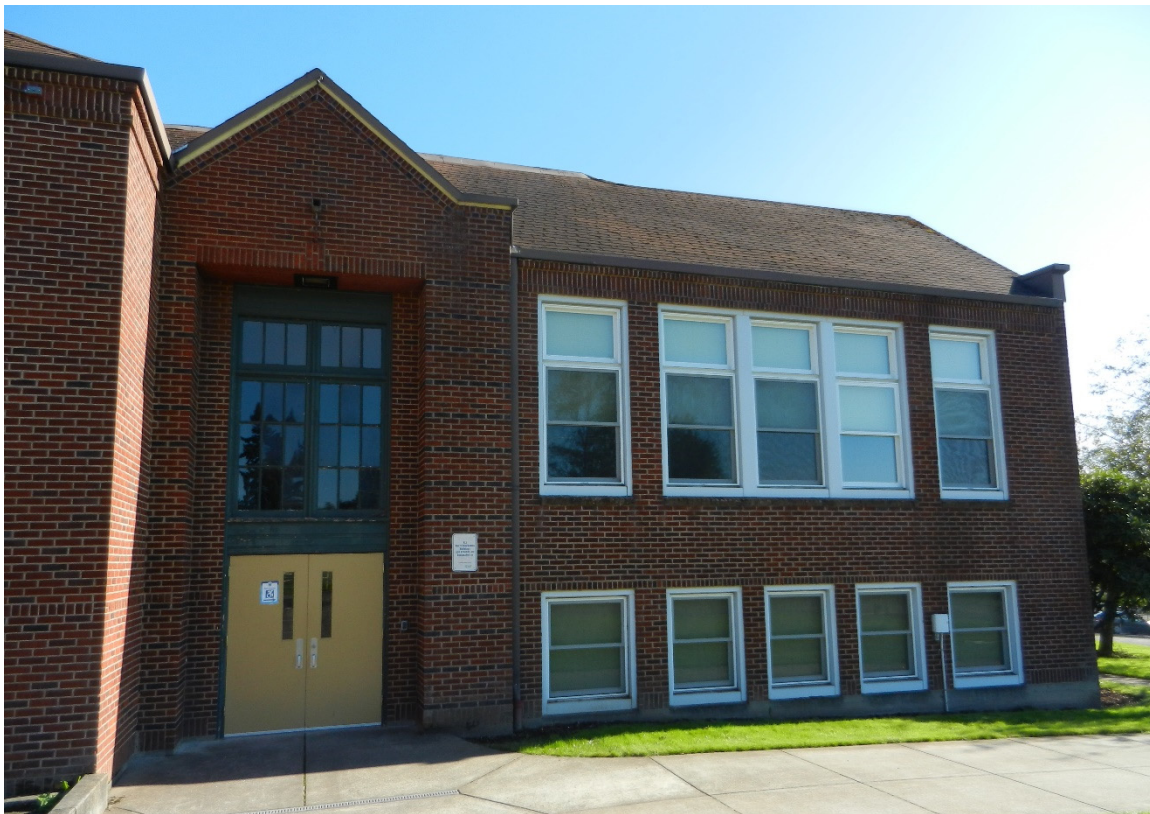
Northern façade, camera facing south (ARG, October 2019).

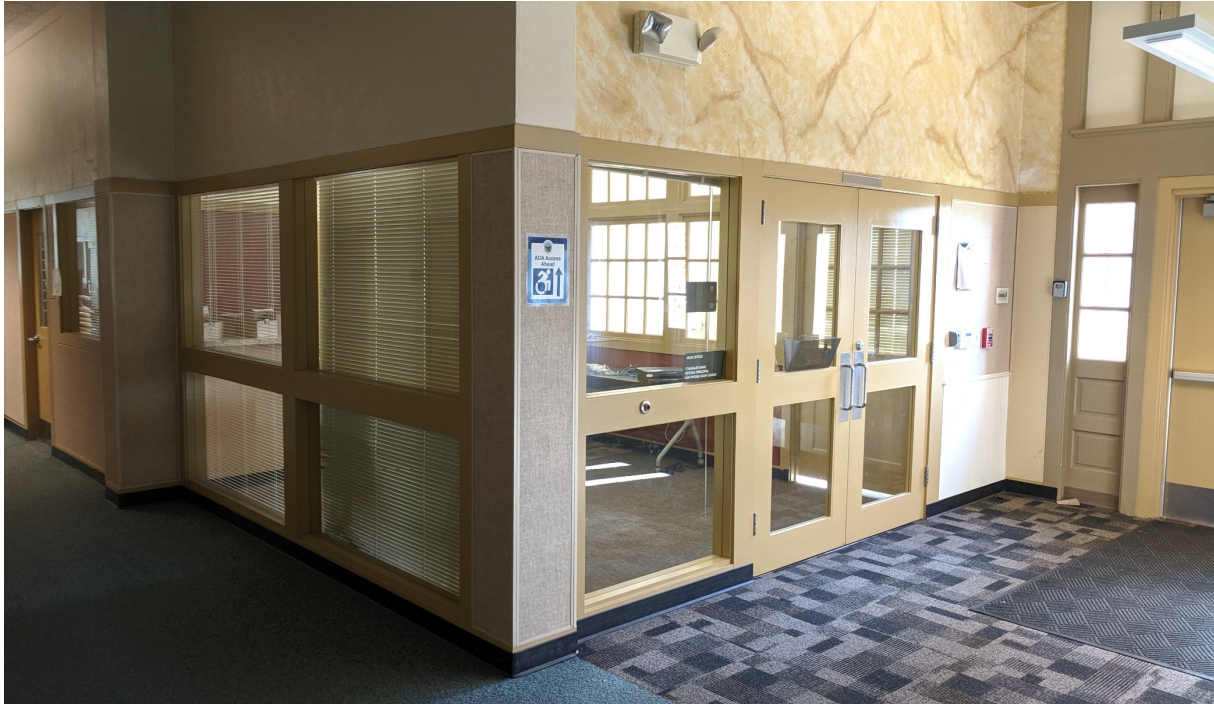
Upper-floor office space in 1936 building (ARG, October 2019).

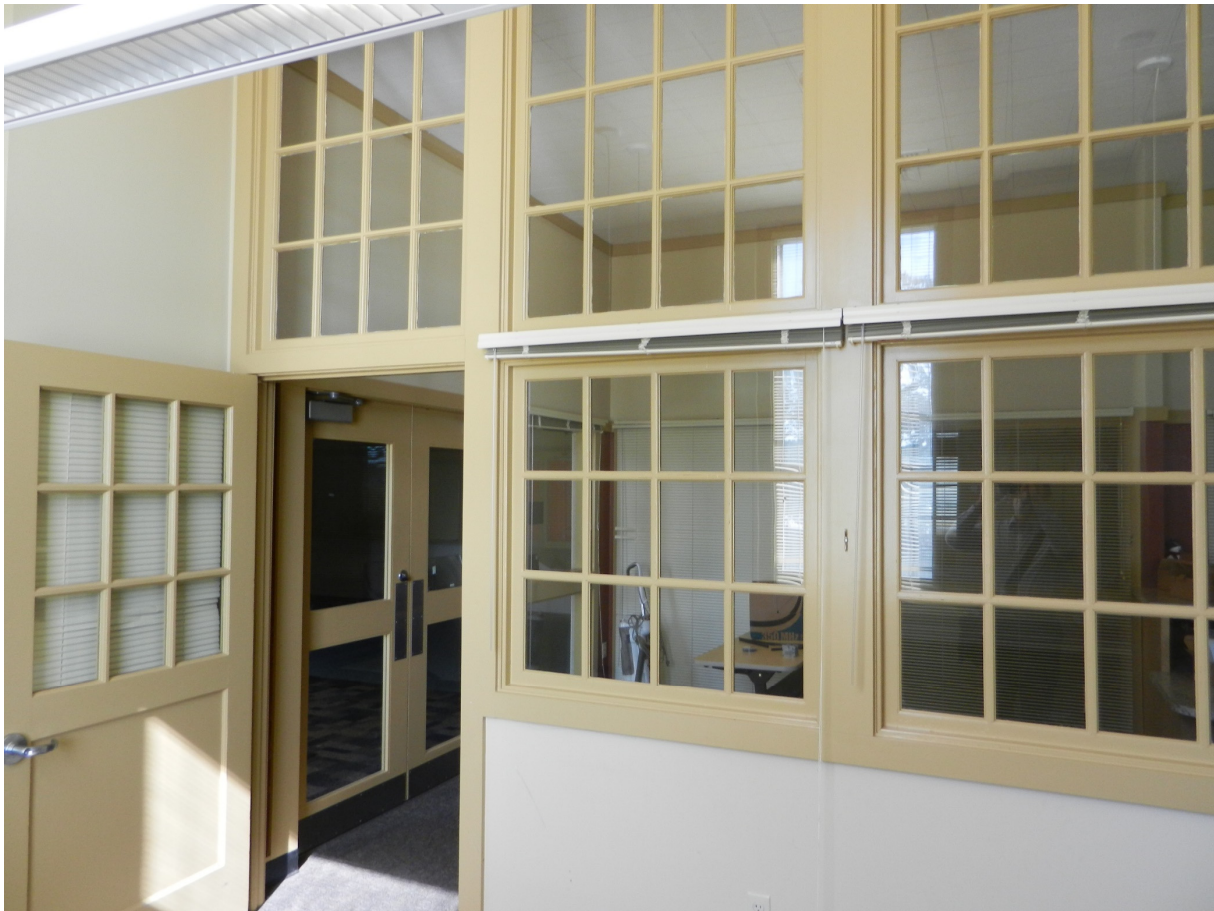
View from principal's office into additional office space in upper floor of 1936 building (ARG, October 2019).

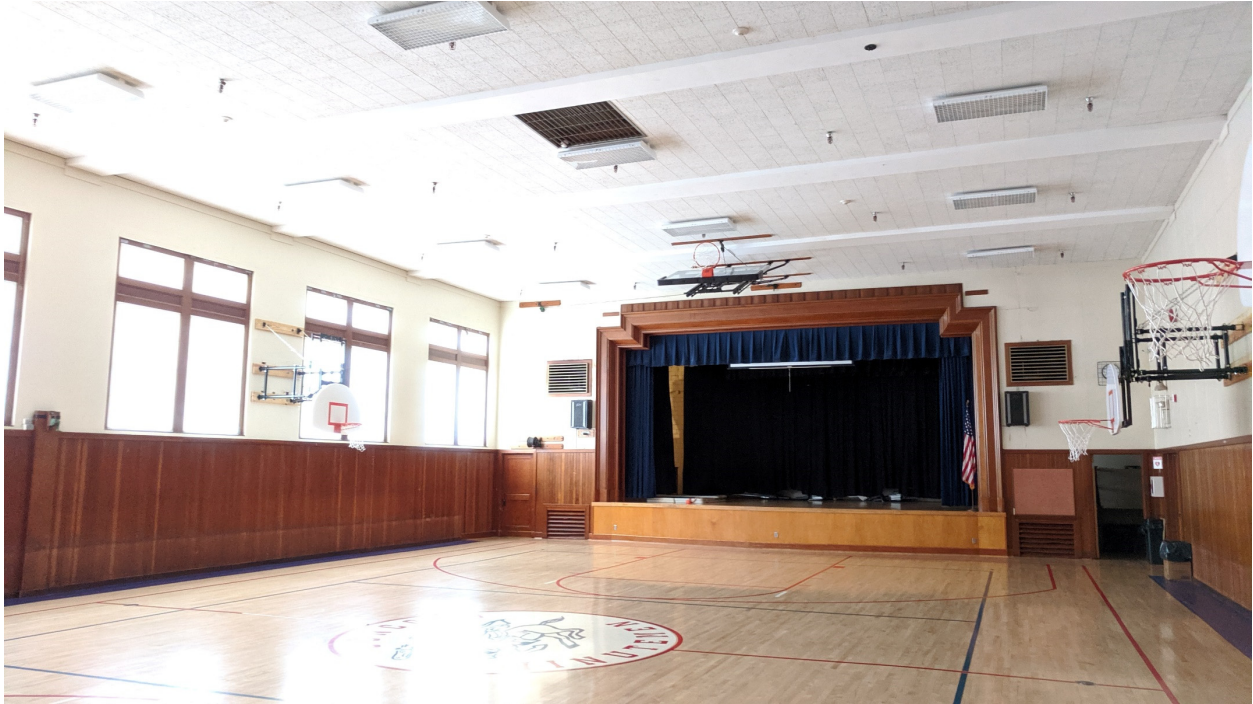
Representative view of wainscot and molding in gymnasium/auditorium in upper floor of 1936 building (ARG, October 2019).

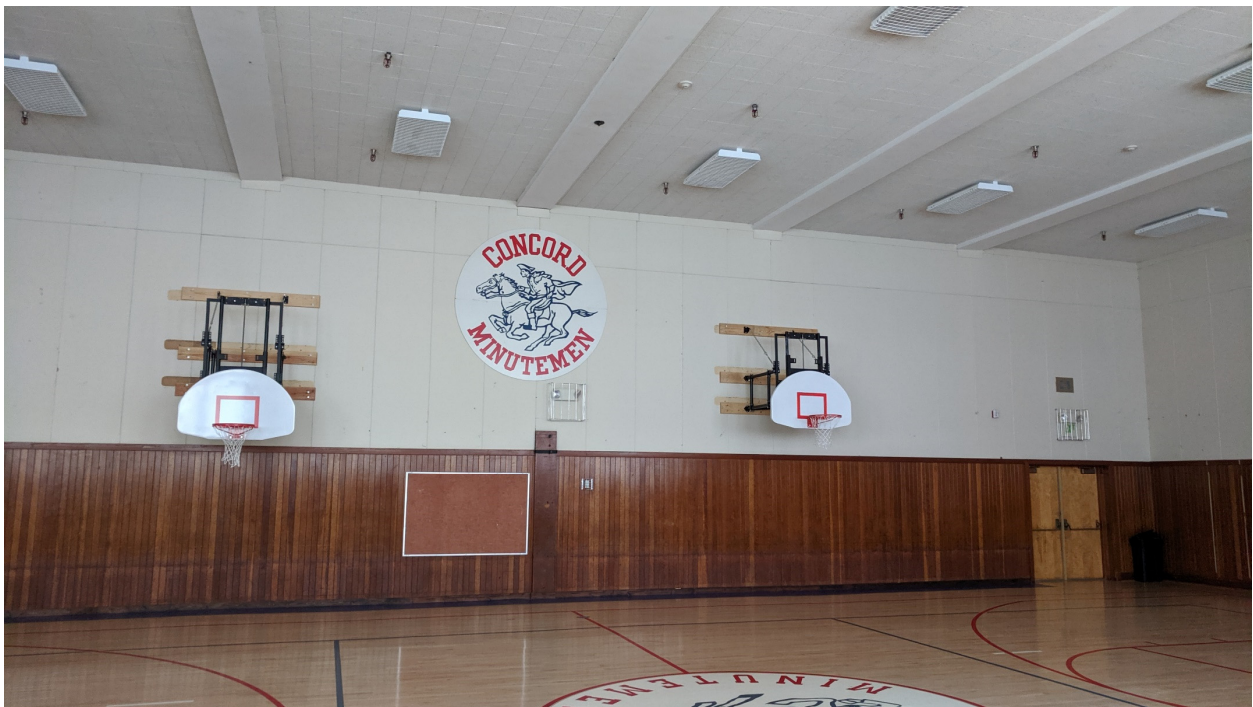
Representative view of wainscot in gymnasium/auditorium in upper floor of 1936 building (ARG, October 2019).

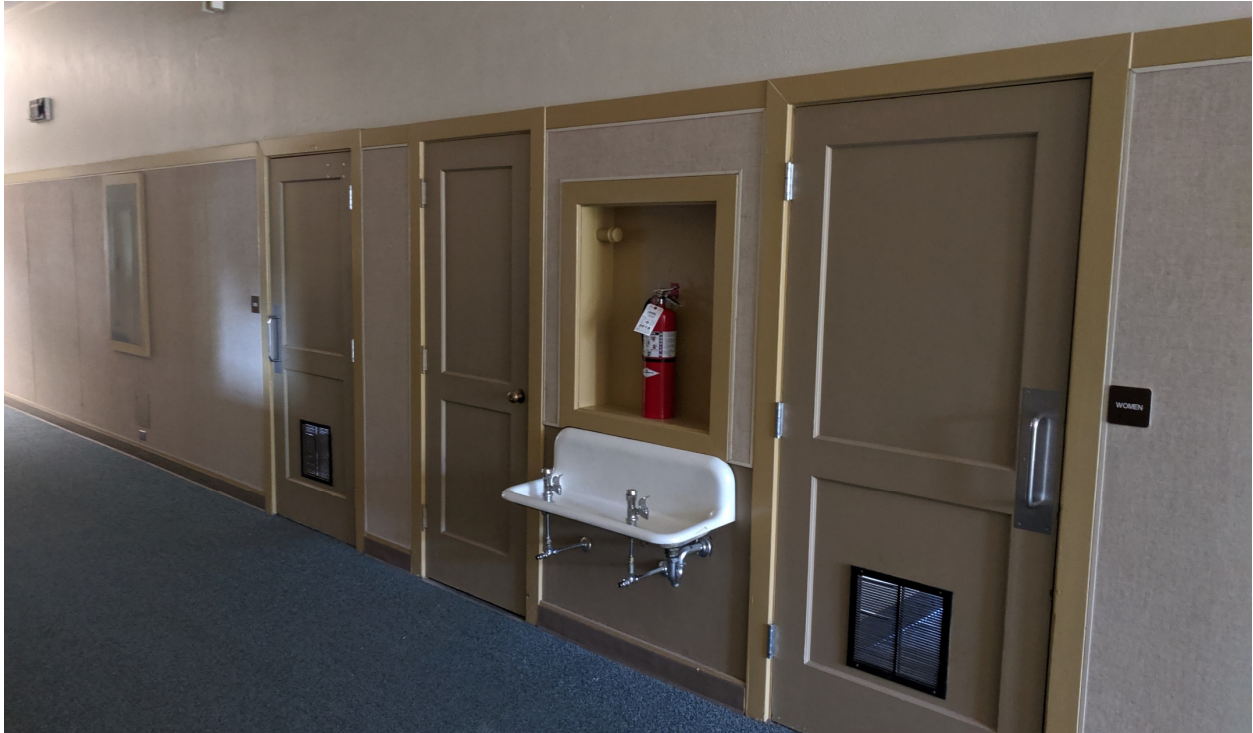
Representative view of paneled wood doors and drinking fountain in upper-floor central corridor in 1936 building (ARG, October 2019).

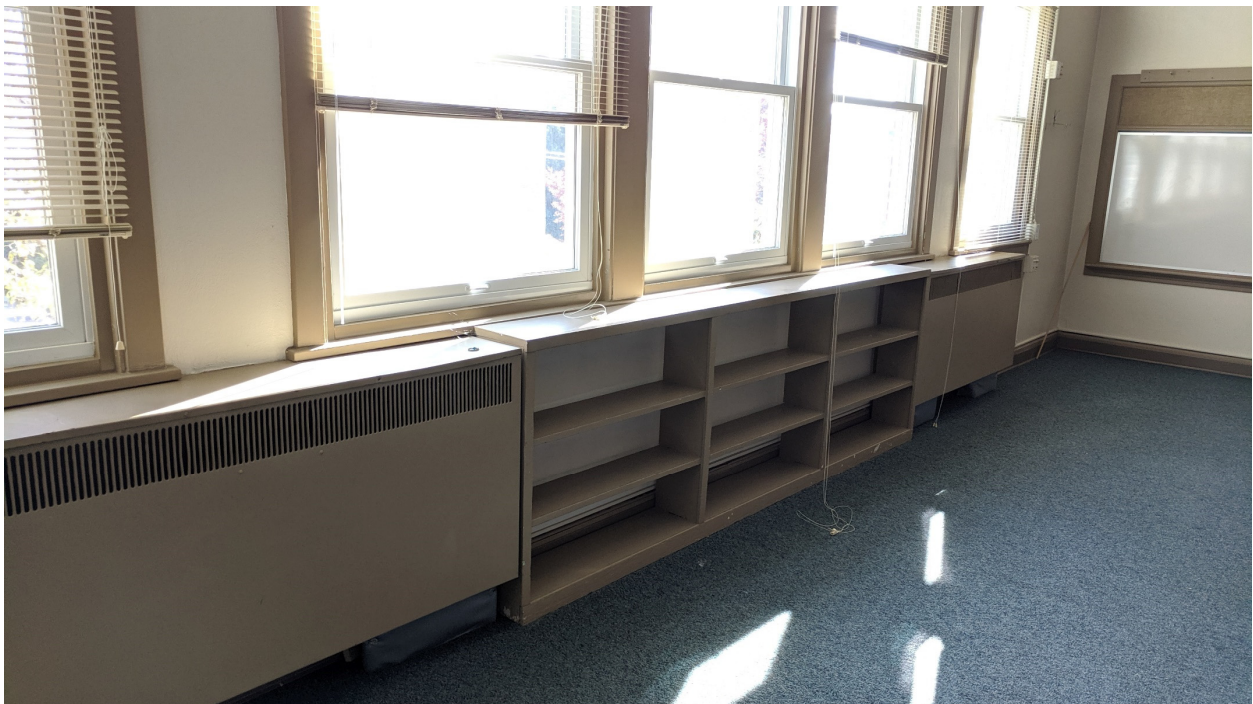
Representative view of built-ins in upper-floor classroom in 1936 building (ARG, October 2019).

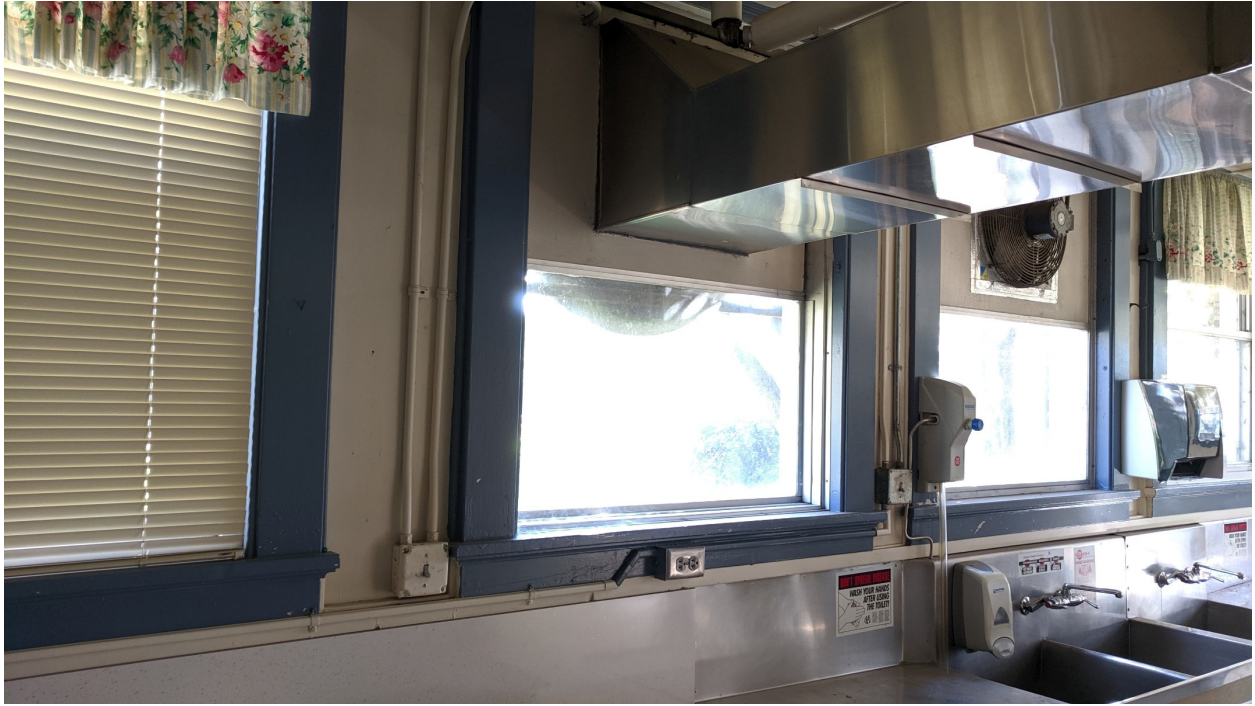
Window casings in kitchen in basement of 1936 building (ARG, October 2019).

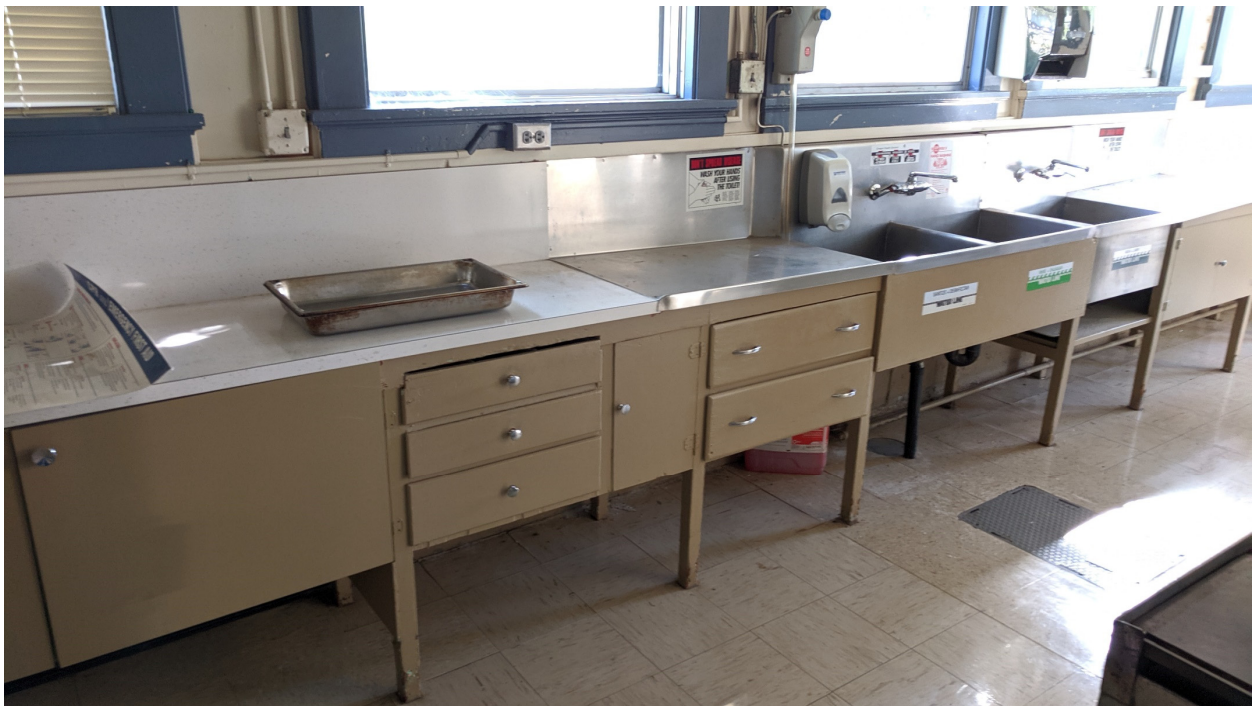
Counters and food prep area in kitchen in basement of 1936 building (ARG, October 2019).
