Architectural
Resources Group

Concord School Historic Resource Assessment

January 2020

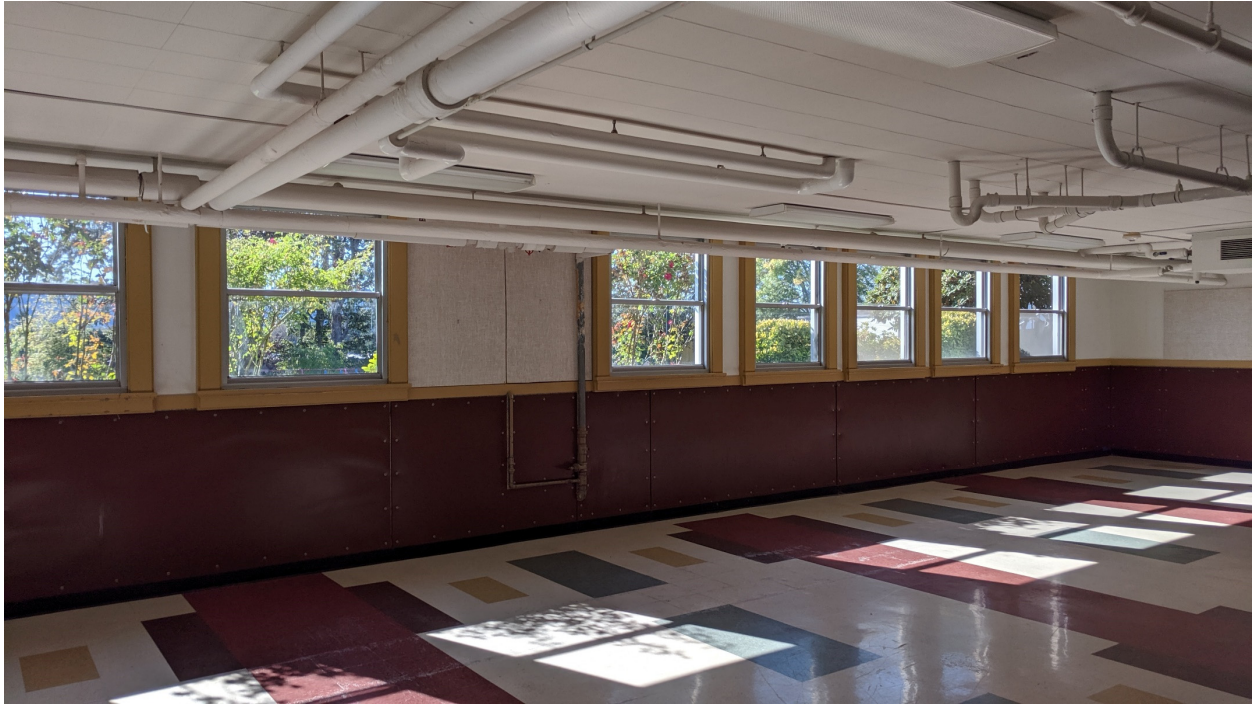
Cafeteria in basement of 1936 building (ARG, October 2019).

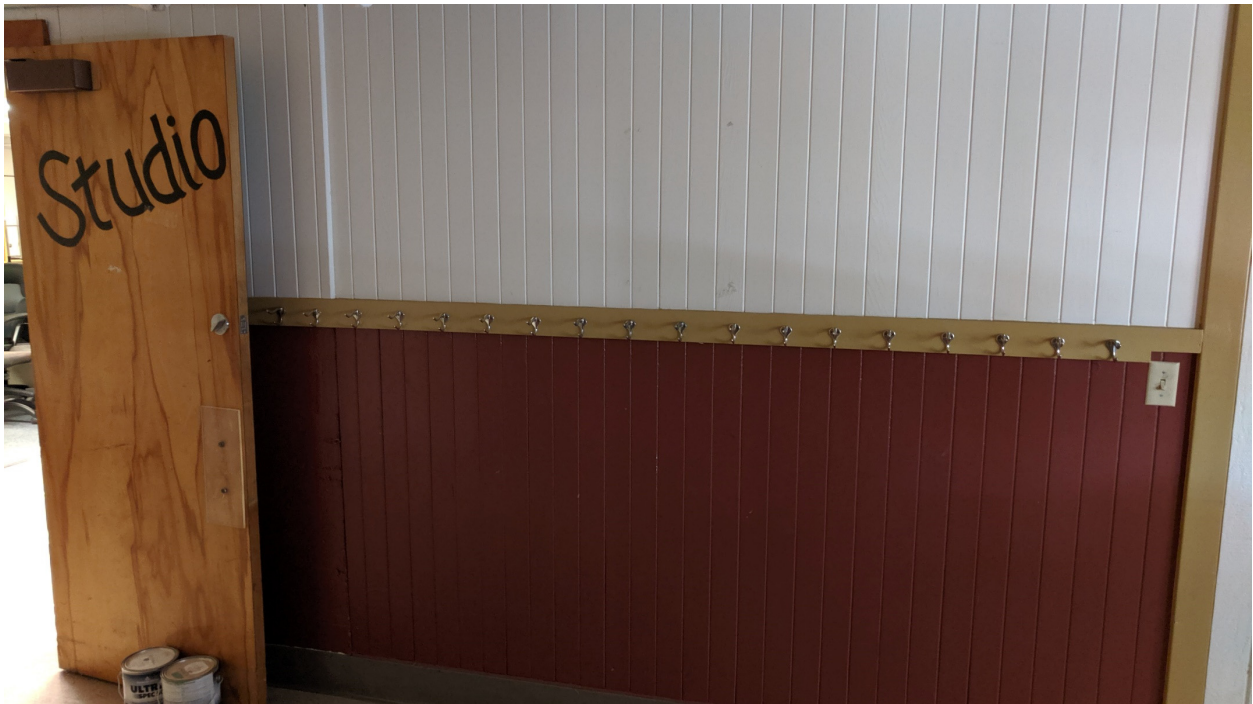
Representative view of beadboard wall paneling in basement of 1936 building (ARG, October 2019).

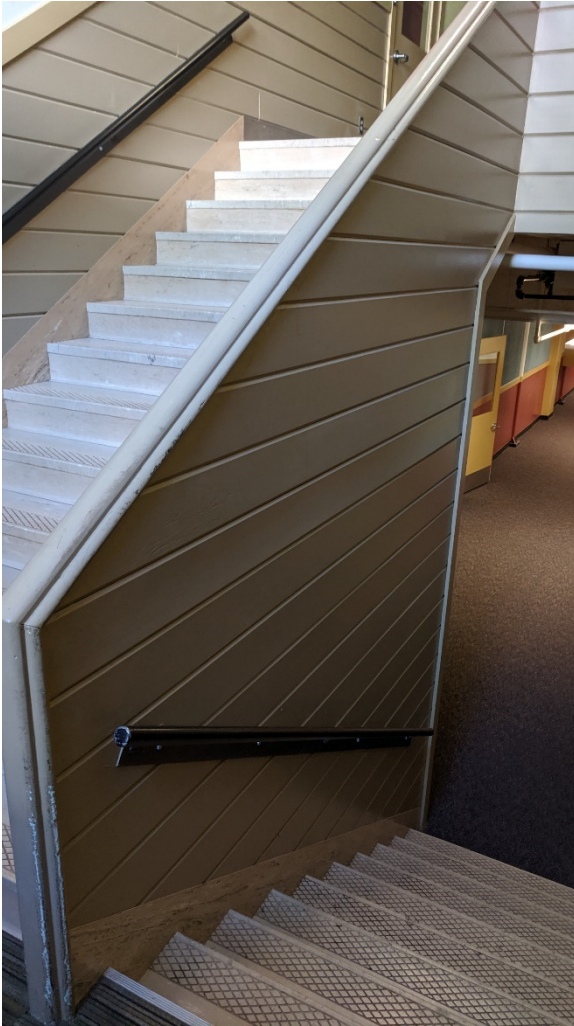
View of stair at 1948 addition (ARG, October 2019).

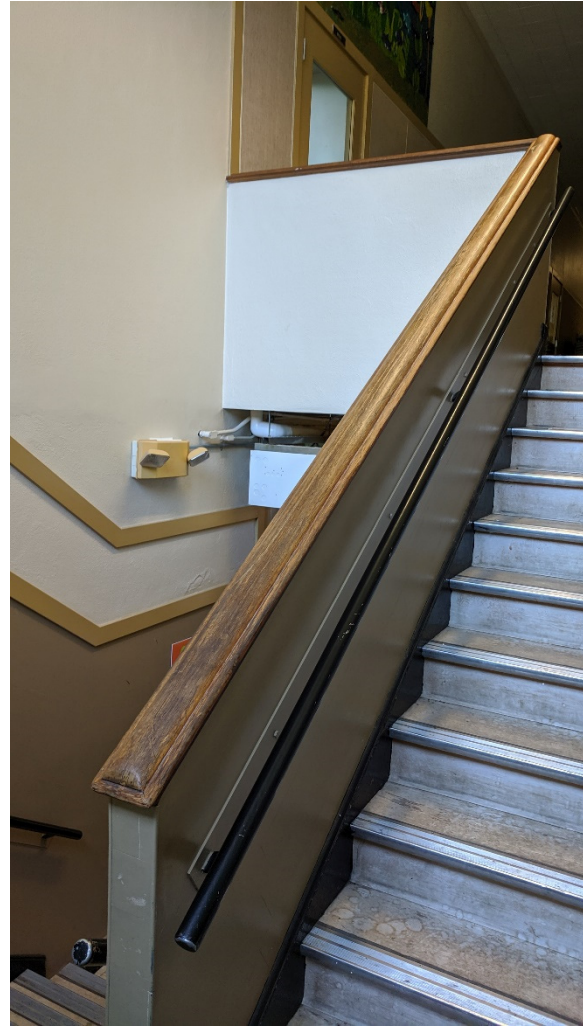
View of stair in 1936 building (ARG, October 2019).

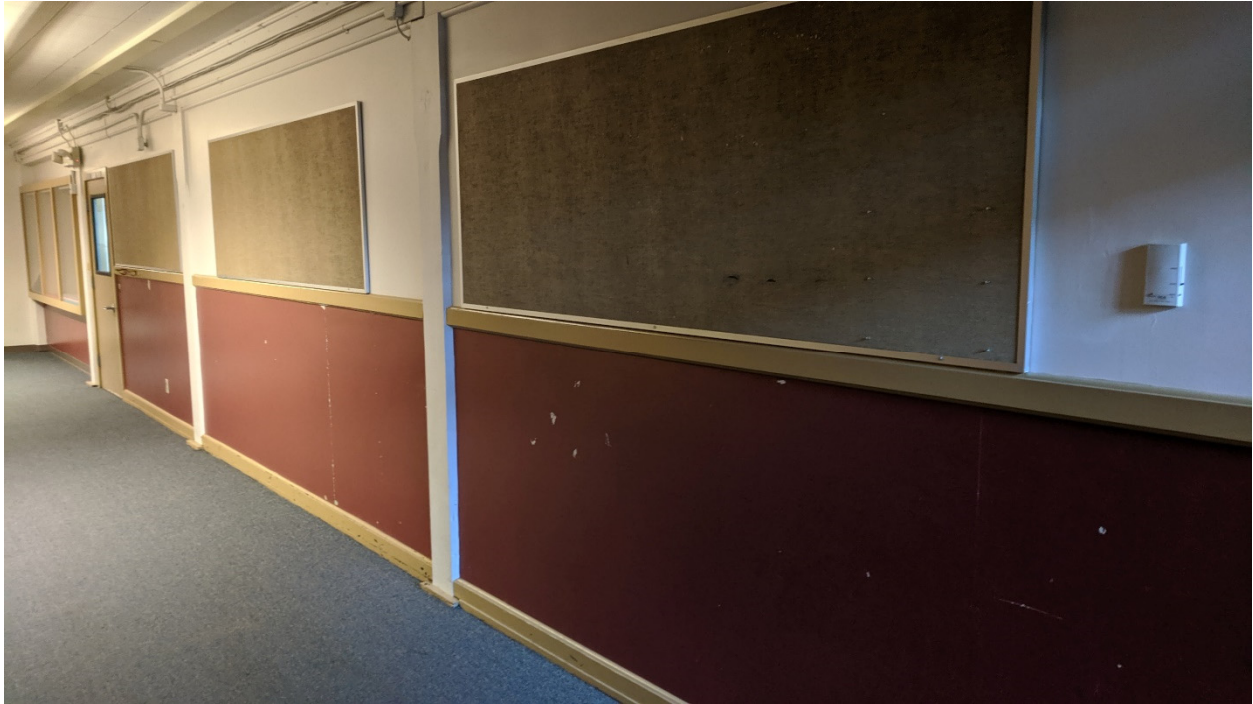
Representative view of corridor in 1948 addition (ARG, October 2019).

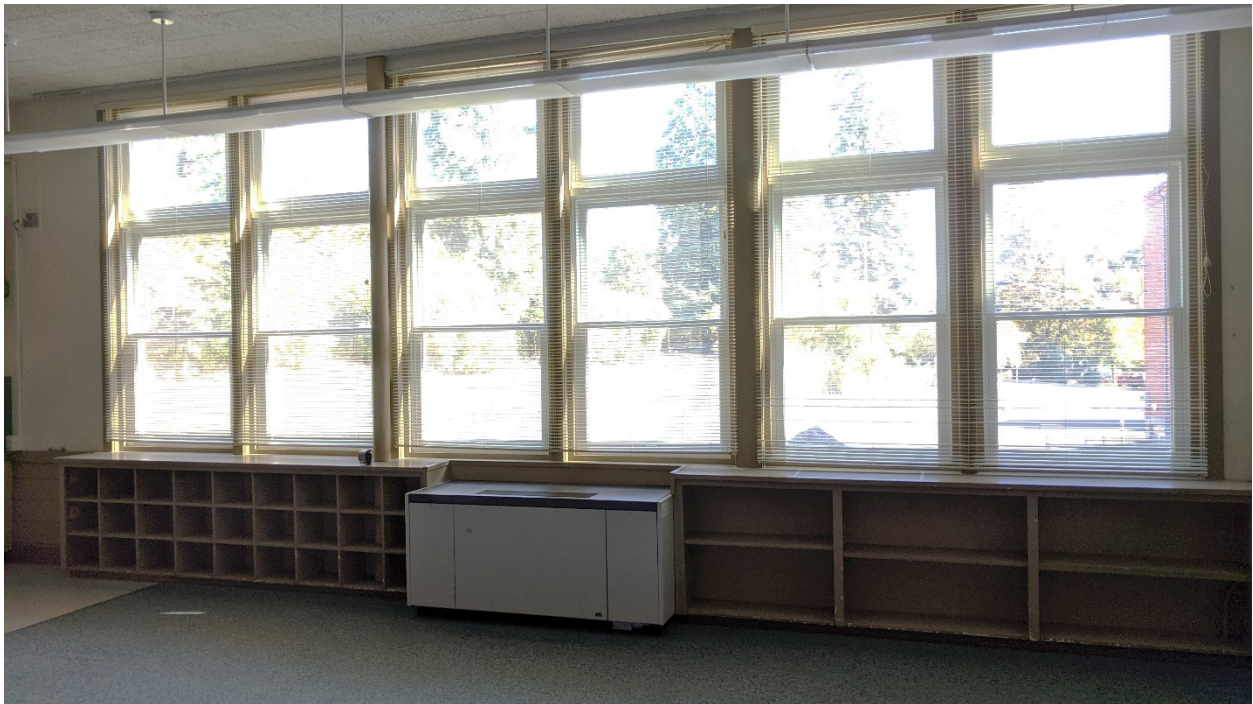
Representative view of built-ins in upper-floor classroom in 1948 addition (ARG, October 2019).

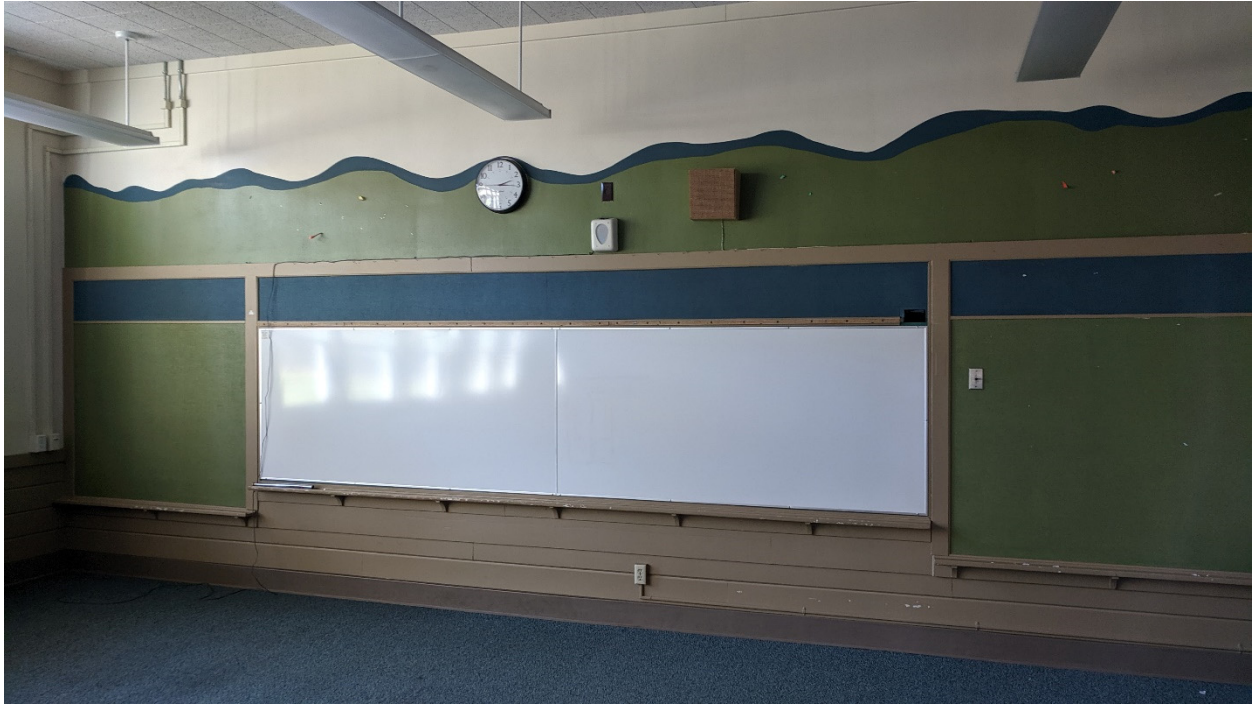
Representative view of chalkboard surrounds in classroom in 1948 addition (ARG, October 2019).

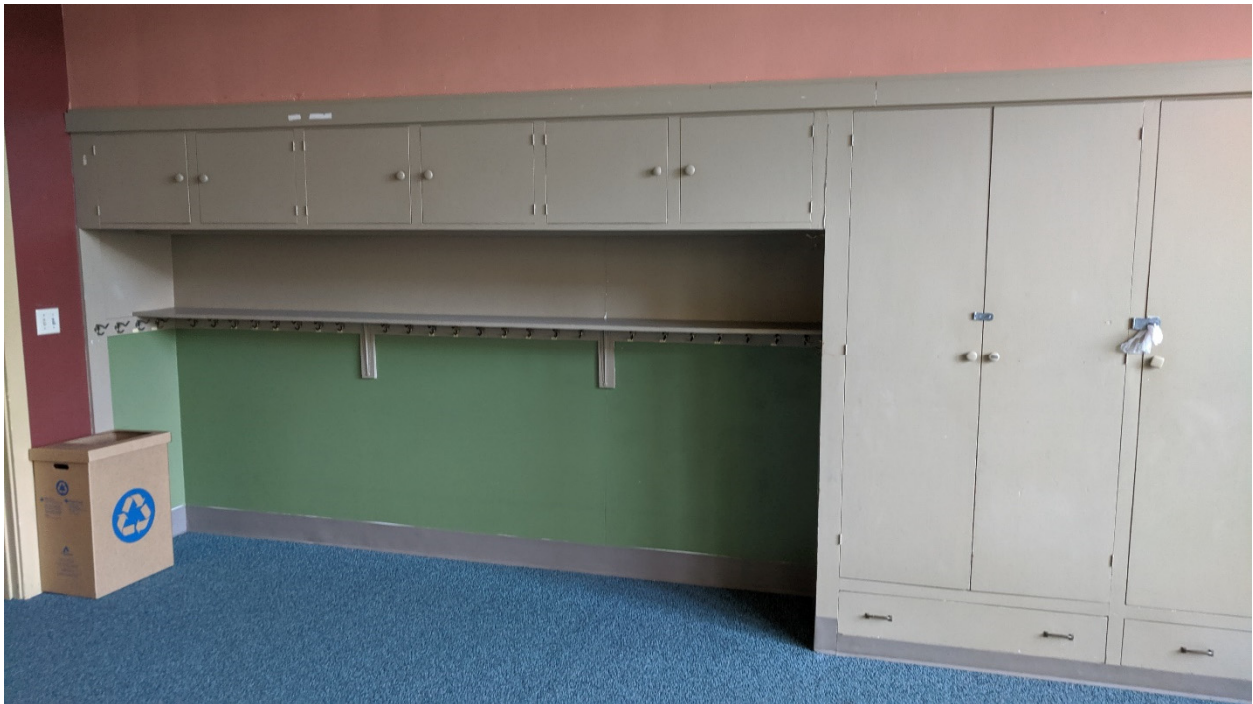
Representative view of built-ins in classroom in 1948 addition (ARG, October 2019).
