**RENTAL ASSISTANCE DEMONSTRATION
PHYSICAL CONDITION ASSESSMENT (RPCA)
HILLSIDE MANOR
2889 SE HILLSIDE STREET
MILWAUKIE, OREGON 97222**

**D3G PROJECT NUMBER:
2018-0031**

**FINAL REPORT ISSUE DATE:
APRIL 13, 2018**

**INSPECTION DATE:
JANUARY 23, 2018**

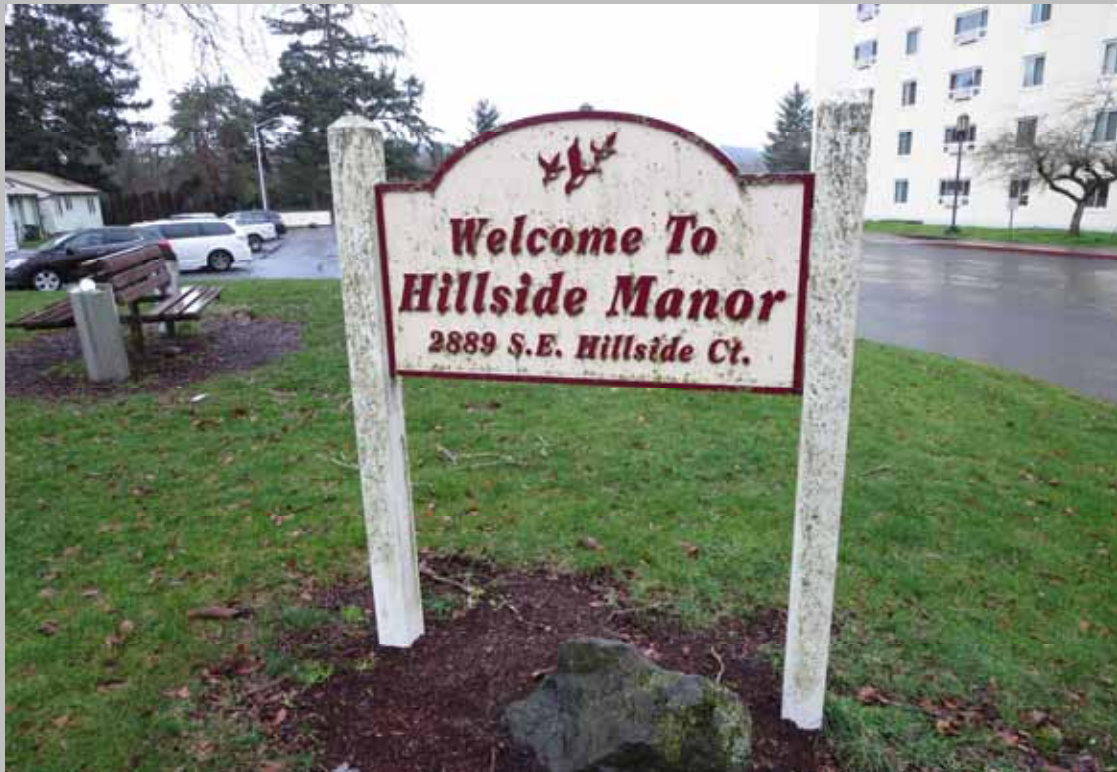
PHOTO #1

Property identification sign

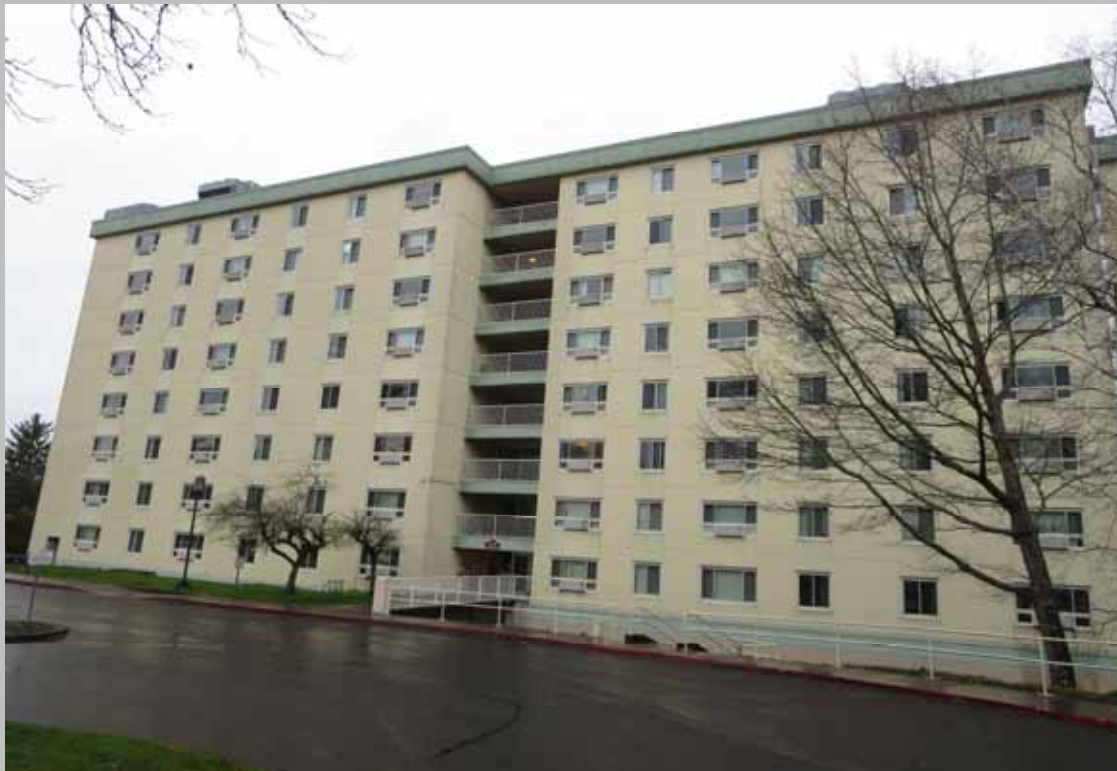
PHOTO #2

Building front elevation

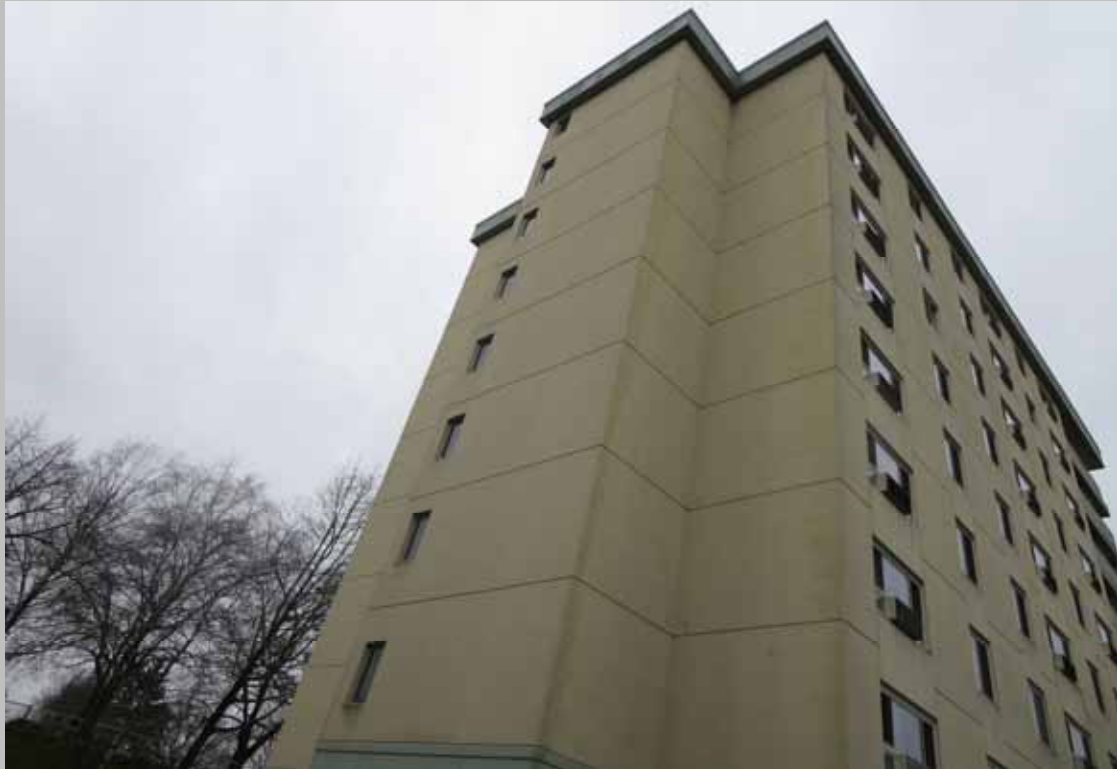
PHOTO #3

Building side elevation

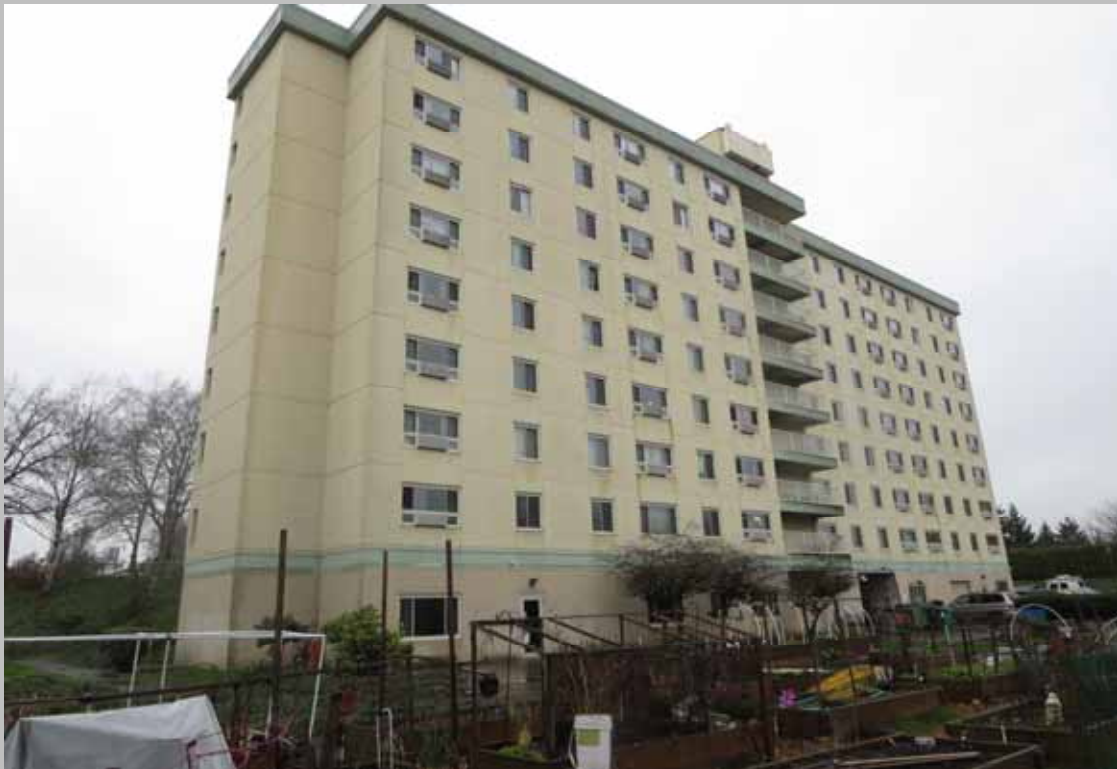
PHOTO #4

Building rear elevation

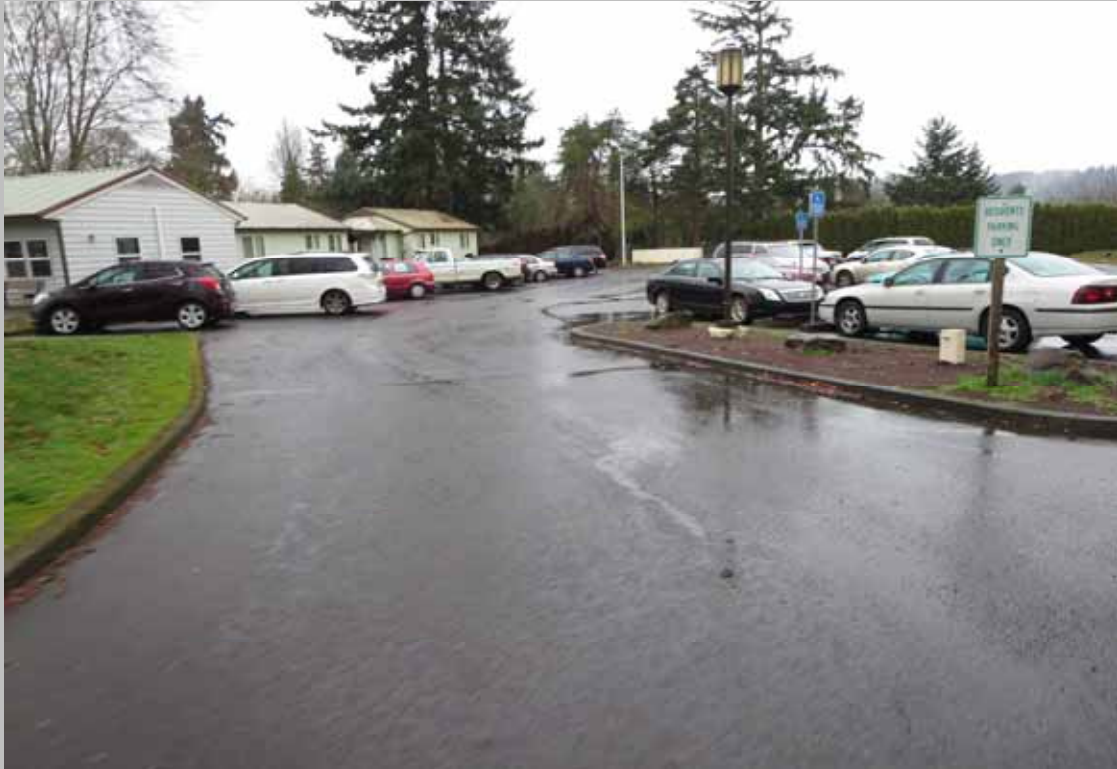
PHOTO #5

Parking area

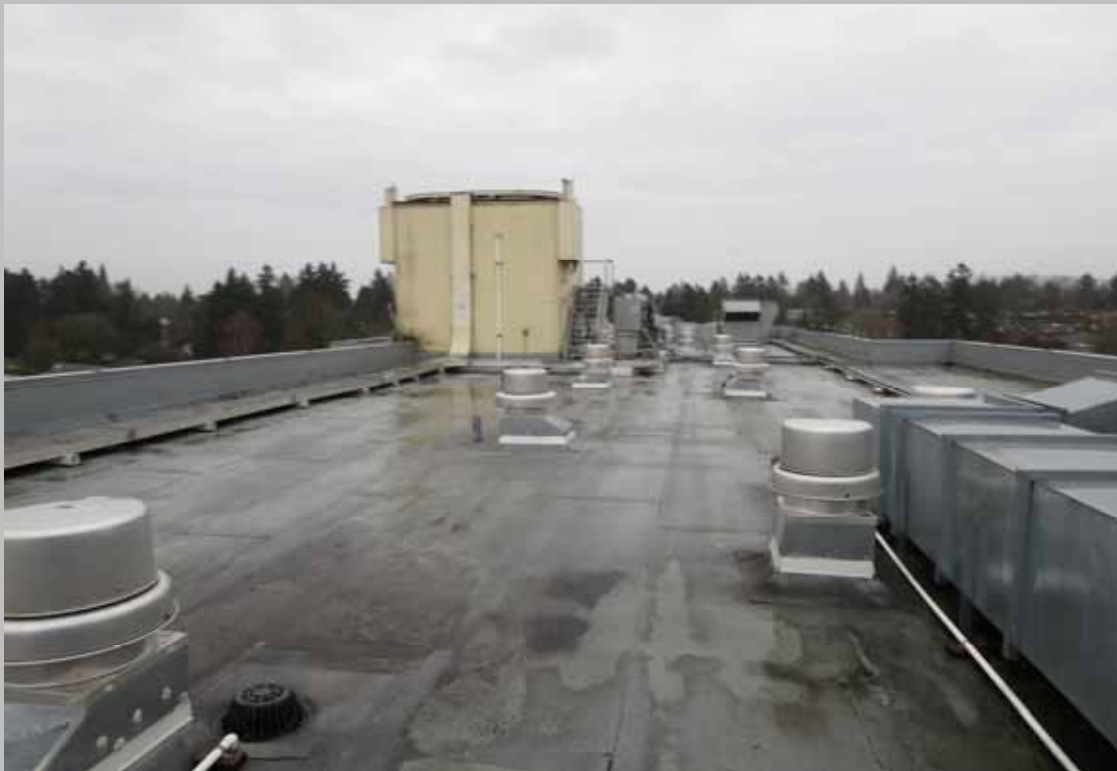
PHOTO #6

Roof section

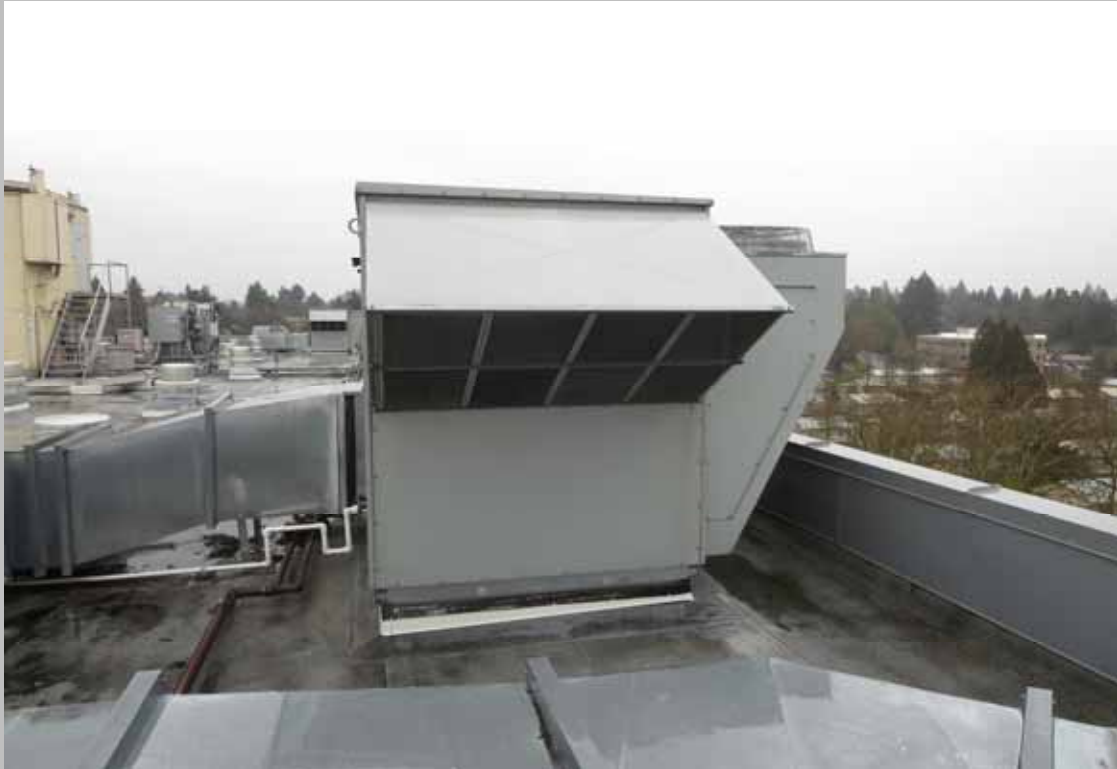
PHOTO #7

HVAC package unit

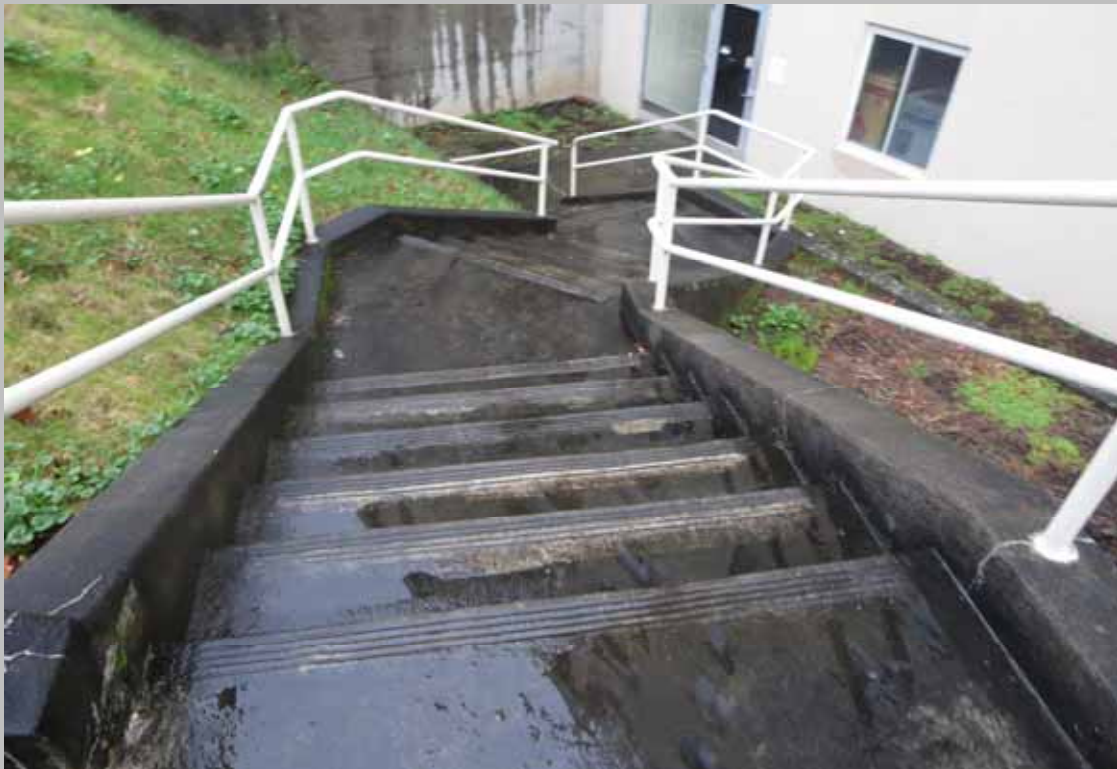
PHOTO #8

Exterior stair

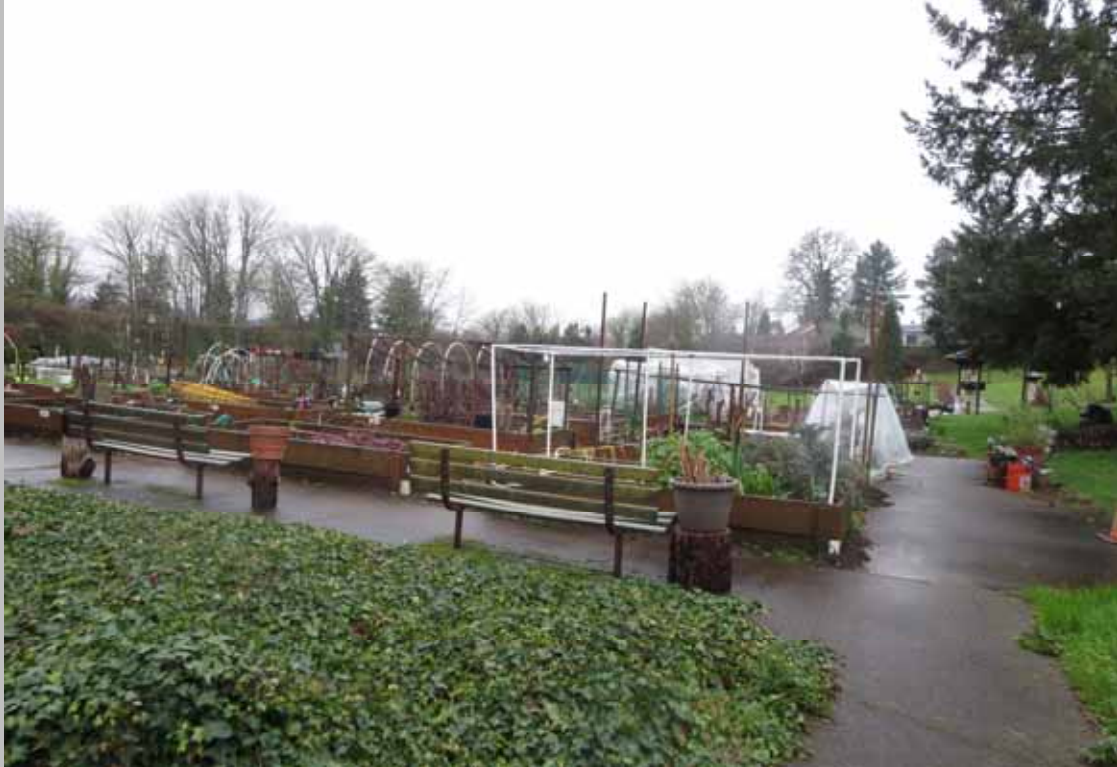
PHOTO #9

Community garden

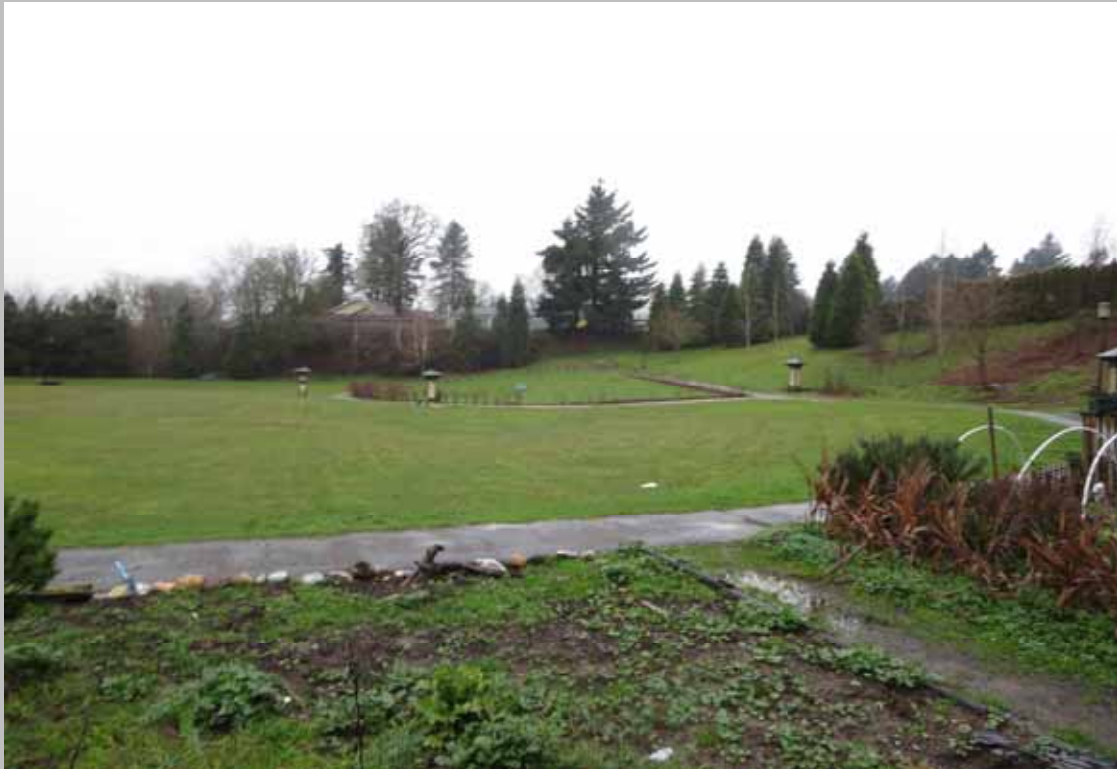
PHOTO #10

Walking path and lawn

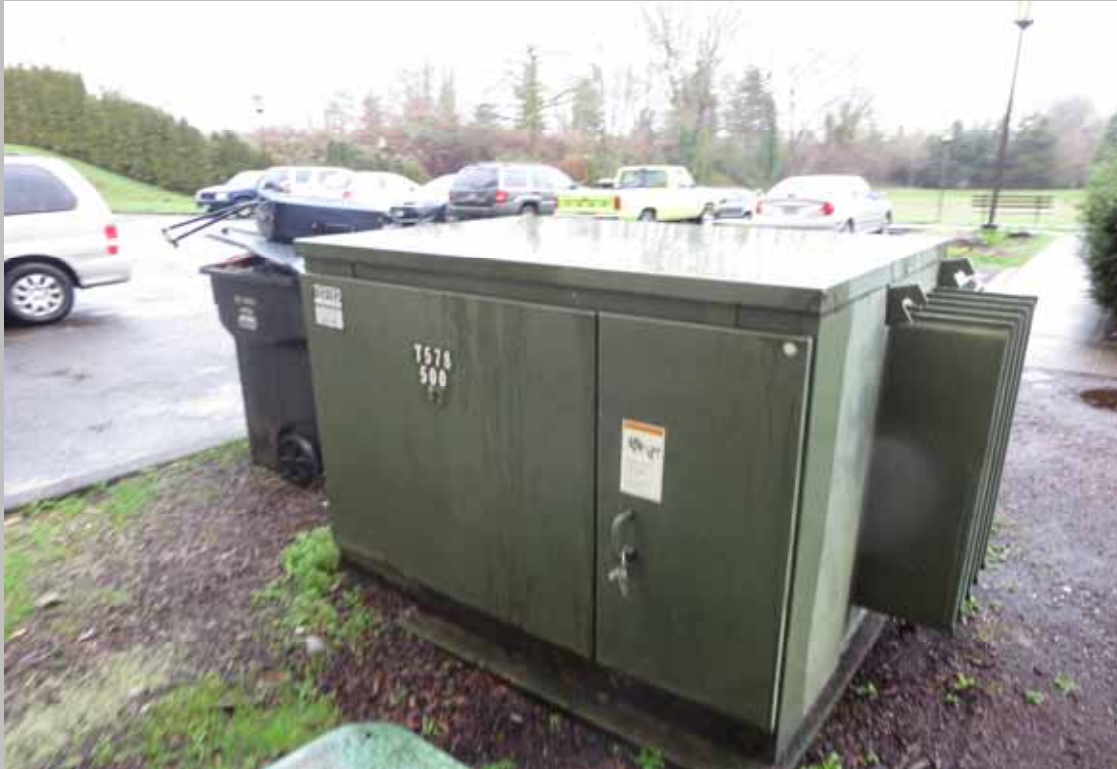
PHOTO #11

Electrical transformer

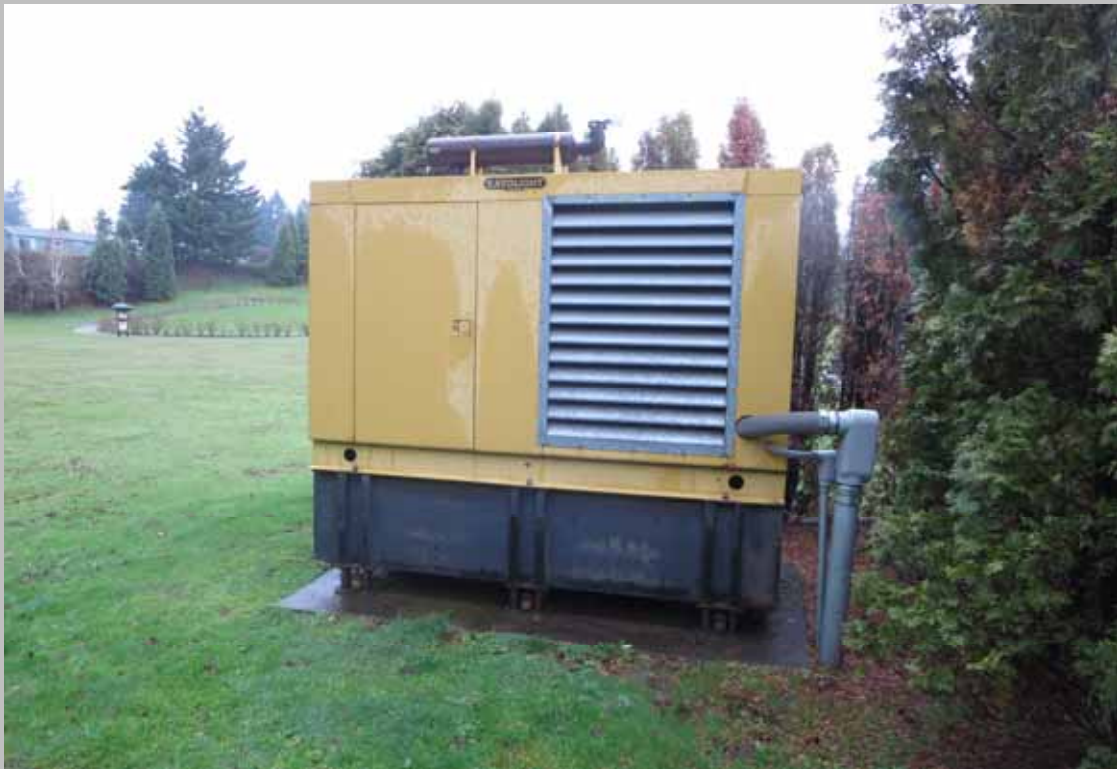
PHOTO #12

Emergency generator

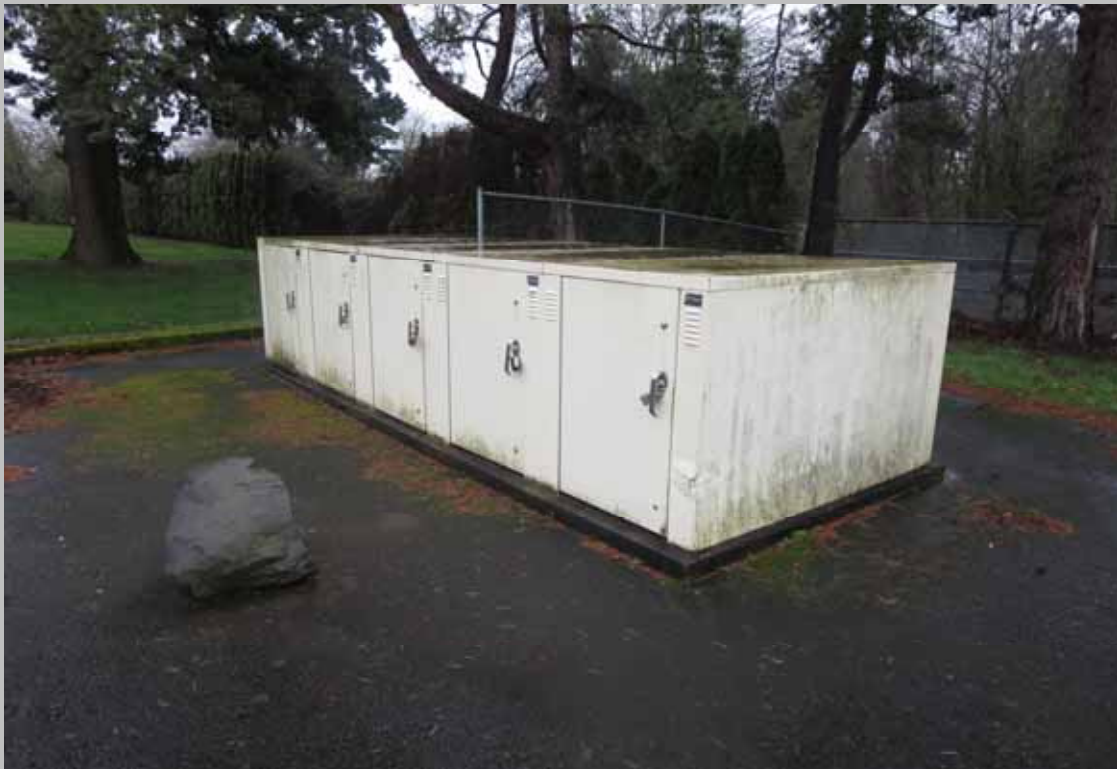
PHOTO #14

Bicycle storage

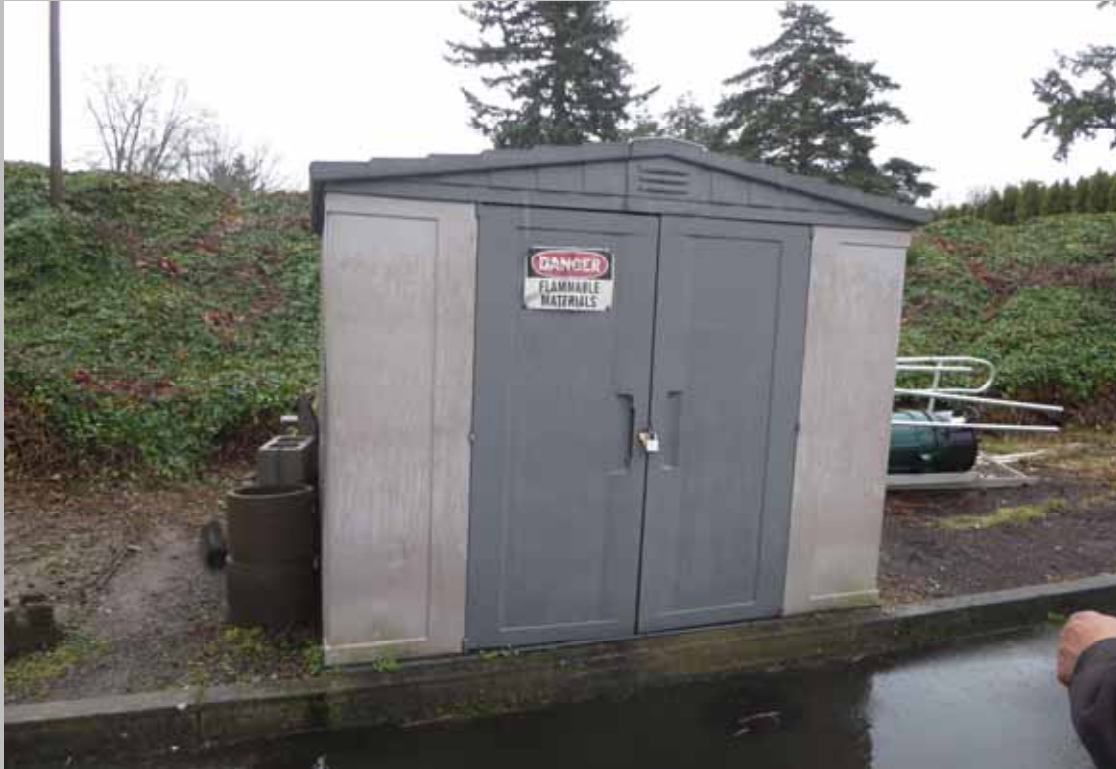
PHOTO #15

Shed

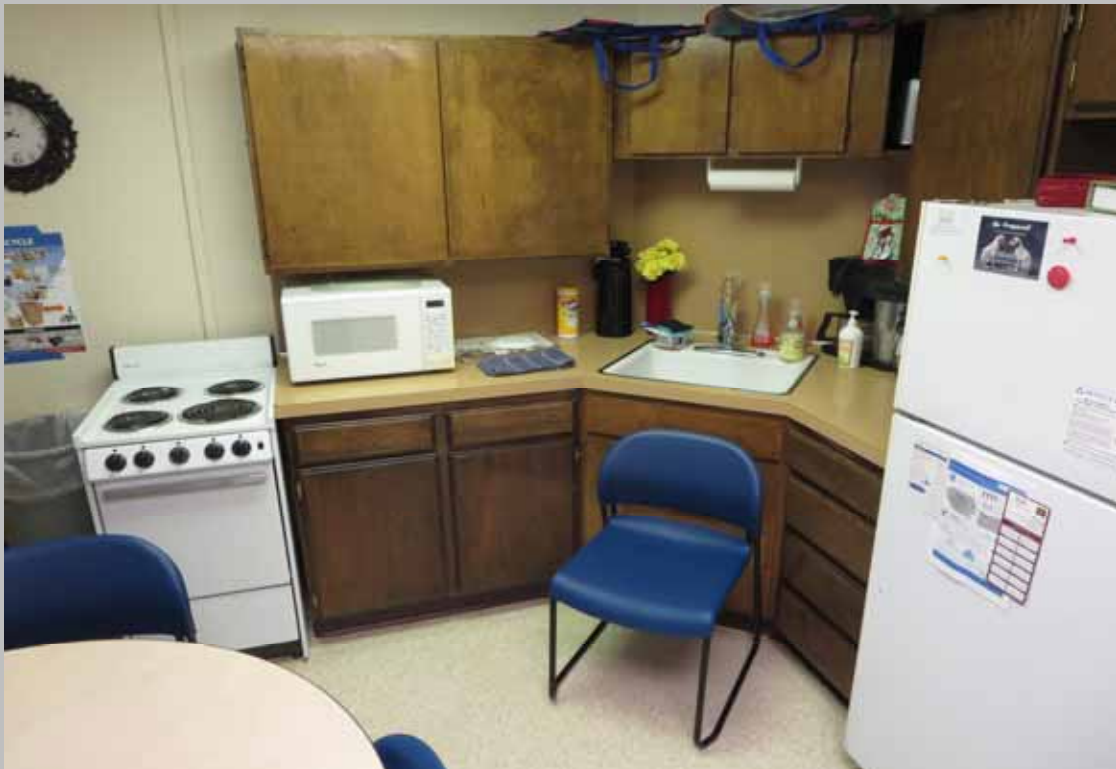
PHOTO #16

Staff kitchen

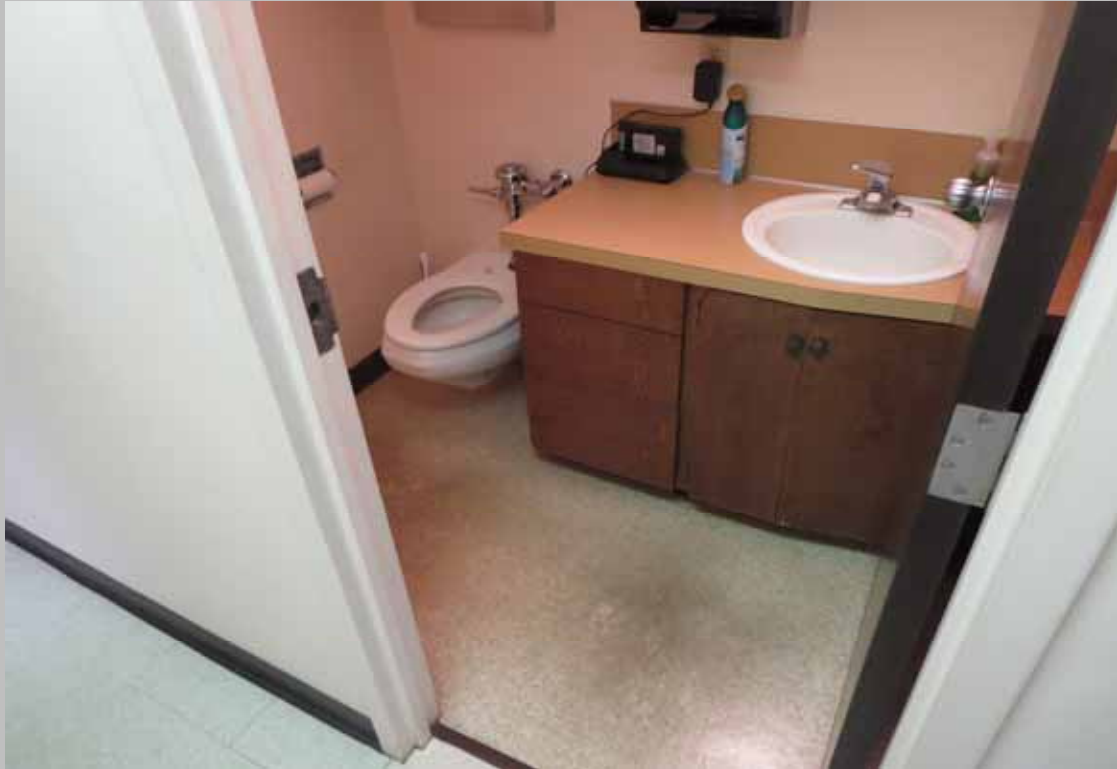
PHOTO #17

Staff restroom

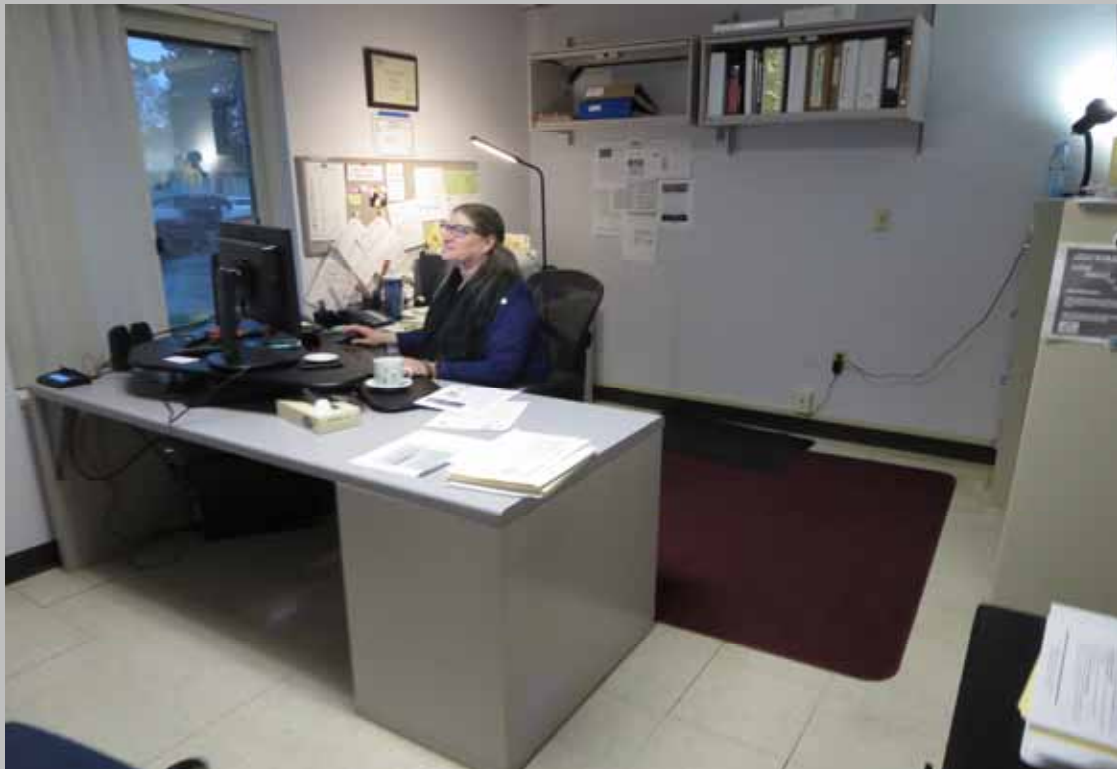
PHOTO #18

Leasing office

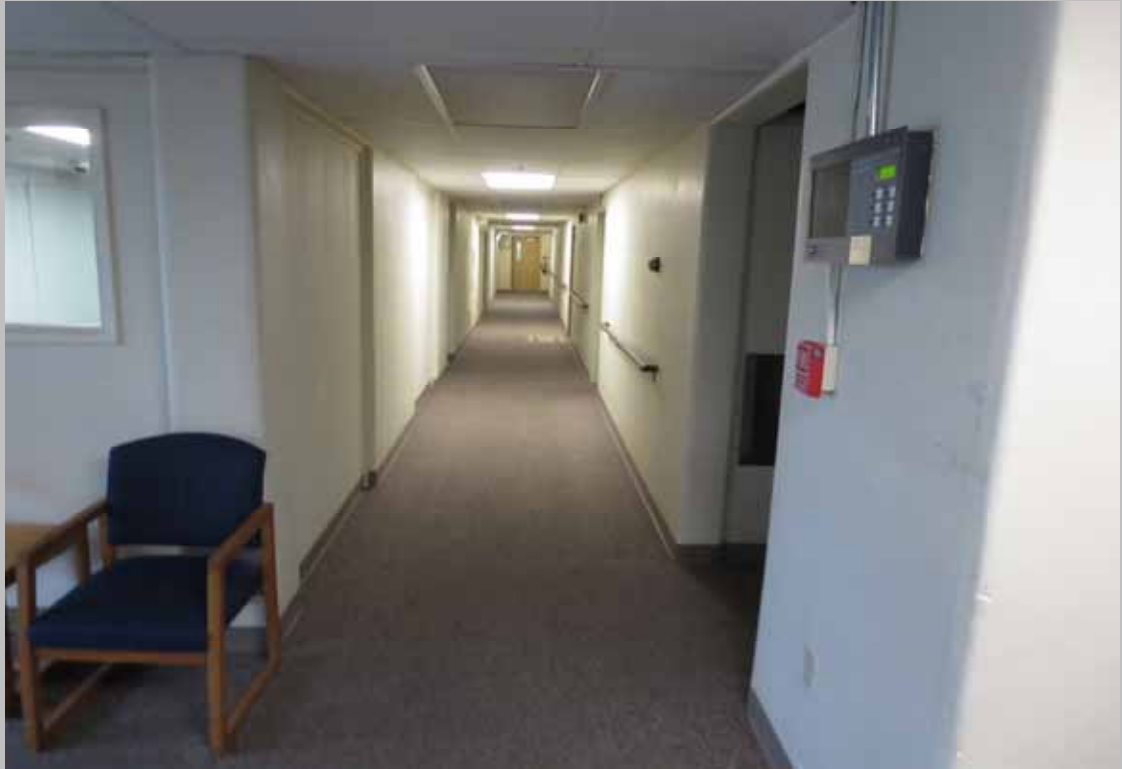
PHOTO #19

Common hallway

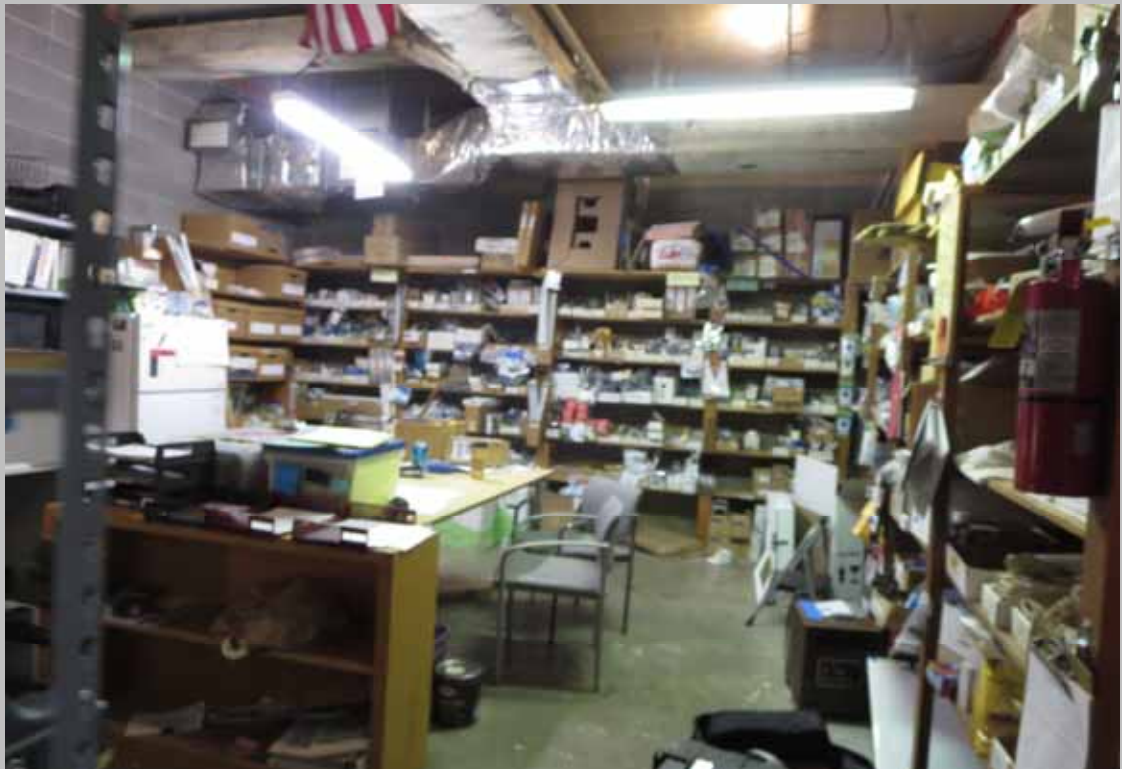
PHOTO #20

Maintenance room

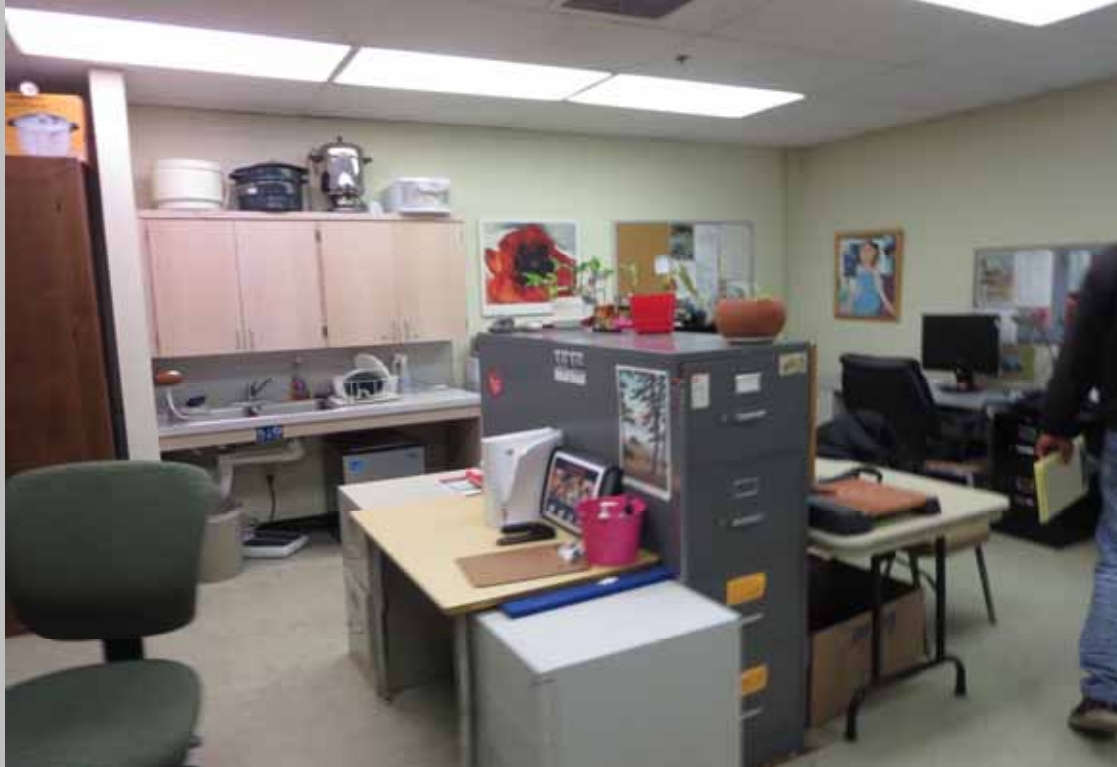
PHOTO #23

Resident services office

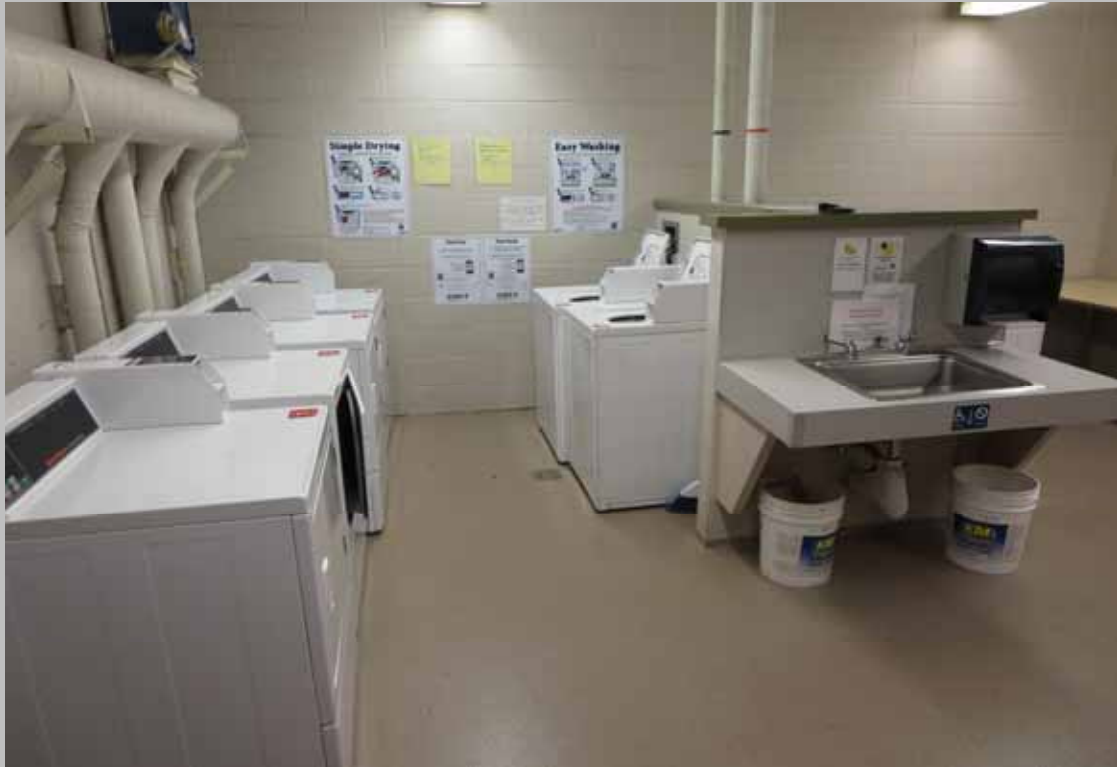
PHOTO #24

Common laundry

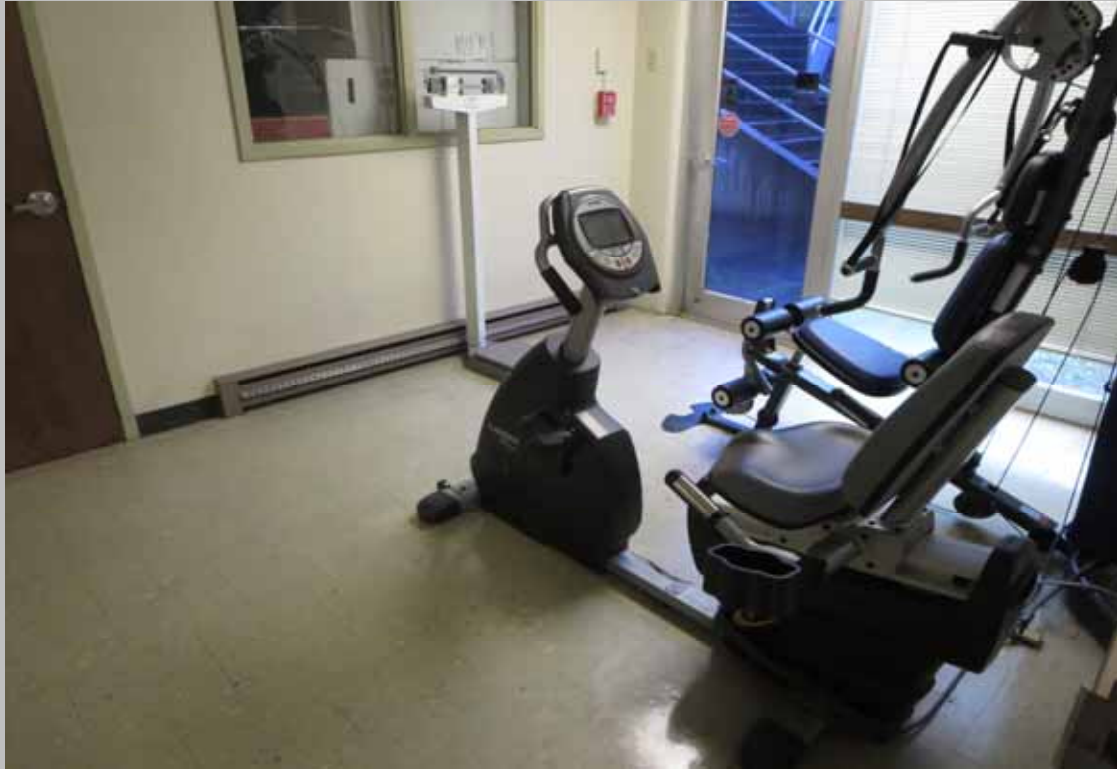
PHOTO #27

Fitness center

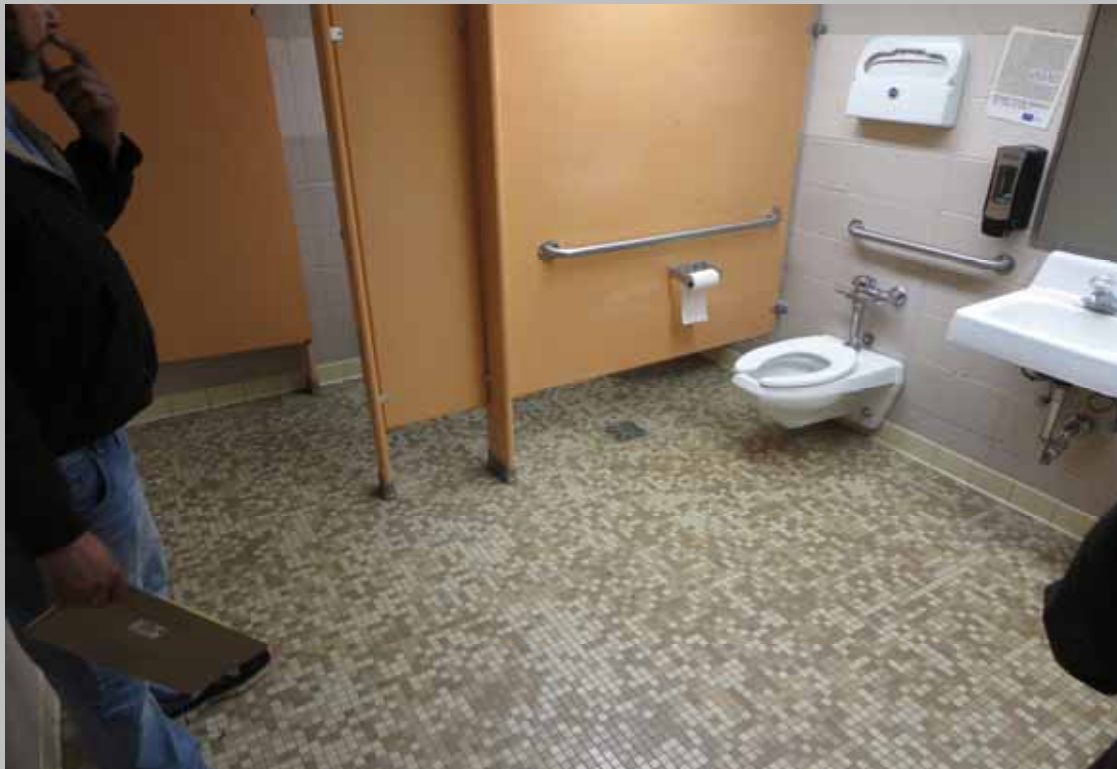
PHOTO #28

Common restroom

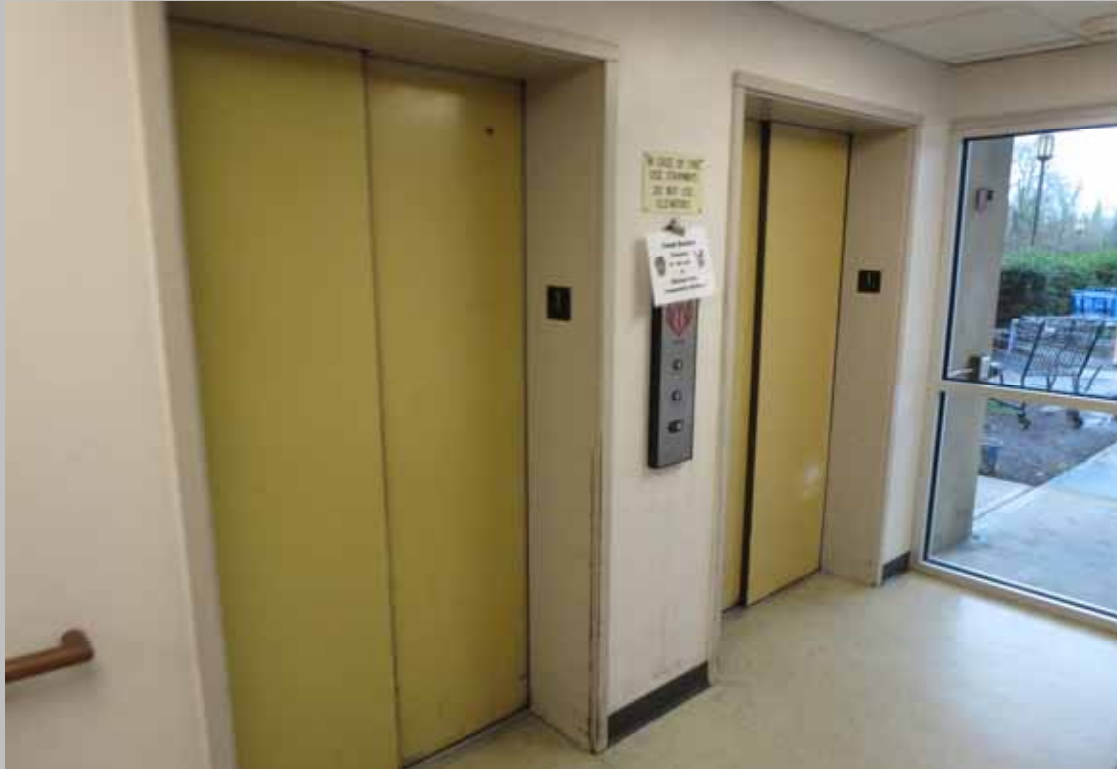
PHOTO #29

Elevator lobby

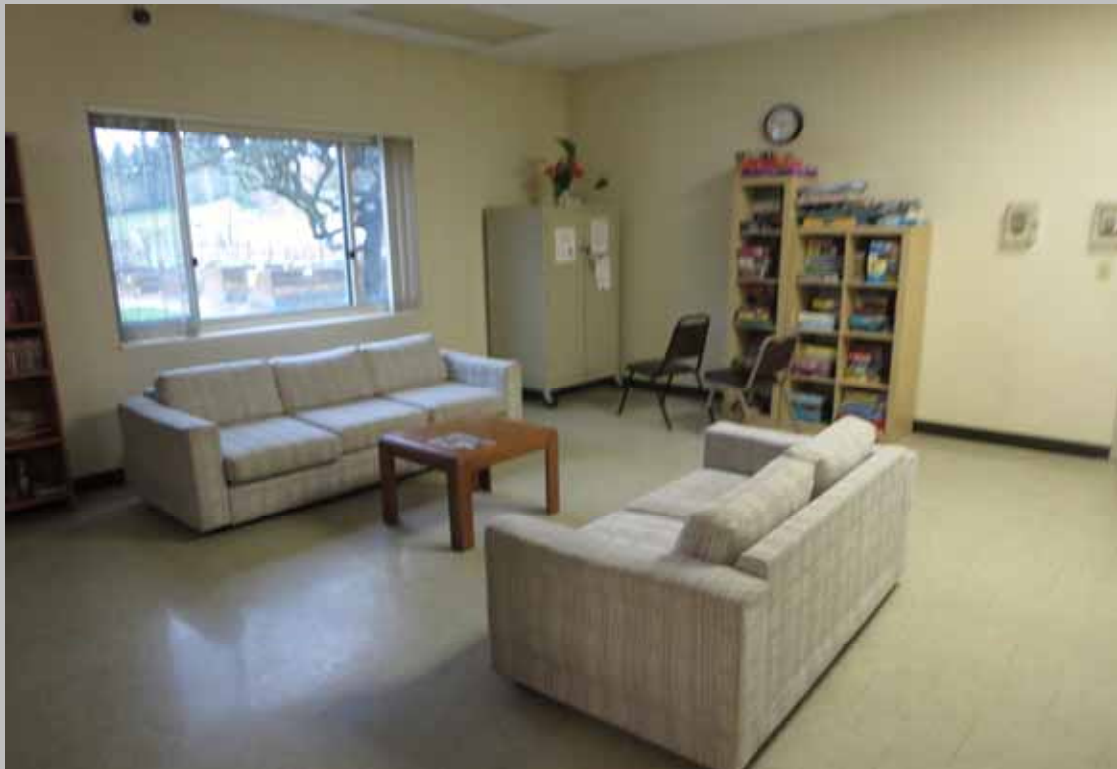
PHOTO #30

Library

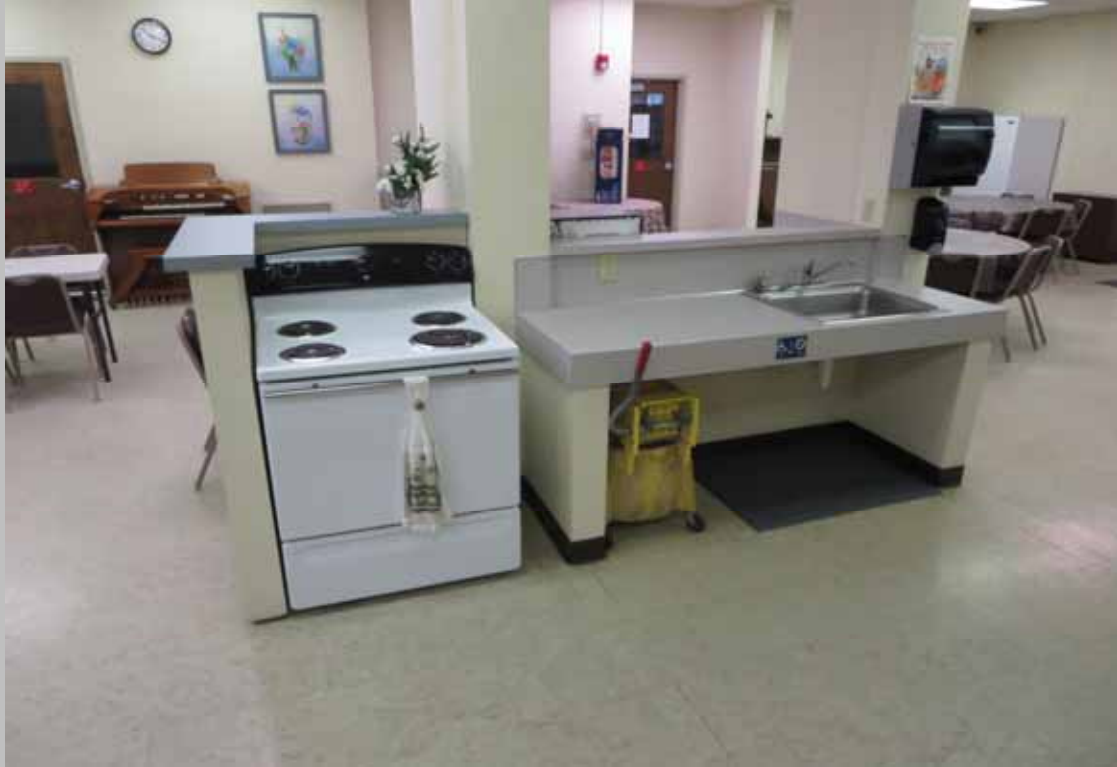
PHOTO #31

Community room

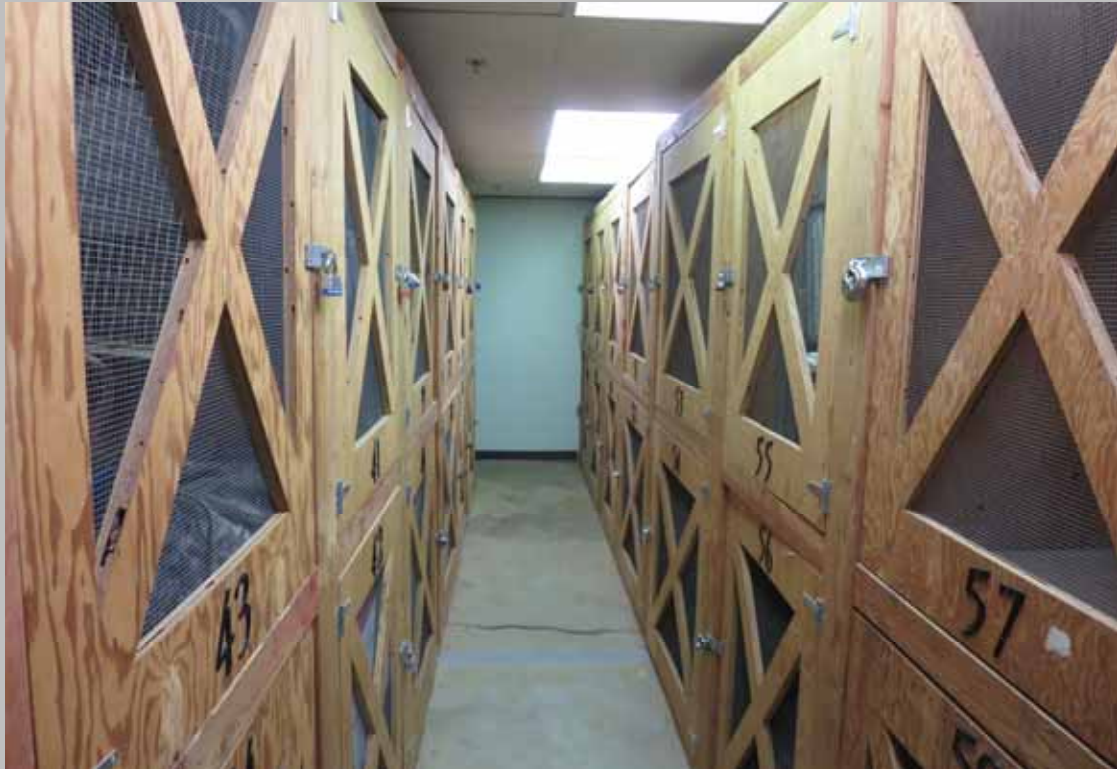
PHOTO #32

Resident storage
