**RENTAL ASSISTANCE DEMONSTRATION
PHYSICAL CONDITION ASSESSMENT (RPCA)
HILLSIDE MANOR
2889 SE HILLSIDE STREET
MILWAUKIE, OREGON 97222**

**D3G PROJECT NUMBER:
2018-0031**

**FINAL REPORT ISSUE DATE:
APRIL 13, 2018**

**INSPECTION DATE:
JANUARY 23, 2018**

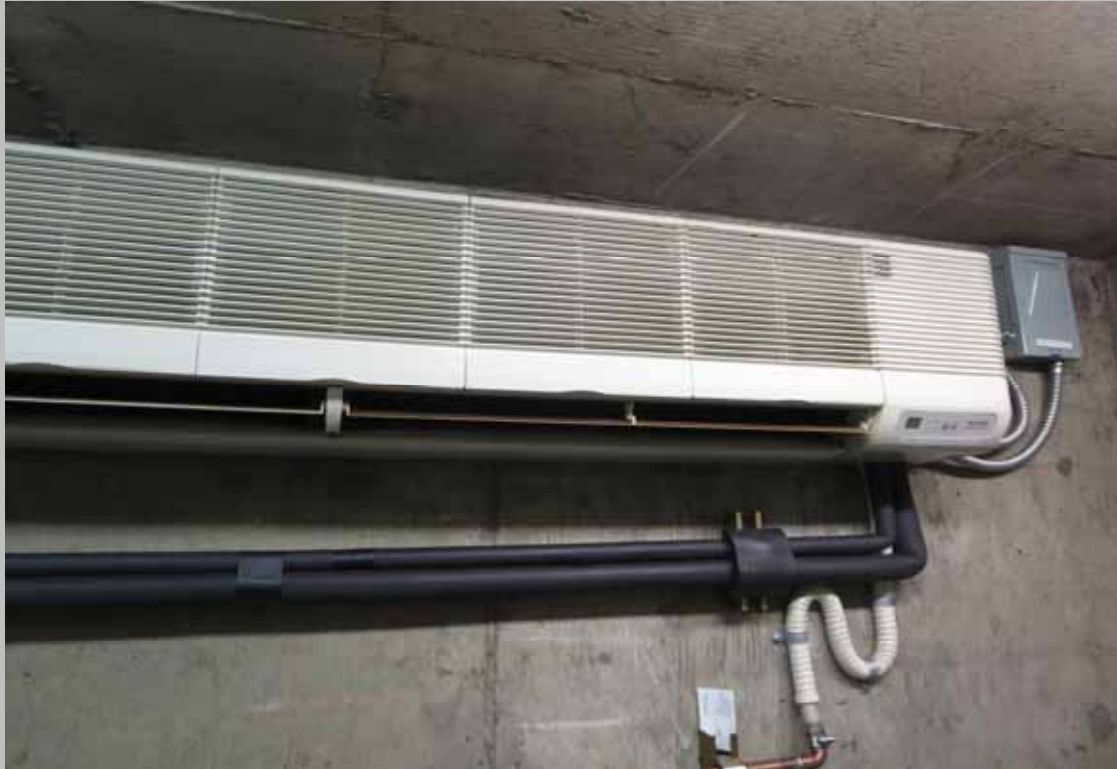
PHOTO #33

Mini split system

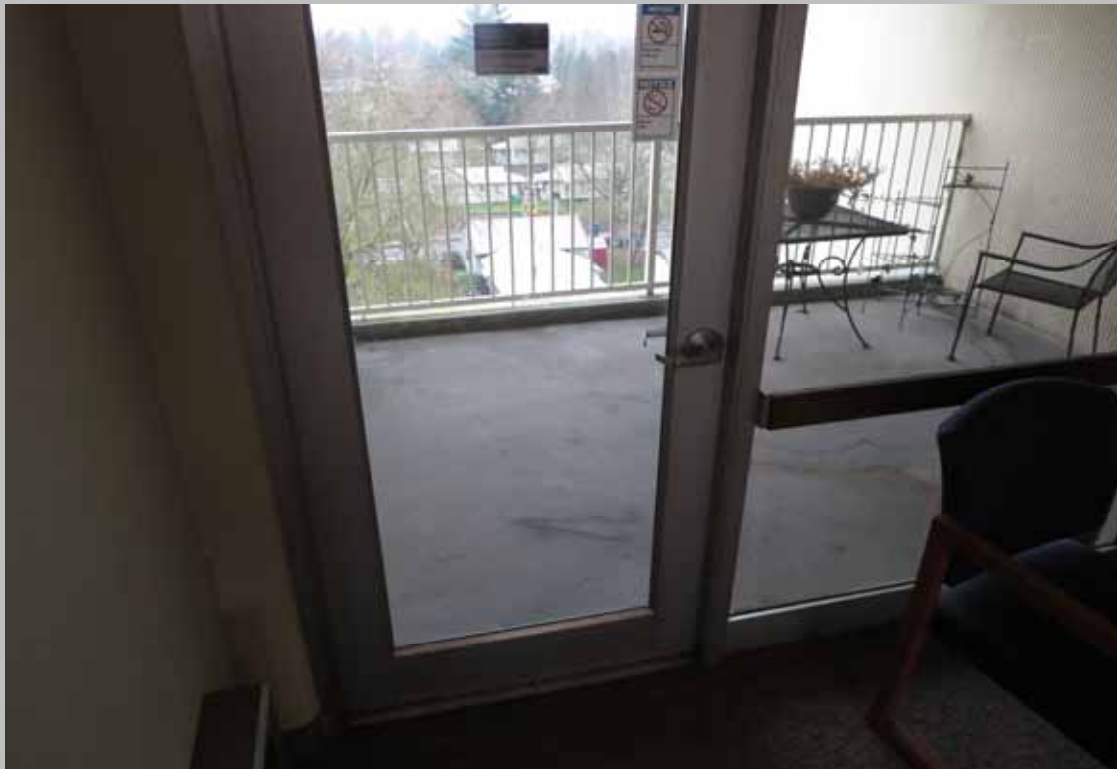
PHOTO #36

Common balcony

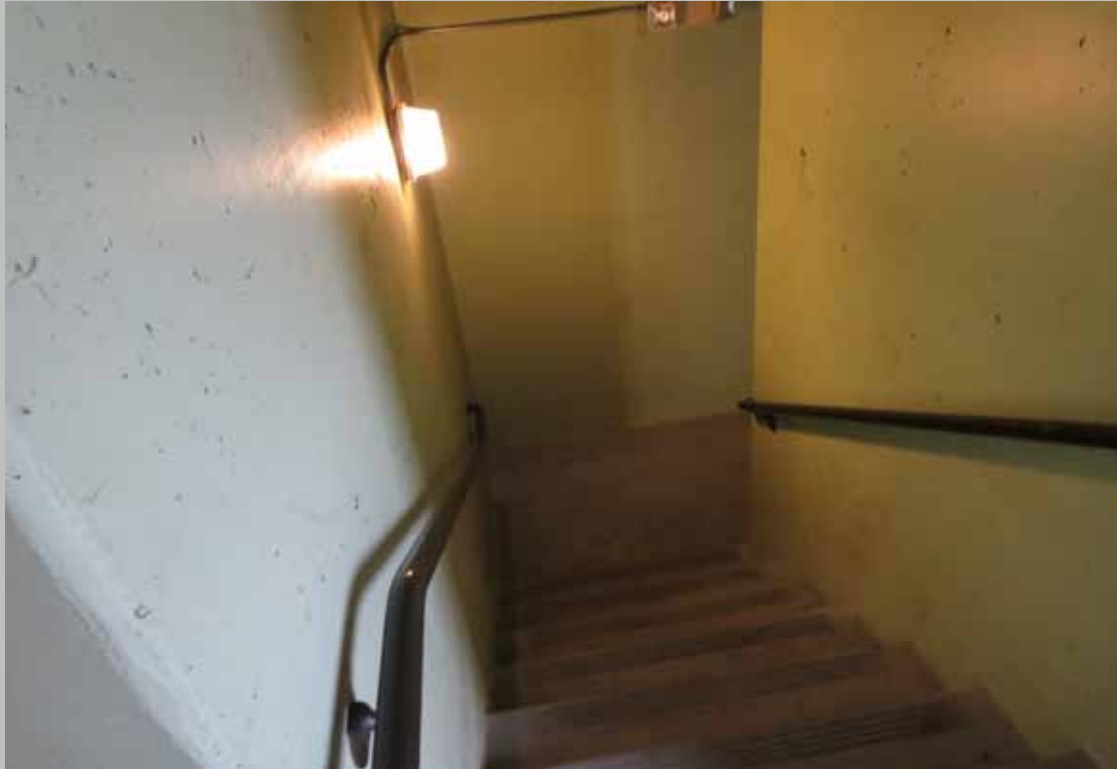
PHOTO #37

Common stairwell

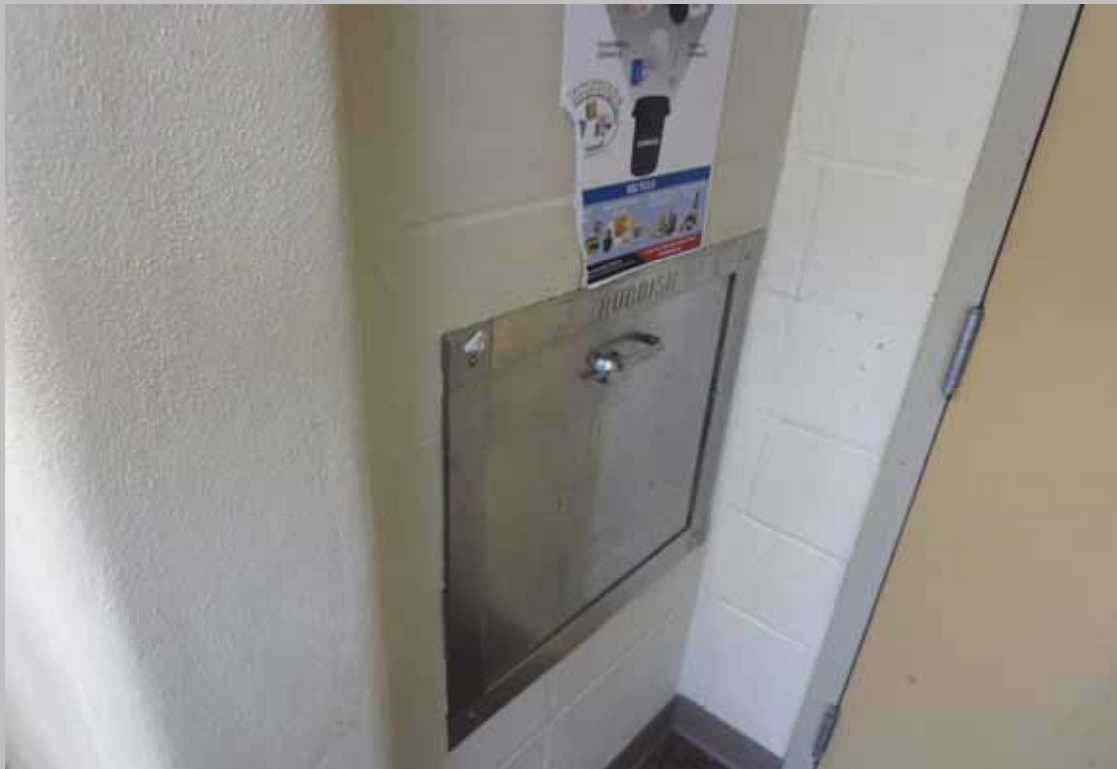
PHOTO #38

Trash chute

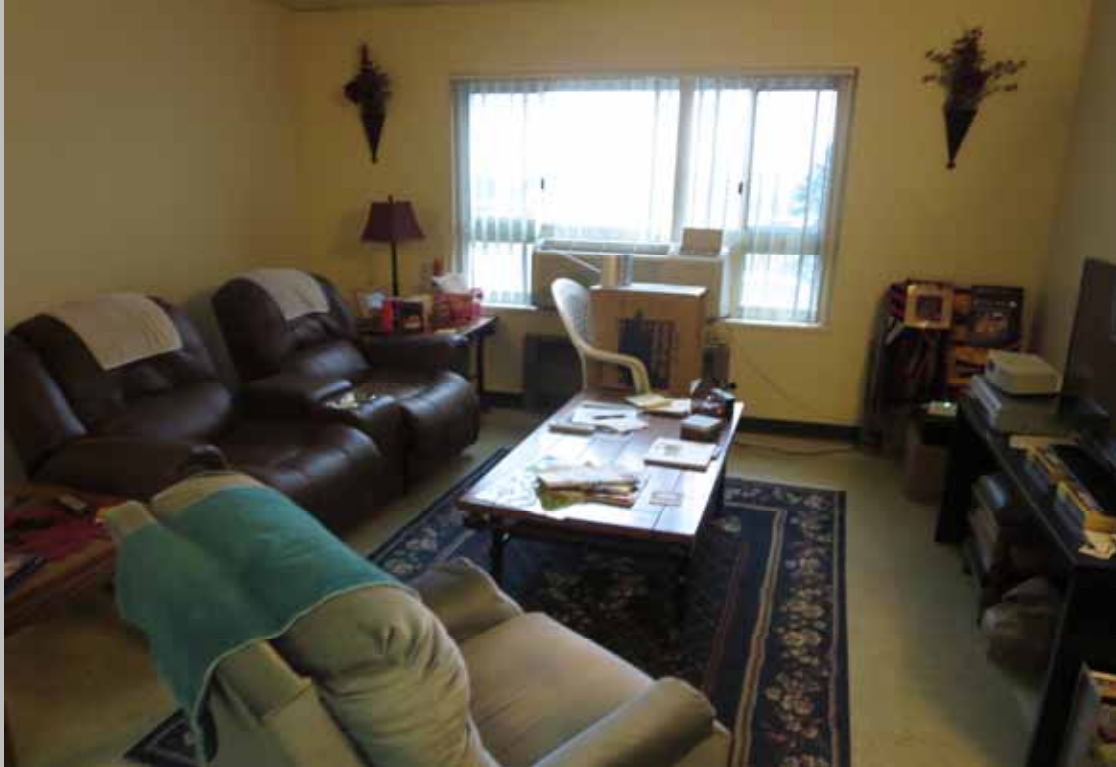
PHOTO #42

Dwelling unit living room

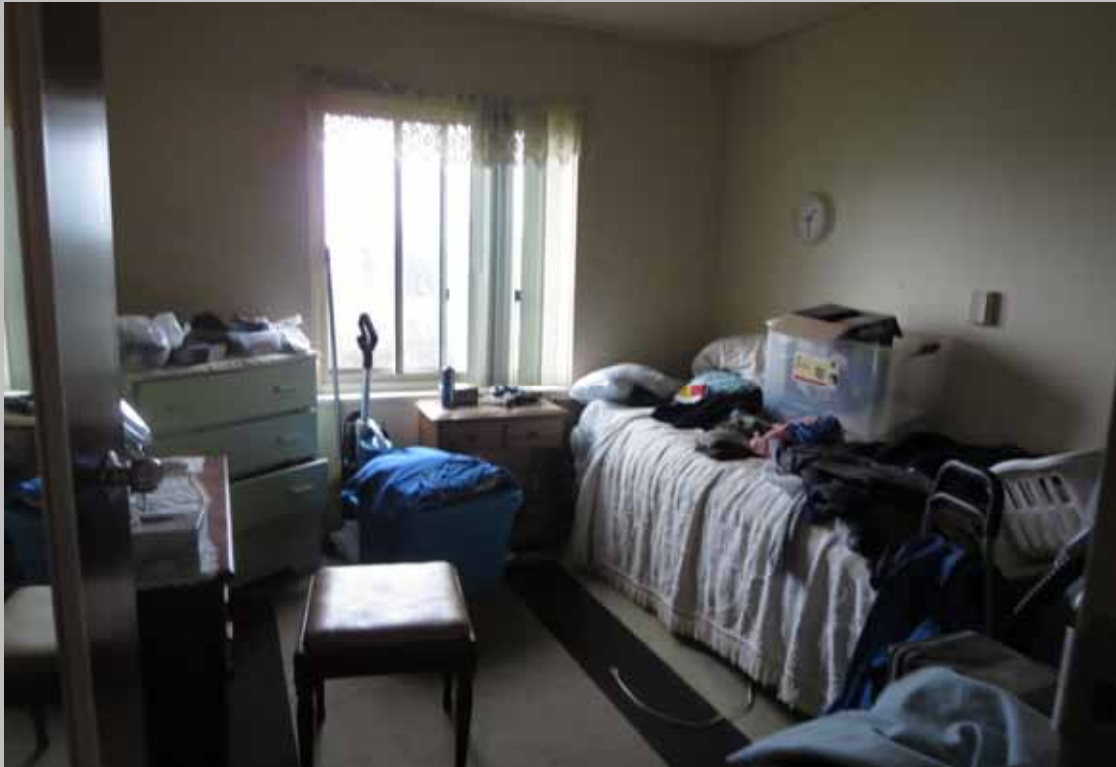
PHOTO #43

Dwelling unit bedroom

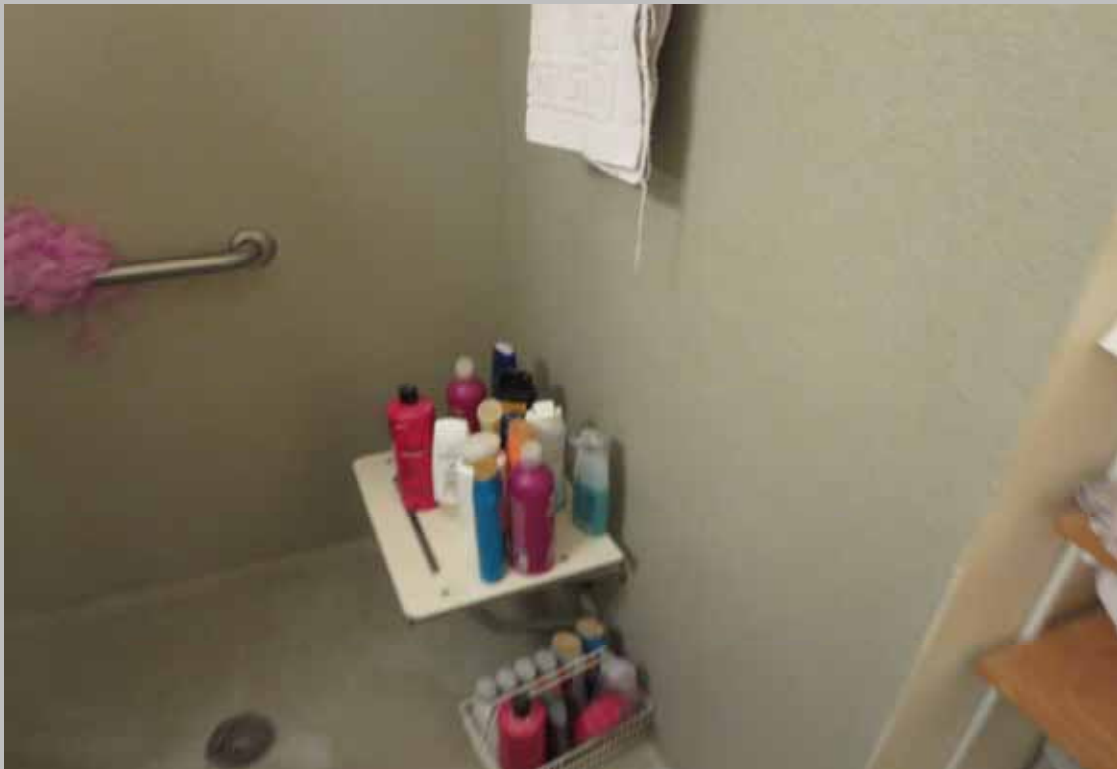
PHOTO #55

Handicapped unit shower
